Application by
Waterford County Council
for Review of Waste Licence Application W0032-02
for Dungarvan Landfill, Co. Waterford

***Replies to Request
for further information in accordance with
Article 14(2)(b)(ii) of the Waste
Management Regulations***

Dungarvan Landfill Waste Licence Application Article 14 Response

Client	Waterford County Council					
Project Title	Dungarvan Landfill Remediation Works					
Document Title	Waste Licence Application W0032-03 Article 14 Response					
Document No.	MDR0350R0011					
This Document Comprises	DCS	TOC	Text	List of Tables	List of Figures	No. of Appendices
	1	1	12	-	-	4

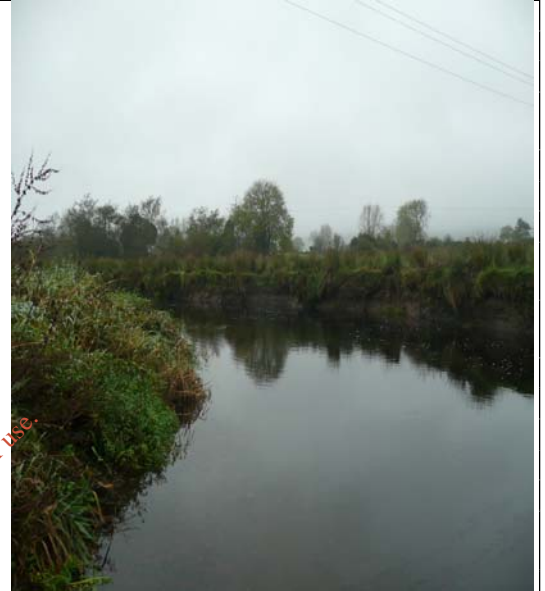
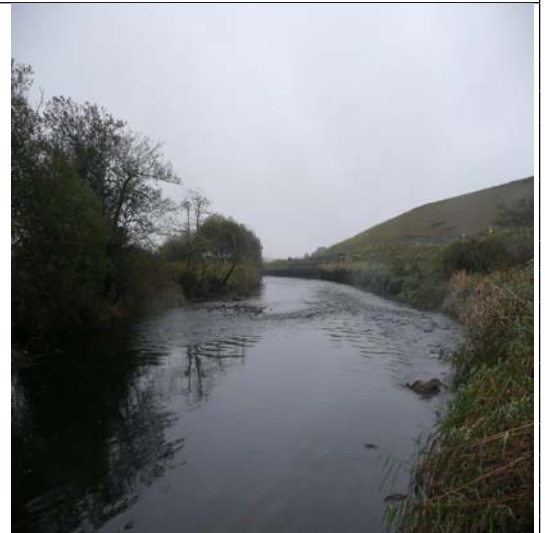
Physical Characteristics of Sampling Locations		
SW2 Downstream of Disused Railway bridge		
GPS	624297, 594952 ITM	
Average River Width (m)	8	
Average River depth (cm)	75 (deep channel >1.5m opposite bank)	
Currents	Moderate flow (50% pool, 10% riffle, 40% glide)	
Colour	none	
Odour	none	
Reducing Conditions	none	
Substratum	20% Boulders, 60% cobble, 10% sand and gravel	
Channel modifications	Evidence of recent bankside erosion on opposite bank	
Vegetation Instream	Type	Abundance
	<i>Enteromorpha</i>	Frequent
	<i>Fontanalis</i>	Frequent
	<i>Ranunculus</i>	Rare
Vegetation Emergent	Type	Abundance
	<i>Apium nodiflorum</i>	Occasional
	<i>Phragmites australis</i>	Occasional
SW1 Opposite drain from Landfill		
GPS	624391, 594673 ITM	
Average River Width (m)	12	
Average River depth (cm)	60	
Currents	Moderate flow (5% pool, 20% riffle, 60% glide)	
Colour	none	
Odour	none	
Reducing Conditions	none	
Substratum	40% cobble, 20% boulder, 30% pebbles

Channel modifications	none	
Vegetation Instream	Type	Abundance
	<i>Enteromorpha</i>	Frequent
	<i>Fontanalis</i>	Rare
Vegetation Emergent	Type	Abundance
	None	-

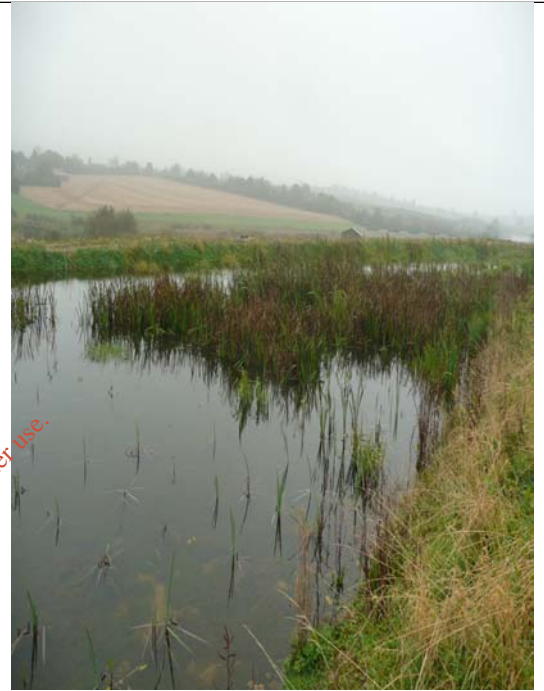
Physical Characteristics of Sampling Locations		
SW4 Large Pond (Southern Boundary of Landfill)		
GPS	624391, 594673 ITM	
Pond Area	Approx 1 acre	
Marginal Complexity	Simple	
Zooplankton	Abundant Daphnia present	
Water Clarity	Clear	
Odour	Smell of H ₂ S	
Substratum	Soft mud	
Notes	Artificial pond with constructed wetland	
Vegetation fully aquatic	Type	Abundance
	<i>Elodea Canadensis</i> <i>Myriophyllum spicatum</i>	Frequent Frequent
Vegetation Emergent	Type	Abundance
	<i>Typha latifolia</i>	Frequent
