Re: Waste Water Discharge Licence Application – Additional Information for D0297-01 – Castletownbere

**Draft Hydrometric Survey
&
Draft Hydrodynamic Modelling Results**

DRAFT HYDROMETRIC SURVEY

**HYDROMETRIC SURVEY
CASTLETOWNBERE CO. CORK
FOR
MARCON COMPUTATIONS
ON BEHALF OF
TOBIN ENGINEERING**

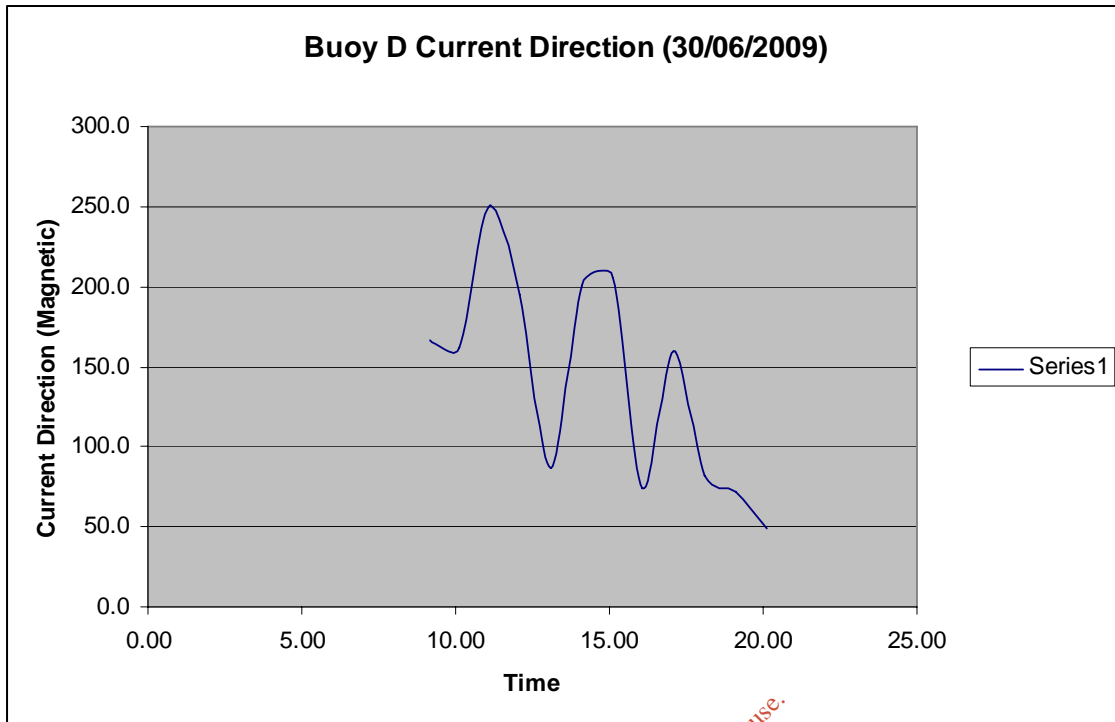
The current measurements recorded at Point D on 30/06/2009 show fluctuating speeds and directions. Current speeds vary from 15 m/sec in the morning to 5 m/sec in the afternoon and then rise again to 20m/sec in the evening. The current direction throughout this period shows fluctuating movement. Currents vary from 250° to 90° in the space of three hours. They then change another two times during the survey period.

Figure 12. Current Direction for Point D on 30/06/2009

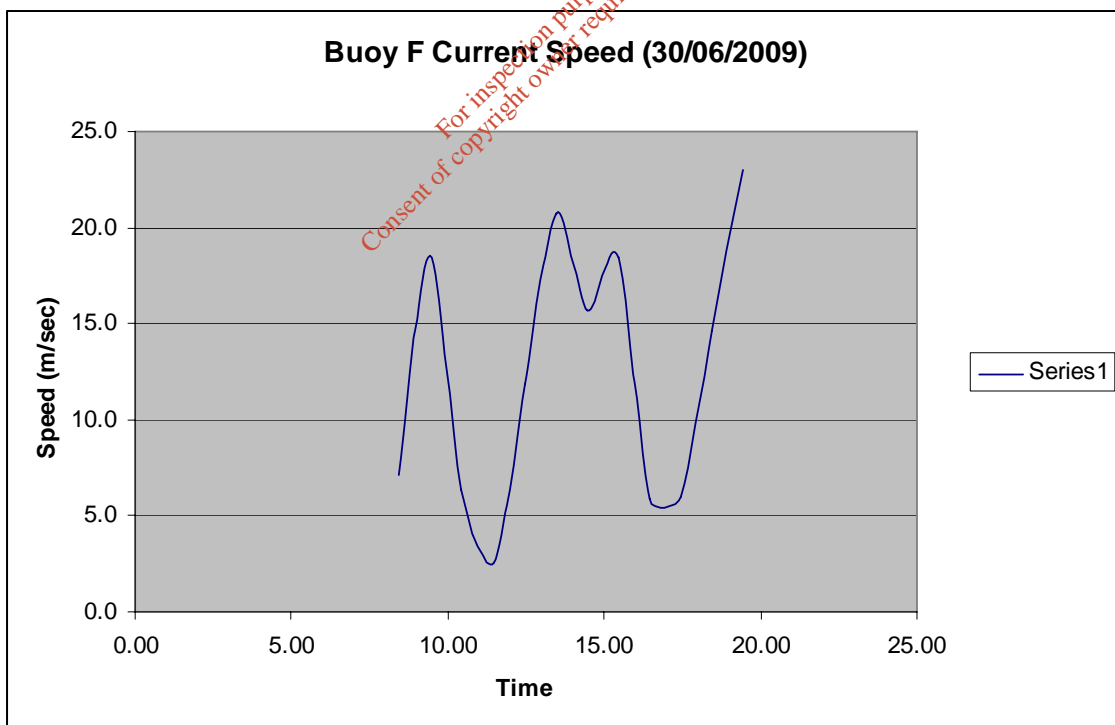
The current measurements recorded at Point F on 30/06/2009 show fluctuating speeds and directions. Current speeds vary from 18 m/sec in the morning to 3 m/sec in the afternoon (low tide) and then rise again to over 23m/sec in the evening when the tide is filling again. The current direction throughout this period shows fluctuating movement. Currents vary from 250° to 90° in the space of three hours.

Figure 15. Current Speed for Point F on 30/06/2009

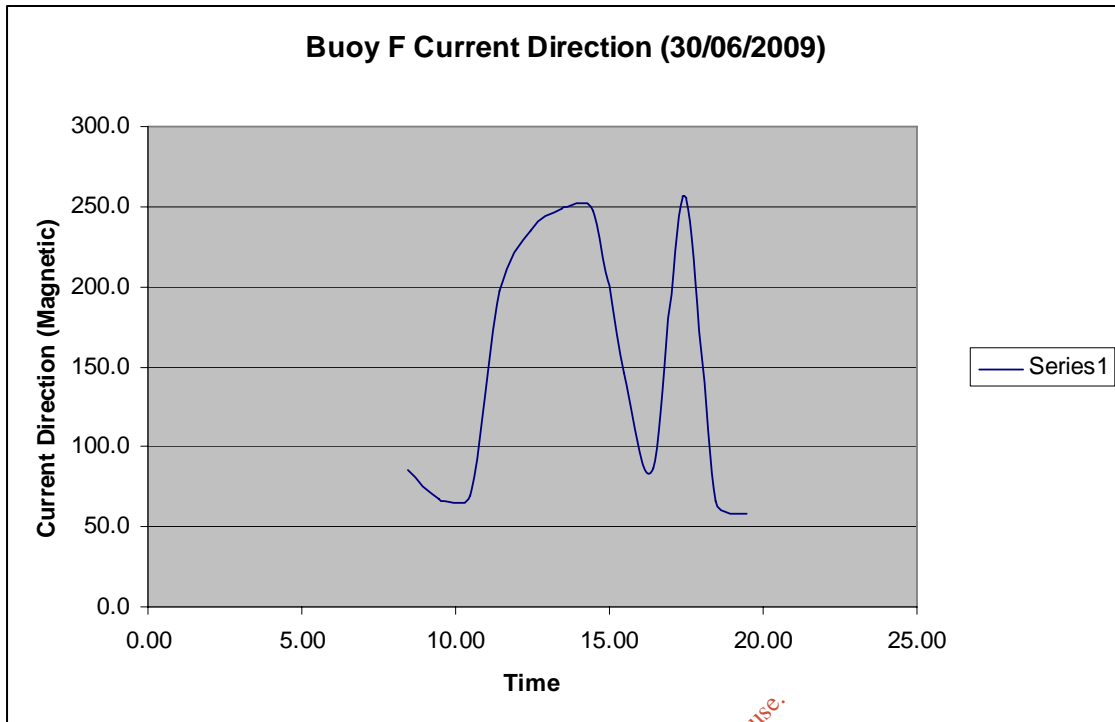
Figure 16. Current Direction for Point F on 30/06/2009

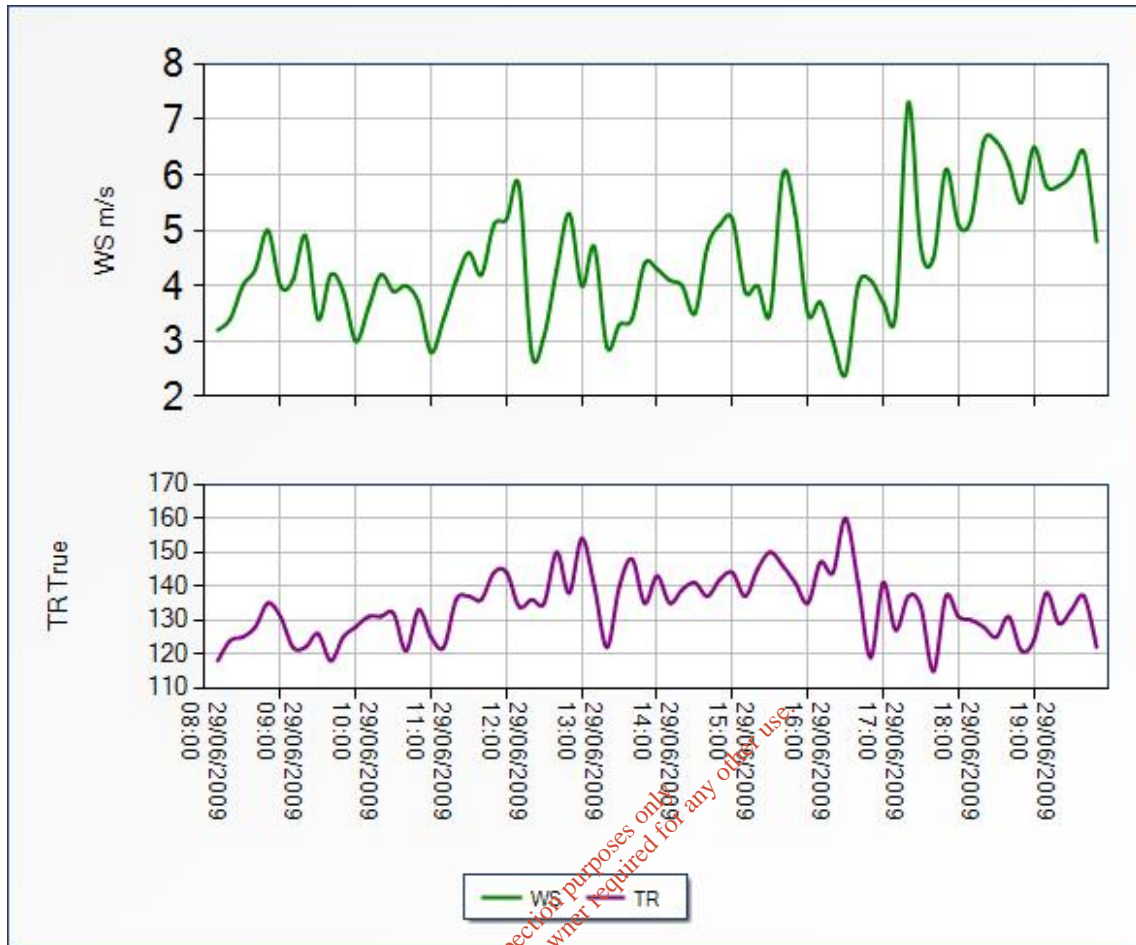
The anemometer readings were plotted using Kestrel software. They demonstrate that on both 29th and 30th June there were gusting winds on 29th ranging rising in speed from 2.5 in the morning to an average of 6m/sec in the afternoon. There was a steady wind direction of 120° to 160° (true). On 30th June wind speeds were decreased. They were steadily high in the morning and then reduced in the afternoon. There was a predominant wind direction of 140° to 170° throughout the entire day.

Figure 17. Wind Speed and direction for 29 June 2009
