CORK CITY COUNCIL

KINSALE ROAD LANDFILL SITE

Annual Environmental Report

January 2008 – December 2008

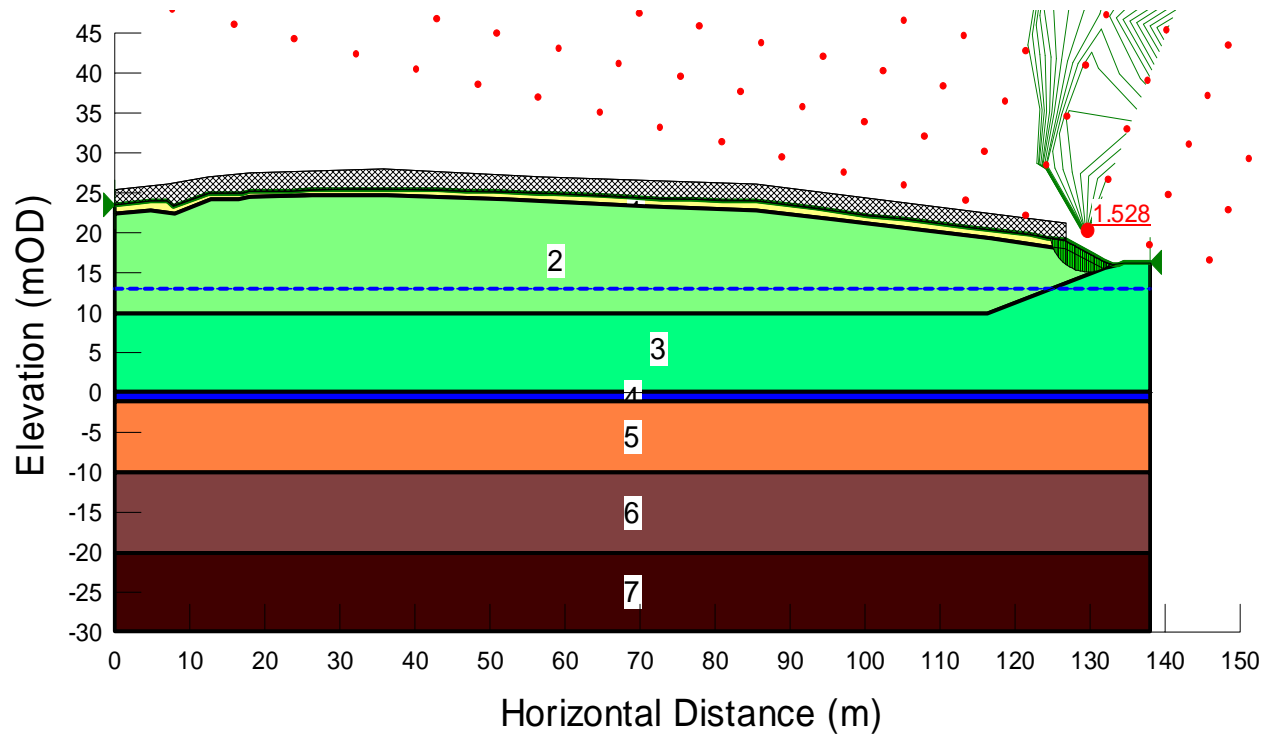
Figure 3.1: Typical slope failure for Section A-A (Morgenstern-Price Method) for Groundwater Level of 13m AOD.

Material #: 1	Description: Clay Cap	Wt: 18	Cohesion: 4	Phi: 29
Material #: 2	Description: New Waste	Wt: 9.5	Cohesion: 10	Phi: 15
Material #: 3	Description: Old Waste	Wt: 11	Cohesion: 10	Phi: 22
Material #: 4	Description: Peat	Wt: 14	Cohesion: 0	Phi: 15
Material #: 5	Description: Silty Clay	Wt: 19	Cohesion: 0	Phi: 26
Material #: 6	Description: Glacial Till	Wt: 20	Cohesion: 0	Phi: 33
Material #: 7	Description: Rock	Wt: 23	Cohesion: 1000	Phi: 45

Slope name	Leachate Level at top of slope (mAOD)	Morgen stern-Price FoS	Bishop FoS	Janbu FoS	Slip Length (m)	Slip type & location
Section A-A	13.0	1.83	1.84	1.53	8	Shallow rotational slip near toe of slope
Section B-B	13.0	1.81	1.80	1.68	77	Deep rotational slip in clay cap, waste and peat
Section C-C	13.0	2.78	2.78	2.59	40	Deep rotational slip in clay cap, waste and peat
Section D-D	13.0	2.31	2.30	2.11	42	Deep rotational slip in clay cap, waste and peat

Factor of safety values against deep-seated rotational or shallow translational failures of the landfill embankment within the waste and underlying strata ranged from 1.53 to 3.03. The lengths of the potential failures are in the range of 8 m to 77 m. Out of the total eight case scenarios, all of the analyses have a factor of safety of 1.5 or above.
