**Re: A0392-01 – Crookhaven Waste Water Discharge Certificate Application –  
Reply to Notice in accordance with Regulation 25(c)(ii) of the Waste Water  
Discharge (Authorisation) Regulations 2007**

## Wastewater Discharge Certificate of Authorisation: A0392-01 Crookhaven

**Habitats Directive Assessment (Screening Report) in respect of**

**Crookhaven Agglomeration**

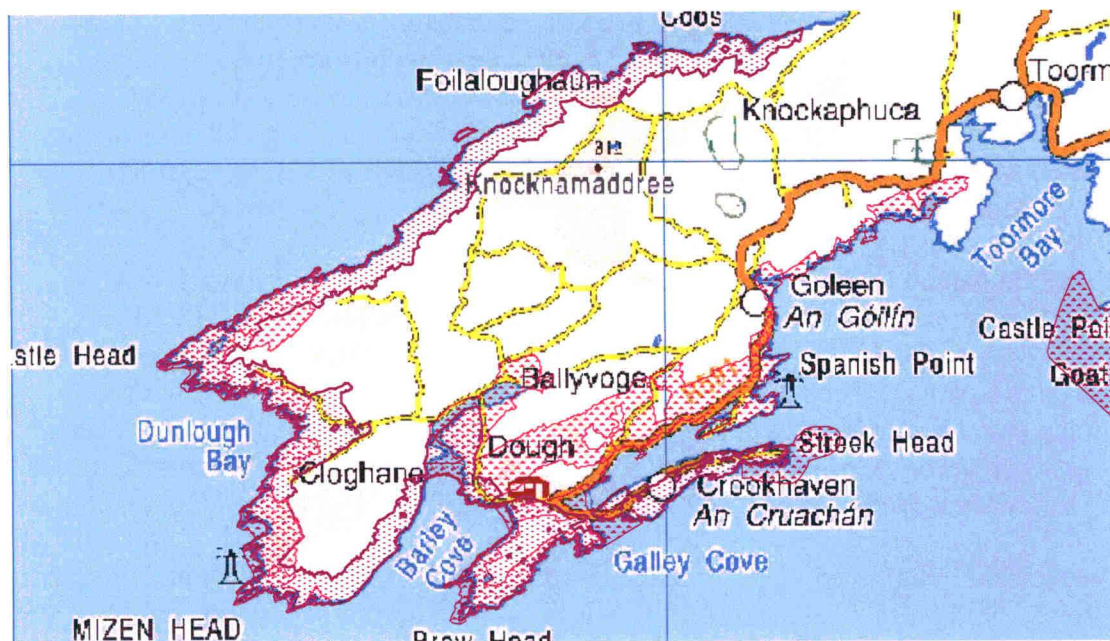
2 Map of Sheeps Head To Toe Head SPA (Partly Only) & Barley Cove To Ballyrisode Point SAC & location of Crookhaven.

The treatment system in Crookhaven is a primary treatment plant (septic tank) adjacent to the Shoreline. Built in the 1970's with a capacity of 31m<sup>3</sup>, it was originally designed for a p.e. of 160. Treated effluent from the septic tank outfalls to Crook Haven via an existing outfall pipe adjacent to the septic tank.

The discharge point relating to Crookhaven agglomeration is approximately 100m from the Sheeps head to Toe Head SPA (Site Code 004156) and approximately 500m from Barley Cove to Ballyrisode Point SAC (Site Code 001040). The agglomeration discharges into Crook Haven which is a large, well exchanged body of water with high dilution and the pe of the agglomeration is <500pe. A Habitats Directive Assessment (Screening Report) for Crookhaven Agglomeration has been carried out and is attached. It can be concluded from this that an appropriate assessment is not required for this agglomeration.

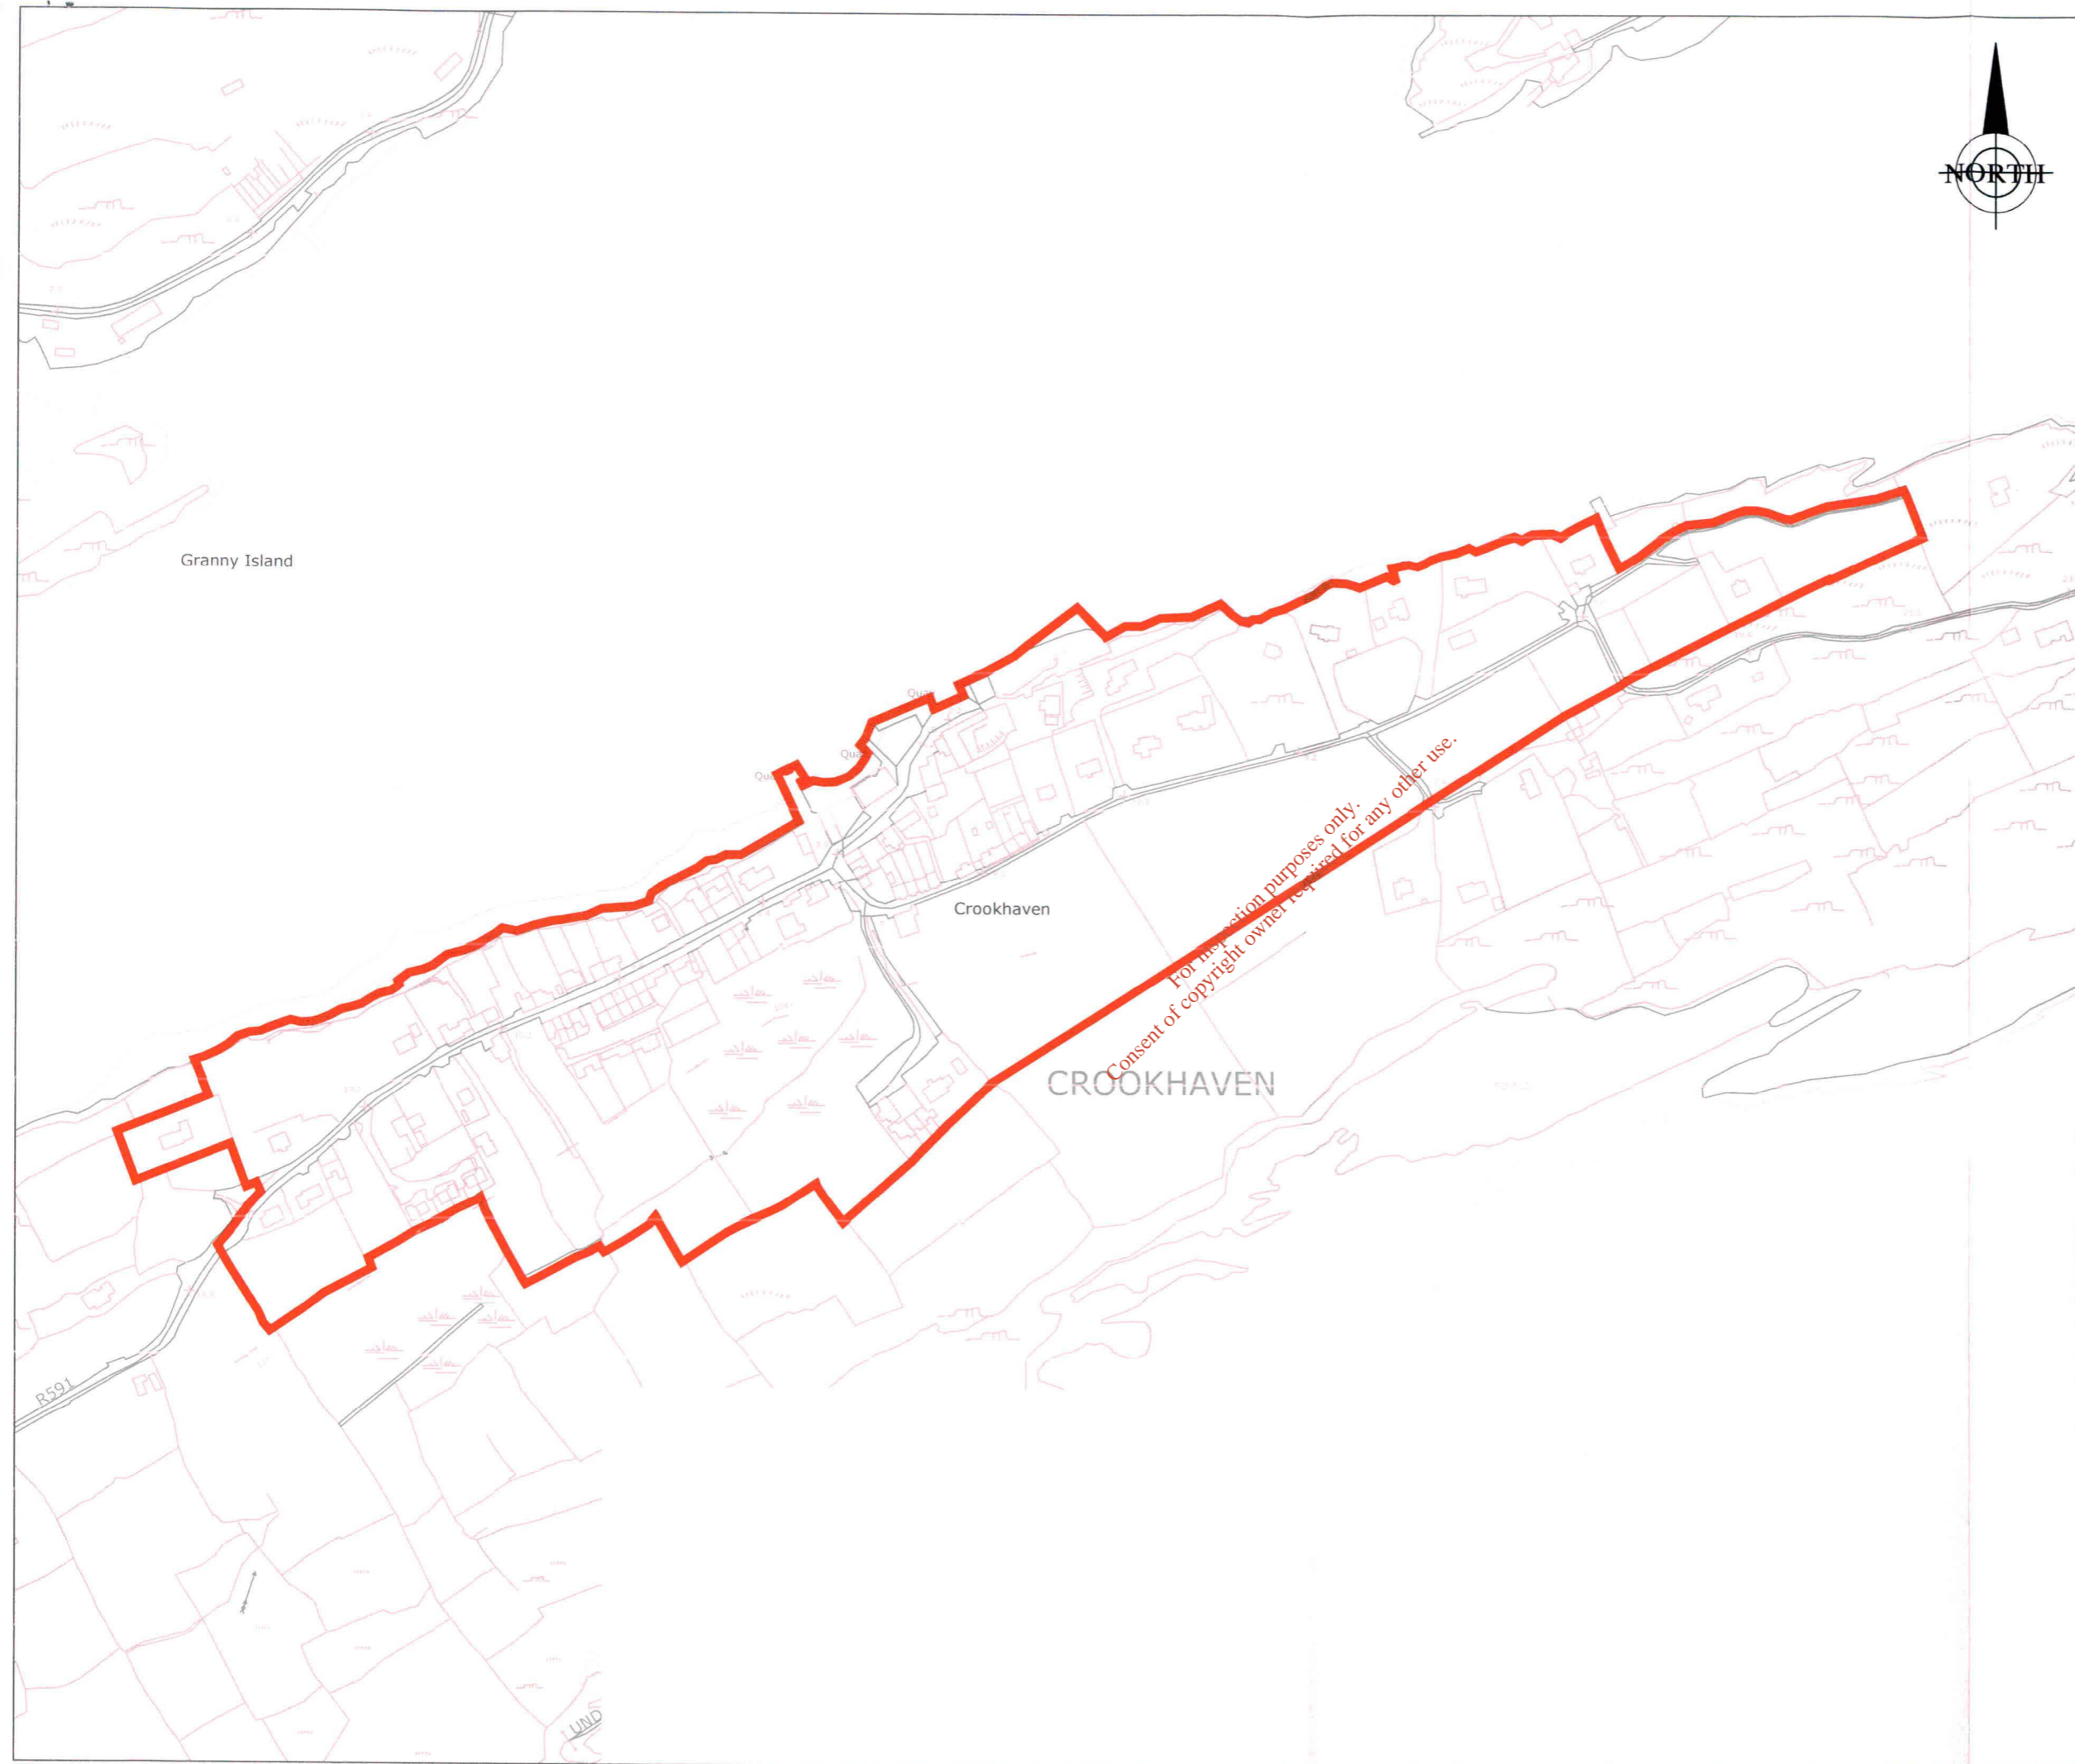
**Drawing Title:**  
ATTACHMENT B.1  
AGGLOMERATION BOUNDARY

No.	Date	Drawn	Checked	Revision Description
A	Jan 2011	OOB		Agglomeration Boundary Revised

See attached drawing no. CROO B1-01 Rev A for revised agglomeration boundary.
