9 February 2011

**RE: ROADSTONE WOOD LIMITED : WASTE LICENCE APPLICATION  
MILVERTON WASTE RECOVERY FACILITY  
RESPONSE TO ARTICLE 14 COMPLIANCE NOTICE**

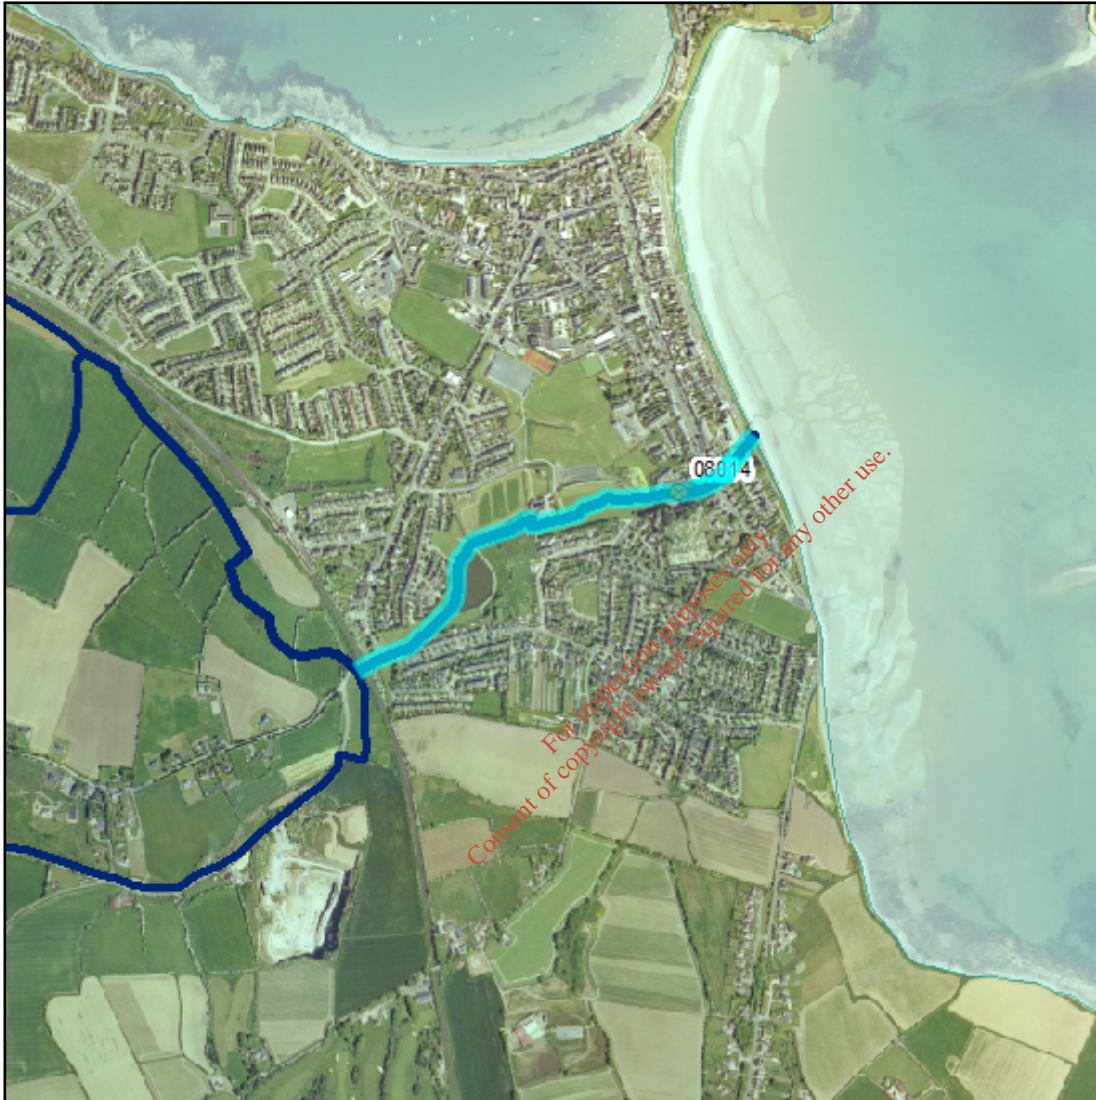
River Name	(08_483)
XY Location	324877,259573 (ING)
River Segment Map

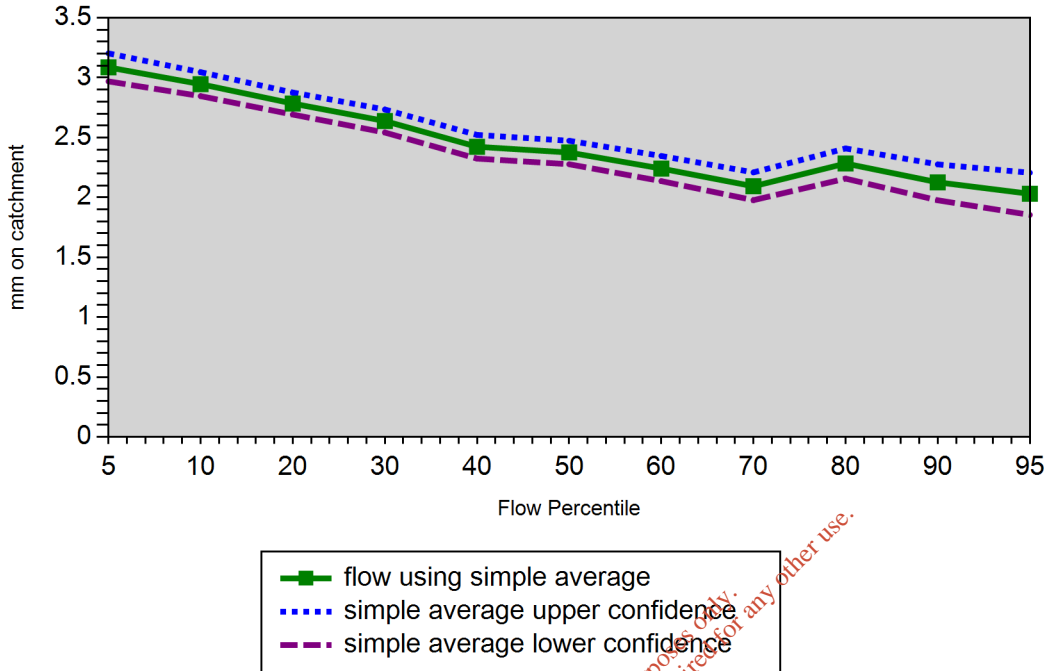
**Flow Duration Curve (mm on catchment)**

Log Flow (mm on catchment)			
%ile	mm	upper 95% confidence limit	lower 95% confidence limit
5	3.086	3.203	2.969
10	2.946	3.046	2.846
20	2.784	2.876	2.692
30	2.638	2.734	2.542
40	2.423	2.522	2.324
50	2.375	2.473	2.277
60	2.241	2.346	2.136
70	2.093	2.209	1.977
80	2.283	2.409	2.157
90	2.126	2.276	1.976
95	2.03	2.206	1.854
