# SOIL AND GEOLOGY 5

- 5.1 This Chapter of the Environmental Impact Statement evaluates the regional and local geological conditions at the proposed inert waste recovery facility at Huntstown and assesses the impact that the backfilling activity will have on the geology of the area.
- 5.2 The information presented in this chapter is based on a detailed examination of the existing quarry and its surroundings and was prepared by EurGeol Dr. John Kelly PGeo, MIMMM, MIQ in accordance with the publication *Geology in Environmental Impact Statements* issued by the Institute of Geologists of Ireland.

**WASTE RECOVERY FACILITY,  
HUNTSTOWN QUARRY,  
NORTH ROAD, FINGLAS, DUBLIN 11**

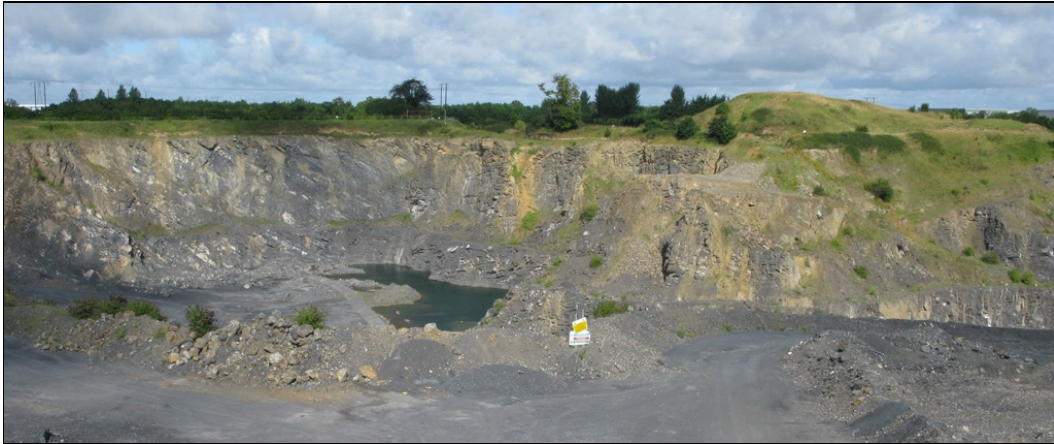
Plate 5-1 Limestones Exposed in Western Face of the North Quarry.  
Note steep dip to north-west and well-bedded nature of the limestones.

- 5.15 The North Quarry, where the proposed inert soil recovery facility is to be located, is developed in a sequence of well-bedded limestones. Academic research on the fossil fauna of the bedrock sequence exposed at the quarry indicates that it is also developed within sub-Waulsortian limestones of the Malahide Formation. The sequence becomes shale dominated to the north-west as seen in borehole GW04 and in the upper part of the faces in the extreme north-west corner of the quarry.

- 5.21 The rock is strong to very strong and weathering is rarely significant more than a few tens of metres below the rock surface.
- 5.22 A detailed local bedrock geology map prepared on the basis of information presented and discussed above is presented in Figure 5-4, while a simplified geological cross-section through the Huntstown Quarry complex is provided in Figure 5-5. Some of the geological features and characteristics discussed above are illustrated in Plates 5-1 to 5-4 at the end of this chapter.

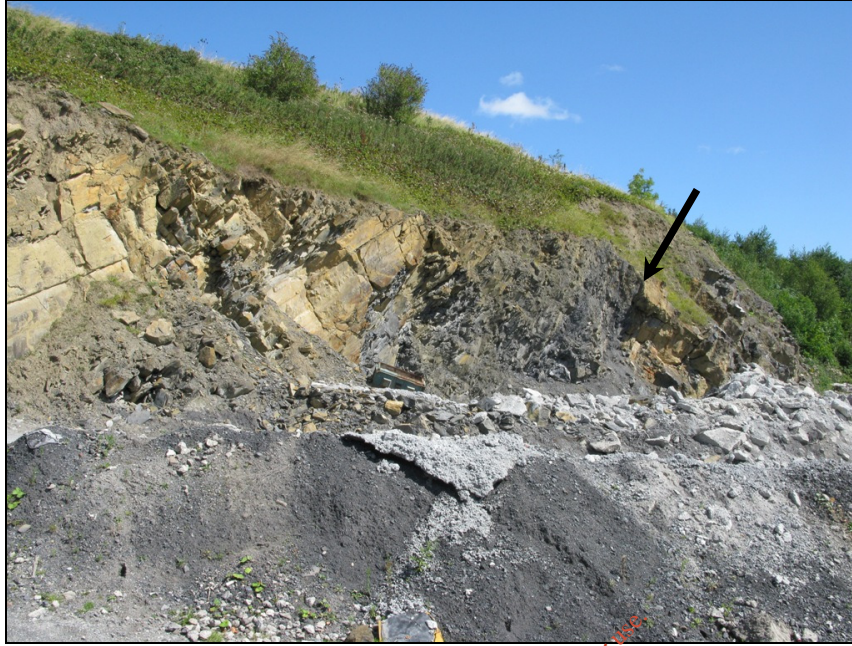
Plate 5-3 Huntstown Central Quarry. Exposure of the Geological Contact between the Waulsortian Limestones of the Feltrim Limestone Formation (to right) and Tober Colleen Formation (to left). Contact marked by arrow.

- 5.14 The Central Quarry is not currently being worked and has been developed as a construction and demolition waste recycling facility. The quarry is developed in pale micritic Waulsortian limestones of the Feltrim Limestone Formation. The contact between the Waulsortian limestones and the overlying Tober Colleen Formation is exposed in the sides of the roadway leading into the Central Quarry from the north

- 5.17 As the limestones exposed in the North Quarry have been dated as being older than, and therefore stratigraphically below, the Waulsortian Limestones of the Central Quarry, there must be a significant reverse fault present between the central and southern quarries. A probable fault plane has been identified in the immediate southern part of the North Quarry where the main access road enters this area. This is interpreted as part of the trace of the reverse fault and the trace of the reverse fault has therefore been located on the basis of this exposure.

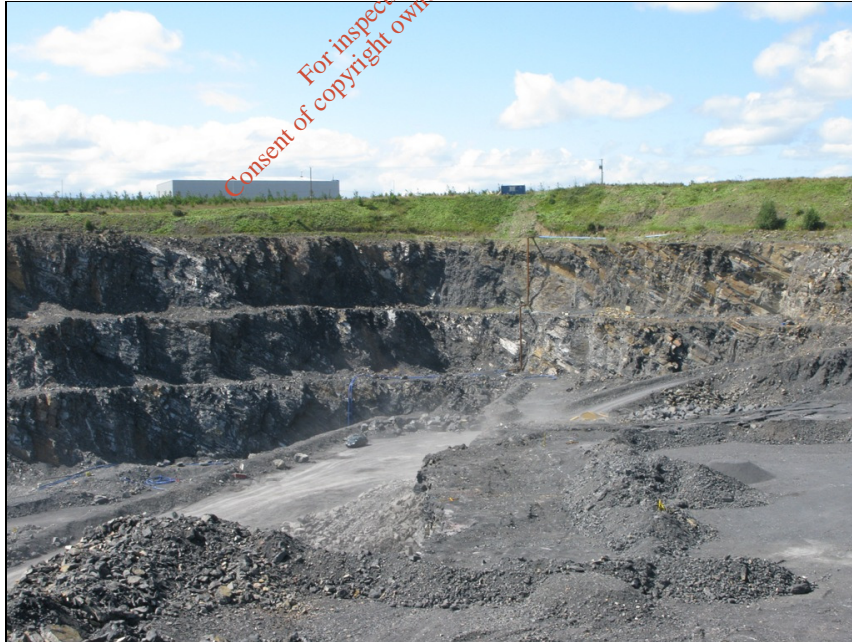
Plate 5-4. Limestone Sequence Exposed in South-western Part of South Quarry

- 5.13 The South Quarry at Huntstown is developed within limestones of the Malahide Formation which dip steeply to the north in the eastern part of the quarry and to the north-west in the western part of the quarry. The limestones are dominated by well-bedded limestones with minor shales. Banded, interbedded limestone and shale are exposed in the north-western corner of this extraction area.
