ANNUAL ENVIRONMENTAL REPORT

JANUARY 2010 THROUGH DECEMBER 2010

Registration Number: W0123-01

Licensee: Custom Compost

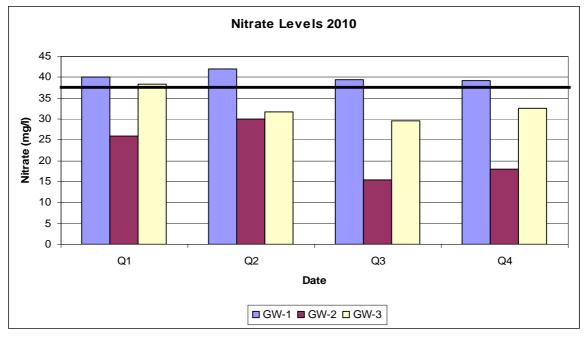
Figure 2.1 Nitrate Levels 2010

Nitrate levels recorded throughout the year vary, with GW-1 exceeding the threshold value of 37.5 mg/l for Nitrate as NO₃ for all four monitoring events. The Nitrate concentration in GW-3 exceeded the limit in Quarter 1. Nitrate levels in groundwater in the South East region of Ireland are known to be elevated and this is evident in the upgradient well, GW-3, with values ranging from 29.6 mg/l (as NO₃) in Quarter 3 to 38.4 mg/l (as NO₃) in Quarter 1 -2010. As the groundwater monitoring results indicate that the nitrate contamination was evident at the upgradient borehole it is likely that a source of contamination is likely upgradient of the site and may have resulted from local agricultural practices in the area. The average levels recorded in GW-1, GW-2 and GW-3 are 40.15 mg/l, 22.40 mg/l and 33.10 mg/l, respectively.

The nitrate levels recorded in all three wells are significant and are illustrated in Figure 2.1 below.

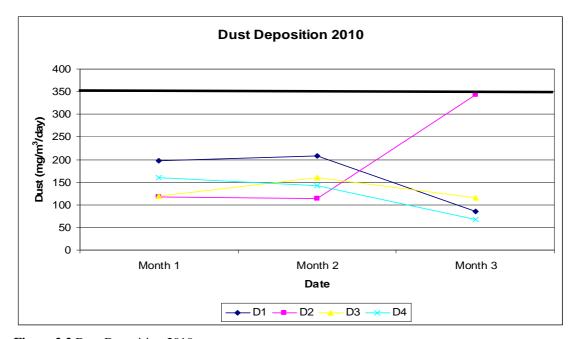
Figure 2.2 Dust Deposition 2010

When the jar at Station D2 was initially installed, in May 2010, there was a good separation from the straw bales. However, by July, the straw bales were stacked quite close to the sampling location which could have resulted in localised contamination of the jar. In addition, some tidying work was also carried out in the area which could have caused localised interference with the sample. The location of Station D2 will be re-examined for 2011 to ensure no localised interference.

It is also possible that the harvesting of crops, barley, in the adjacent fields could have caused the unusual elevated dust deposition at Station D2 in July. The dust deposition rate recorded for all four analysis events are illustrated in Figure 2.2 below.

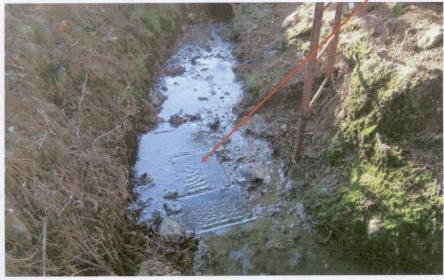
SW-1 Sampling point

Surface water ditch at SW-1, 14th December 2010

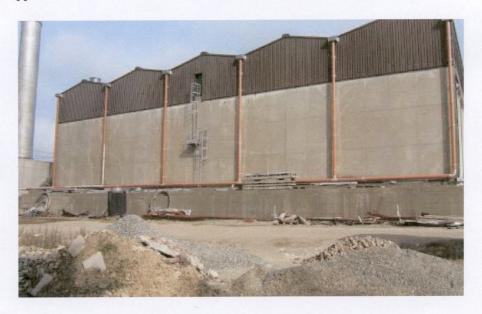
Appendix 3. New roof water collection system, taken 1st September 2010
