**Connaught Regional Residual Landfill
EPA Waste Licence W0178-02**

Annual Environmental Report

January 2010 - December 2010

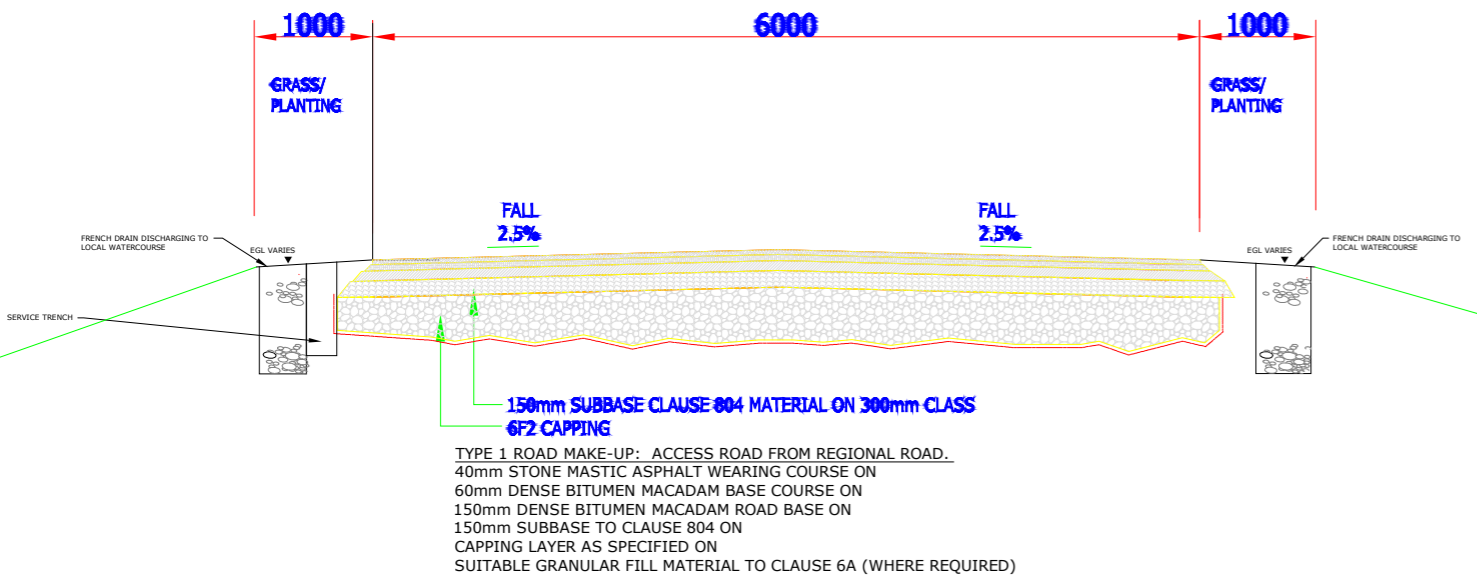
TYPE 1 - ACCESS ROAD FROM REGIONAL ROAD(TYPICAL DETAIL)
