GALMOY MINES LTD
MIANAIGH GHABHALMHAIGH TEORANTA

Annual Environmental Report 2010

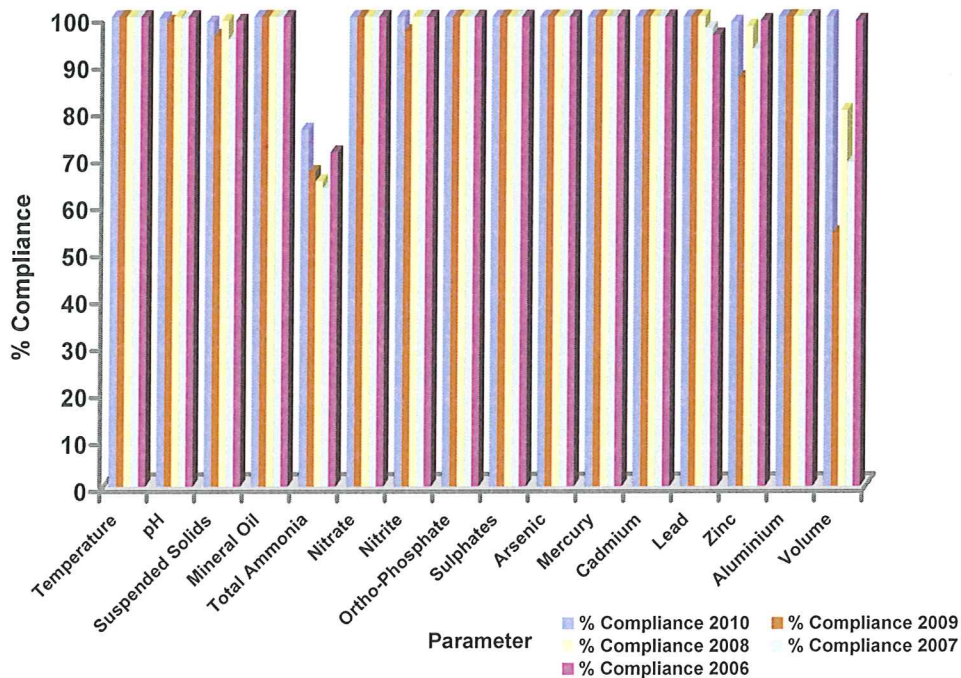
Figure 6-1 Rate of Compliance for Parameters Monitored at SW1 2005 - 2010

The Discharge Effluent is a combination of treated water from the PS8 and GW1 settlement ponds. It is discharged directly to the River Goul. Figure 6-1 shows the percentage rate of compliance for each of the parameters measured at SW1 from 2005 - 2010. The compliance rate is calculated based on the daily concentration for each parameter with respect to emission limit values as per licence conditions. Twelve out of sixteen parameters achieved one hundred percent compliance for 2010. Non-compliances for pH, suspended solids, total ammonia and zinc are detailed in Section 19 – Notification of Incidents.

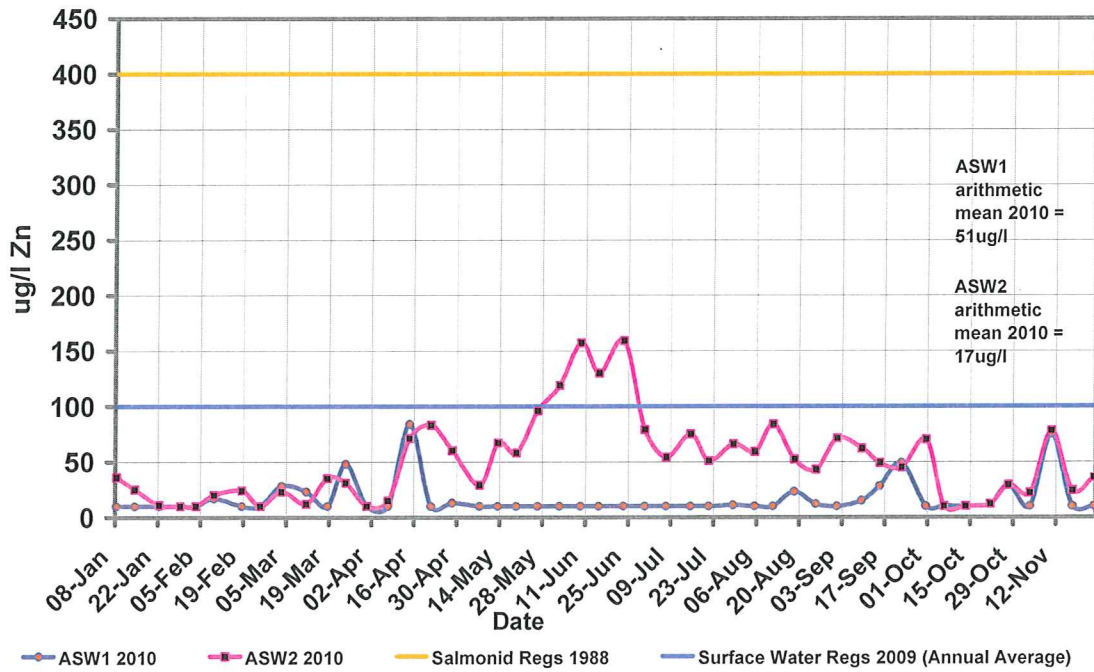
Figure 7-4 Zinc concentration upstream and downstream River Goul 2010

Figure 7-4 illustrates the concentration of zinc monitored in the River Goul over the reporting period January – December 2010. The zinc levels downstream vary considerably but are significantly lower than the Salmonid Water Regulation 1988 limits. The limit for zinc in the Surface Water Regulations 2009 has been set at 100µg/l. The downstream samples have breached this limit on occasion.

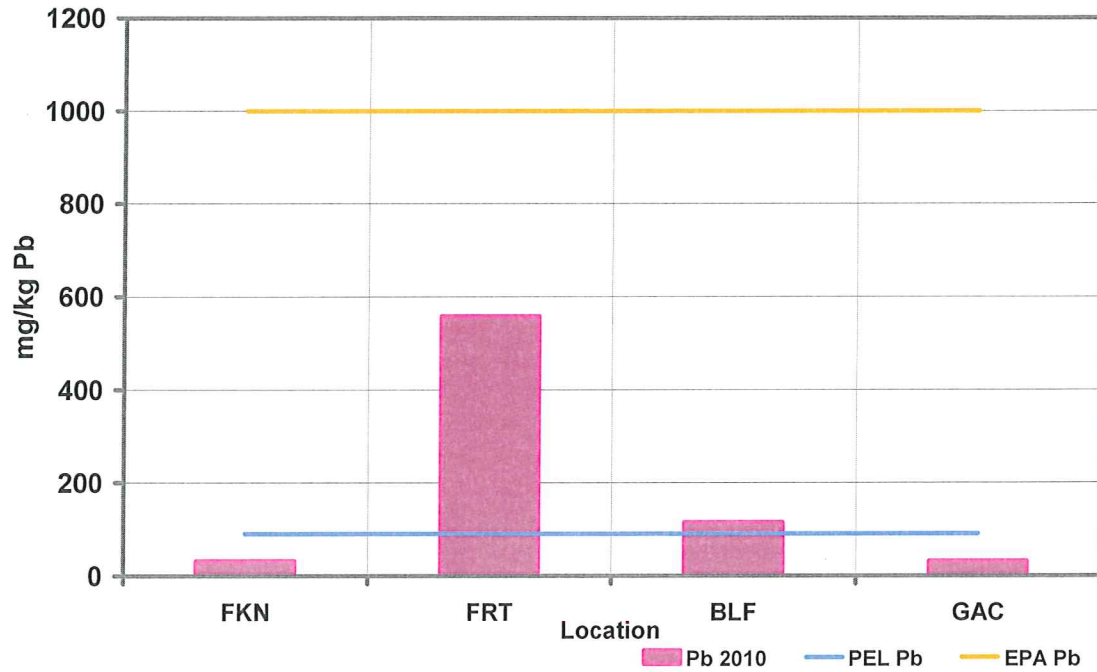
Figure 9-1 Concentration of lead in river sediments from the rivers Goul and Glasha, 2010

The sediment results reflect similar trends from previous surveys and do not exceed EPA guidelines. Figures 9-1 and 9-2 compare the levels of lead and zinc at the same sites reported in the 2009 AER. All sites were assessed using EPA sampling and analytical methodology. Further information on this survey can be obtained

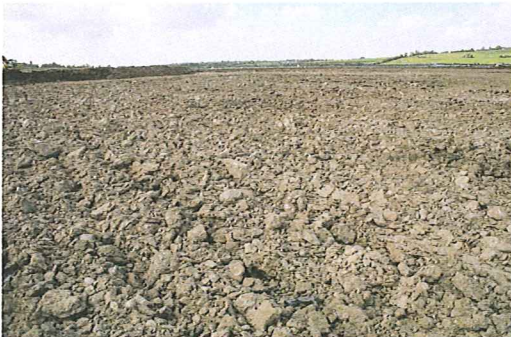
Photo No. 1.

Restoration of Phase 1 TMF recommenced in April 2010 as weather conditions improved. Additional glacial till material was imported from the donor area to form the final dome shape. In total approximately 58,000m³ of glacial till has been imported onto the surface of Phase 1 TMF for capping purposes. Contouring and preparation of Phase 1 TMF continued throughout June 2010, the glacial till material was ripped into the underlying compost and some topsoil was imported and spread to provide a suitable growing medium. The tails surface has been capped with organic and glacial till material to a depth ranging from 0.5m to 2m at the centre of the capped area. Photo No.1 below shows the capped area after ripping has been carried out. Photo No. 2 shows importation of topsoil. Grass-seeds were sown on the capped surface of Phase 1 TMF on the 28TH June 2010 (Photo No. 3). As is normal agricultural practice chemical fertiliser was applied on the Phase 1 grass-seeded area to provide the necessary nutrients. Due to the very dry weather conditions prior to sowing, the grass was slightly slow in becoming established. However, once sufficient rainfall/moisture became available growth began to flourish. As seen in Photo. No 4 below (taken 7th Oct. 2010) a good grass cover has been established and analysis results of a grass sample taken in late 2010 show levels of metals well within limits for feedstuff for animals.

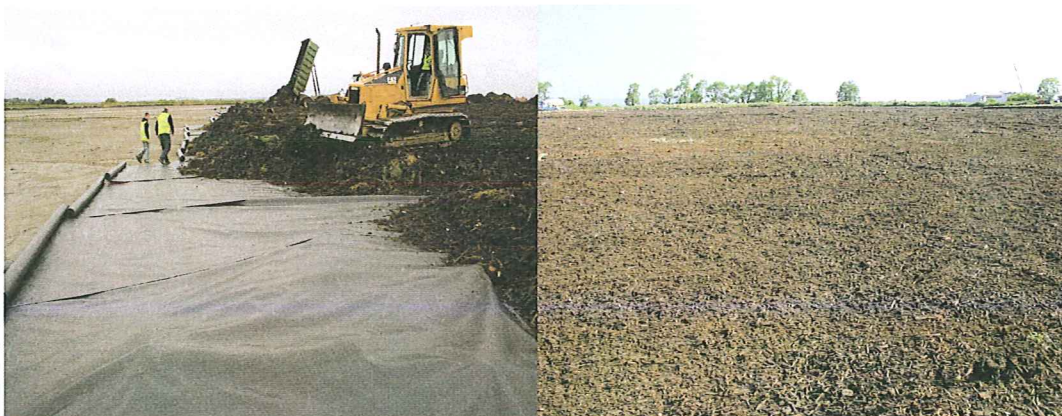
Photo. No 5.

Prior to 2010 the rehabilitation of Phase 2 TMF involved the placement of a compost cap over the exposed tailings surface. The method of rehabilitation has now been altered to include the use of glacial till into the cap. To allow for incorporation of glacial till into the Phase 2 composted area, approximately 35,000m³ of compost was stripped from the original compost capped area and redistributed to extend the compost cap to approximately 8 hectares. Prior to the redistribution of the compost any standing surface water on Phase 2 was pumped to Phase 3, this coupled with very favorable weather conditions provided a stable, level surface on which to work. Notwithstanding this, PB 120 Terram was also used to minimize any disturbance of the cap and any loss of capping material into the tails. Photograph No. 5 below shows the placement of PB 120 Terram and the redistribution of compost on Phase 2 TMF. This work was carried out throughout June 2010. Photo No. 6 below shows the composted area after redistribution of compost.

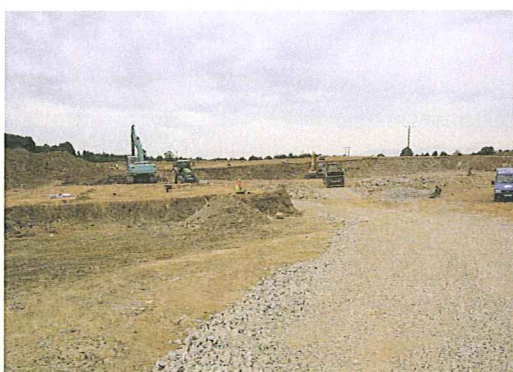
Photo No 7.

Importation of glacial till onto Phase 2 TMF continued throughout August and September 2010. Rehabilitation works were discontinued in October 2010 due to wet weather conditions causing a reduction in trafficability on the TMF surface. A topographical survey of the borrow area was carried out and approximately 112,000m³ of glacial till is estimated to have been removed from and spread on Phase 2 TMF. The topsoil stockpiled at the borrow area will be redistributed in 2011 when weather conditions are suitable and the area will then be re-seeded.

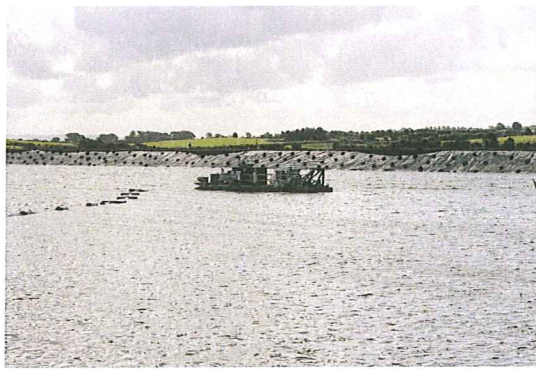
Photo No. 9.

surface on which to place capping material. Photo No 9 below shows the dredging in Phase 3. Photo No 10 shows the pumping of the tailings slurry to Phase 2.
