ANNUAL ENVIRONMENTAL REPORT 2010

BALLYNAMUCK WASTE DISPOSAL SITE

Waste Licence Register No. W0032-2

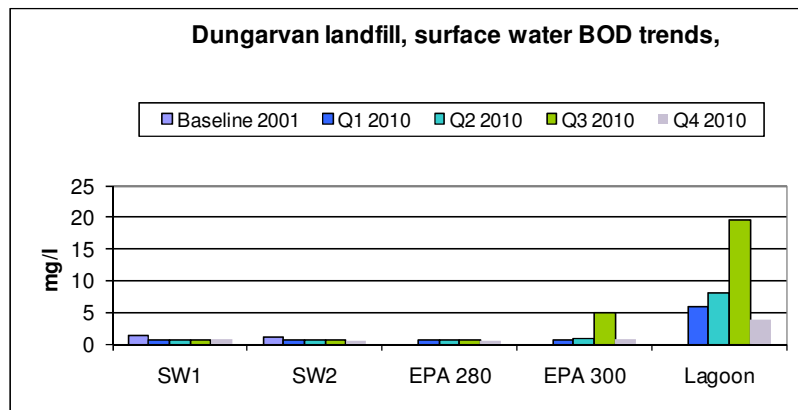
Key Parameter – BOD

Discussion

BOD levels were low at river sites throughout the year and slightly elevated in the lagoon. This is not unusual for such a small confined waterbody. The river site SW3 had elevated suspended solids at times, possibly due to tidal effects. Other water quality tests were satisfactory.

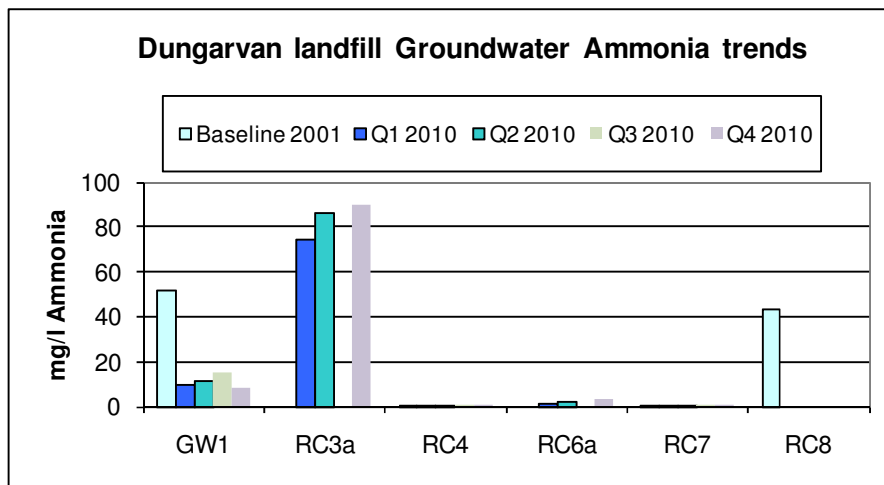
Key Parameter – Ammonia

5.2.3 DISCUSSION

Ammonia was elevated at sites GW1, RC3a, RC6a, and RC8. In general, RC4 and RC7, outside the landfill area, had relatively low *ammonia*. RC7 had a high ionic content at times, possibly indicating brackish water intrusion.

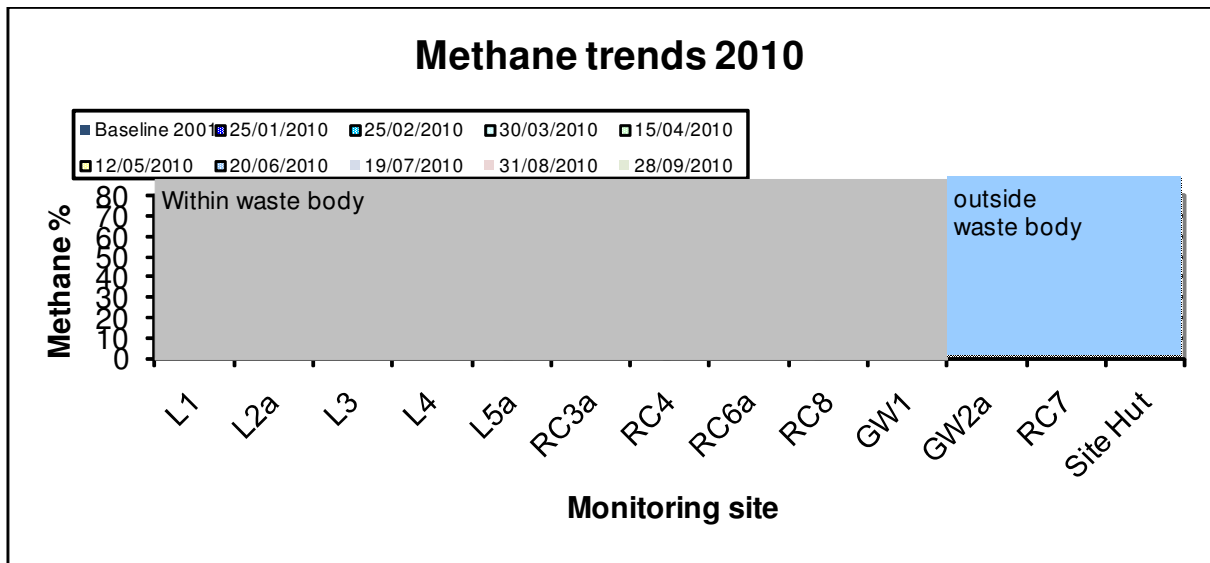
Figure 5.5.1 Methane trends 2010

Relatively low levels of methane were detected at most boreholes within the waste deposit area, and were lower compared to baseline levels in 2001.

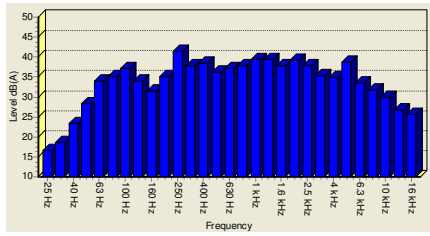
Fig 5.6.1 Dungarvan landfill noise monitoring 16/7/10, location B1, octave band analysis, A weighting

Noise levels were compliant at all locations with the noise emission requirement of 55 dB(A) LAeq (30 mins). Noise levels recorded in July 2010 were generally lower than baseline levels of 1998.

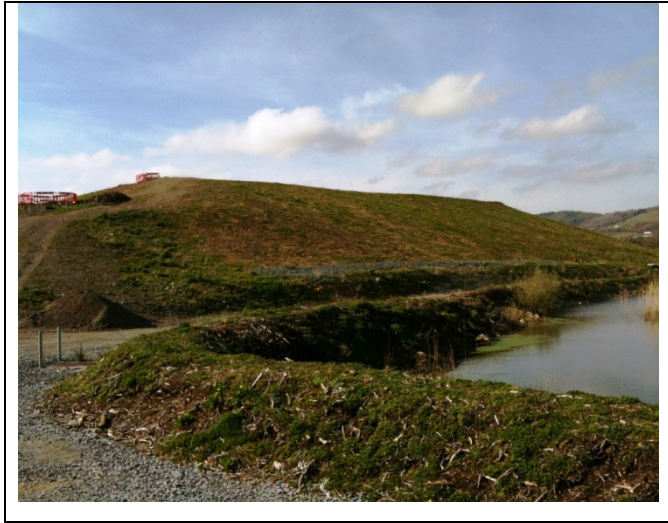
1. Eastern Slope, north of Haul Road

A surface water drainage channel and channel for leachate pumping have been dug along the base of this slope and a pump/sump for dilution of leachate have also been installed along with gravel pathways to the sump pump and existing monitoring well. These works have not destabilised the slope in any way. Vegetation thereon is thriving.

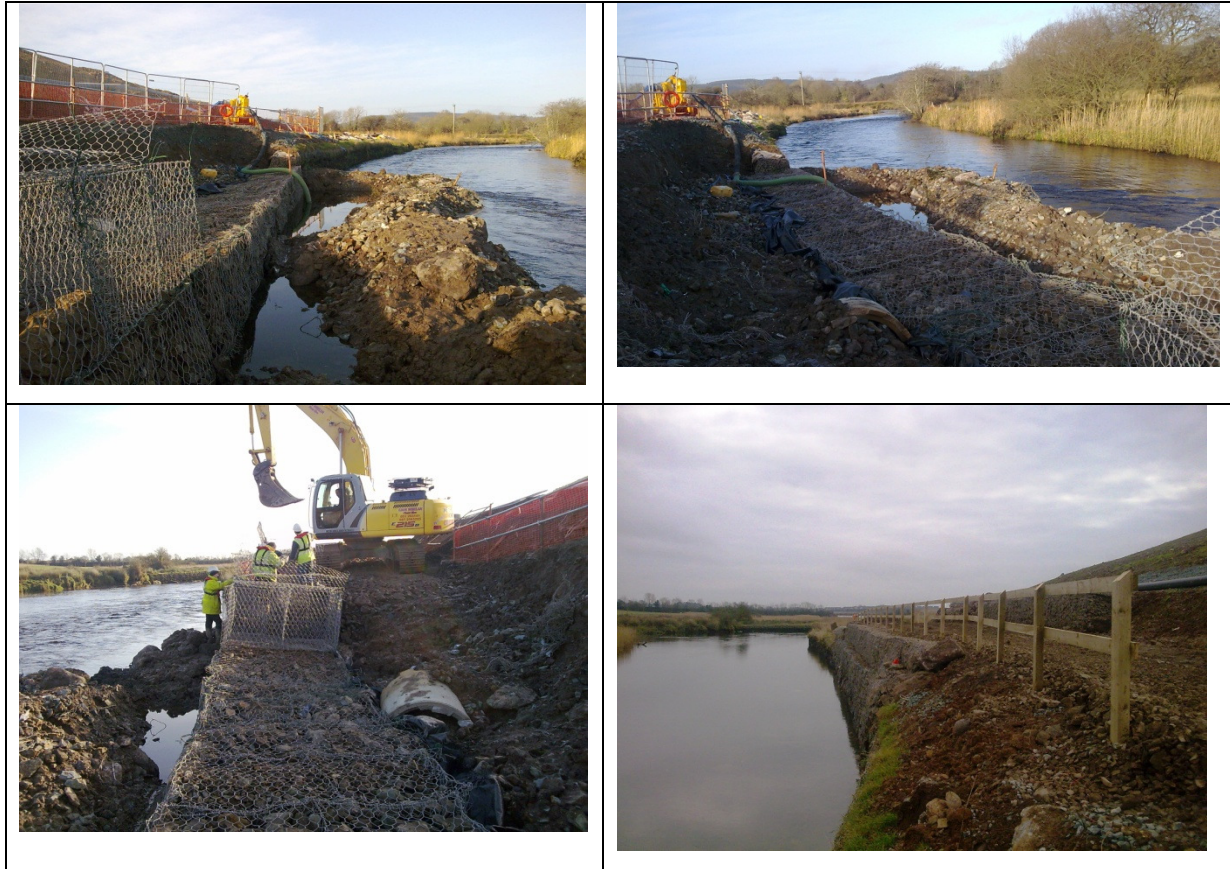
2. Northern Slope on eastern end of landfill, adjacent to Colligan River

A section of river gabions providing bank protection at Dungarvan landfill collapsed in October 2008, caused by heavy construction traffic during capping works. Substantial works involving the replacement of 20m length of damaged gabions, approx 4m deep, strengthening the gabions structure by deepening the extent, and raising the gabions retaining to track level were subsequently carried out. The above photos illustrate the work. The works that were undertaken have proved to be successful as No slippage has taken place in the area since the works have been carried out.

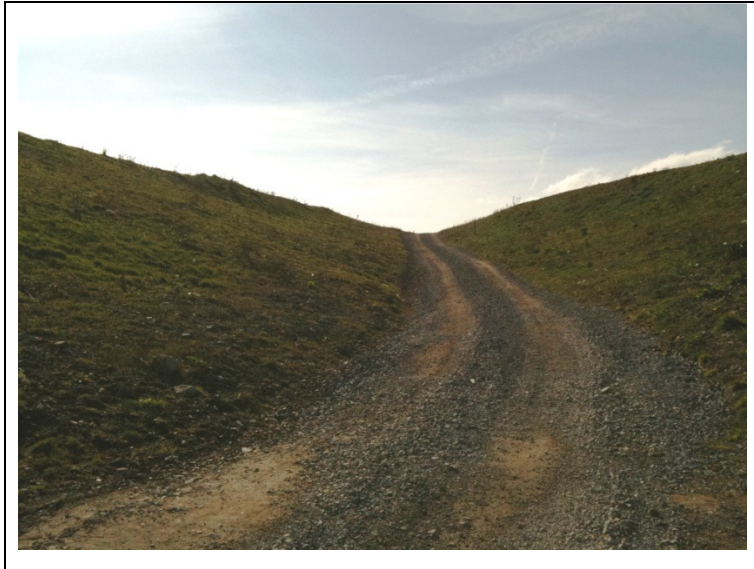
3. Former Haul Road

Slopes along both sides of the former landfill haul road remain stable and vegetation is thriving thereon. This will be augmented during the next reporting period with suitable wild flowers.

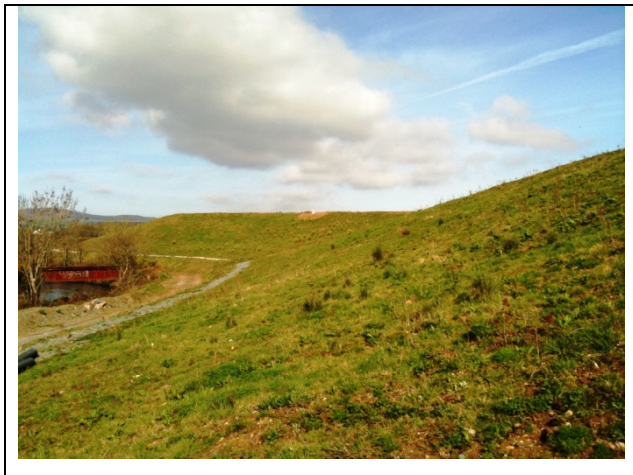
4. Northern slope at western end of landfill

A channel which forms part of the leachate extraction system has been dug along the base of this slope. The channel has had No adverse effect on the stability of the slope. Vegetation in this area is thriving.

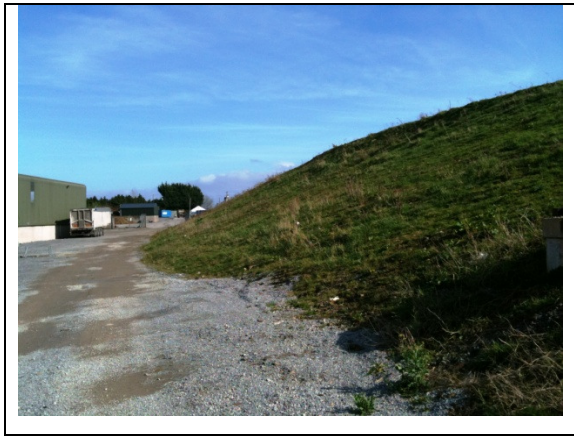
5. Northern facing slope on southern side of haul road

This is the largest slope on the landfill. The largest wetland pond in the leachate extraction system has been formed at the top of this slope. Despite this there is No sign of shrinkage or instability as a result of the works carried out in this area. Vegetation on this slope is strong.

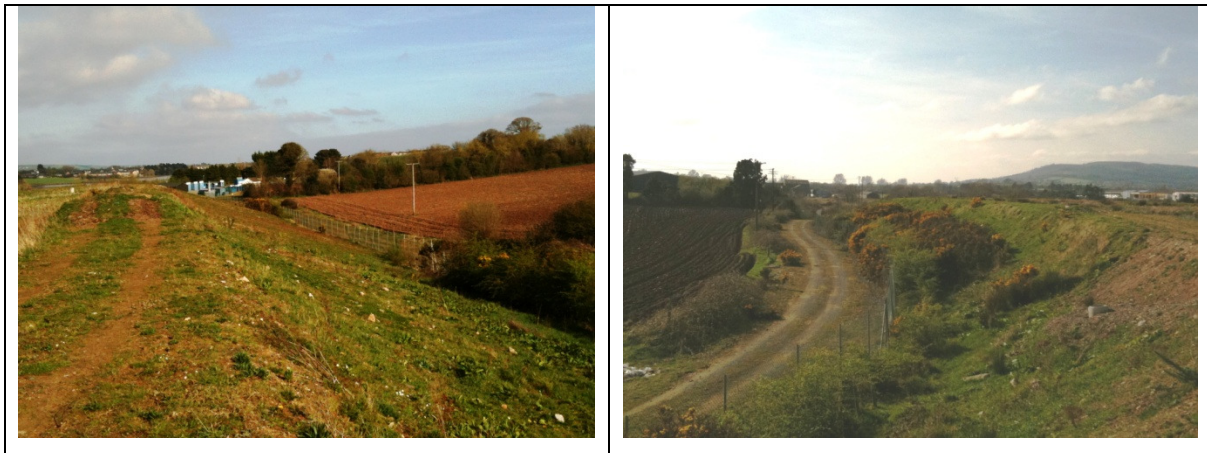
6. Southern Slope of Landfill

Generally there are No stability issues on this slope aside from a small area that needs attention in around monitoring points RC3A and GW1 where a gravel access path has been formed and has caused some instability. This will be addressed under the remediation contract and repair works in this area will be carried out by Waterford County Council staff.
