**Silliot Hill Integrated Waste Management Facility
Kilcullen, Co. Kildare.**

Waste Licence Ref: W0014-01

Annual Environmental Report - 2010

Prepared by:
Kildare County Council,
Aras Chill Dara,
Devoy Park,
Naas,
Co. Kildare.

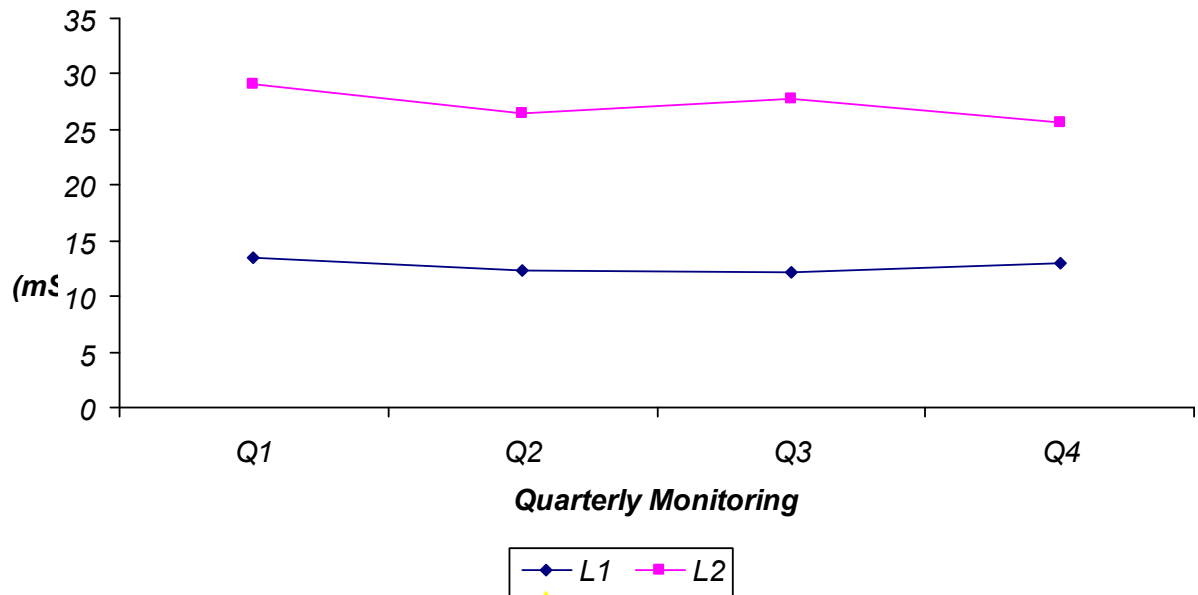
Figure 5.10. Conductivity Levels at Leachate Monitoring Points.

Figure 5.9 shows the levels of conductivity measure at leachate wells throughout the year and these are typical concentrations for leachate

L3 and L4 are manholes that receive foul drainage from the hard-standing areas on-site and hence, have chemistry similar to contaminated storm water rather than pure leachate. L3 also has a high total and faecal coliform count.

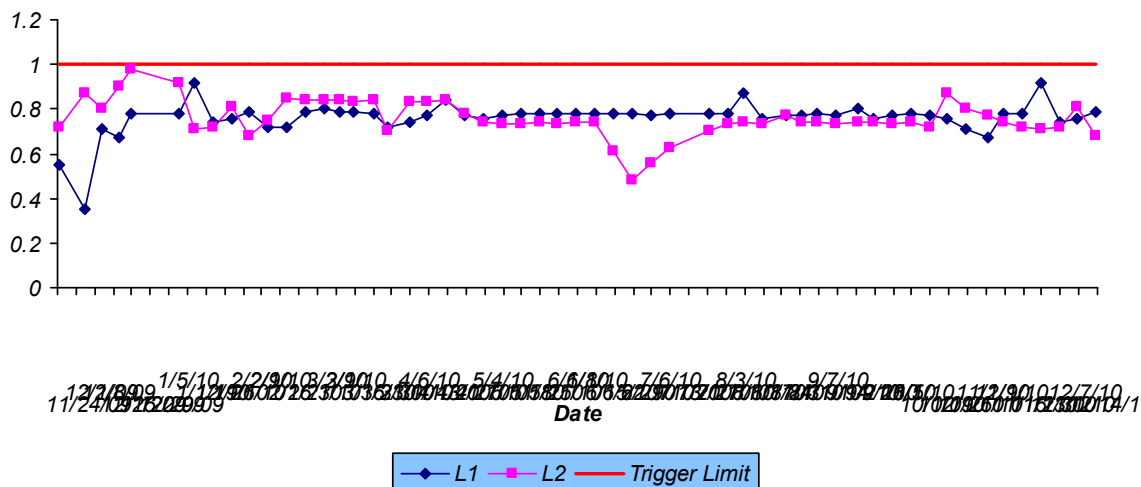
Figure 5.11. Leachate Levels at L1 & L2

liner at the base of the landfill in Phase 2'. Access to L1 and L2 was restored at the end on November 2009. Figure 5.10 illustrates the weekly leachate levels at L1 and L2 from November 2009 to December 2010.

Leachate levels in L1 and L2 have not exceeded the limits of 1m over the liner. As part of the capping works new pumps and level sensors were installed in both of the leachate sumps. The level sensors are connected into the SCADA system which automatically and continuously monitors the levels of leachate in L1 and L2.

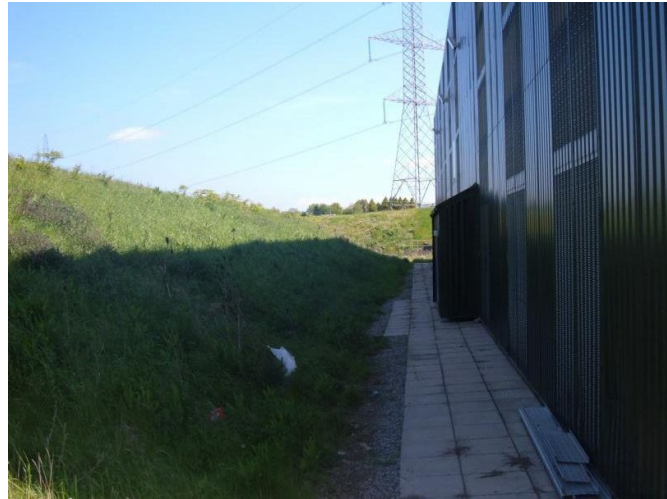
Plate Nr: 4

Caption: Further along east of building (looking south). Note regular shape of slope.

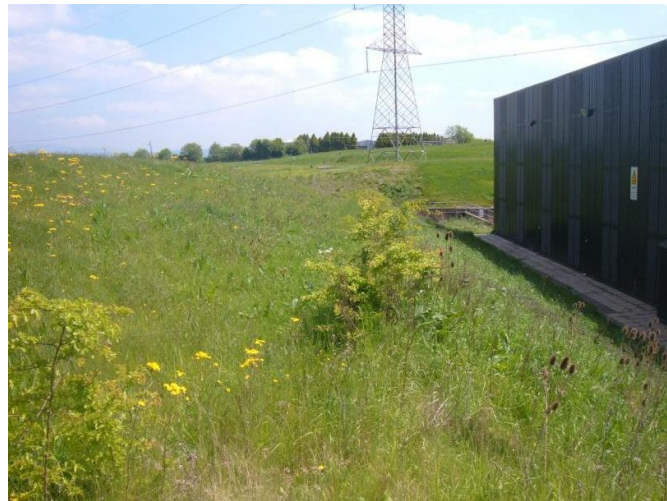
Plate Nr: 5

Caption: Bench level (approx. 3 m in width) on eastern slope.

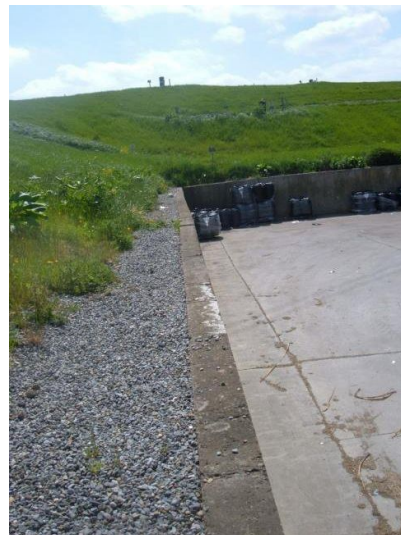
Plate Nr: 20

Caption: Similar view to plate 19. Note wall in background (to southwest of building) dipping to left of photograph.

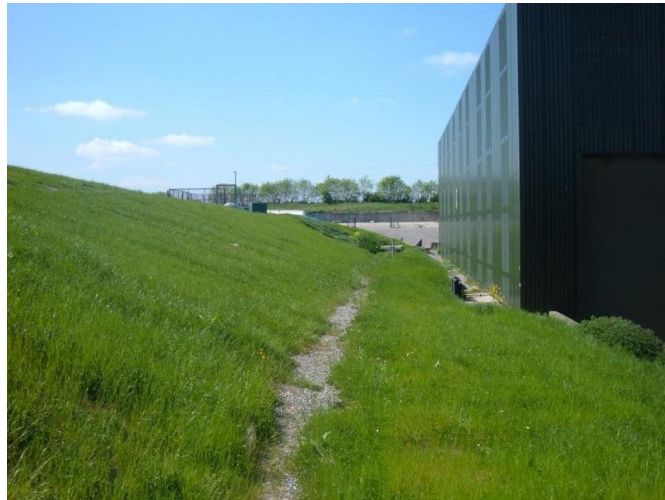
Plate Nr: 23

Caption: Looking north along slope to west of building. Note gravel drainage trench running north to collection chamber.

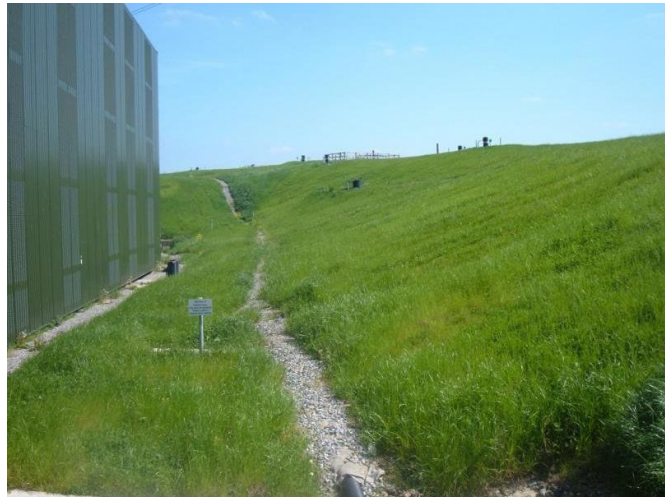
Plate Nr: 29

Caption: Further view along gravel drainage trench as plate 28. Note pipe surrounded in geotextile filter.

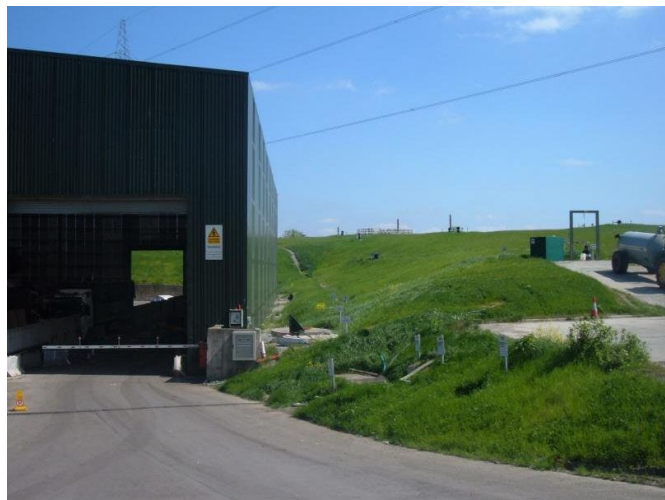
Plate Nr: 30

Caption: View south along west of building. Note: retaining wall terminating in return to the front right of the building; regular profile of slope; infrastructure to side of building and on top of slope in background.

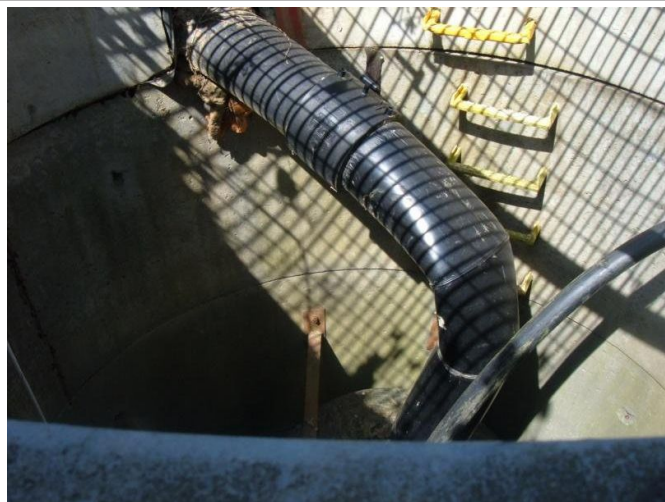
Plate Nr: 36

Caption: Squeezed pipe in chamber to north of access road. See plate 12 for location.
