ANNUAL ENVIRONMENTAL REPORT

2010

Location of Activity: Derryclure Landfill,
Derryclure,
Tullamore,
Co. Offaly

SLOPE STABILITY REPORT

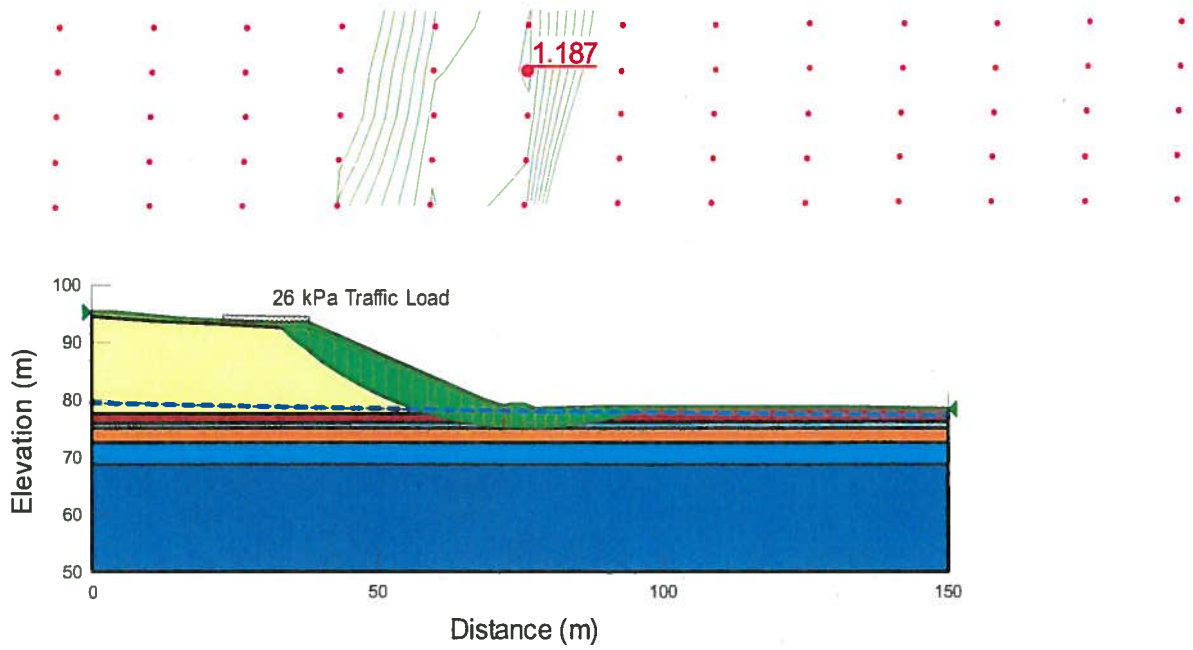
Figure 3.1: Typical deep rotational slope failure for Slope 1 Leachate Level 79.4 mAOD (MP method).

Material #: 1	Description: Clay Capping	Wt: 18	Cohesion: 1.6	Phi: 22.4
Material #: 2	Description: Waste (old)	Wt: 11	Cohesion: 7.1	Phi: 17.6
Material #: 3	Description: Peat (consolidated)	Wt: 10.5	Cohesion: 1.6	Phi: 24
Material #: 4	Description: Soft Silt/Clay	Wt: 18	Cohesion: 0	Phi: 23.2
Material #: 5	Description: M Dense Sand	Wt: 20	Cohesion: 0	Phi: 25.6
Material #: 6	Description: Stiff Clay/Silt	Wt: 19	Cohesion: 1.6	Phi: 23.2
Material #: 7	Description: Bedrock

Slope Name	Waste parameters (C, γ & ϕ)	Leachate Level (mAOD)	Morgenstern-Price FoS	Bishop FoS	Janbu FoS	Slip Length (m)	Slip location
1	7.1,11,17.6	79.4	1.18	1.17	1.10	69	Deep rotational slip through cap, waste peat and silt
2	8, 9.5, 12	74.7	1.08	1.08	1.01	51	Deep rotational slip through cap and waste
3	8, 9.5, 12	74.7	1.43	1.43	1.41	36	Deep rotational slip through cap and waste
4	8, 9.5, 12	74.7	1.33	1.33	1.27	36	Deep rotational slip through cap and waste

The results of the stability analysis show safety ratio for potential deep rotational slope failures along the existing slope cross-sections modelled ranged from 1.01 to 1.43. The lower value safety ratios obtained in the analysis were calculated using the Janbu Method which is considered conservative. All slopes analysed gave factors of safety above the minimum required factor-of-safety of 1.0 in accordance with IS EN 1997-1.

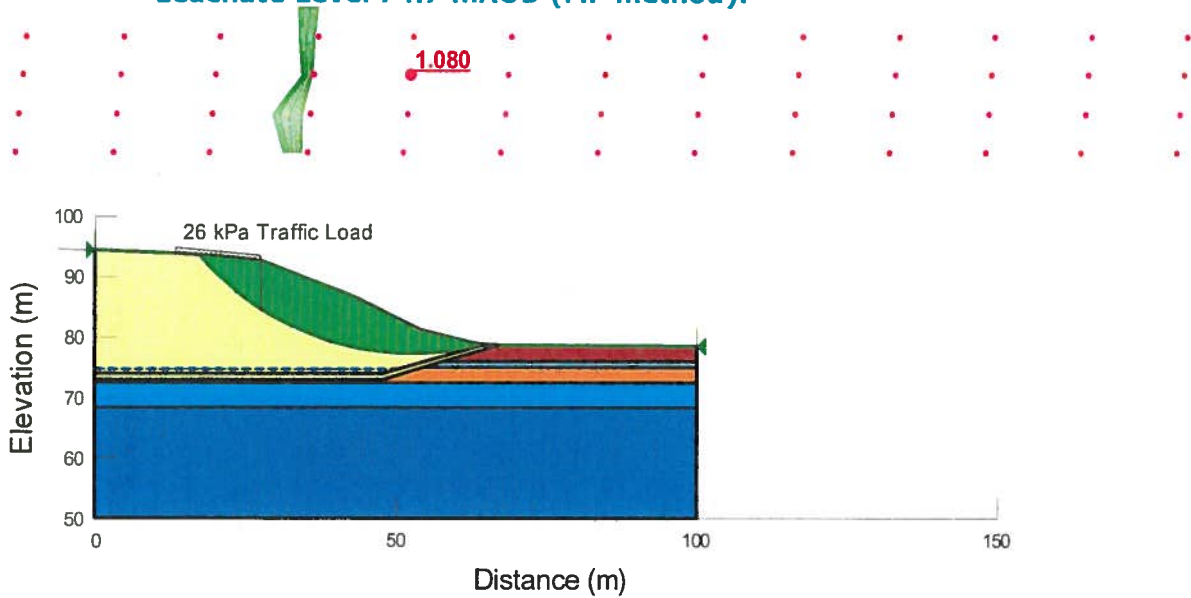
**Figure 3.2: Typical deep rotational slope failure for Slope 2
Leachate Level 74.7 mAOD (MP method).**

Material #: 1	Description: Waste (new)	Wt: 9.5	Cohesion: 8	Phi: 12
Material #: 2	Description: Clay Liner	Wt: 19	Cohesion: 3.2	Phi: 21.6
Material #: 3	Description: Peat (consolidated)	Wt: 10.5	Cohesion: 1.6	Phi: 24
Material #: 4	Description: Soft Silt/Clay	Wt: 18	Cohesion: 0	Phi: 23.2
Material #: 5	Description: M Dense Sand	Wt: 20	Cohesion: 0	Phi: 25.6
Material #: 6	Description: Stiff Clay/Silt	Wt: 19	Cohesion: 1.6	Phi: 23.2
Material #: 7	Description: Bedrock

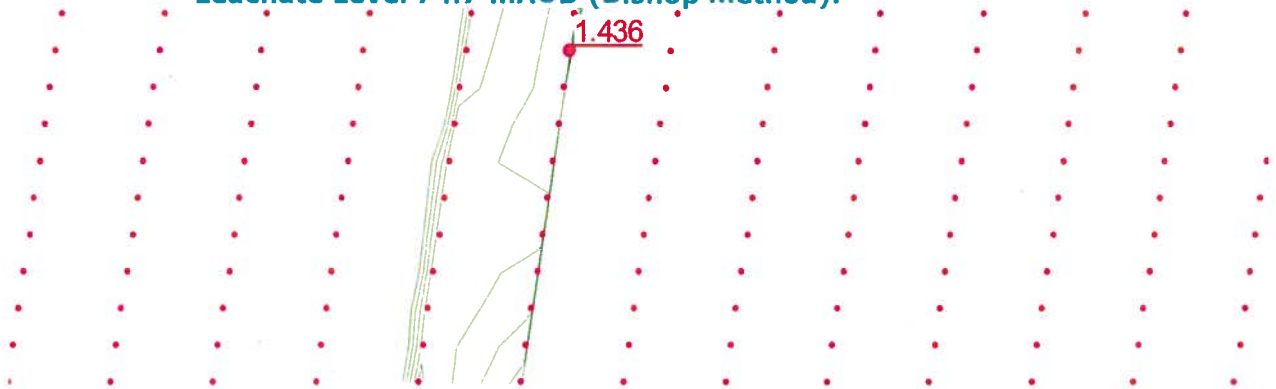
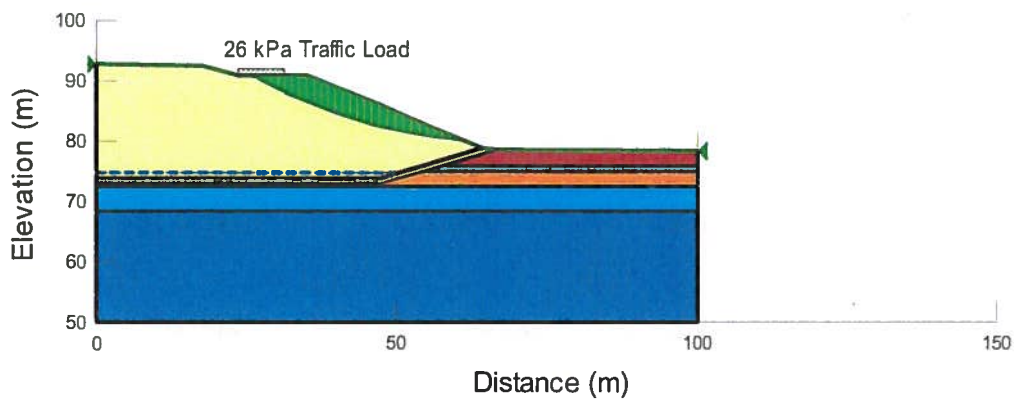
**Figure 3.3: Typical deep rotational slope failure for Slope 3
Leachate Level 74.7 mAOD (Bishop method).**

Material #: 1	Description: Waste (new)	Wt: 9.5	Cohesion: 8	Phi: 12
Material #: 2	Description: Clay Liner	Wt: 19	Cohesion: 3.2	Phi: 21.6
Material #: 3	Description: Peat (consolidated)	Wt: 10.5	Cohesion: 1.6	Phi: 24
Material #: 4	Description: Soft Silt/Clay	Wt: 18	Cohesion: 0	Phi: 23.2
Material #: 5	Description: M Dense Sand	Wt: 20	Cohesion: 0	Phi: 25.6
Material #: 6	Description: Stiff Clay/Silt	Wt: 19	Cohesion: 1.6	Phi: 23.2
Material #: 7	Description: Bedrock

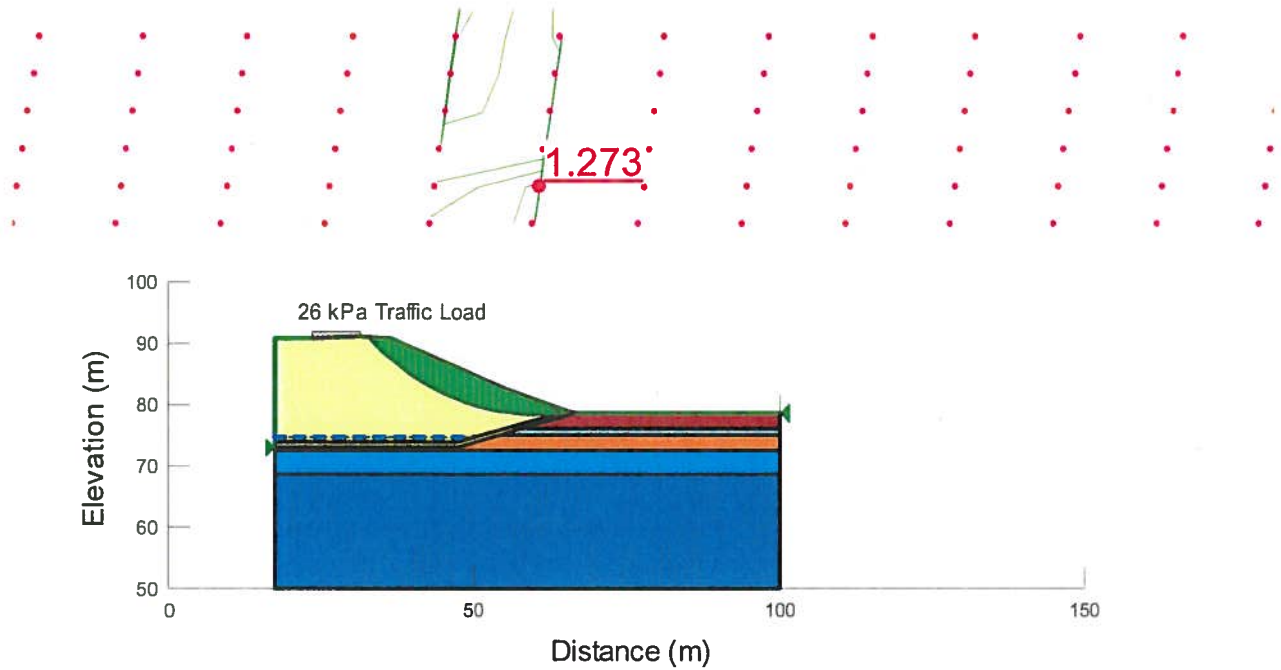
**Figure 3.4: Typical deep rotational slope failure for Slope 4
Leachate Level 74.7 mAOD (Janbu method)**

Material #: 1	Description: Waste (new)	Wt: 9.5	Cohesion: 8	Phi: 12
Material #: 2	Description: Clay Liner	Wt: 19	Cohesion: 3.2	Phi: 21.6
Material #: 3	Description: Peat (consolidated)	Wt: 10.5	Cohesion: 1.6	Phi: 24
Material #: 4	Description: Soft Silt/Clay	Wt: 18	Cohesion: 0	Phi: 23.2
Material #: 5	Description: M Dense Sand	Wt: 20	Cohesion: 0	Phi: 25.6
Material #: 6	Description: Stiff Clay/Silt	Wt: 19	Cohesion: 1.6	Phi: 23.2
Material #: 7	Description: Bedrock
