# **BALLYMURTAGH LANDFILL**

## **Waste Licence W0011-01**

# **ANNUAL ENVIRONMENTAL REPORT 2010**

*May 2011*

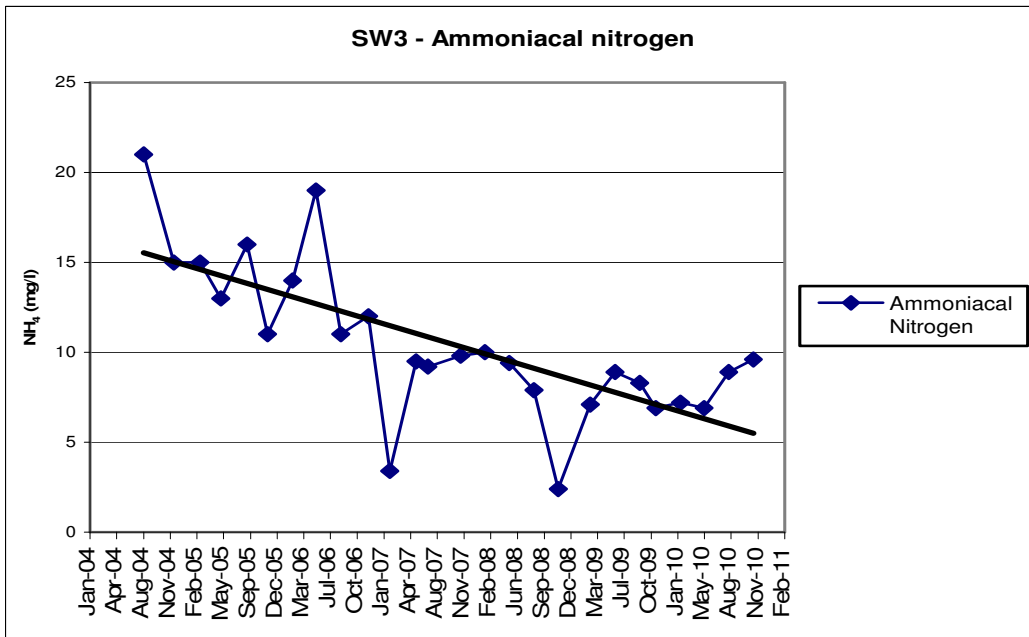
**Figure 2.4: Ammoniacal Nitrogen concentrations at SW3 (Aug 04 - Nov 10)**

Surface water quality at SW3 (Ballymurtagh Road Adit) shows evidence of Acid Mine Drainage in the form of low pH (range 3.9 – 4.3) (see Figure 2.3), elevated conductivity (ranging from 1,810 $\mu$ S/cm to 2,200 $\mu$ S/cm), and elevated sulphate (1,195mg/l – 1,581mg/l). Sulphate concentrations were elevated throughout the year and remain similar to those recorded in previous years as shown in Figure 2.5. Elevated concentrations of iron, cadmium, copper, manganese, lead and zinc were also detected in the annual sample. Dissolved oxygen concentrations ranged from 7.4 mg/l in August 2010 to 8.1 mg/l in November 2010. The lowest dissolved oxygen concentration was recorded in the 3<sup>rd</sup> quarter (7.4 mg/l) and this is likely due to seasonal variances. BOD levels ranged from (<2 mg/l – 15mg/l). Ammoniacal Nitrogen levels were elevated at SW3, ranging from 6.9mg/l NH<sub>4</sub> to 9.6mg/l NH<sub>4</sub>). Since the site was capped, the overall trend is that the Ammoniacal Nitrogen levels have gradually decreased, as can be seen in Figure 2.4.

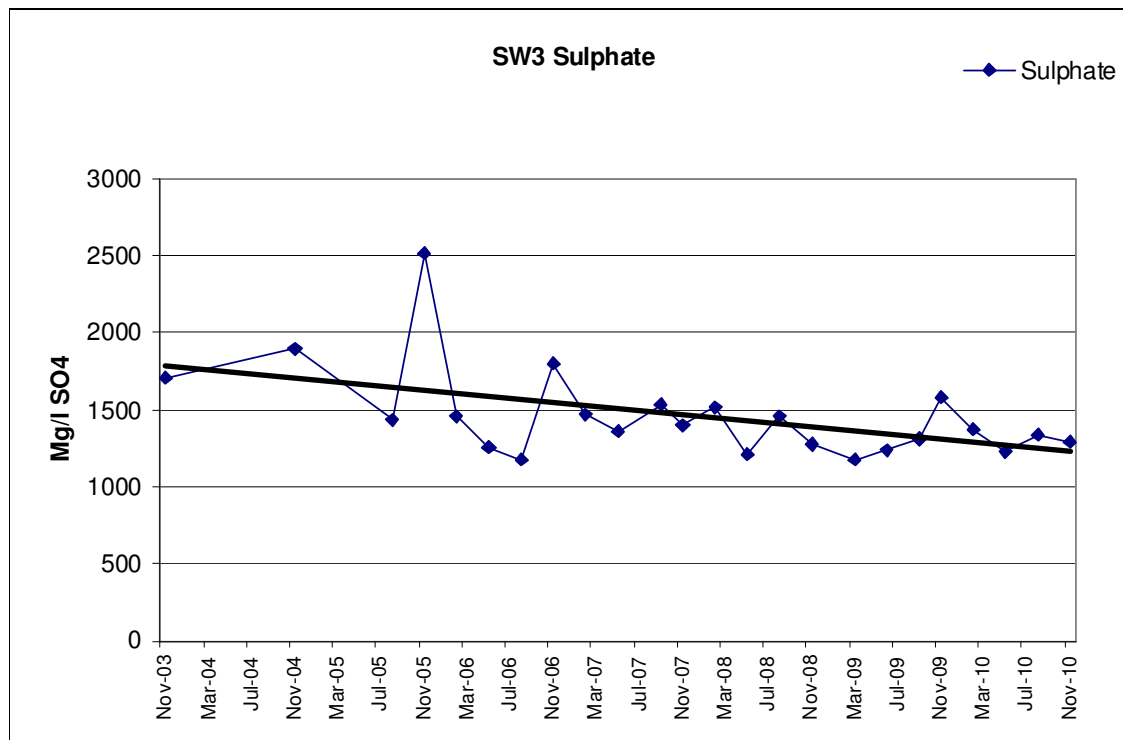
**Figure 2.5: Sulphate concentrations at SW3 from Nov 03 - Nov 10**

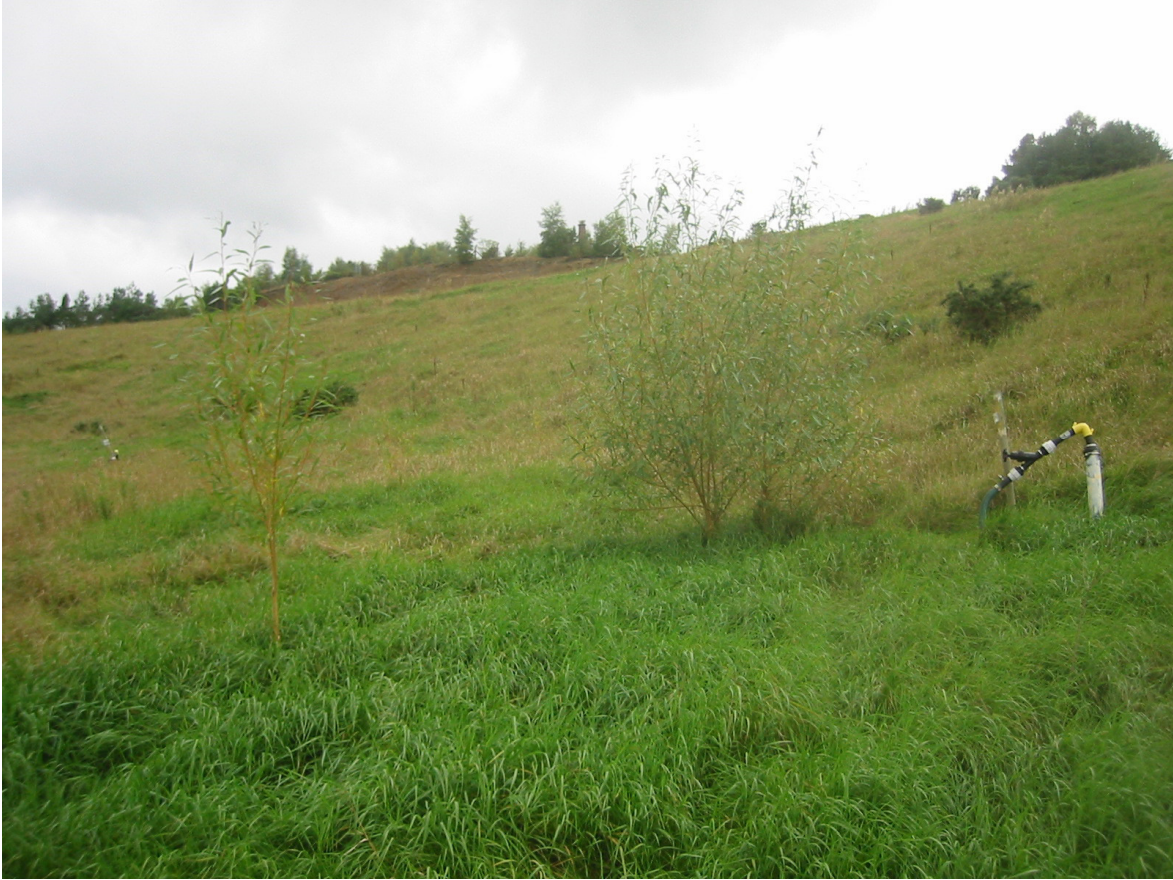
The surface has been sown with grasses into which other plants are now spreading and tending to replace some of the original species. Trees and bushes cover the steeper slope at the eastern end. Many of these were originally planted and they have been augmented in 2009/10 by additional lines of hawthorn, ash, birch and oak along the crest. Other new planting has been done southwest of the gas flaring plant while a number of willows *Salix x rubens* and *S.alba* have been set throughout on the main surface (Photo 1).

Photo 1. Young willows *Salix x rubens* on main surface

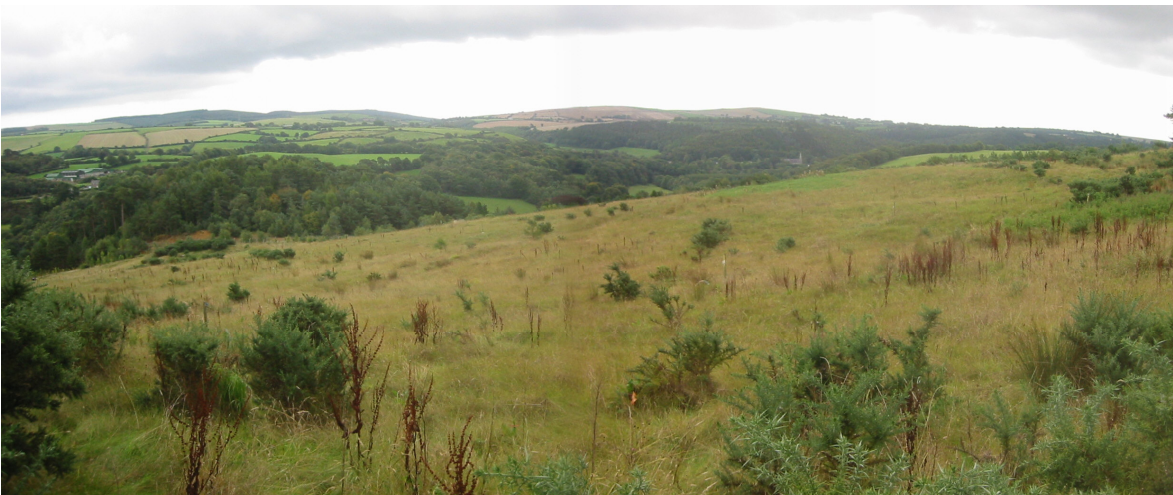
Photo 2. Spread of gorse in upper part of landfill

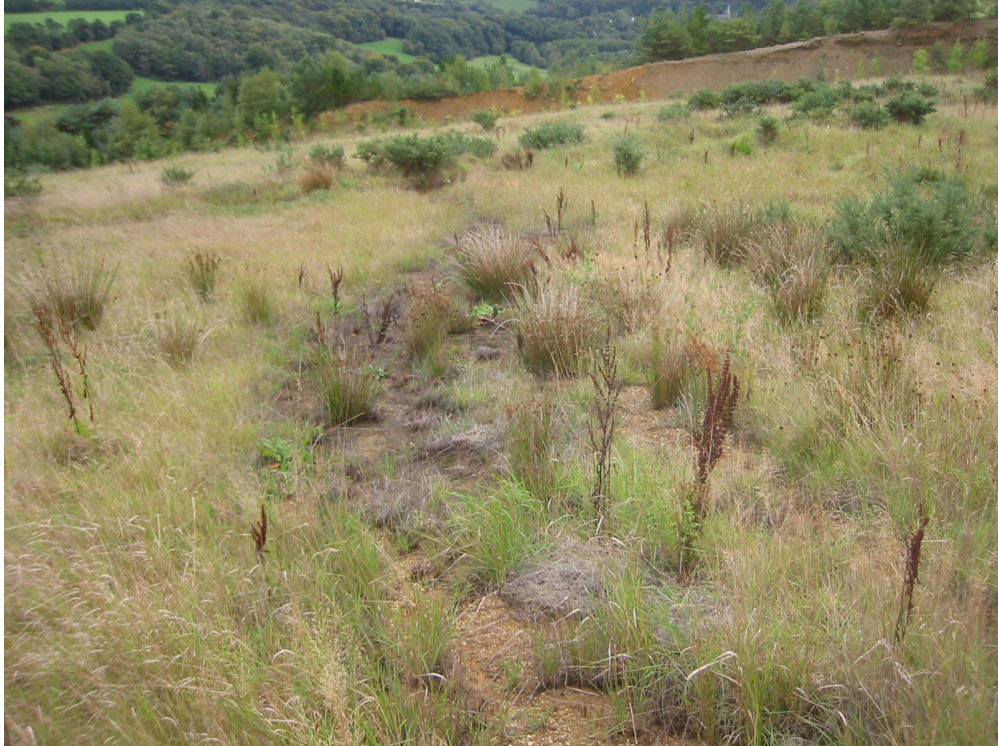
Photo 3. Effect of drainage on vegetation at western end

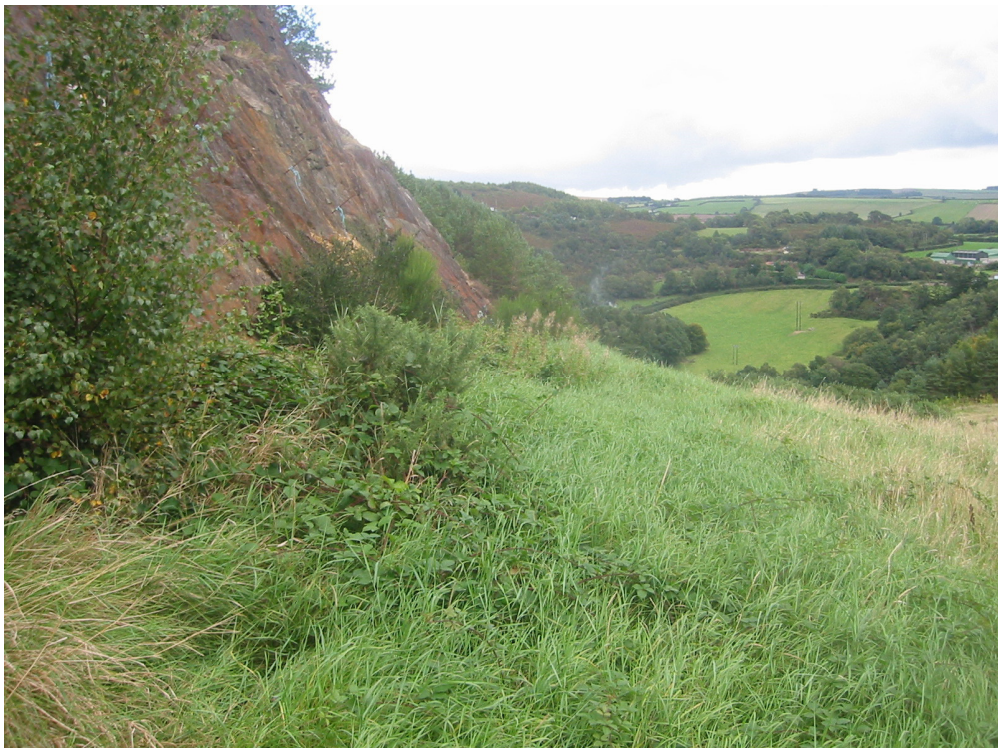
A peripheral effect is also noticed under the rock face on the northern side where surface flow off the rocks raises the nutrient content of the vegetation and allows for vigorous plant growth (Photo 4). This has been noted in previous years but shows every sign of increasing its influence southward. Scutch Elytrigia repens is a dominant ground cover and there is also broad-leaved dock *Rumex obtusifolius*, bush vetch *Vicia sepium*, hairy sedge *Carex hirta* and bramble *Rubus fruticosus* colonising away from the edge. Under the cliff itself grey willow *Salix cinerea*, large bindweed *Calystegia silvatica*, butterfly bush *Buddleja davidii*, winter heliotrope *Petasites fragrans* and the two horsetails *Equisetum arvense* and *E.telmateia* still occur. The latter also grows below the island of original woodland at the western end, along with hedge woundwort *Stachys sylvatica*.

Photo 4. Zone of high nutritional status close to northern side

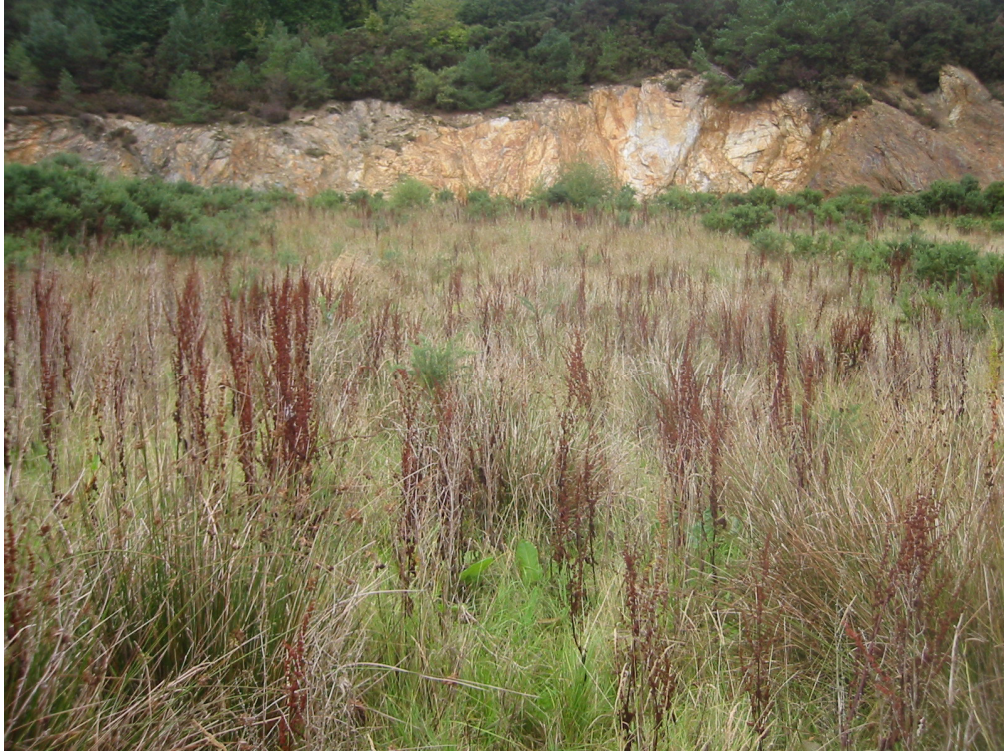
Photo 5. Docks *Rumex* spp and rushes *Juncus* spp within gorse stand in NW corner

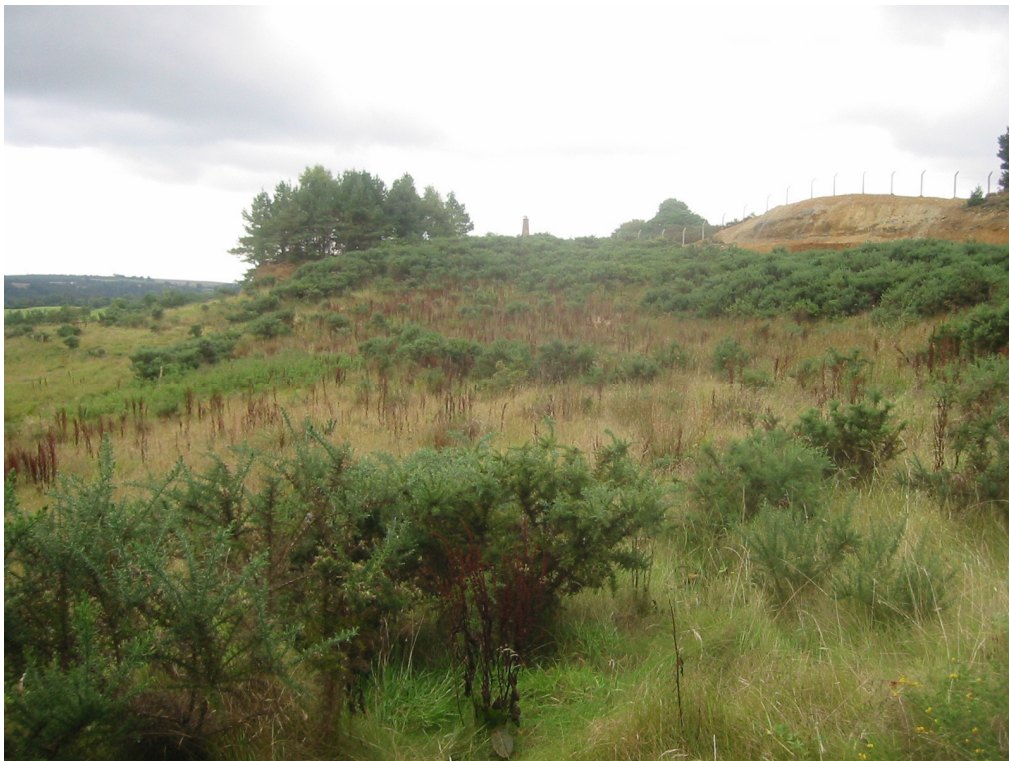
Photo 6. 'Island' of trees at western end viewed from NW corner

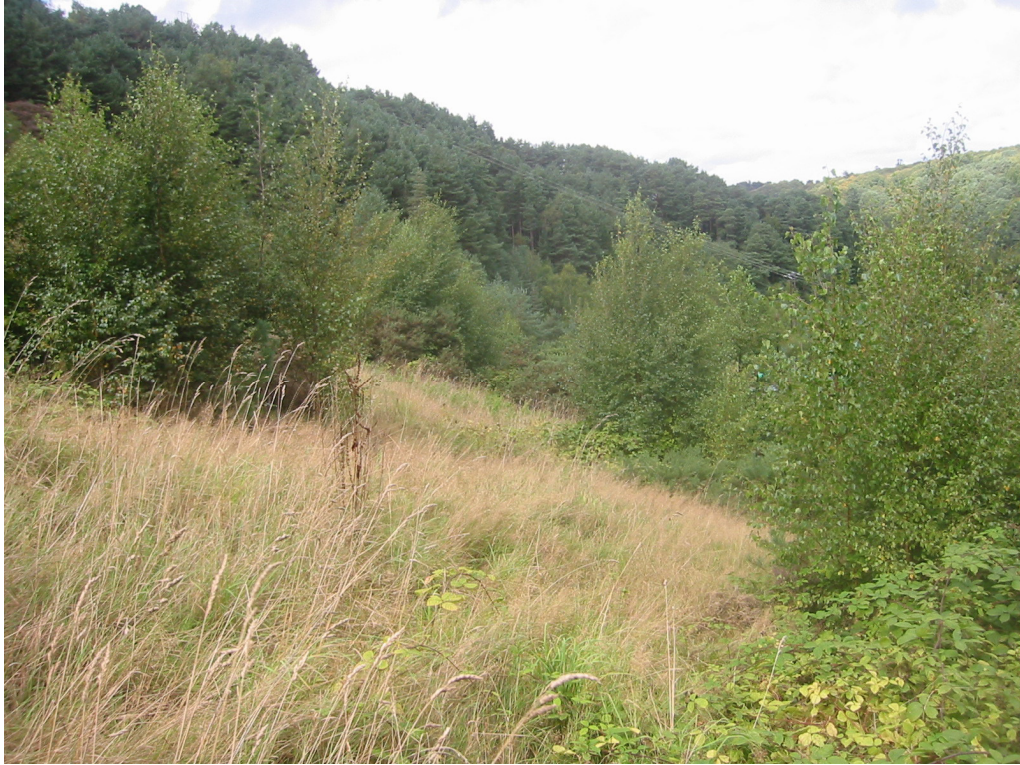
The older trees on the slope are now 4m or more in height (Photo 7) and include birches *Betula pubescens* and *B.pendula*, pines *Pinus contorta*, *P.sylvestris*, and willows *Salix cinerea* and a little *S.aurita*. Alder *Alnus glutinosa* is growing particularly well (8m) in a few places. The shaded conditions in 2009 suited

Photo 7. Good growth of birches on main slope

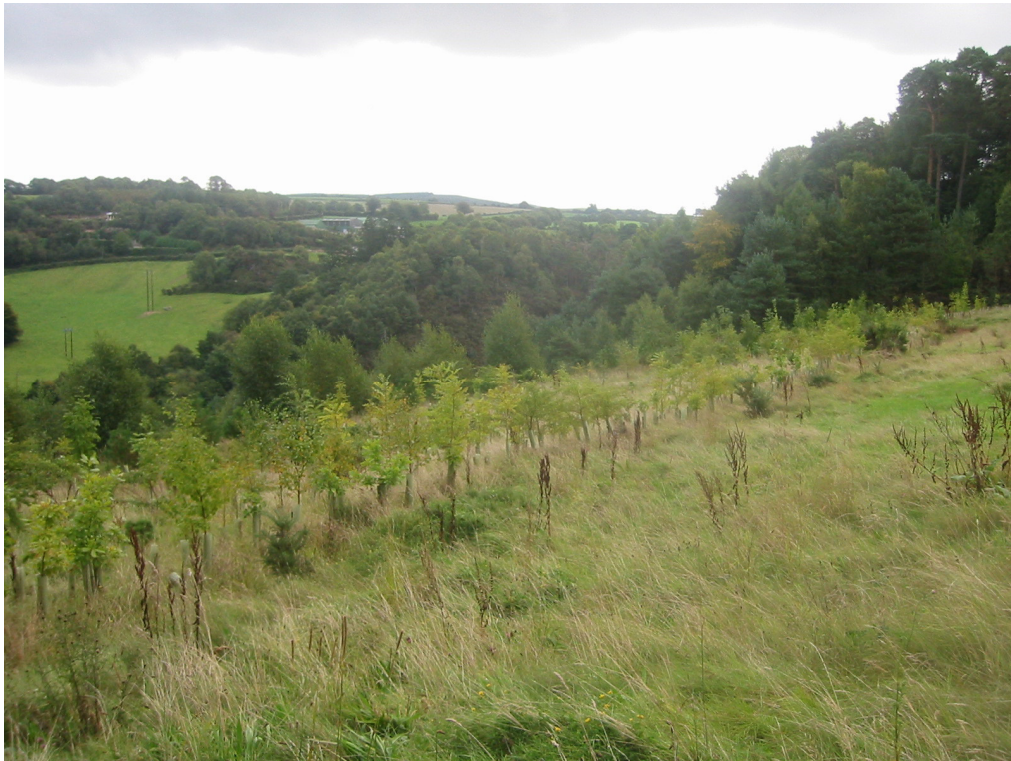
Photo 8. New planting of hawthorn, ash etc at crest of slope

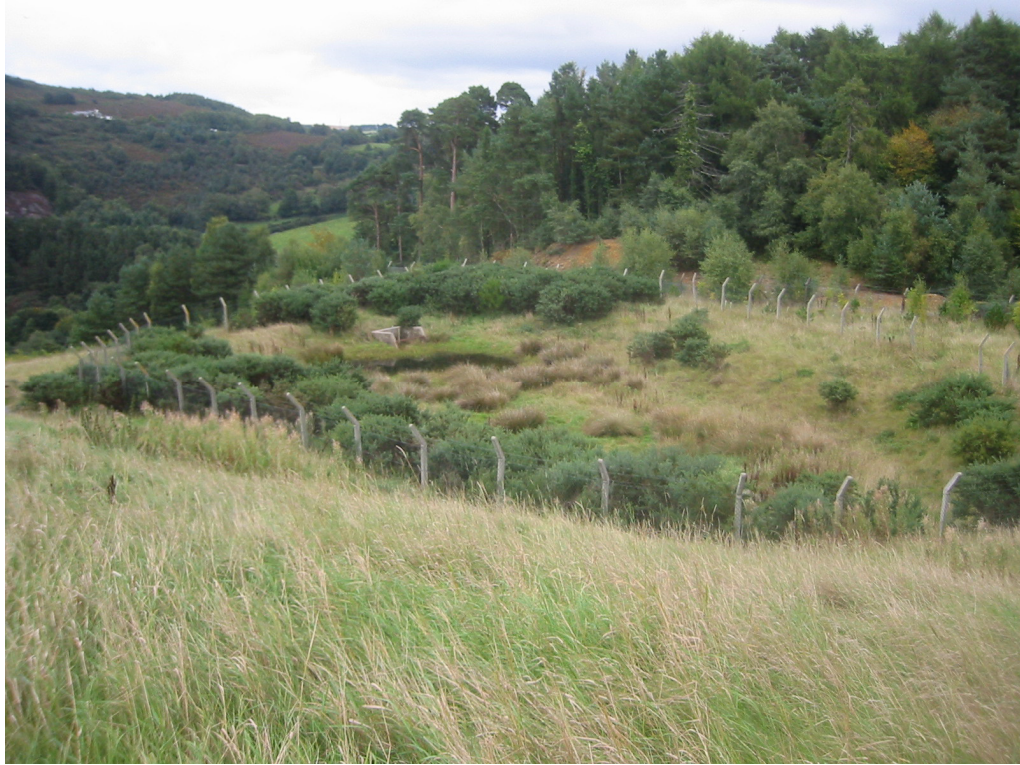
Photo 9. Lagoon on southern side of site

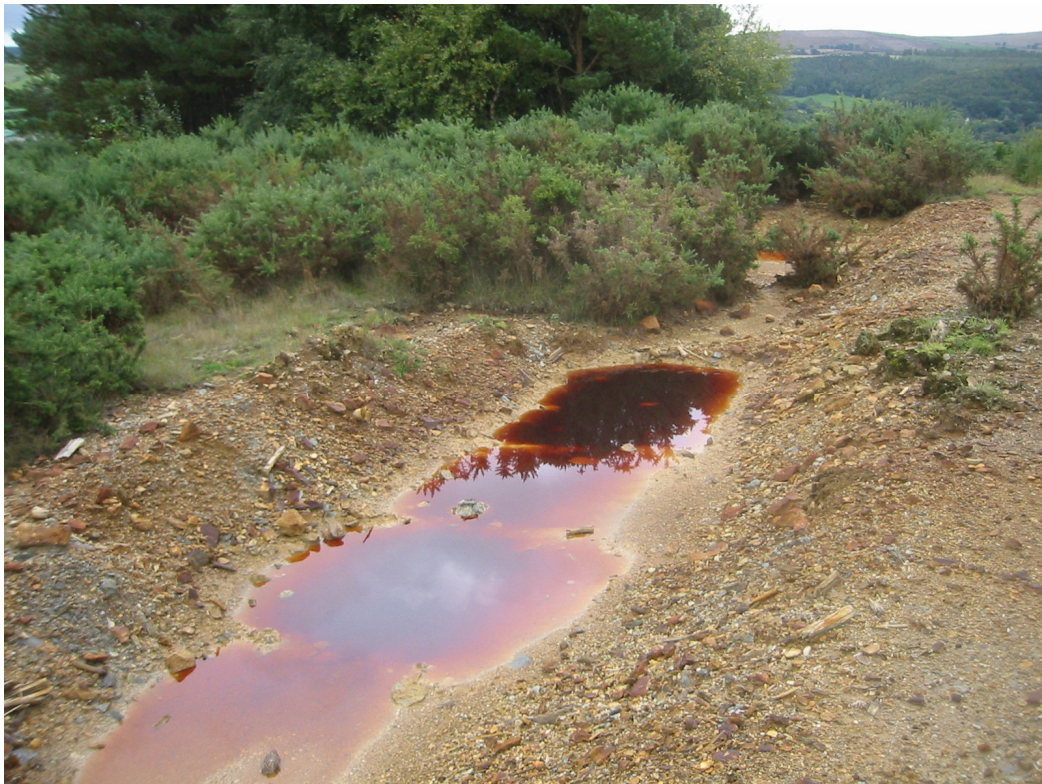
Photo 10. Acid drainage off site to west. 'Island' trees in background.
