**ANNUAL ENVIRONMENTAL REPORT 2010**  
**SUBMITTED TO ENVIRONMENTAL PROTECTION AGENCY**  
REPORTING PERIOD: JANUARY – DECEMBER 2010

**ENVA**  
**CLONMINAM INDUSTRIAL ESTATE**  
**PORTLAOISE**  
**CO. LAOIS**

**WASTE LICENCE NUMBER W0184-1**

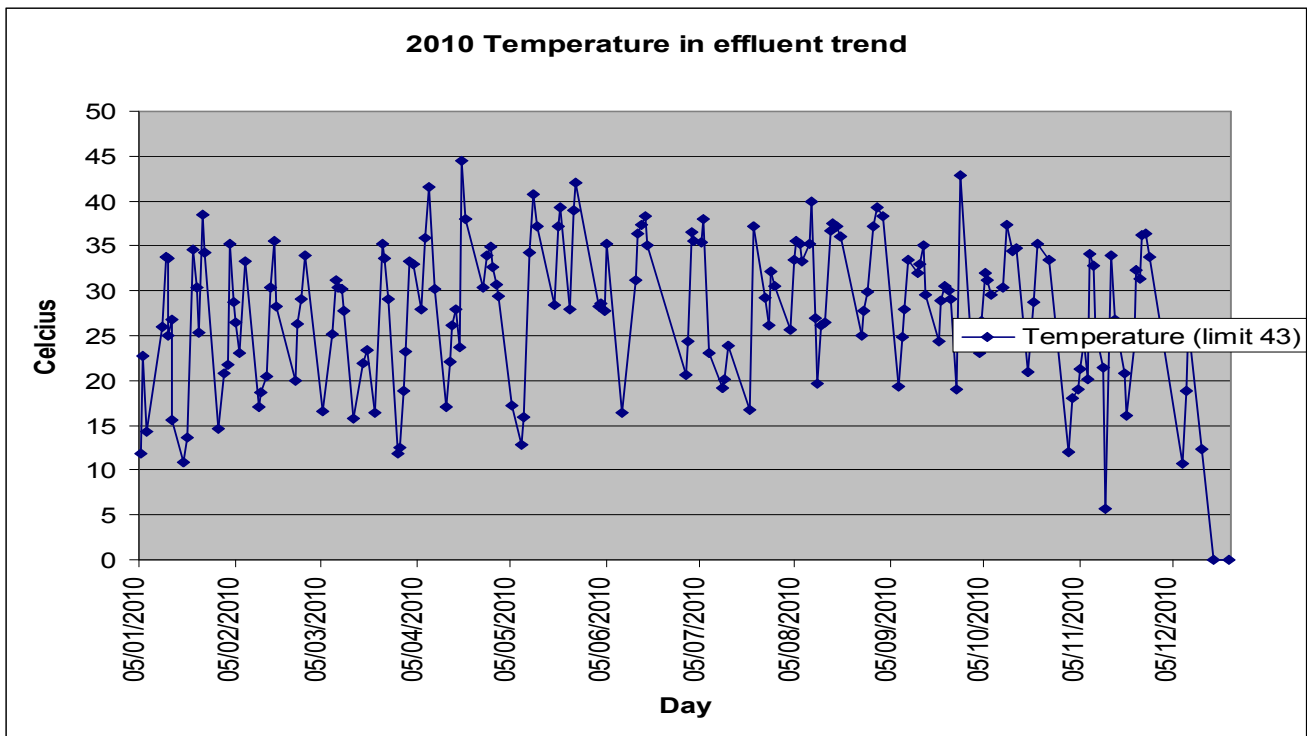
Figure 3.1(k):Temperature levels in effluent 2010

The results of daily analysis in April identified one temperature exceedence on the 19<sup>th</sup>, and an Ammonia exceedence on the 22<sup>nd</sup> of July as can be seen in figure 3.1(k) and 3.1(l) below. Both of these exceedence's falls under section 6.10 (b) of Waste licence W0 184-1.

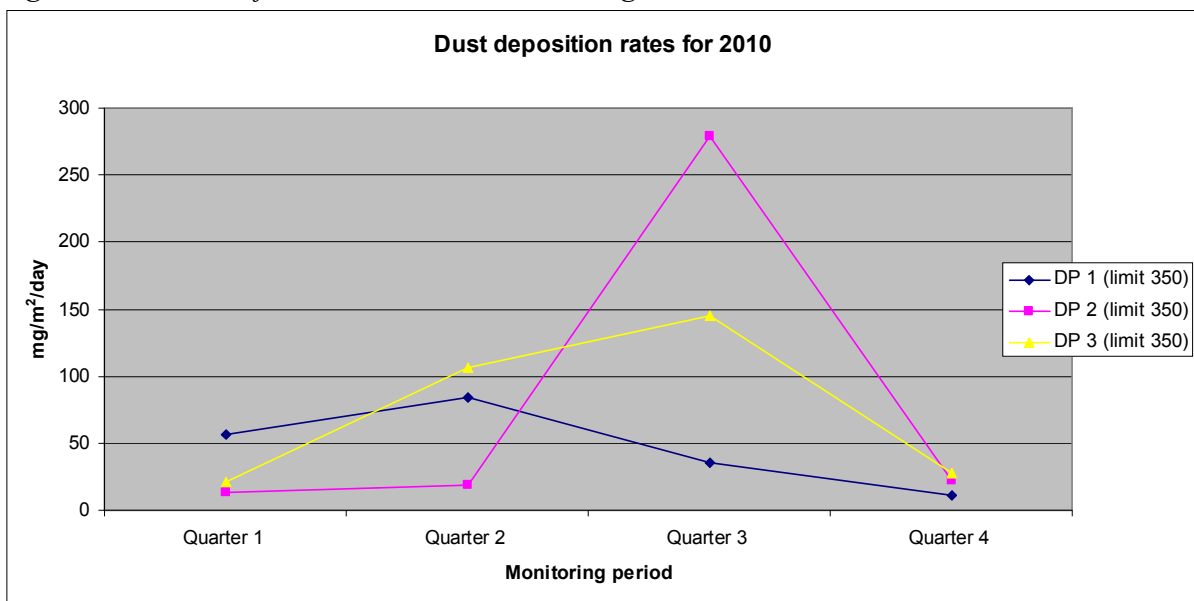
Figure 3.3: Levels of dust recorded on site during 2010.

All monitoring locations were below the limit for the reporting period.

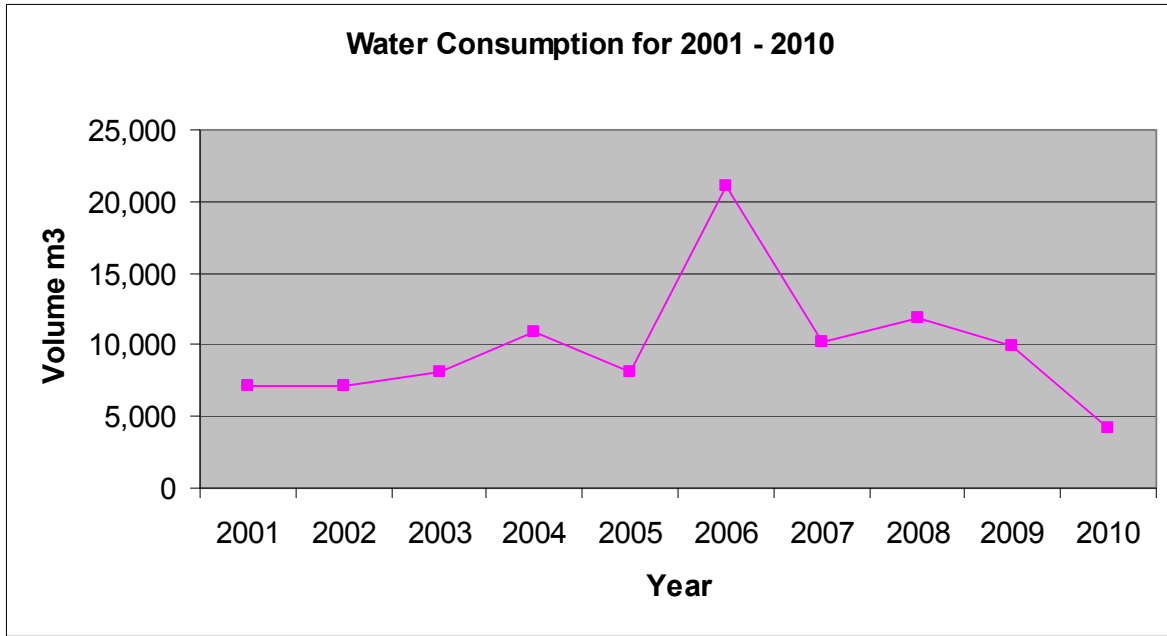
Figure 4.1.2: Water usage on site between 2001 and 2010

Water usage on site since 2001 had exhibited a general increasing trend which can mainly be attributed to both the increase of activities and personnel on site since 2001. A dramatic increase in water consumption was experienced in 2006 due to a leaking pipe underground.

Following the detection of this leak the water consumption reduced back to levels of normal consumption for the sites activities. This normal range of consumption was maintained with a slight decrease in water usage during 2009. 2010 saw a further decrease in water usage this can be attributed to the isolation of activities at an adjacent premises from enva activities.

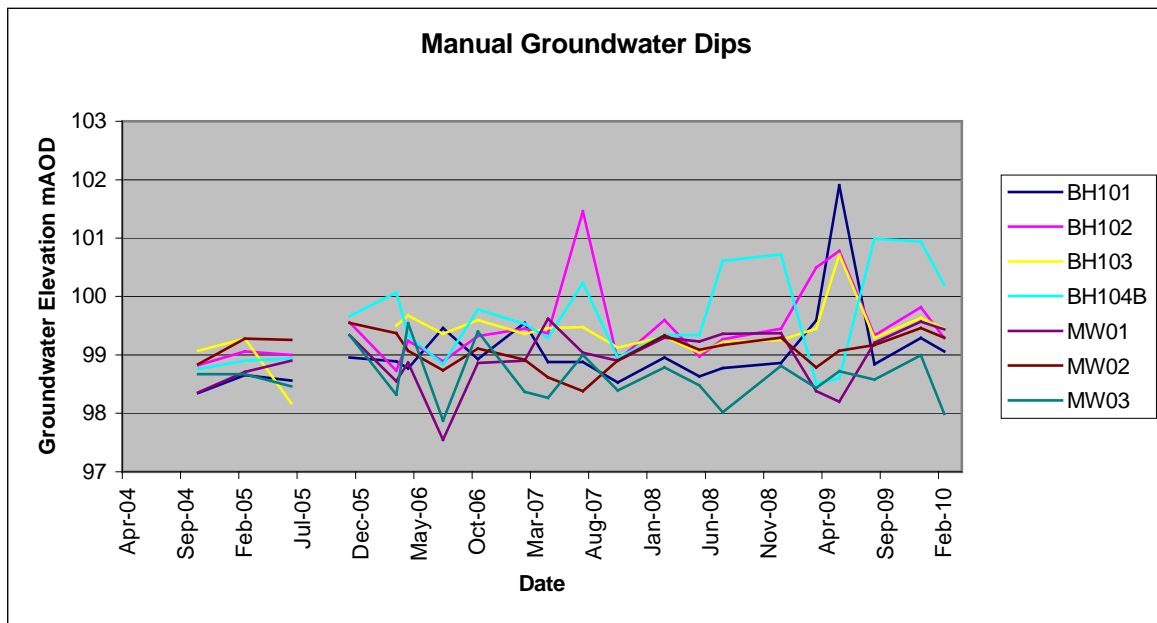
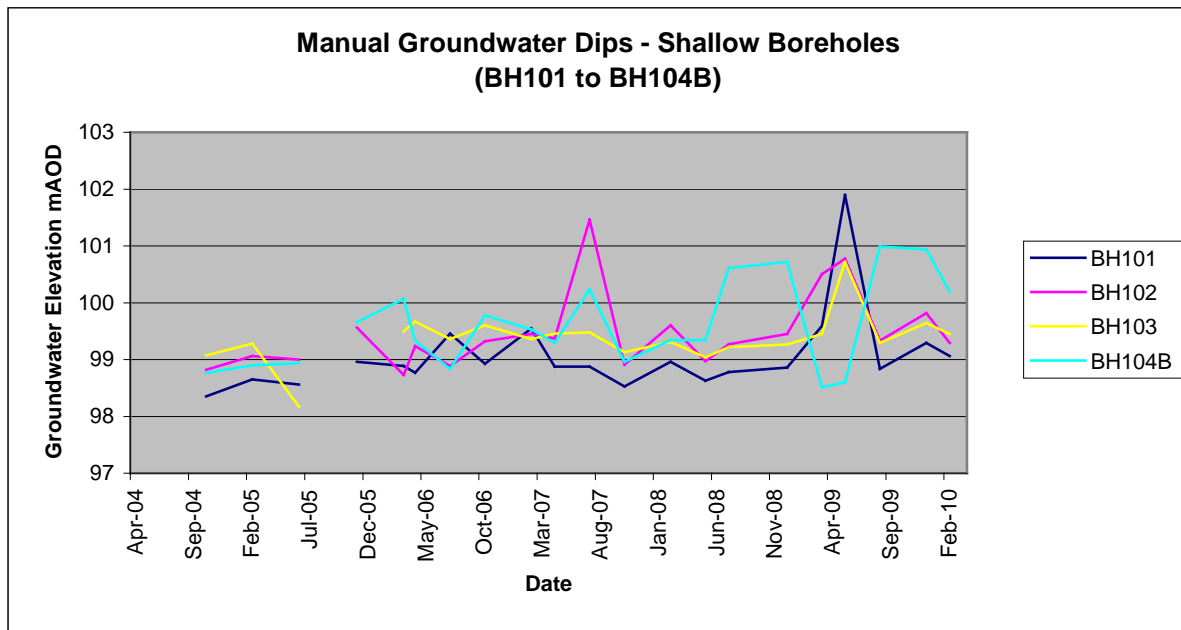
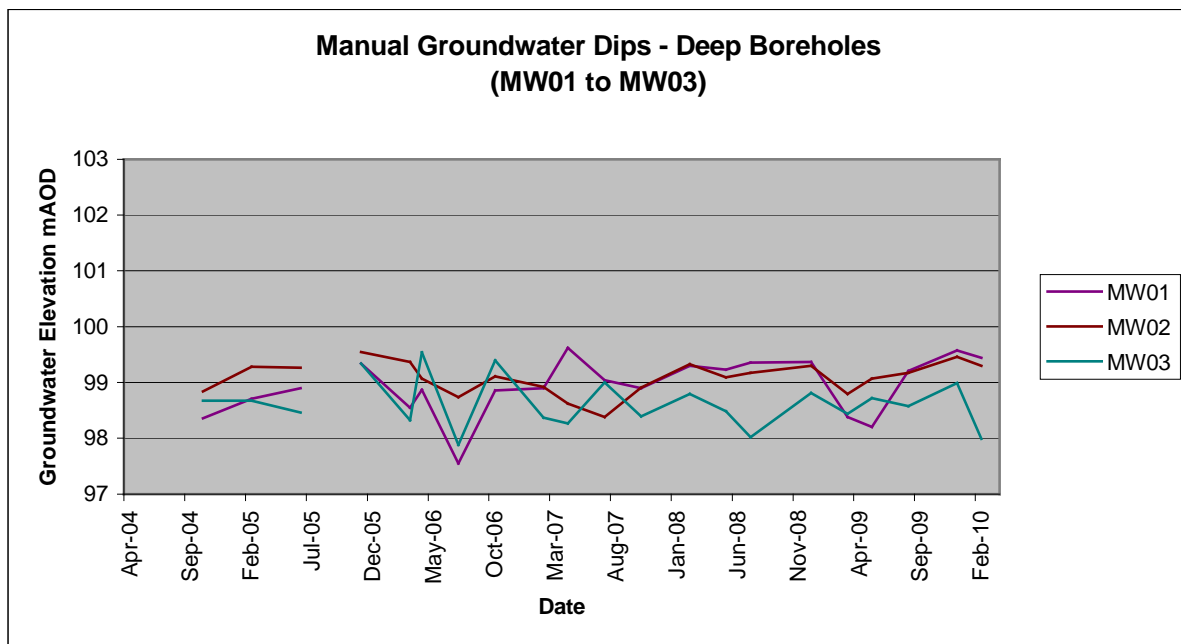
The groundwater levels generally show a similar pattern of fluctuation over time indicating a degree of connection between boreholes. The graphs show that groundwater levels vary significantly between monitoring rounds and that the location of the up-gradient and down gradient holes also vary meaning that groundwater changes direction.

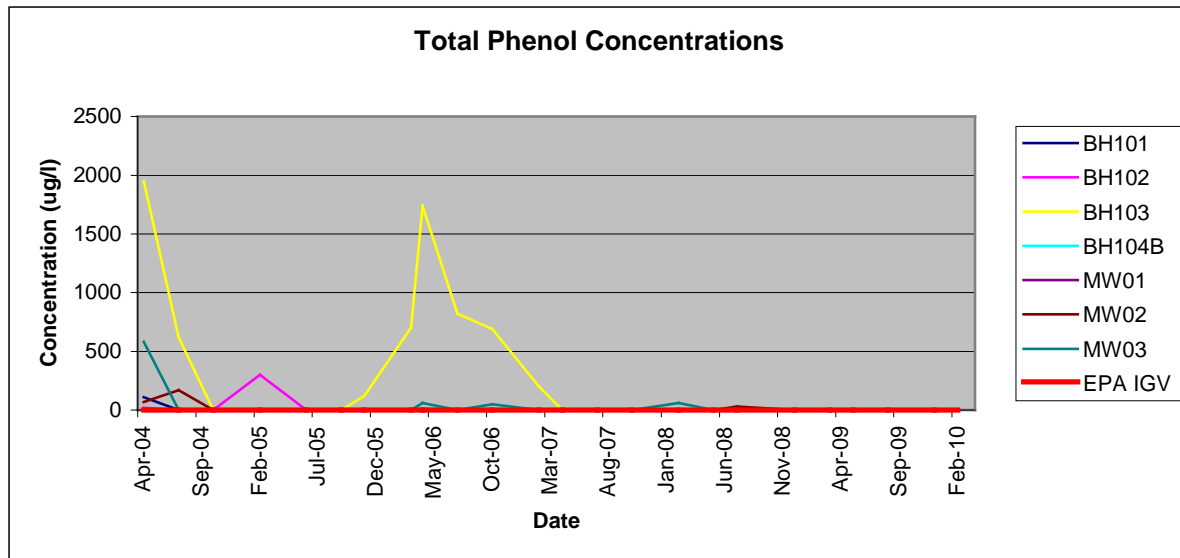
**Figure 6 Phenol Concentrations in all Monitoring Wells**

Phenols have been detected historically in all boreholes with the highest concentrations recorded in BH103. However concentrations in BH103 have declined since April 2007. Phenol concentrations have since been recorded below the IGTV of 0.5 µg/l in all monitoring wells since December 2008 indicating natural attenuating conditions within the groundwater.

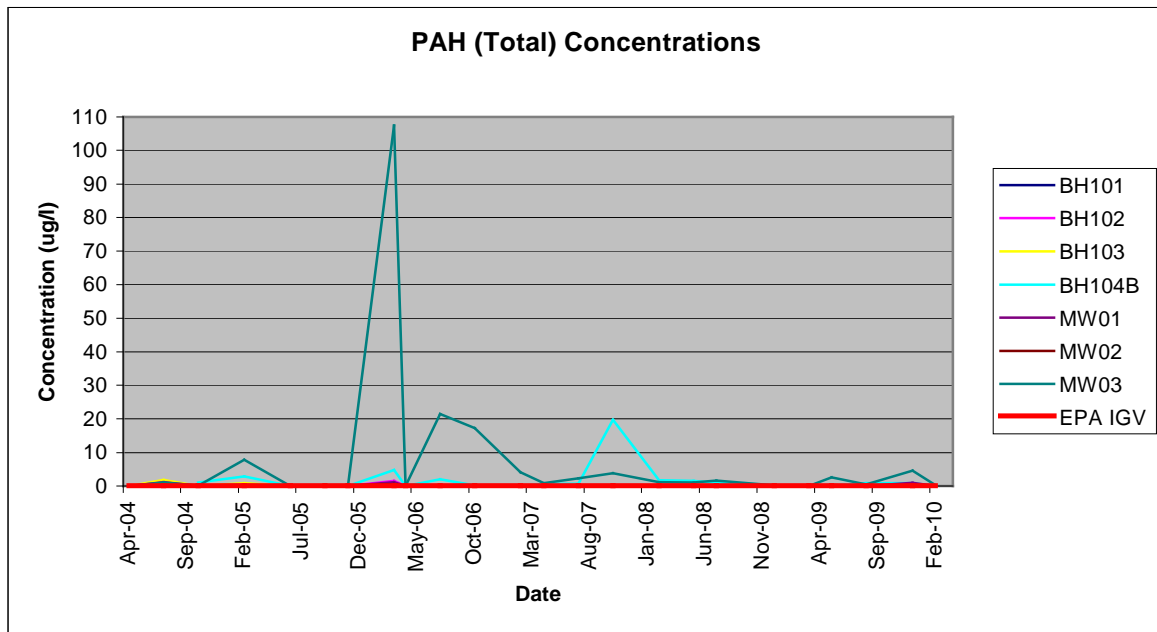
**Figure 7 PAH (Total) Concentrations in all Monitoring Wells**

Figure 7 illustrates that PAH's (Polycyclic Aromatic Hydrocarbons) have been detected within all monitoring wells above the recommended EPA IGTV of 0.1 µg/l. The highest concentrations have been detected within MW03 and BH104B. Historically a range of PAH's including Benzo(a)pyrene, Benzo(g,h,i)perylene, Indeno(1,2,3)cd pyrene, Fluoranthene and Napthalene have been detected in MW03. Figures 8 to 11 illustrates some of the PAH compounds which were detected above their respective IGTV's.

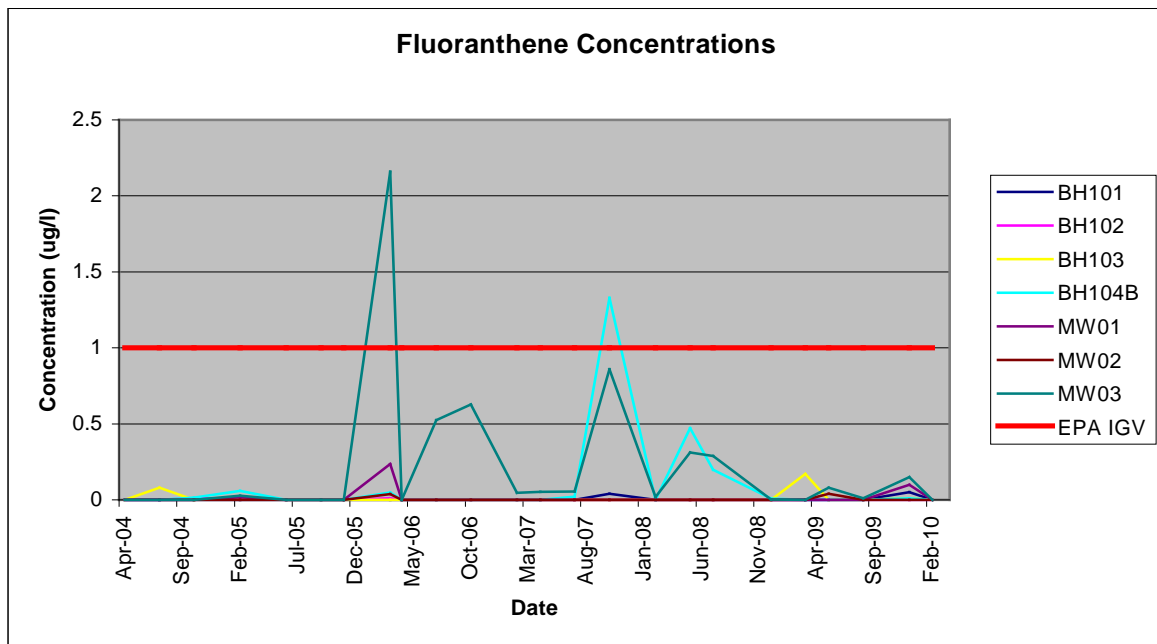
**Figure 8 Fluoroanthene Concentrations in all Monitoring Wells**

Figure 8 illustrates that Fluoroanthene has been detected above the IGV of 1.0  $\mu\text{g/l}$  in groundwater monitoring wells BH104B and MW03. These elevated concentrations above the IGV have been detected on one occasion, in March 2006 in MW03 (2.158  $\mu\text{g/l}$ ) and October 2007 in BH104B (1.33  $\mu\text{g/l}$ ). All other monitoring wells recorded concentrations below the IGV of 1.0  $\mu\text{g/l}$ .

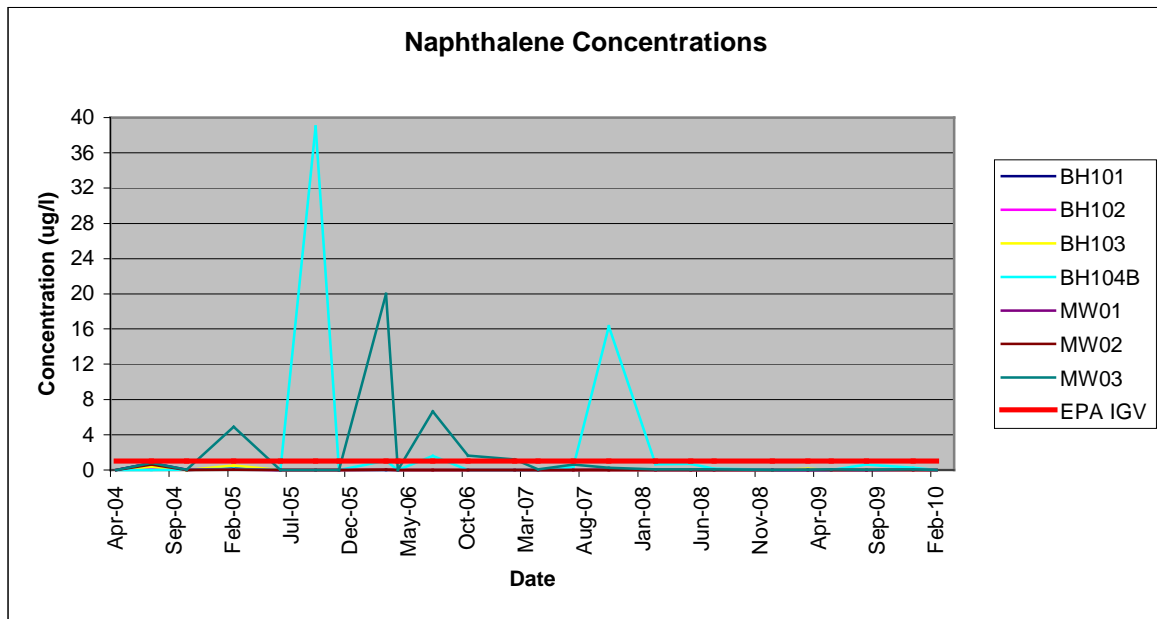
**Figure 9 Naphthalene Concentrations in all Monitoring Wells**

A similar trend to Fluoroanthene has been noted in Figure 9, with concentrations of Naphthalene recorded above the IGV of 1.0 µg/l in BH104B and MW03. A concentration of 39 µg/l was detected in BH104B in September 2005. Since then, the concentrations have decreased, however 3 exceedances of the IGV were noted in March 2006 (1.069 µg/l), July 2006 (1.594 µg/l) and October 2007 (16.31 µg/l). Since October 2007, the concentrations in BH104B have decreased below the IGV. There have been 5 exceedances of the IGV of 1.0 µg/l in MW03, with the highest concentration detected in March 2006 (19.986 µg/l). Naphthalene concentrations have been recorded below the IGV of 1.0 µg/l since April 2007.

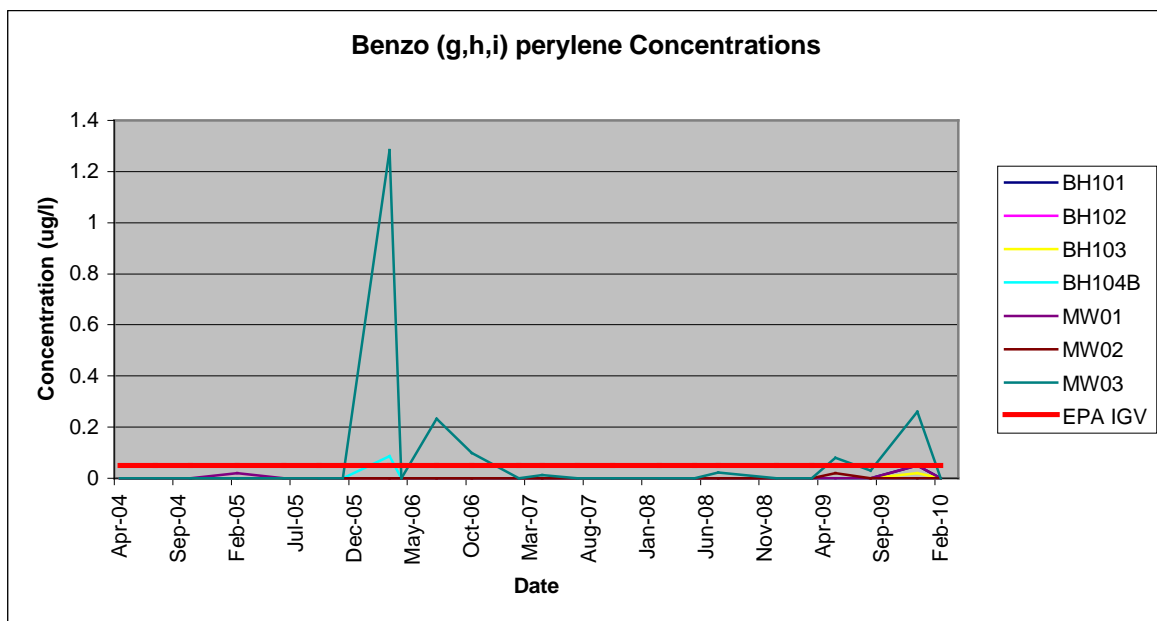
**Figure 10 Benzo (g,h,i) perylene in Monitoring Wells BH104 & MW03**

Figure 10 illustrates the concentrations of Benzo (g,h,i) perylene in BH104B and MW03. There has been one occasion in March 2006 at BH104B where the concentration detected (0.087 µg/l) was above the IGV of 0.05 µg/l. There have been 5 occasions at MW03 where concentrations detected were above the IGV, with the most recent elevated level in December 2009, corresponding to Quarter 4 2009.

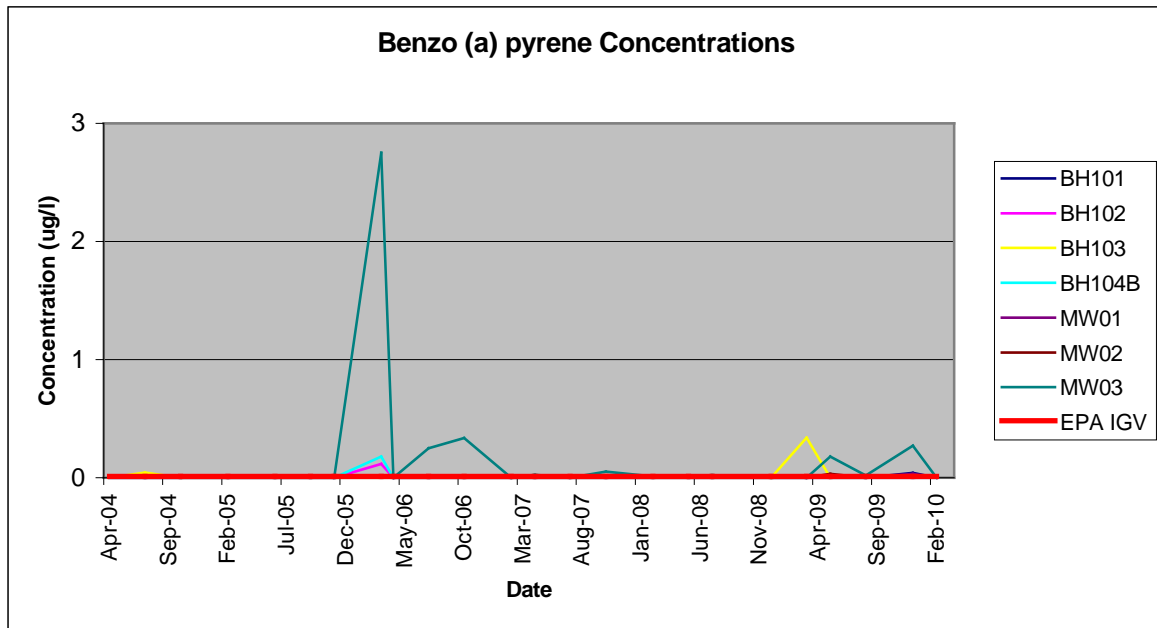
**Figure 11 Benzo (a) pyrene in all Monitoring Wells**

Figure 11 illustrates the concentrations of Benzo (a) pyrene in all groundwater monitoring wells and indicates that Benzo (a) pyrene has been detected historically in all boreholes above the IGV of 0.01 µg/l. Similarly with other trends, the highest concentrations have been detected in MW03. Concentrations have decreased since March 2006 when an elevated concentration of 2.751 µg/l was detected, however there have been a number of detections above the IGV, with the most recent elevated level in December 2009, corresponding to Quarter 4 2009. Other elevated levels above the IGV in December 2009 occurred in BH101, BH103 and MW01.

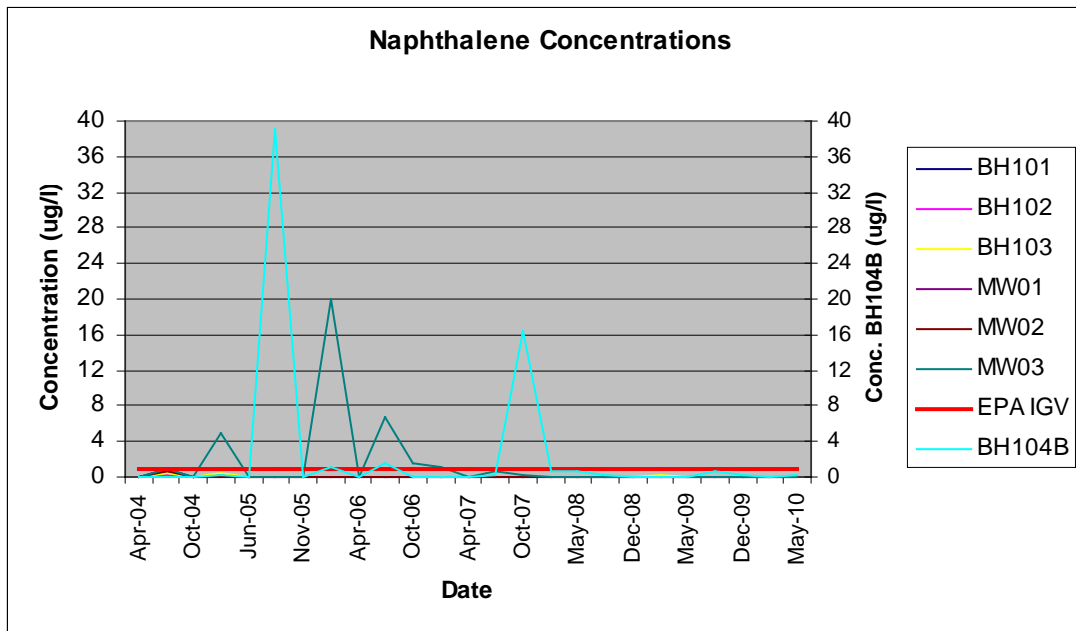
**Figure 9 Naphthalene Concentrations in all Monitoring Wells**

A similar trend to Fluoroanthene has been noted in Figure 9, with concentrations of Naphthalene recorded above the IGV of 1.0 µg/l in BH104B and MW03. A concentration of 39 µg/l was detected in BH104B in September 2005. Since then, the concentrations have decreased, however 3 exceedances of the IGV were noted in March 2006 (1.069 µg/l), July 2006 (1.594 µg/l) and October 2007 (16.31 µg/l). Since October 2007, the concentrations in BH104B have decreased below the IGV. There have been 5 exceedances of the IGV of 1.0 µg/l in MW03, with the highest concentration detected in March 2006 (19.986 µg/l). Naphthalene concentrations have been recorded below the IGV of 1.0 µg/l since April 2007. Most recently concentrations detected during the previous monitoring event in February 2010 have been below the laboratory limit of detection of 0.01 µg/l at all locations.

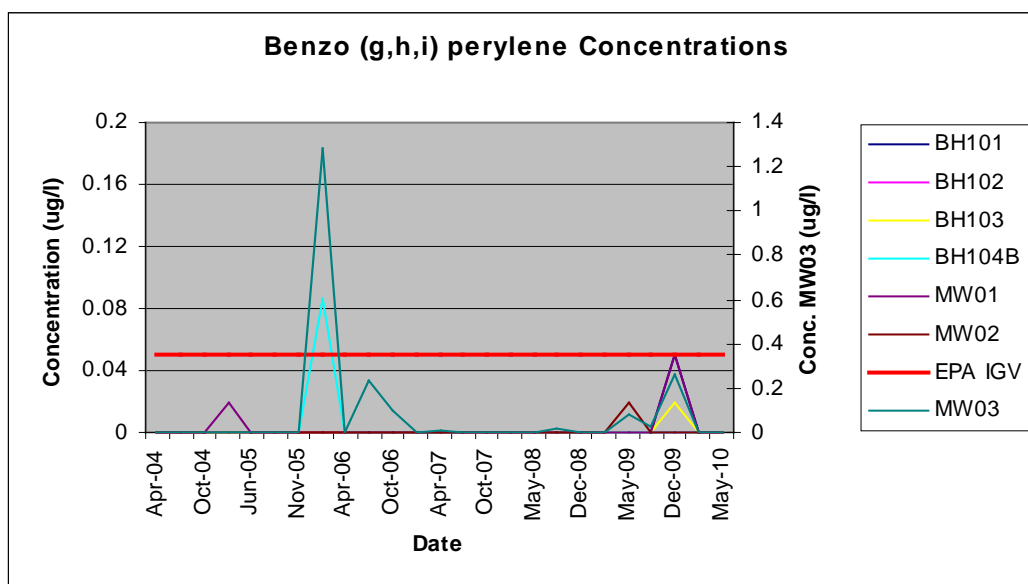
**Figure 10 Benzo (g,h,i) perylene in Monitoring Wells BH104 & MW03**

Figure 10 illustrates the concentrations of Benzo (g,h,i) perylene in BH104B and MW03. There has been one occasion in March 2006 at BH104B where the concentration detected (0.087 µg/l) was above the IGV of 0.05 µg/l. There have been 5 occasions at MW03 where concentrations detected were above the IGV, with the most recent elevated level in December 2009, corresponding to Quarter 4, 2009. The results of the previous monitoring event in February 2010 recorded concentrations below the laboratory limit of detection of 0.01 µg/l at all locations.

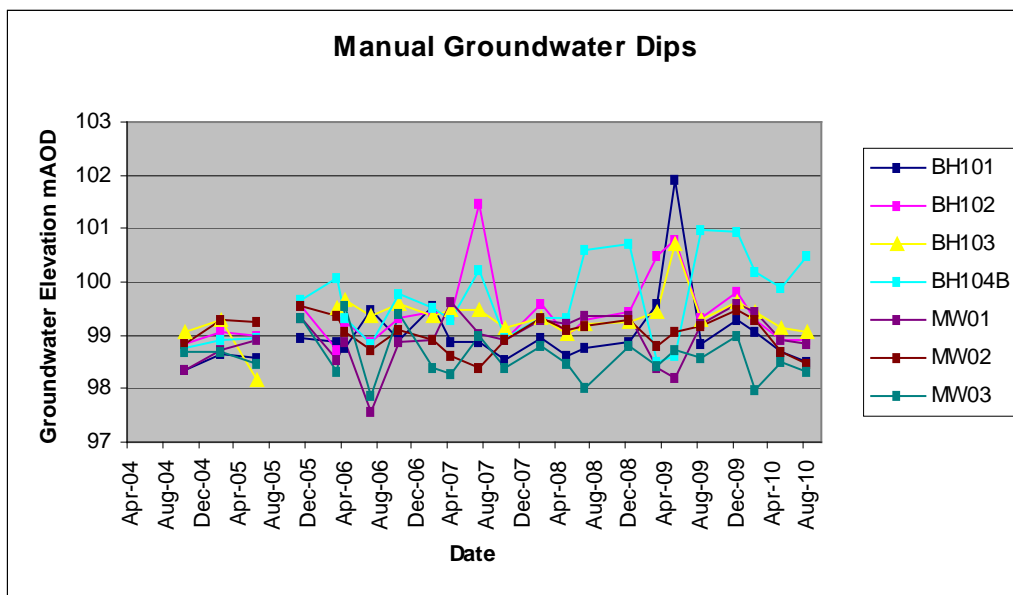
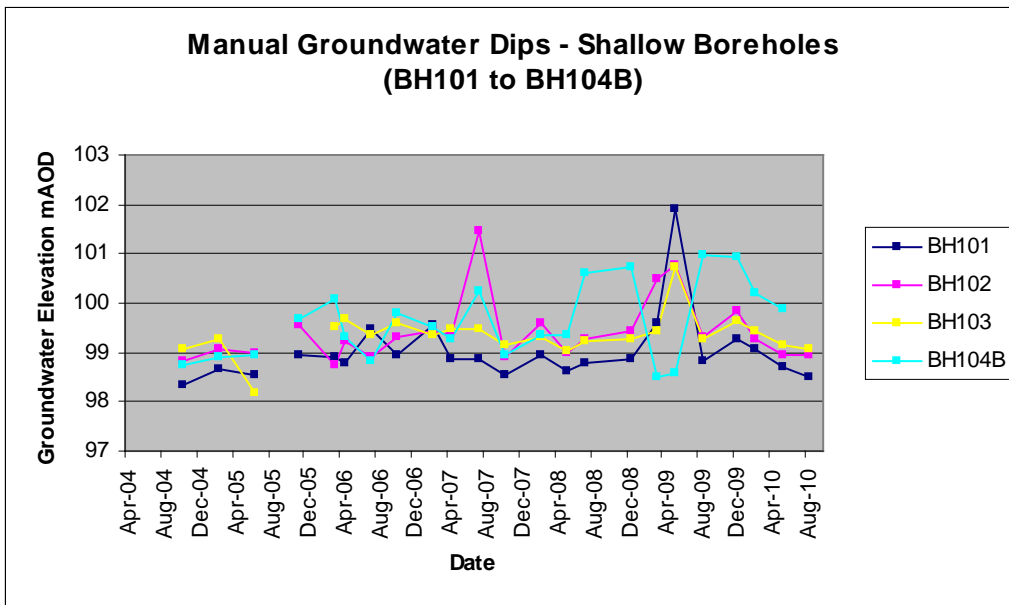
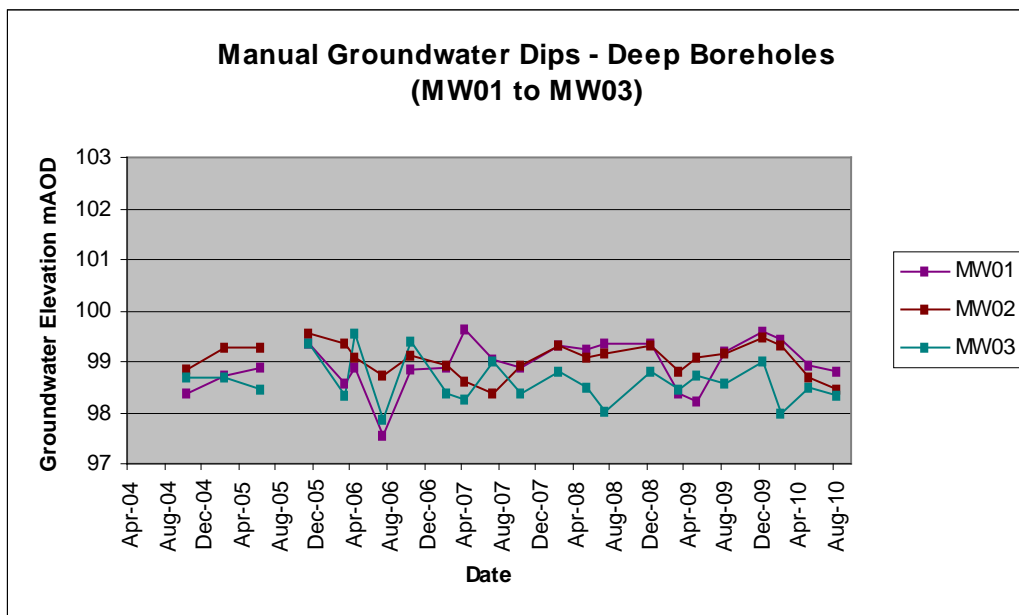
The groundwater levels generally show a similar pattern of fluctuation over time indicating a degree of connection between boreholes. The graphs demonstrate that groundwater levels can vary considerably between monitoring rounds; however, the general direction of flow in the shallow and deeper groundwater bearing unit is predominantly in a south easterly direction and occasionally in a southerly direction.

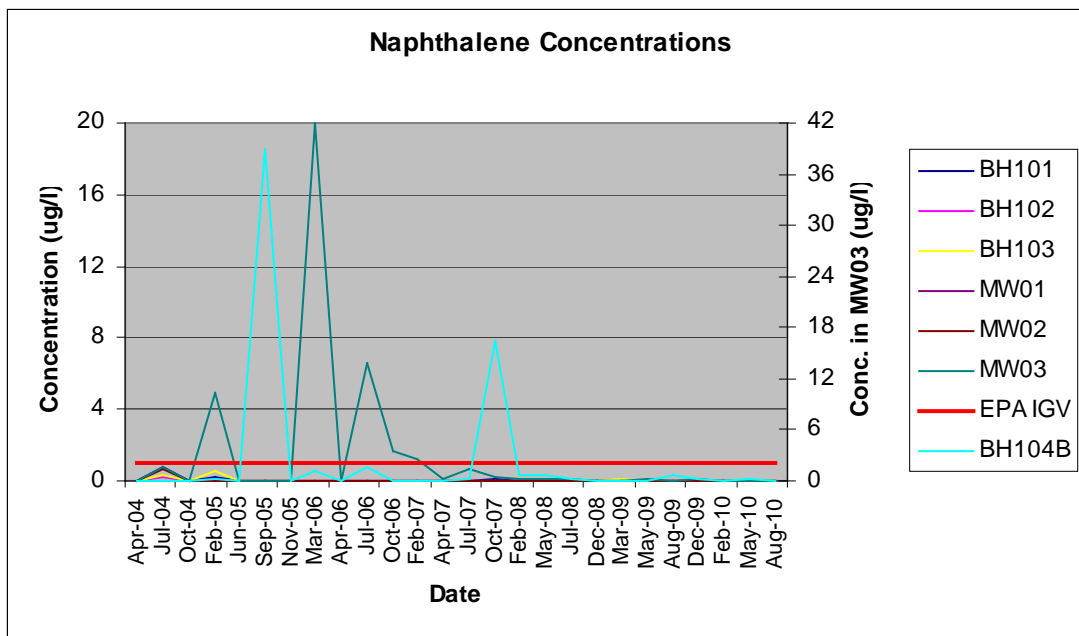
**Figure 9 Naphthalene Concentrations in all Monitoring Wells**

A similar trend to Fluoroanthene has been noted in Figure 9, with concentrations of **Naphthalene** recorded above the IGV of 1.0 µg/l in BH104B and MW03 only. 4 no. exceedances of the IGV were noted in BH104B in September 2005 (39 µg/l), March 2006 (1.069 µg/l), July 2006 (1.594 µg/l) and October 2007 (16.31 µg/l). Since October 2007, the concentrations in BH104B have decreased below the IGV. There have been 5 exceedances of the IGV of 1.0 µg/l in MW03, with the highest concentration detected in March 2006 (19.986 µg/l). Naphthalene concentrations have been recorded

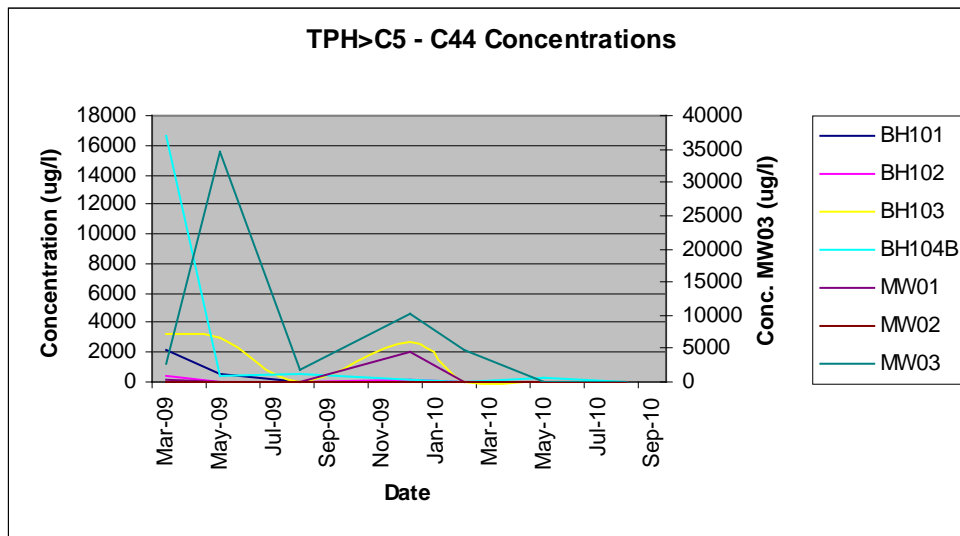
**Figure 12 TPH (Carbon Range C5-C44) in all Monitoring Wells**

During the Quarter 1, 2010 monitoring event, hydrocarbons were detected in borehole MW03. The predominant aliphatic carbon range in MW03 comprised of C16-C21 (1000 µg/l), C21-C35 (2300 µg/l) and C25-C44 (990 µg/l). The predominant aromatic carbon range in MW03 comprised of C16-C21 (220 µg/l) and C21-C35 (620 µg/l). No detections were observed at other locations.

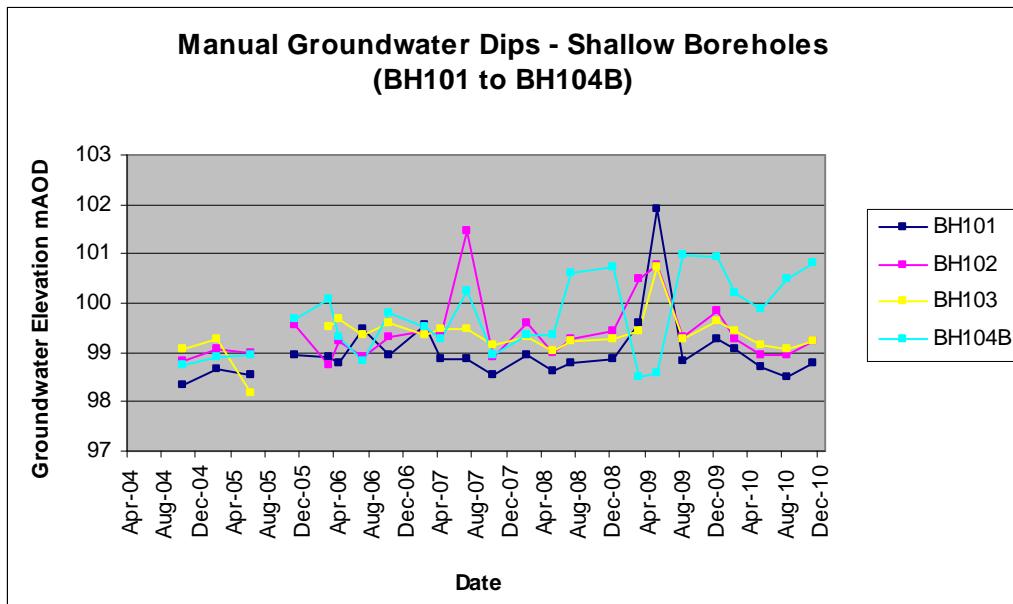
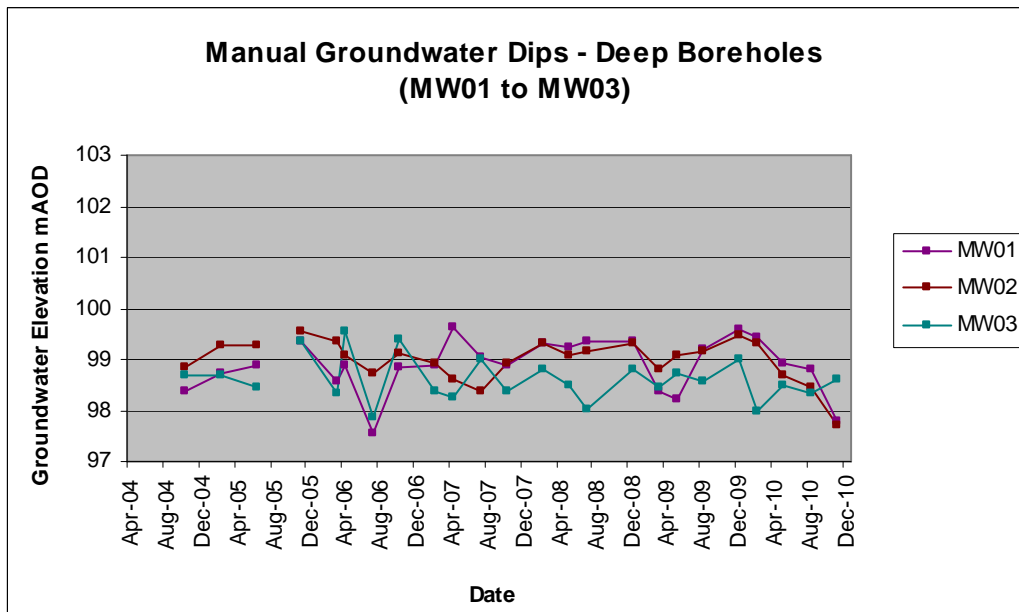
The groundwater levels generally show a similar pattern of fluctuation over time indicating a degree of connection between boreholes. The graphs demonstrate that groundwater levels can vary considerably between monitoring rounds; however, the general direction of flow in the shallow and deeper groundwater bearing unit is predominantly in a south easterly direction and occasionally in a southerly direction.

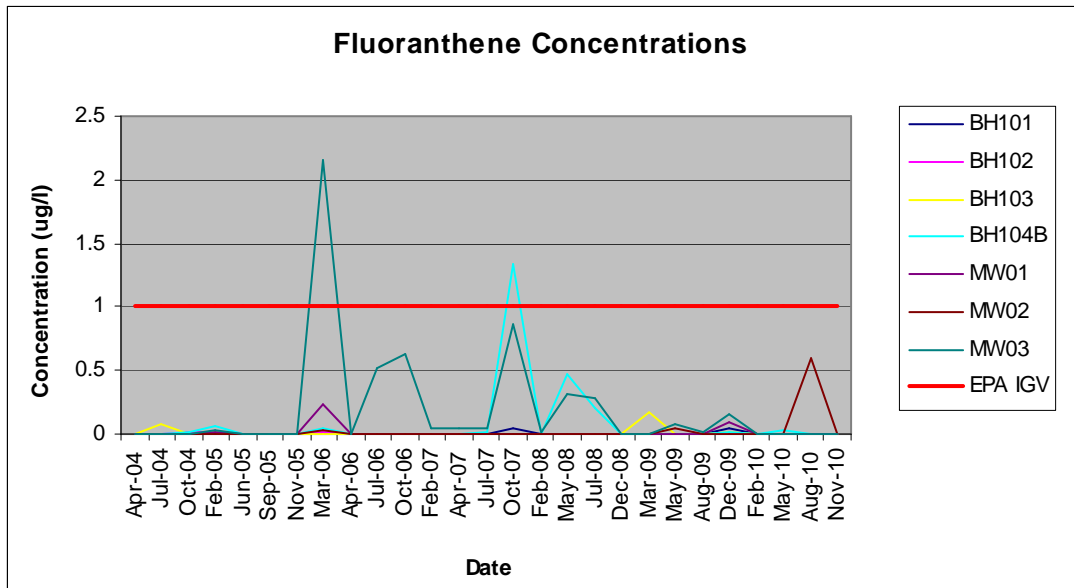
**Figure 8 Fluoroanthene Concentrations in all Monitoring Wells**

Figure 8 illustrates that **Fluoroanthene** was previously detected above the IGV of 1.0 µg/l in groundwater monitoring wells BH104B and MW03 only. These elevated concentrations have been detected on one occasion in MW03 (March 2006, 2.158 µg/l) and BH104B (October 2007, 1.33 µg/l). The remaining monitoring wells recorded concentrations below the IGV of 1.0 µg/l.

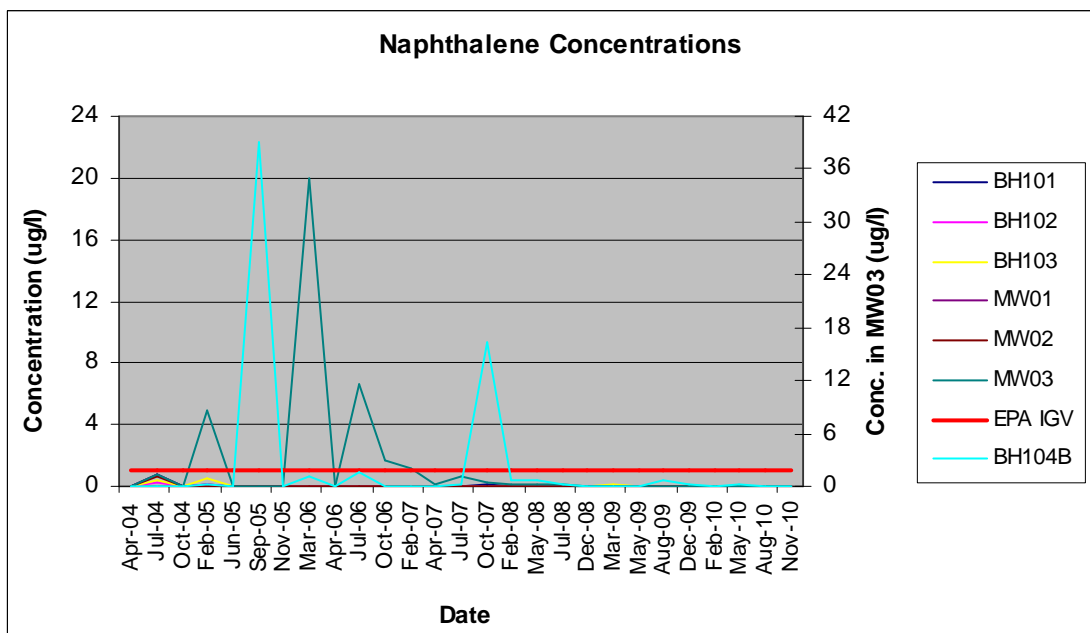
**Figure 9 Naphthalene Concentrations in all Monitoring Wells**

A similar trend to Fluoroanthene has been noted in Figure 9, with concentrations of **Naphthalene** recorded above the IGV of 1.0 µg/l in BH104B and MW03 only. 4 no. exceedances of the IGV were noted in BH104B in September 2005 (39 µg/l), March 2006 (1.069 µg/l), July 2006 (1.594 µg/l) and October 2007 (16.31 µg/l). Since October 2007, the concentrations in BH104B have decreased below the IGV. There have been 5 exceedances of the IGV of 1.0 µg/l in MW03, with the highest concentration detected in March 2006 (19.986 µg/l). Naphthalene concentrations have been recorded below the IGV of 1.0 µg/l since April 2007. The concentrations detected in August 2010 were slightly

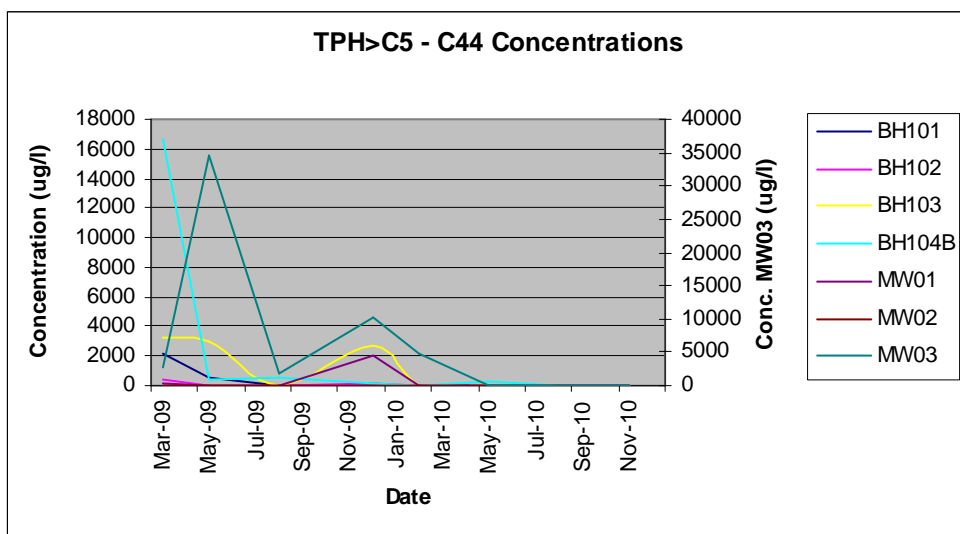
**Figure 12 TPH (Carbon Range C5-C44) in all Monitoring Wells**

During the Quarter 1, 2010 monitoring event, hydrocarbons were detected in borehole MW03. The predominant aliphatic carbon range in MW03 comprised of C16-C21 (1000 µg/l), C21-C35 (2300 µg/l) and C25-C44 (990 µg/l). The predominant aromatic carbon range in MW03 comprised of C16-C21 (220 µg/l) and C21-C35 (620 µg/l). No detections were observed at other locations.
