Client:	Roadstone Provinces Ltd.
Project:	Exploratory Site Investigation at Brownswood
Title:	Factual Site Investigation Report

FACTUAL SITE INVESTIGATION REPORT
AT BROWNSWOOD, CO. WEXFORD

REPORT ON GROUND INVESTIGATION

Report No. KD8062

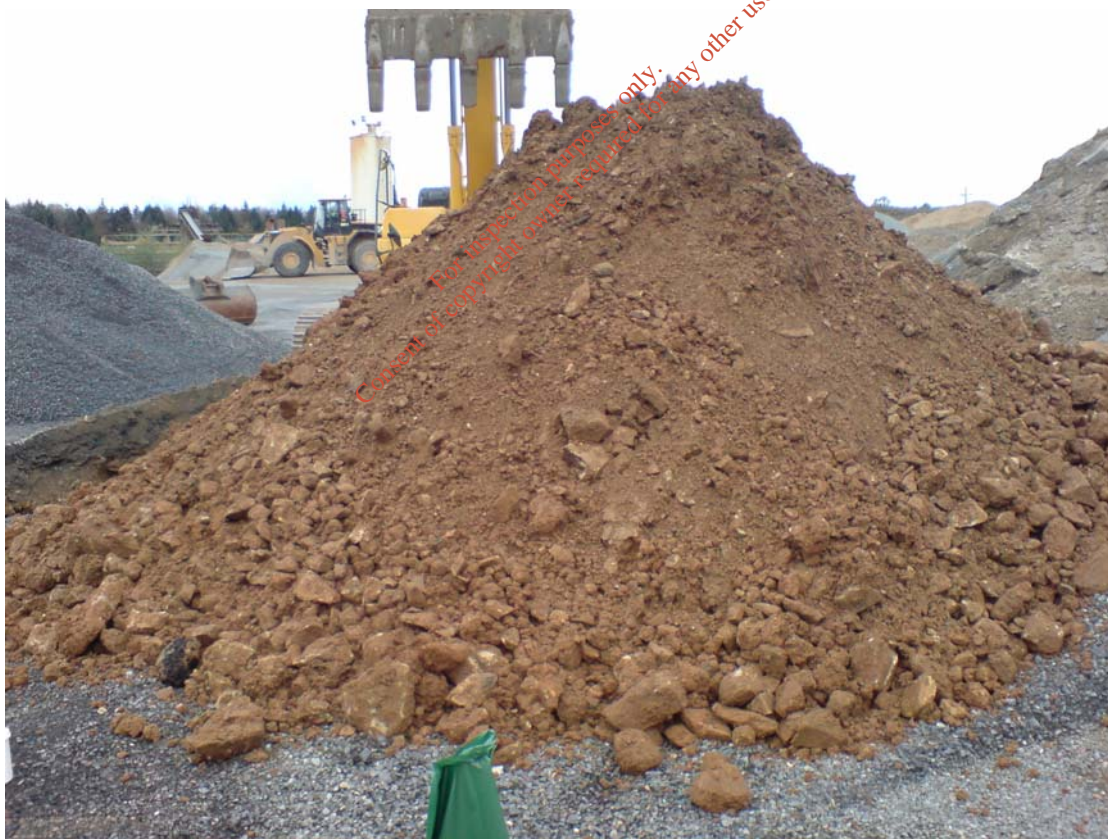
Plate 2. Spoil from Trial Pit 1.

Material uncovered consisted predominantly of subsoil and broken rock with very occasional inert construction and demolition (C&D) material (<1%), which is concentrated within the uppermost 1-3 m. C&D material included concrete, macadam blacktop, metal and plastic. Material encountered is believed to have originated from the 'Paul Murphy' quarry, comprising 'strippings' (soil, subsoil, weathered and broken rock). Material uncovered is shown below in Plate No. 2. No odour or hydrocarbon staining was encountered within Area A. No domestic waste or tyres was encountered within this area. The logs for the trial pits and the auger holes are presented in Appendix B. The drilling of the shell & auger holes in this type of terrain is recognised as being difficult and several attempts at drilling ended in obstructions, generally within the upper 3 m. Two drill holes were successfully drilled to 10 m and one successful to 23 m. No water table was met in any of the boreholes. Plate 3 and 4 show views into Trial Pit 1 and Trial Pit 2.

Finding: It is concluded that area consists predominantly of subsoil strippings. The borehole and trial pit logs and the soils results and the water results suggest that the area is uncontaminated.

Action: It is concluded that Area does not require remediation. However, in accordance with the Section 55 Notice groundwater monitoring wells are to be placed in locations to allow long term groundwater quality monitoring to take place.

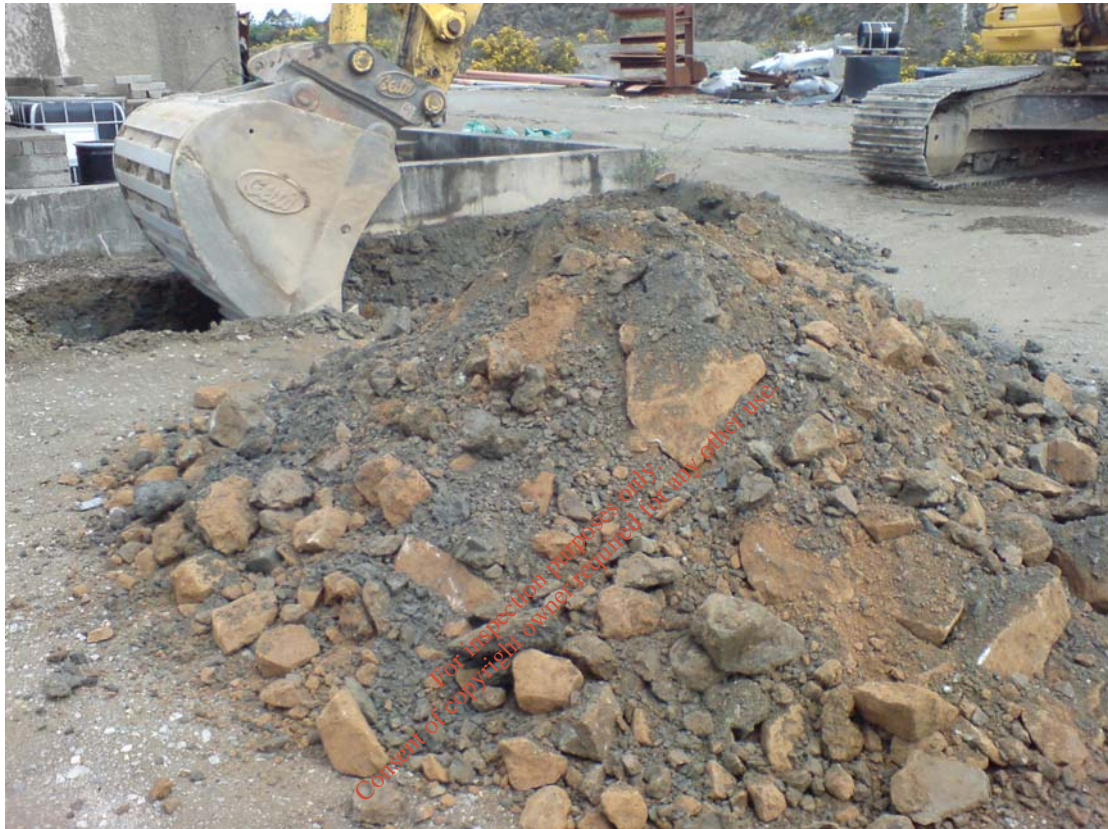
Plate 5. View of location of Trial Pit 3 and material recovered.

Trial Pit No. 3 was located next to the oil bund as can be seen in Plate 5, 6 and 7. Material uncovered consisted primarily of compacted hardcore, subsoil and broken rock. Odour and hydrocarbon staining was encountered in the uppermost 0.5m. The uppermost material is compacted hardcore, below which comprises broken rock and subsoil. There is no staining or odour from the material deeper in the trial pit. The deeper material recovered can be seen in Plate 7.

Area B: The results taken from Area B (Trial Pit 3) indicate hydrocarbon contamination at the surface. The sample taken from Area B supports the visual inspection that there is a localised zone of oil spillage and corresponds to the strong odour noted during the trial pitting. The results from Area B indicate that the total concentration of the sixteen speciated hydrocarbons are elevated (31,596 µg/kg), indicate contamination and are just below the Dutch Intervention Value of 40,000 µg/kg. The extent is limited to the area around the oil bund.

Action: It is concluded that the area is remediated by digging out the contaminated ground and disposed of by a permitted contractor and replaced with inert material.

Suitable remediation and disposal is recommended for Area B (around the old oil bund at the eastern end of the garage) and Area C (around the dismantled primary rock crusher).

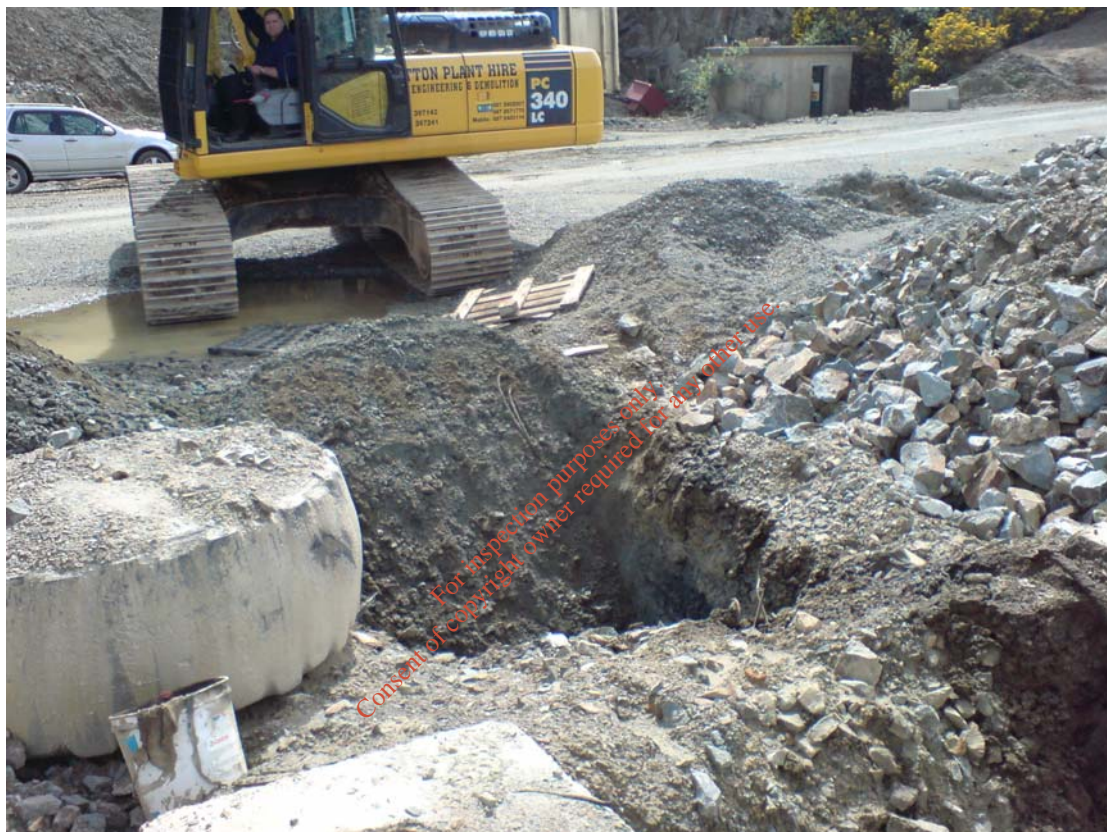
Plate 7. Trial Pit 7.

Trial Pit No. 7 was located next to the dismantled primary crushing area, where oil staining was identified from the reconnaissance survey. Material uncovered consisted primarily of compacted hardcore, subsoil and broken rock. Views of the trial pit in Area C are given in Photographs 7, 8, and 9 below. Odour and hydrocarbon staining was encountered in the uppermost 1m. The uppermost material is compacted hardcore, below which comprises broken rock and subsoil. There is no staining or odour from the material deeper in the trial pit.

Finding: an upper layer of made ground which appears to be contaminated based on the visual inspection and the trial pit.

Action: It is concluded that the area is remediated by digging out the contaminated ground and disposed of by a permitted contractor and replaced with inert material.

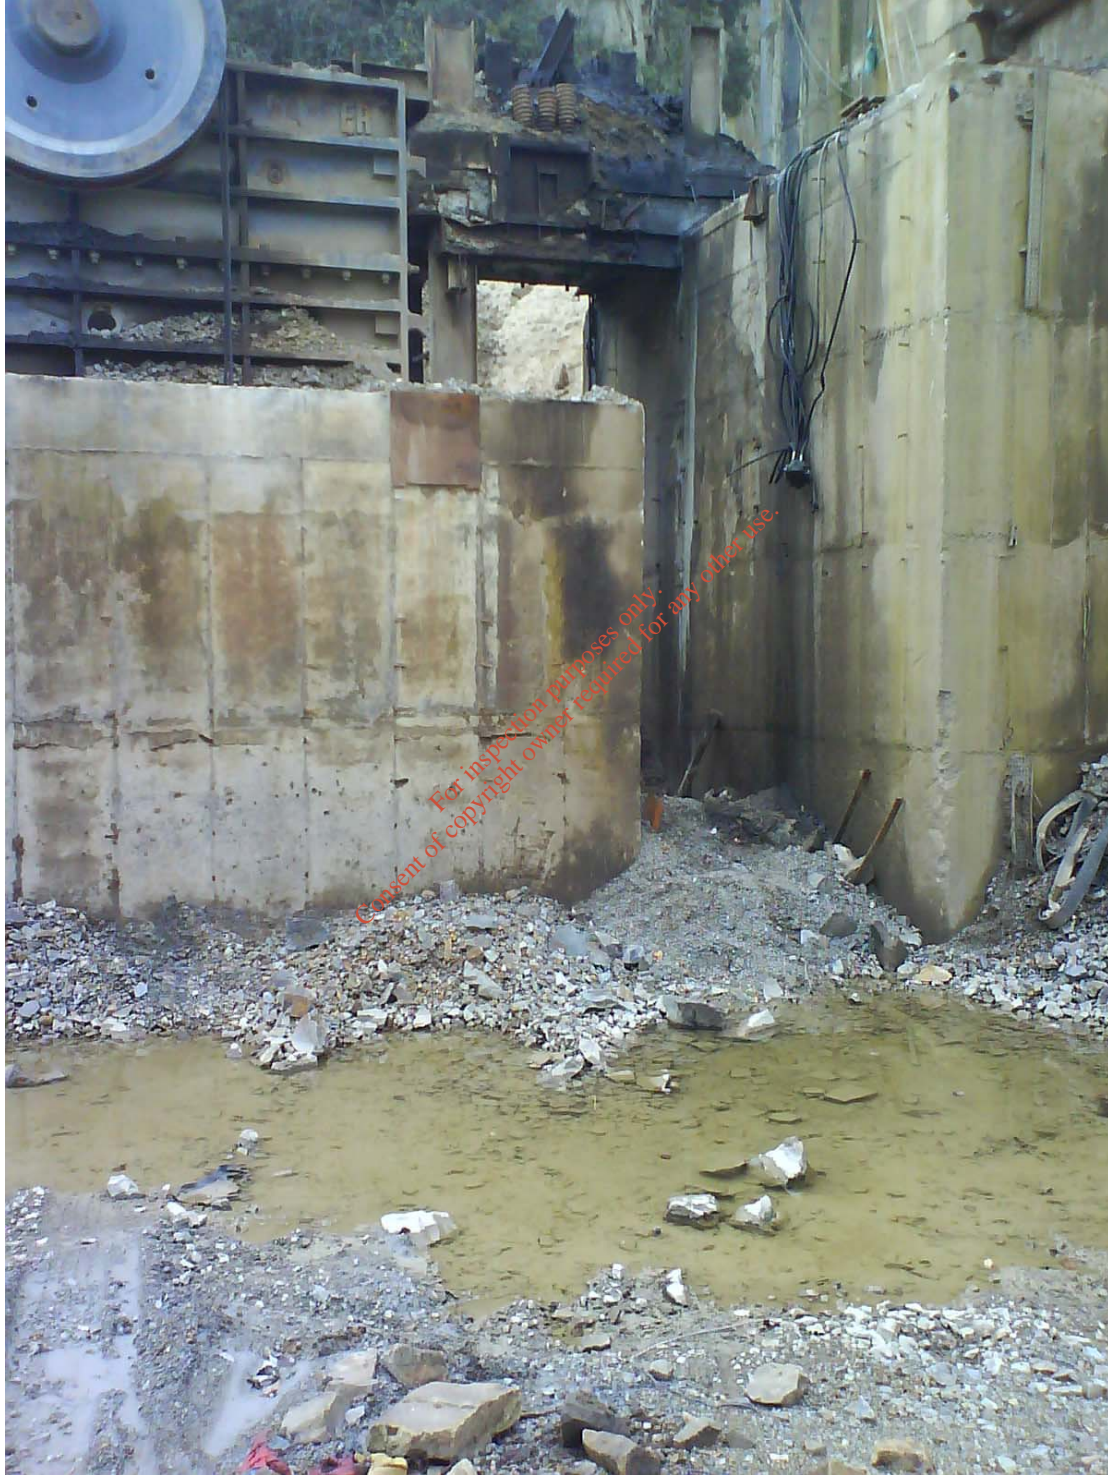
Plate 10: Location of Trial Pit 6 next to dismantled rock breaker

Two trial pits were excavated (Trial Pit No. 5 & 6) next to the dismantled rock breaker, shown in Plate 10. Material uncovered consisted primarily of broken rock. Standing water was present. There is no staining or odour from the excavated material or the trial pit.

Finding: It is concluded that this ground around the rock breaker does not appear to be contaminated.

Action: No further action is required.

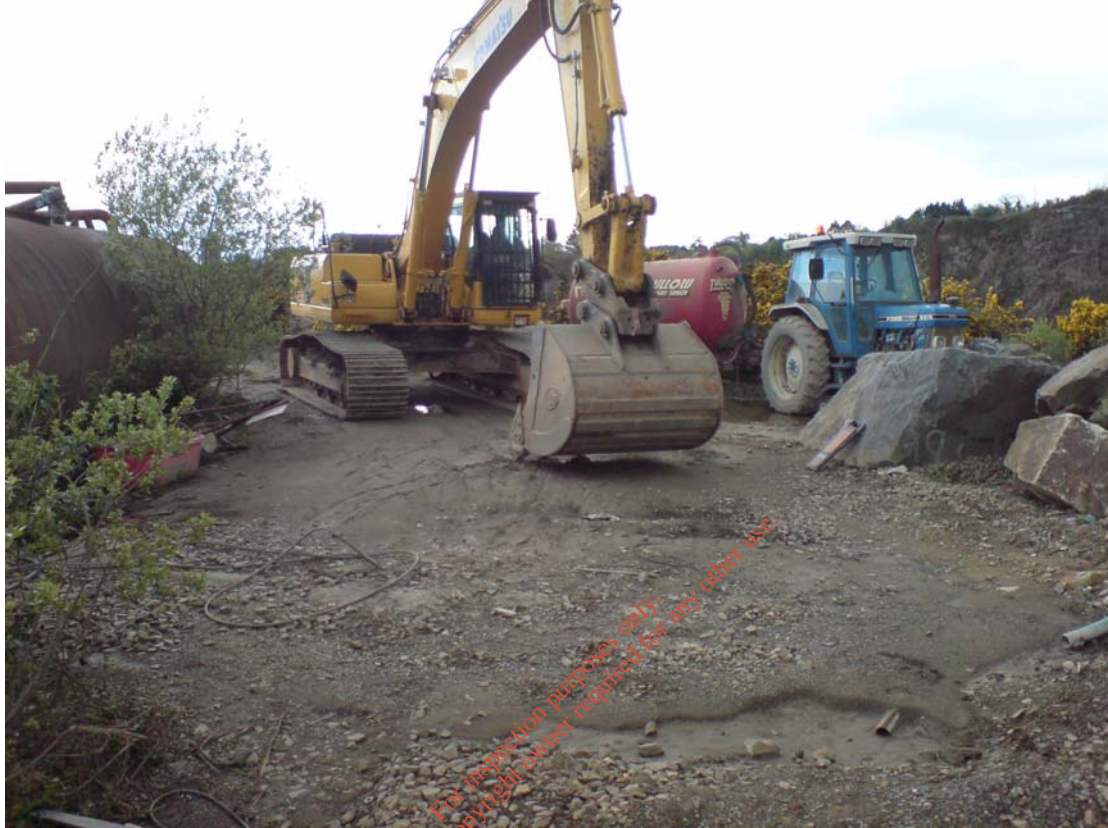
Plate 12: Location of Trial Pit 4

Trial Pit No. 4 was located in an area designated for washing vehicles, shown in Plate 12. Material uncovered consisted primarily of broken rock. There is no staining or odour from the excavated material or the trial pit.

Finding: It is concluded that this ground does not appear to be contaminated.

Action: No further action is required.

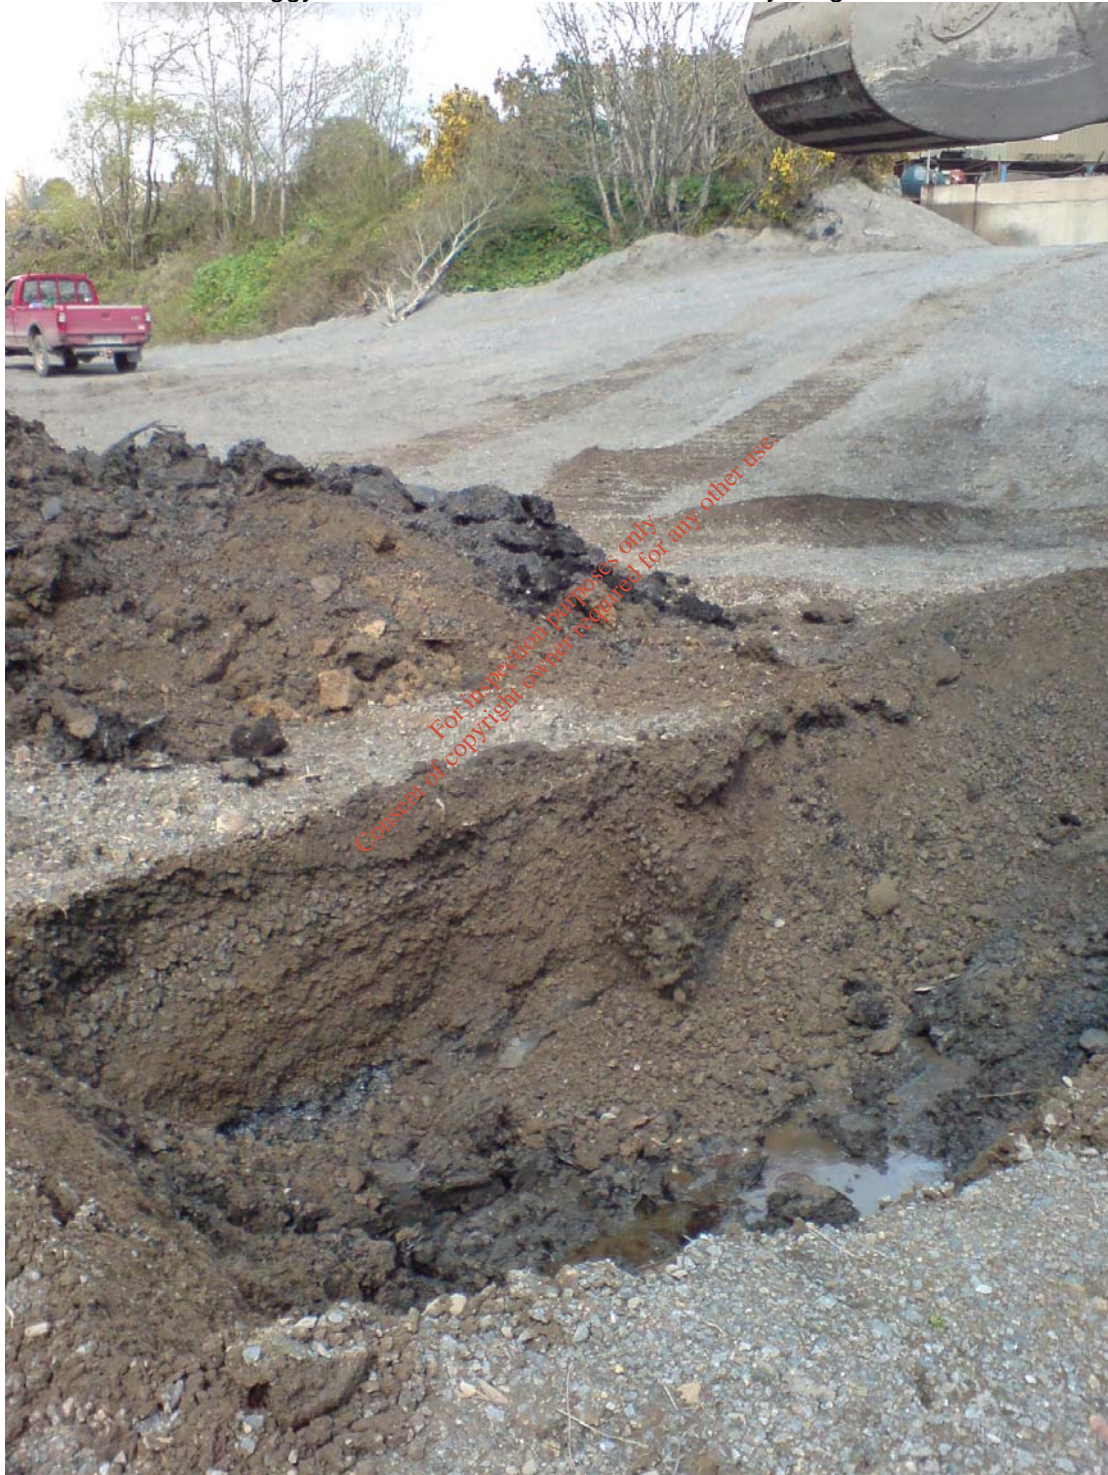
Plate 13: Trial Pit 8

Trial Pits No. 8, 9 and 10 were located in an area to the front of the site, shown in Plates 13, 14 and 15. There is no staining or hydrocarbon odour from the excavated material or the trial pits, apart from a sulphur smell in Trial Pit No. 8 at approximately 1.2m bgl to 1.5 m bgl where a fibrous vegetative horizon is located. This area has bull rushes and a boggy saturated area located immediately alongside. .

Finding: It is concluded that this ground does not appear to be contaminated.

Action: No further action is required.
