ROADSTONE WOOD LTD.
ENVIRONMENTAL IMPACT STATEMENT
WASTE RECOVERY FACILITY,
BROWNSWOOD, CO. WEXFORD
VIEWPOINTS C & D

FIGURE 10-3

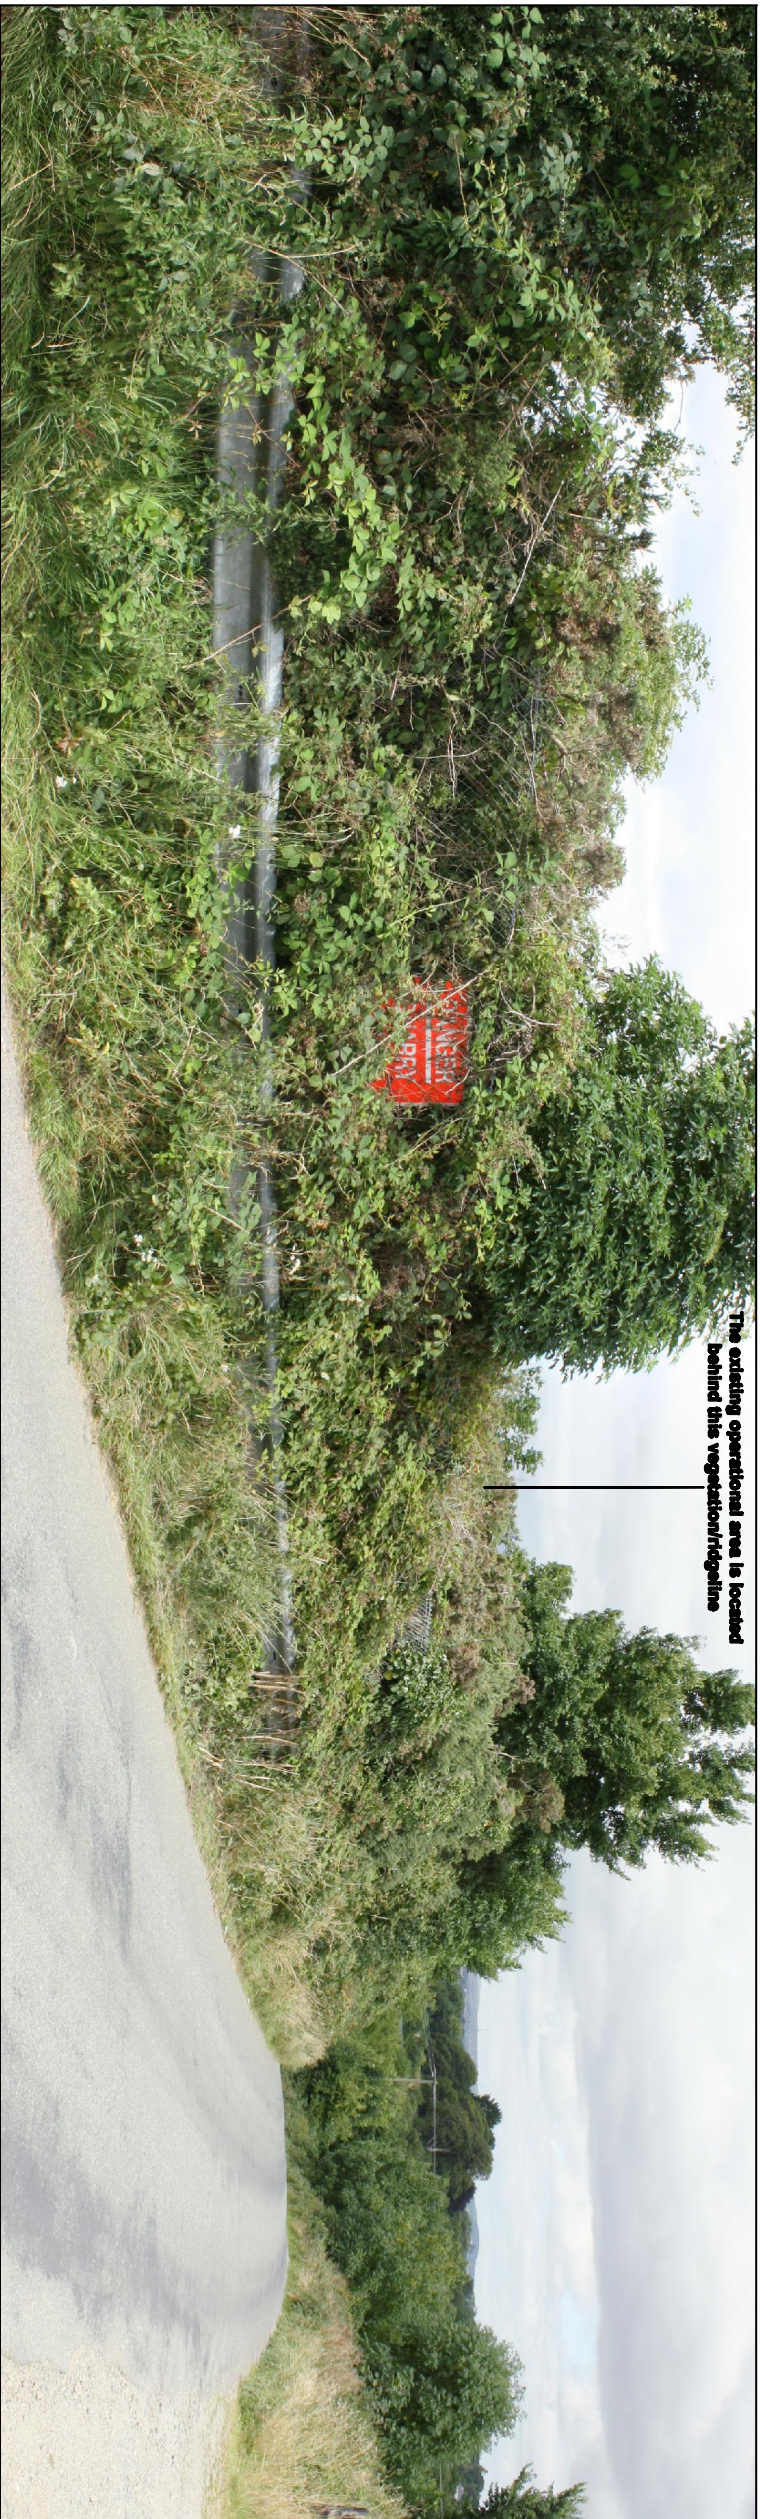
VIEWPOINT C: VIEW ALONG LOCAL ROAD EAST OF THE APPLICATION SITE

The existing operational area is located behind this vegetation/hedge line

Grid Reference: 298008E,137297N

Distance from site boundary: 20m

Approximate Elevation: 52m AOD

Direction of View: West

DESCRIPTION: THE APPLICATION SITE IS NOT VISIBLE FROM THIS AREA, DUE TO INTERVENING TOPOGRAPHY AND MATURE VEGETATION.

SENSITIVITY OF VIEWPOINT: MEDIUM

MAGNITUDE OF CHANGE TO VIEW: NONE

RESIDUAL VISUAL IMPACT: NONE

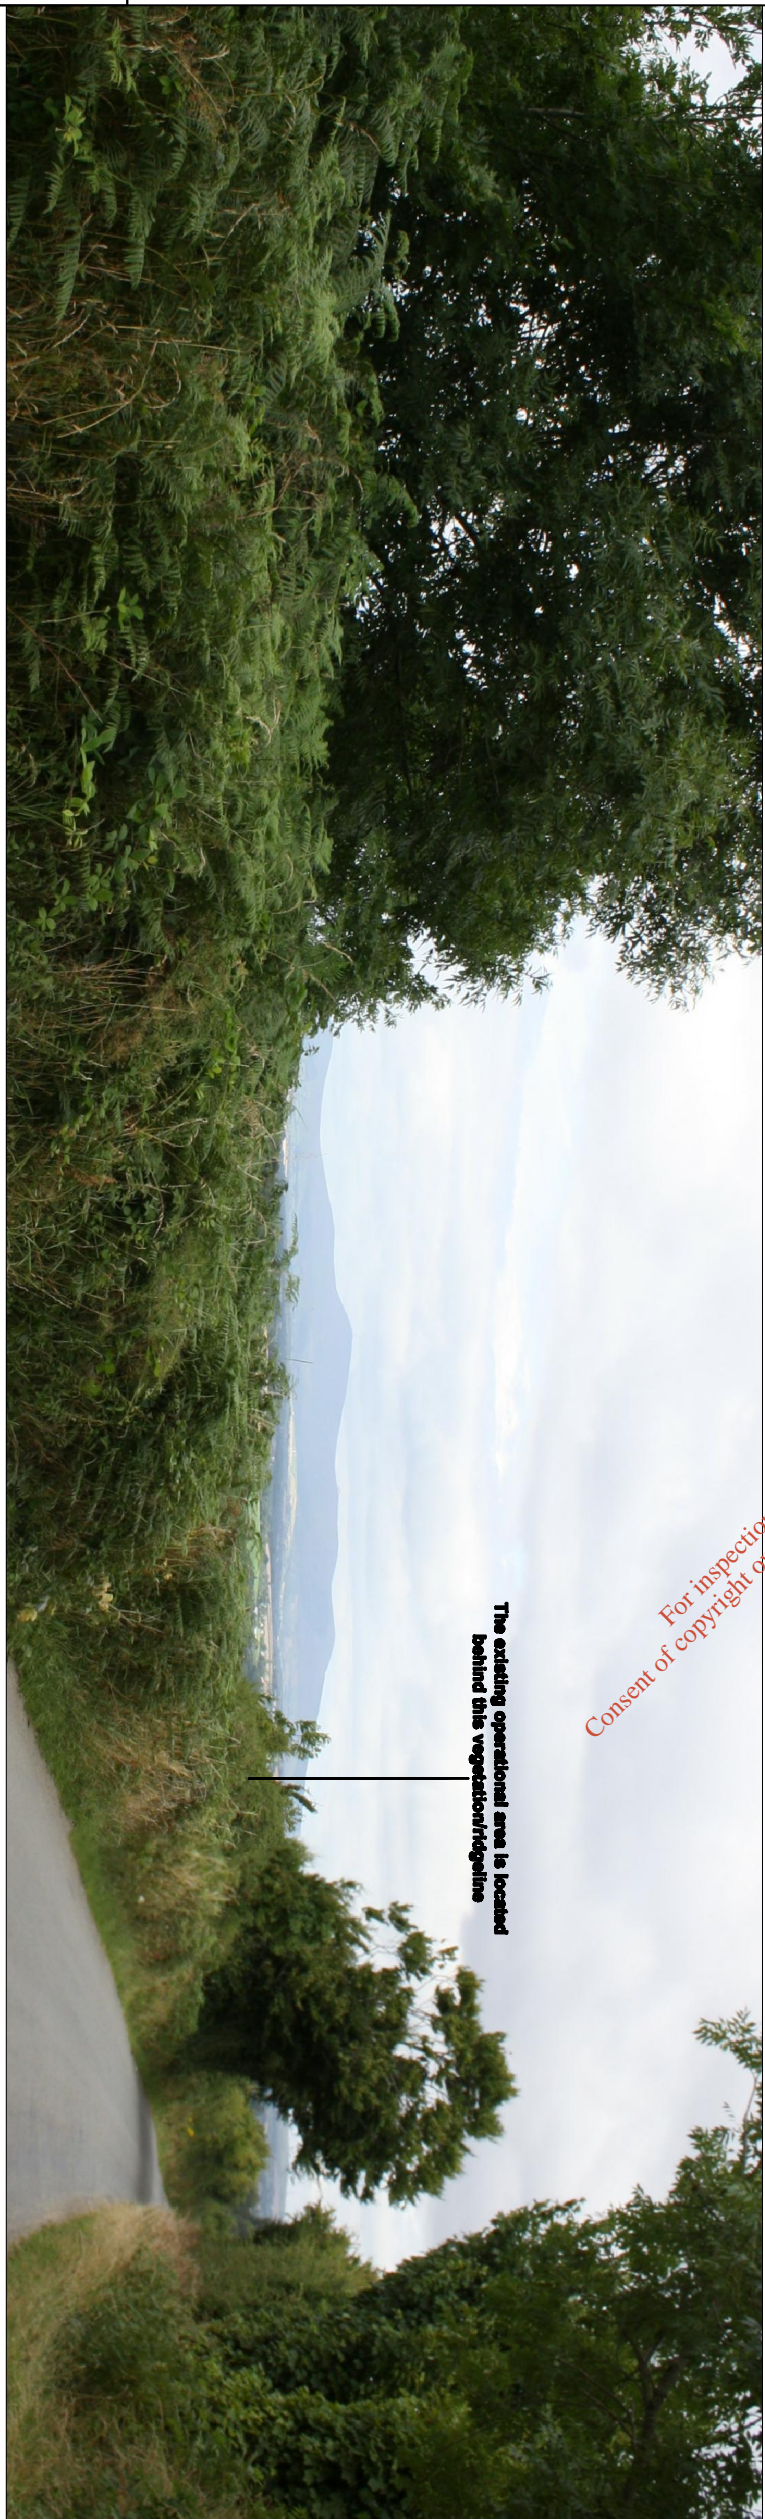
VIEWPOINT D: VIEW ALONG LOCAL ROAD SOUTH EAST OF THE APPLICATION SITE

The existing operational area is located behind this vegetation/hedge line

Grid Reference: 298118E,136783N

Distance from site boundary: 500m

Approximate Elevation: 68m AOD

Direction of View: North West

DESCRIPTION: THERE ARE A NUMBER OF PROPERTIES IN THE VICINITY OF THIS VIEWPOINT WITH SIMILAR VIEWS. THE APPLICATION SITE IS NOT VISIBLE FROM THIS AREA, DUE TO INTERVENING TOPOGRAPHY AND MATURE VEGETATION.

Sensitivity of Viewpoint: LOW

Magnitude of Change to View: NONE

Residual Visual Impact: NONE
