ROADSTONE WOOD LTD.
 ENVIRONMENTAL IMPACT STATEMENT
 WASTE RECOVERY FACILITY,
 BROWNSWOOD, CO. WEXFORD
 VIEWPOINTS E & F

FIGURE 10-4

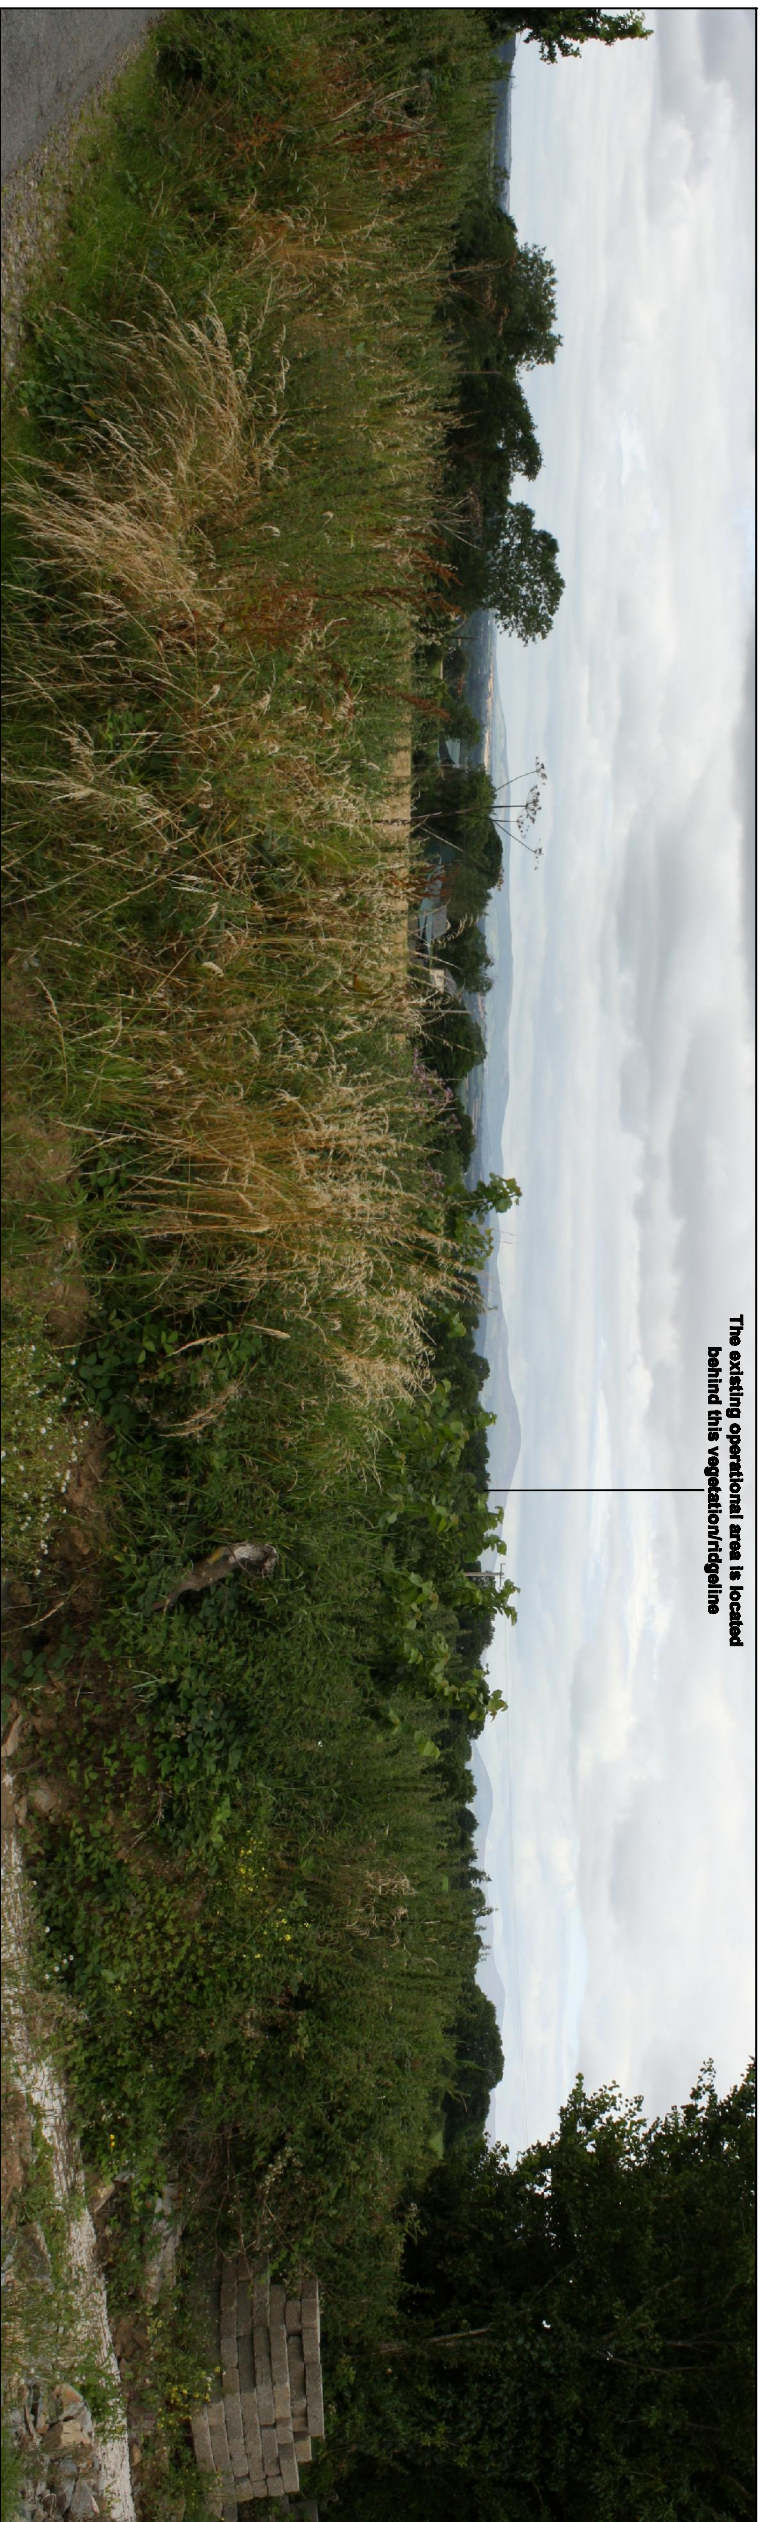
VIEWPOINT E: DISTANT VIEW ALONG LOCAL ROAD SOUTH WEST OF THE APPLICATION SITE

The existing operational area is located behind this vegetation/ridgeline

DESCRIPTION: THE APPLICATION SITE IS NOT VISIBLE FROM THIS AREA, DUE TO INTERVENING TOPOGRAPHY AND MATURE VEGETATION.

SENSITIVITY OF VIEWPOINT: NEGLIGIBLE

MAGNITUDE OF CHANGE TO VIEW: NONE

RESIDUAL VISUAL IMPACT: NONE

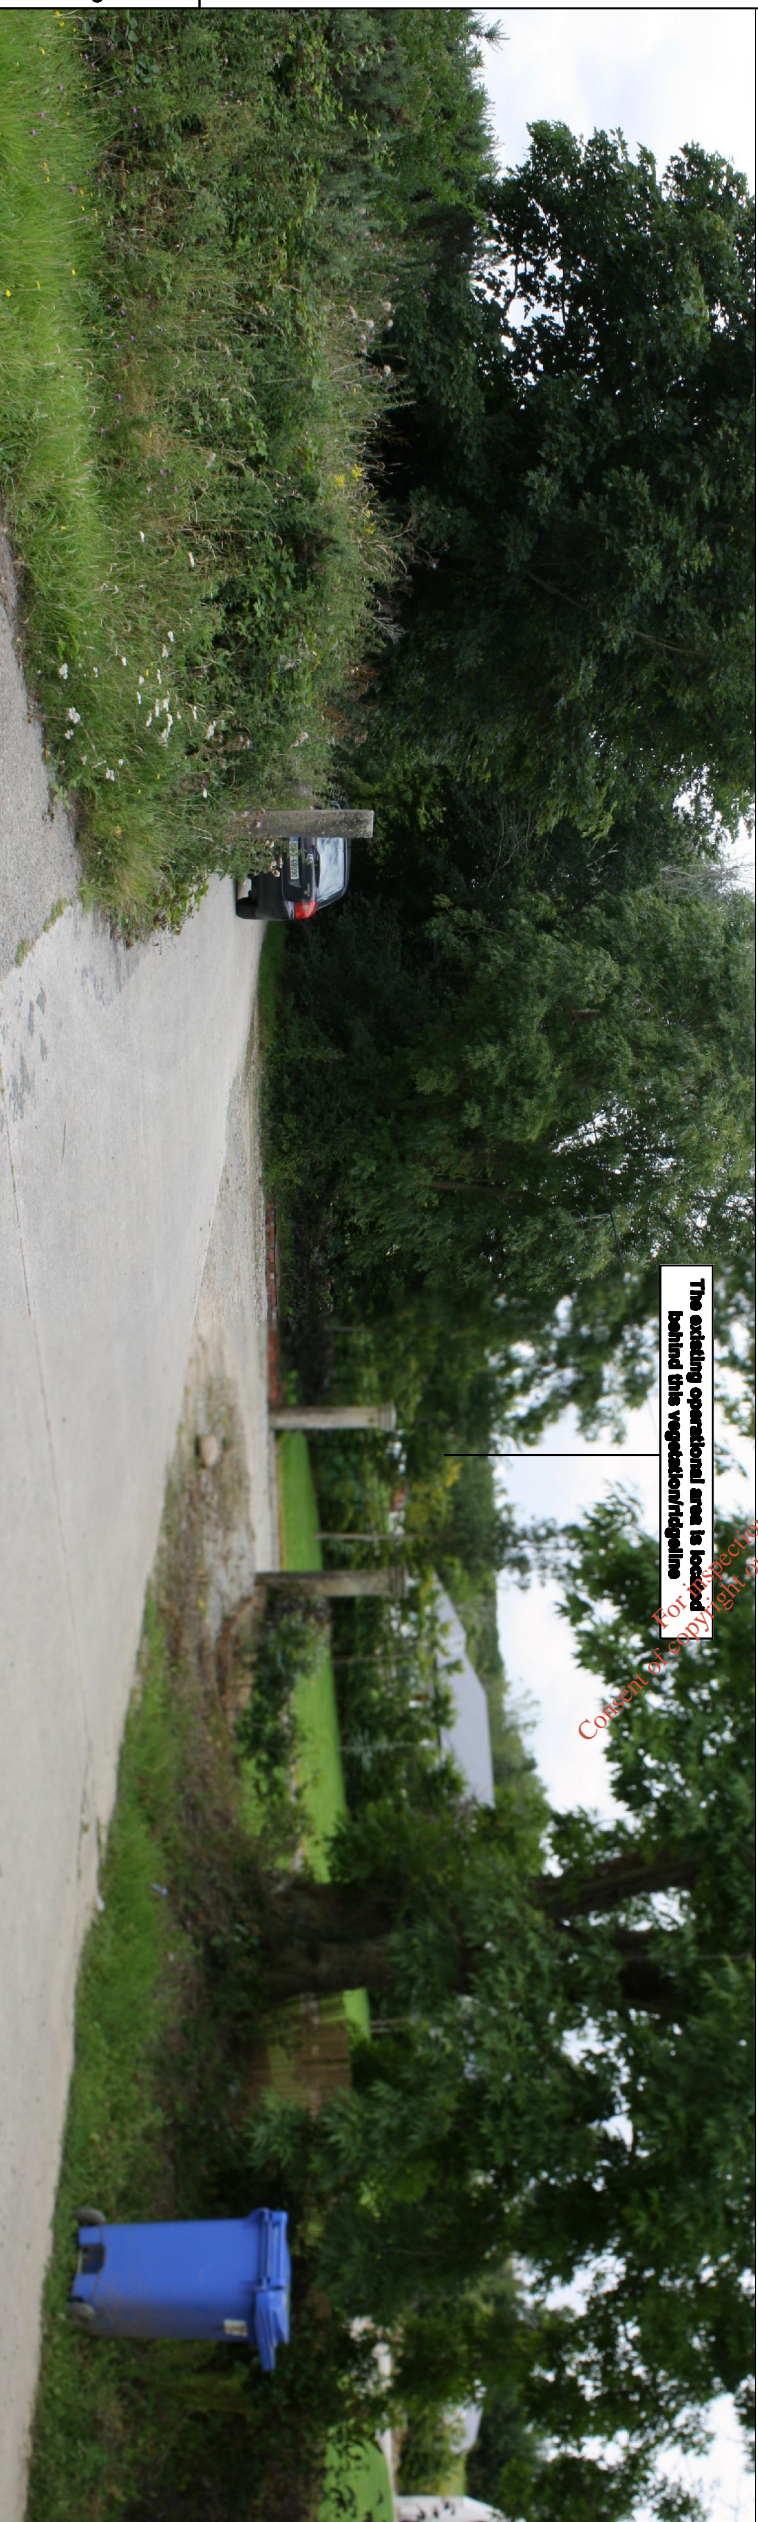
VIEWPOINT F: DISTANT VIEW ALONG LOCAL ROAD SOUTH OF THE APPLICATION SITE

The existing operational area is located behind this vegetation/ridgeline

DESCRIPTION: THERE ARE A NUMBER OF PROPERTIES IN THE VICINITY OF THIS VIEWPOINT WITH SIMILAR VIEWS. THE APPLICATION SITE IS NOT VISIBLE FROM THIS AREA, DUE TO INTERVENING TOPOGRAPHY AND MATURE VEGETATION.

Sensitivity of Viewpoint: LOW

Magnitude of Change to View: NONE

Residual Visual Impact: NONE
