Rampere Landfill
Baltinglass
Co. Wicklow

Waste Licence: W0066-03

Annual Environmental Report – 2010

Report Compiled by: Wicklow County Council

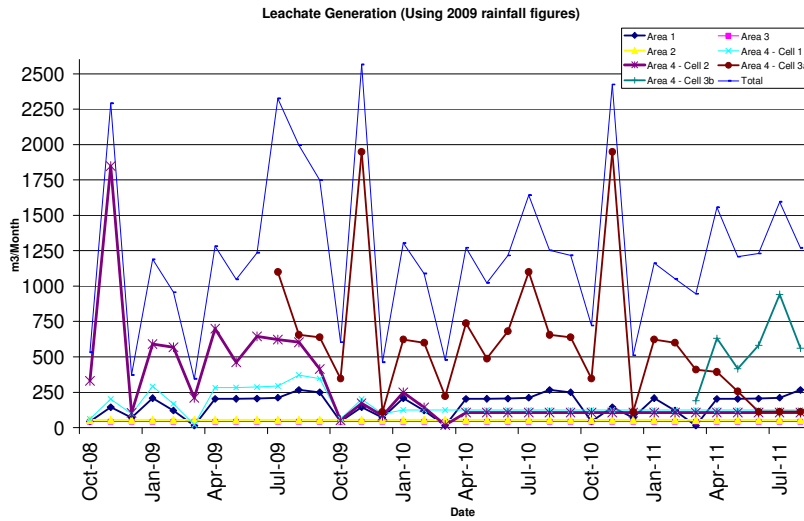
Figure 5.2 Estimated Leachate Generation at Rampere Landfill

Monthly leachate volumes were calculated for the entire landfill area based on monthly rainfall for 2010, the surface area and status of each cell within the landfill (i.e. capped/ active etc.). Figure 5.2 overleaf shows the estimated leachate generation for the reporting period and for the coming years 2010 and 2011.

The calculated total leachate generated at the site over the reporting period was 12,625m³.
 From the above graph, the trend in leachate generation is as follows:

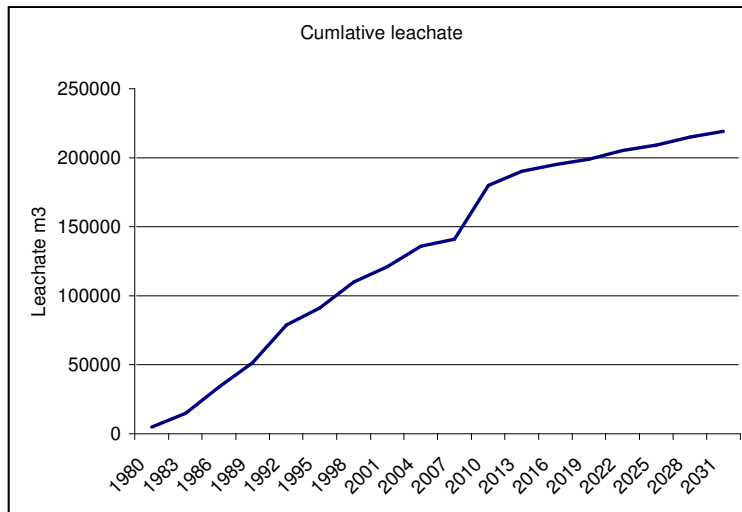
Figure 5.3 Cumulative Leachate Production at Rampere Landfill

Area 4, generated the most leachate during the period. During the period Cell 1 and Cell 2 were fully capped. Leachate production began Cell 3 during 2009 also.

*Volumes estimated from a 30 year average

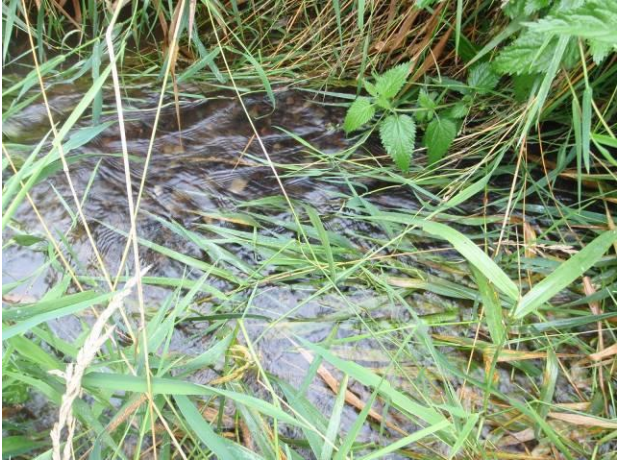
Site Code	1
Site Location	S8640 9181
Site Photograph

Width	2m
Depth	5-10cm
Substrate	Gravel, Mud, Sand, few Cobble
Flow Type	Riffle 60% Glide 40%
Instream Vegetation	<i>Phalaris arundinacea</i> 20% <i>Rorippa nasturtium-aquaticum</i> agg.%
Dominant Bankside Vegetation	Nettle, Grass, <i>Phalaris arundinacea</i>
Estimated % summer Cover of Stream by Bankside Vegetation	<5%
Trout Adult Habitat	Poor-Fair
Trout Nursery Habitat	Fair
Trout Spawning Habitat	Fair-Good

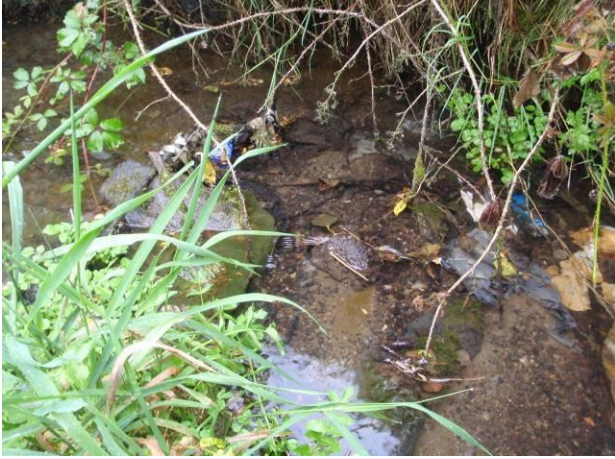
Site Code	2
Site Location	S8660 9167
Site Photograph

Width	2.5m
Depth	12cm
Substrate	Sand, Gravel, Mud, Cobble (few), Large Rocks
Flow Type	Fast Glide 80% Riffle 20%
Instream Vegetation	Phalaris arundinacea 10% Apium nodiflorum <5% Bryophyta <5% Algae <5%
Dominant Bankside Vegetation	Hawthorn
Estimated % summer Cover of Stream by Bankside Vegetation	20%
Trout Adult Habitat	Fair
Trout Nursery Habitat	Fair - Good
Trout Spawning Habitat	Poor – Fair

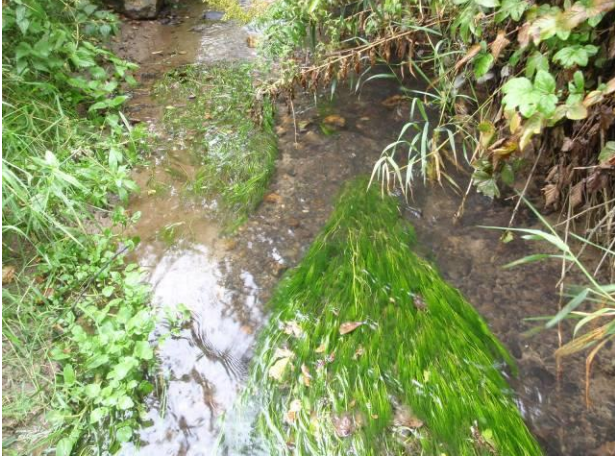
Site Code	4
Site Location	S 8749 9089
Site Photograph

Width	2-2.5m
Depth	12cm
Substrate	Sand, Gravel, Cobble, Silt
Flow Type	Glide 65% Riffle 35%
Instream Vegetation	<i>Ranunculus</i> sp. 20%
Dominant Bankside Vegetation	Alder
Estimated % summer Cover of Stream by Bankside Vegetation	20%
Trout Adult Habitat	Poor - Fair
Trout Nursery Habitat	Fair-Good
Trout Spawning Habitat	Fair

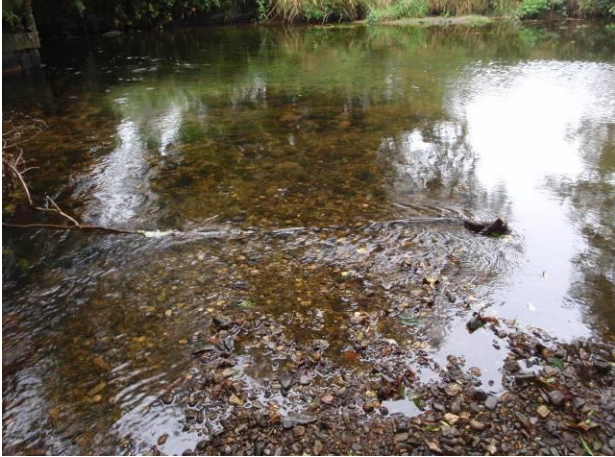
Site Code	A
Site Location	S8763 9145
Site Photograph

A photograph of a stream with a rocky bed and a fallen log in the water. The water is clear and reflects the surrounding greenery. The stream flows over a bed of sand, cobble, gravel, and large rocks. A fallen log is partially submerged in the water, creating a small riffle. The banks are lined with trees and vegetation.
Width	c. 20m
Depth	10-40cm
Substrate	Sand, Cobble, Gravel, Large Rocks
Flow Type	Riffle 10% Glide 90%
Instream Vegetation	<i>Ranunculus</i> sp. 60% Moss 10%
Dominant Bankside Vegetation	Ash, Beech
Estimated % summer Cover of Stream by Bankside Vegetation	15%
Trout Adult Habitat	Good
Trout Nursery Habitat	Good
Trout Spawning Habitat	Fair

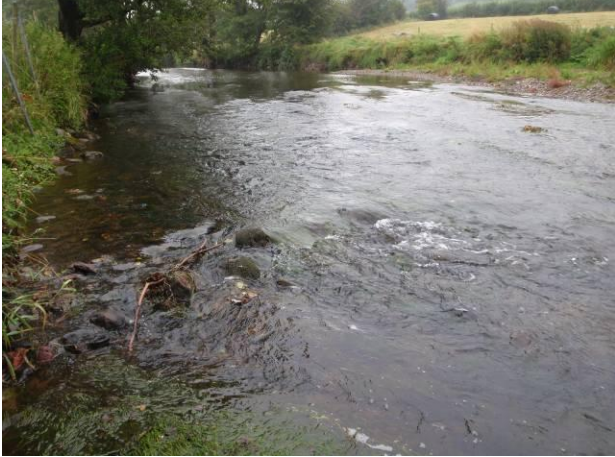
Site Code	B
Site Location	S8742 9081
Site Photograph

Width	16m
Depth	10 - 30 cm
Substrate	Gravel, Cobble, Sand
Flow Type	Riffle 75% Glide 25%
Instream Vegetation	<i>Ranunculus</i> sp. 20% Filamentous Algae 10% Bryophyta 5%
Dominant Bankside Vegetation	Alder
Estimated % summer Cover of Stream by Bankside Vegetation	<5%
Trout Adult Habitat	Good
Trout Nursery Habitat	Good - Fair
Trout Spawning Habitat	Good
