1 Introduction

Pfizer Nutritionals Ireland Limited (Pfizer) is an IPPC licensed facility based at Askeaton, Co. Limerick. The site manufactures infant formula, mainly for the export market and is one of the largest such sites in the world. 600 staff are employed at the facility.

Appendix C – Full Report for Water Body Deel Estuary – July 2010

Dye Study In The River Deel, Asketon, Co. Limerick.

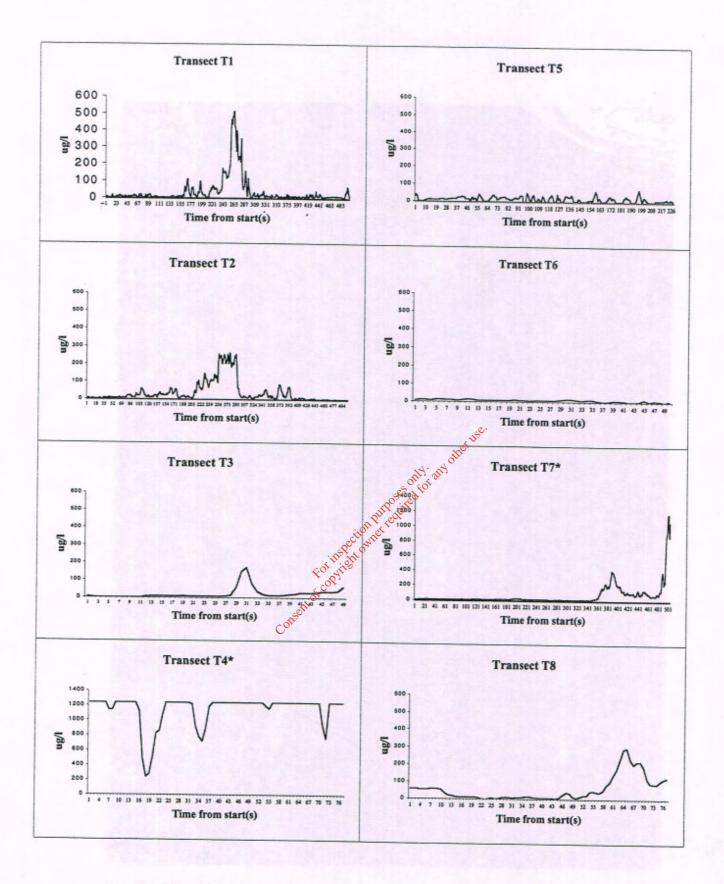
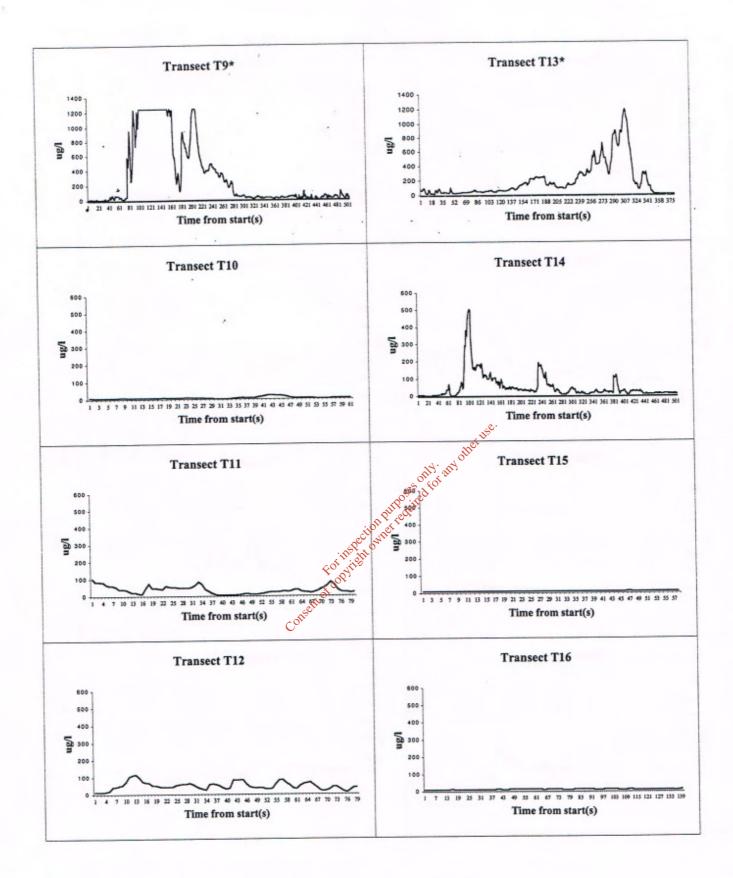
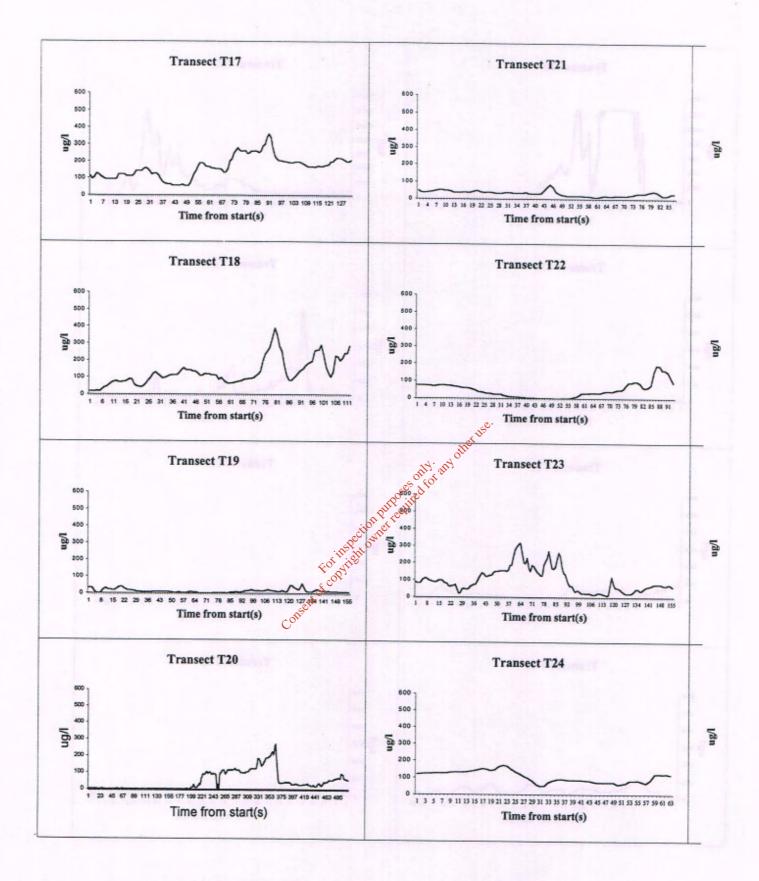
Figure 2. Dye concentrations recorded during each of the transects, River Deel, 28-08-01

* notes different scale on y axis

Figure 2 presents concentrations recorded during each of the transects carried out on the 28th August 2001, while Figure 3(a-f) presents a visual interpretation of dye concentrations along these transects. On release, the dye expanded north and south in a narrow streak from the release point, extending from 52° 36.689 N, 8° 58.845 W to 52° 36.664 N, 8° 58.845 W by 10:27. At 11:00, the dye had diluted sufficiently to allow concentration readings with the fluorimeter. The first transect (not shown in Figure 3) followed a path along the estuary with the outfall its centre point. The maximum concentration recorded was approximately 500 µg/l with concentrated readings occurring over a short span. This maximum concentration is relatively low for initial transects, a fact which is highlighted by concentrations recorded later during transect T4 (see Figure 2) where the fluorimeter recorded the maximum recordable value (1238 μ g/l) across the transect. This is due to the dye movement across the mudflats surrounding the main channel, which is initially inaccessible to the boat due to depth limitations. In the first 30 minutes of sampling (Figure 3a) the main dye patch remained in the wider area to the north of the outfall point (i.e. area to the left of photograph 4). Over the next two hours (Figure 3b, 3c), the plume slowly moves south towards the river dispersing across the channel as it progresses. However, as is evident from the dye concentration charts (Figure 2, T7-T14), the concentrated area of dye remained close to the side of the channel (Photograph 5). By 14:00, the mudflats surrounding the main channel were submerged and the dye began to disperse evenly across the channel as it moved south. Over the next
