## **Tier 3 Environmental Risk Assessment Former Landfill at Tipperary Town**

South Tipperary County Council

**October 2011**

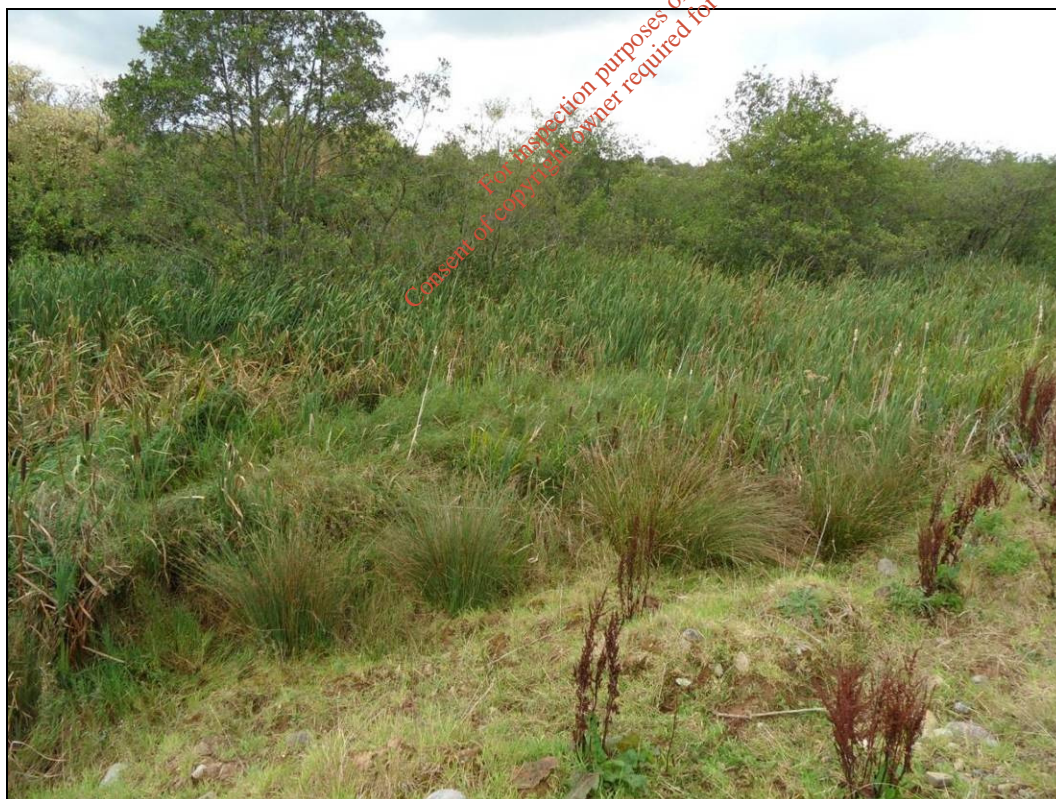
**Plate 8** *Typha* dominated swamp with Alder woodland along the northern line of the closed landfill. *Juncus* was common along the interface between the drier C&D spoil and the reed swamp wetland.
