**Annual Environmental Report**  
**For Kyletalesha Landfill**  
**Waste Licence W0026-03**

Prepared By:  
Laois County Council  
County Hall  
Portlaoise  
Co. Laois

**March 2012**

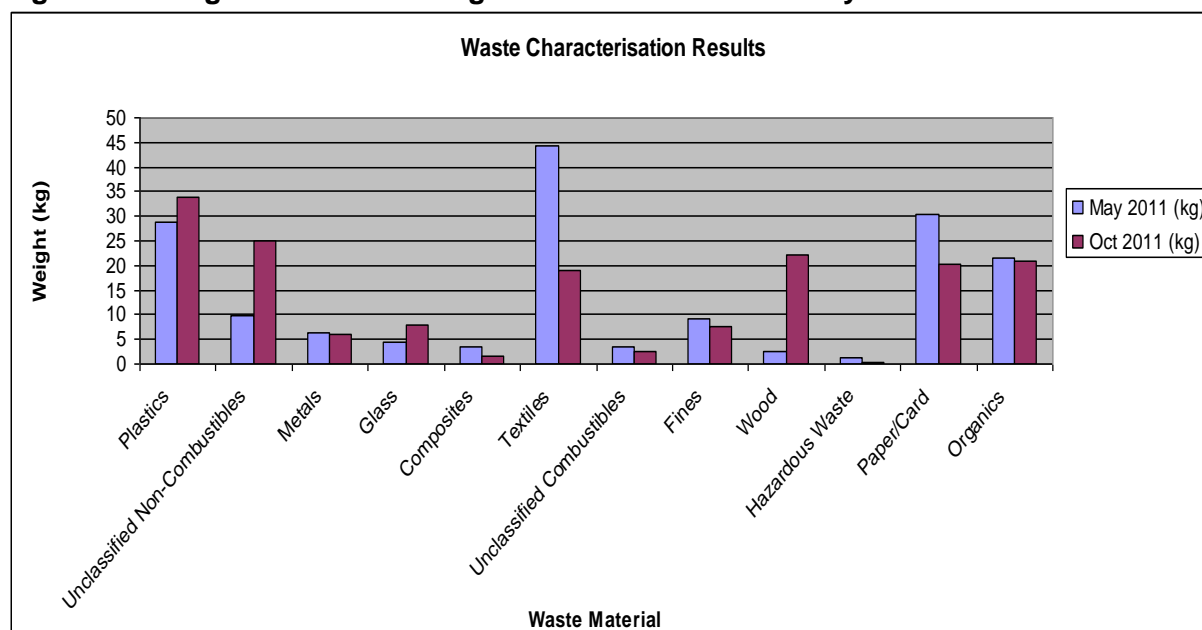
The characterisation results indicated that the weight of full BMW wastes had reduced between the May and October sampling events. It also provided an indication of the success of Laois' efforts to reduce the BMW content of waste disposed to landfill from the public deposit area. A comparison of waste material weights between the two assessment events is provided in Figure 1 below.

**Figure 1 – Weights of Waste Categories Characterised in May and October 2011**
