Pollboy Landfill

Annual Environmental Report (AER) 2011

March 2012

Client:	Ballinasloe Town Council					
Project Title:	Pollboy Landfill					
Document Title:	Annual Environmental Report (AER) 2011					
Document No:	MGE0029RP00015					
This Document Comprises:	DCS	TOC	Text	List of Tables	List of Figures	No. of Appendices
	1	1	21	1	1	12

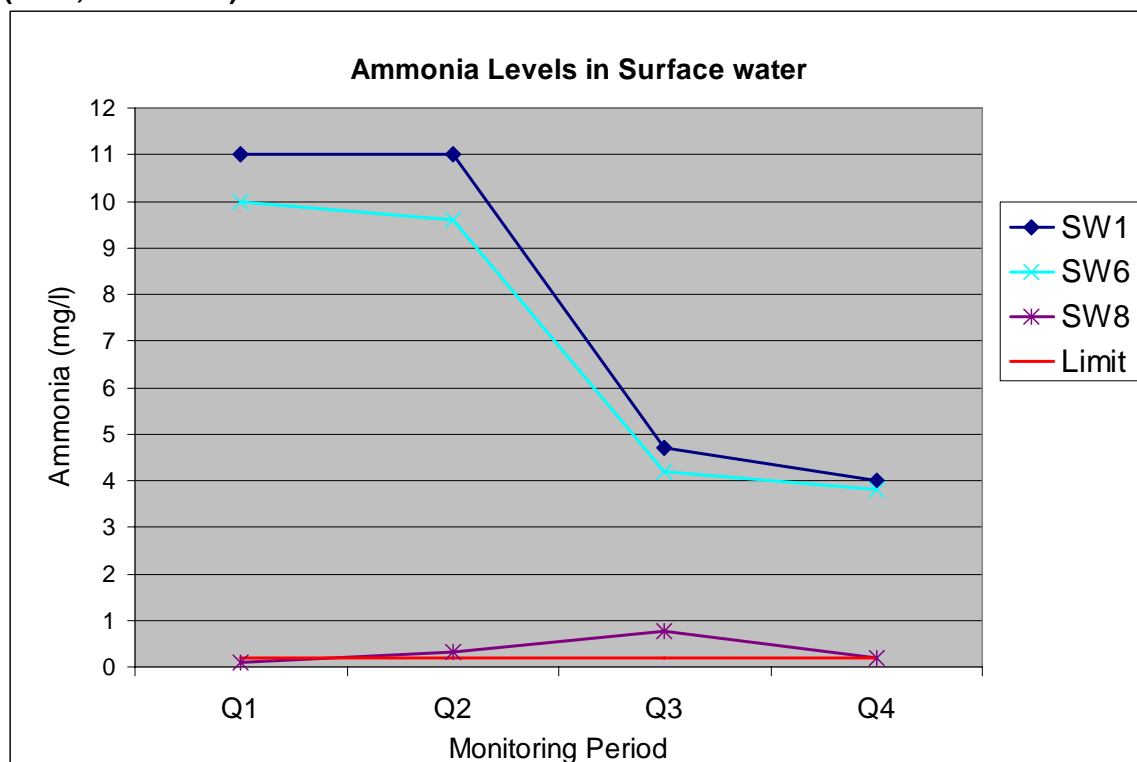
Figure 4.1 Elevated Ammonia Levels in Surface Water for the Reporting Period (SW1, SW6-SW8)

Figure 4.1 shows ammonia levels which exceeded the standard limits in surface water sampling points SW1, SW6 and SW8 during 2011.

Levels of ammonia were above the required limit of 0.3mg/l (as set out in SI 278, 2007) at surface water sampling points SW1, SW6 and SW8, throughout the four sampling periods 2011. At SW1 and SW6 ammonia levels decreased from Q1 through to Q4. At SW6, levels were only slightly in excess of the limit in Q2 and Q3 and returned below the limit in Q4

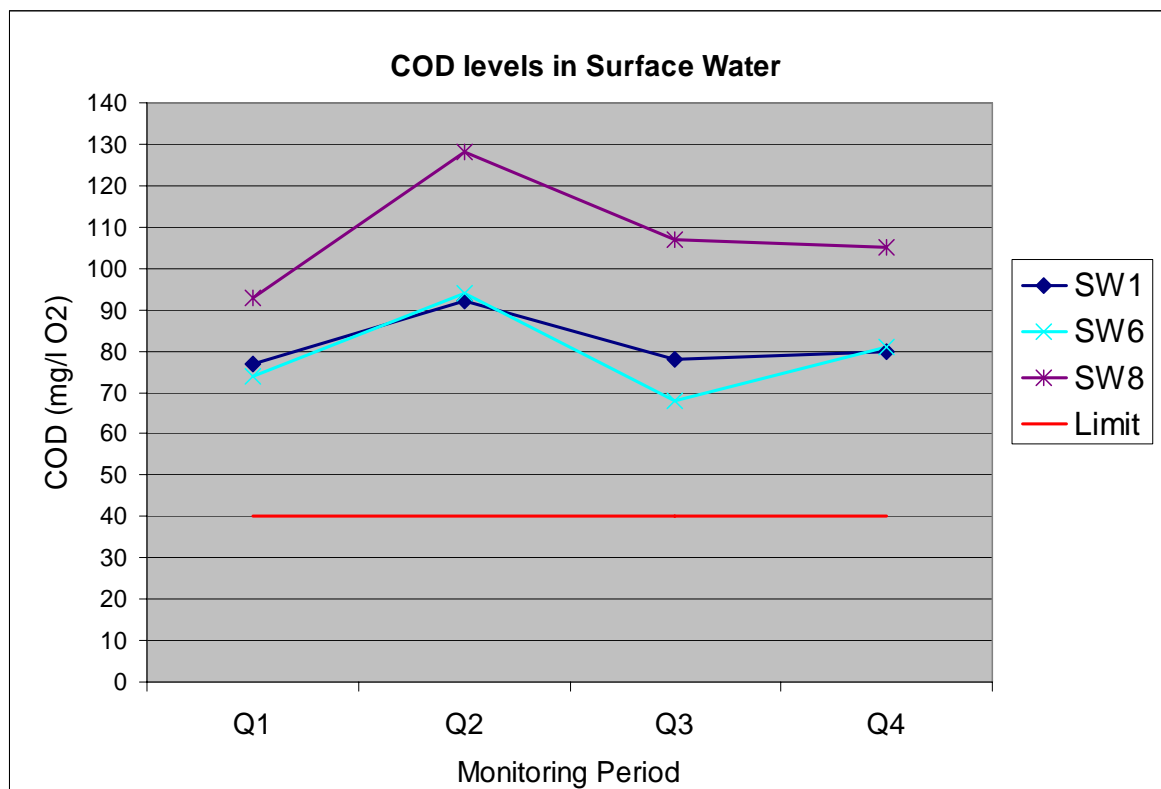
Figure 4.2 Elevated COD Levels in Surface Water for the Reporting Period (SW1, SW6 and SW8)

Levels of COD were also above the required limit of 40mg/l O₂ (as set out in SI 294, 1989) at surface water sampling points SW1, SW6 and SW8, throughout the four sampling periods 2011. **Figure 4.2** shows the COD levels which exceeded the standard limits in surface water sampling points SW1, SW6 and SW8 during 2011.

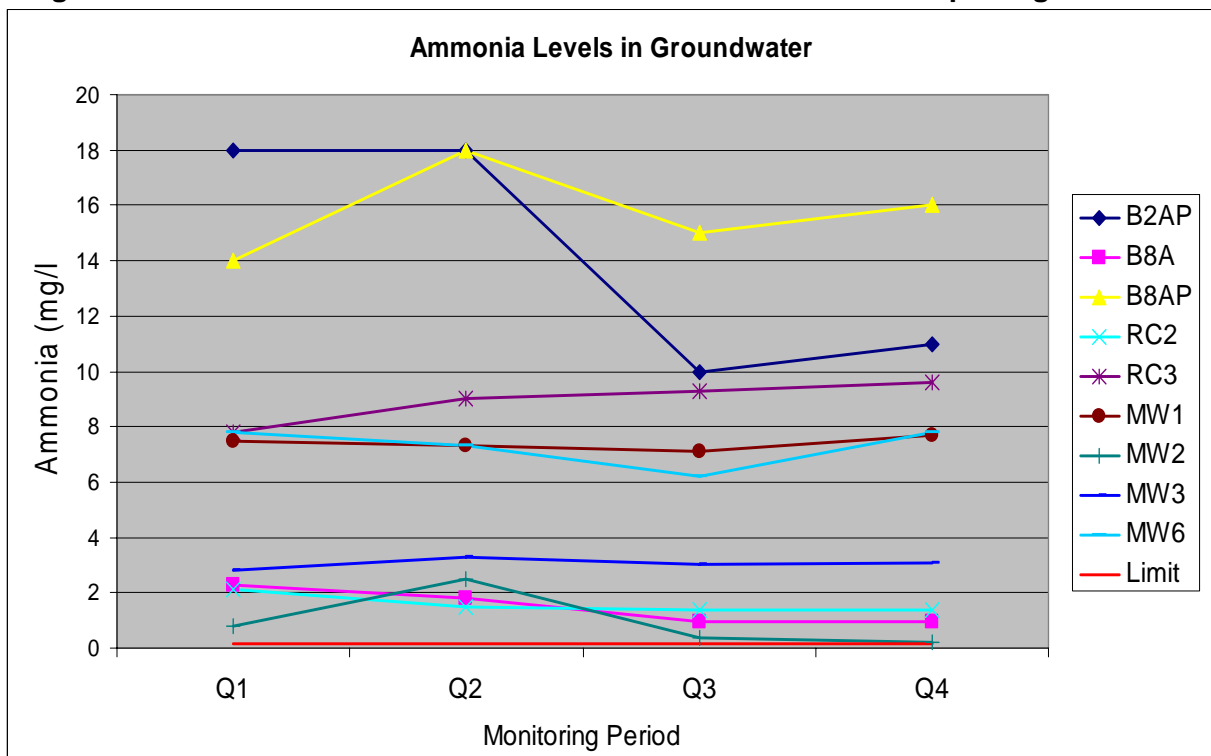
Figure 4.3 Elevated Ammonia Levels in Groundwater for the Reporting Period

Levels of ammonia were found to be above the required limit of 0.3mg/l (as set out in SI 9, 2010) at all groundwater sampling points, throughout the four sampling periods in 2011. The most elevated levels of ammonia (16-18mg/l) were found at B2AP and B8AP. B2AP and B8AP sampling points are both located down gradient of the landfill. Sample point RC3, which also displayed elevated levels of ammonia (7.8-9.6mg/l), is located approximately 10 metres from the waste mass.

Figure 4.3 shows the ammonia levels in groundwater which exceeded the standard limits in 2011.

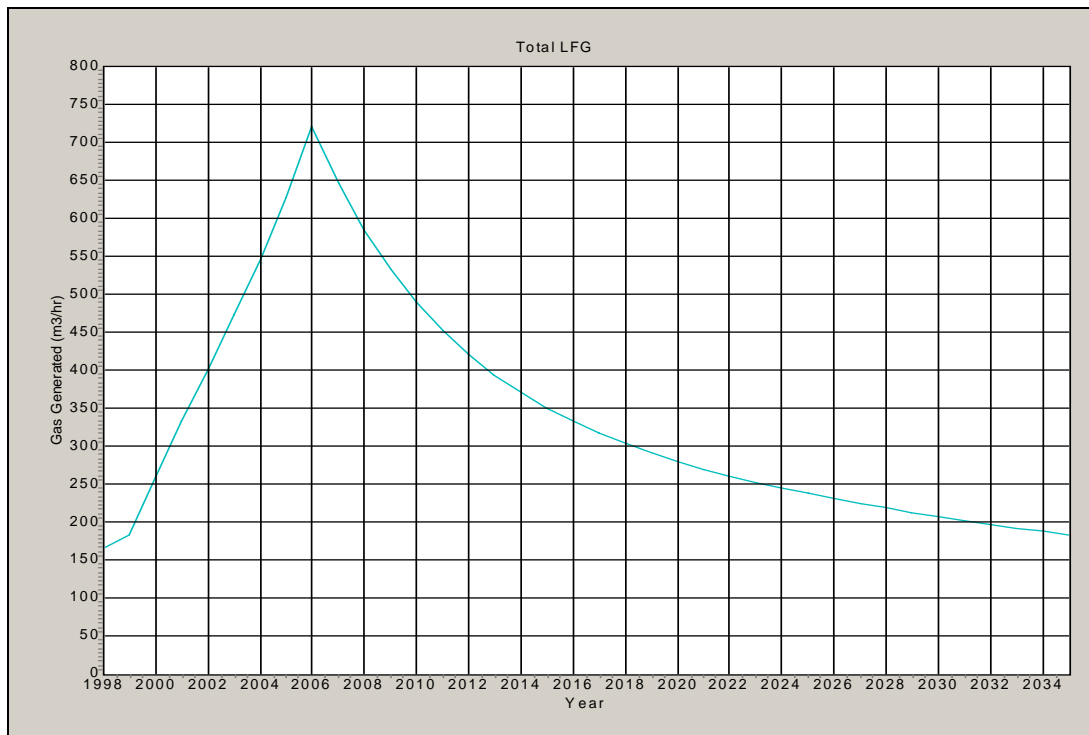
Figure 10.1: Total Bulk Landfill Gas 1998 to 2035 at the 50th Percentile

A Gas Utilisation Feasibility Study for Pollboy Landfill was prepared in August 2005. As part of this study the total quantity of landfill gas generated was estimated using the GasSim Model. For comparison purposes, an estimate was also made using the “Rule of Thumb” method contained in the EPA Landfill Site Design Manual. This assumes that a tonne of waste produces 6m³ of landfill gas per year from the time of emplacement. Results are shown in **Figures 10.1** and **10.2**, for each modelling exercise.

For 2011, a generation rate of 450 m³/hr of landfill gas was estimated using the GasSim Model and 600 m³/hr was estimated using the Rule of Thumb method.

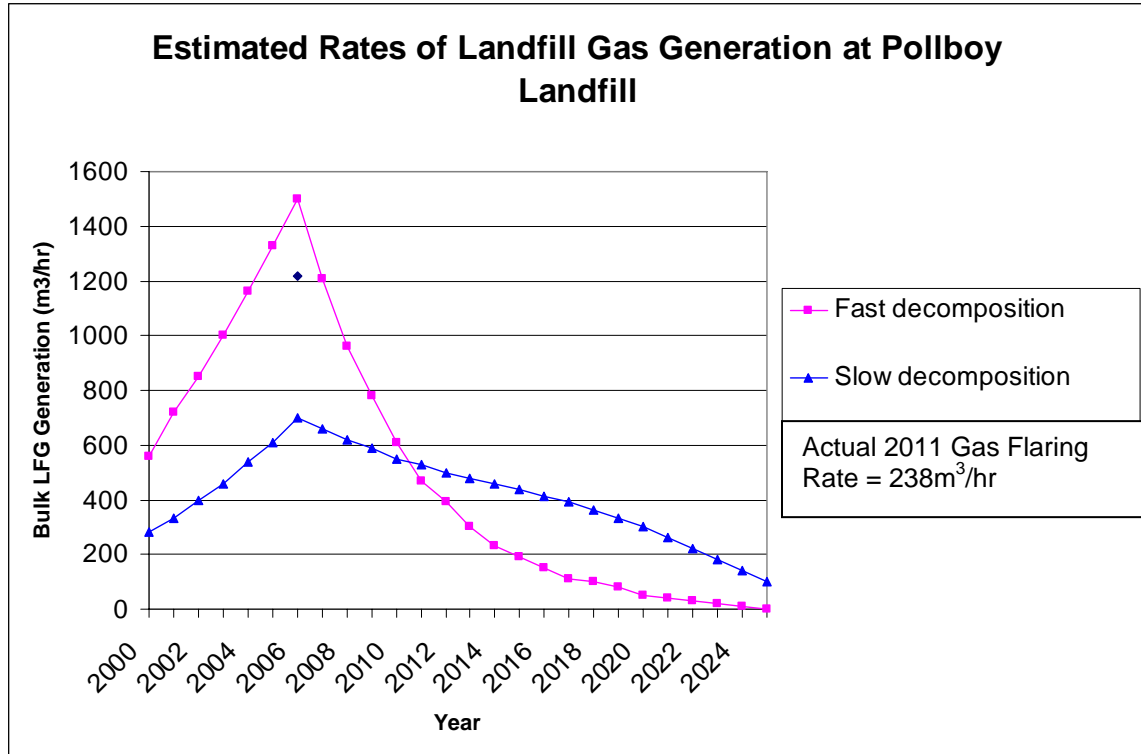
Figure 10.3: Estimated Rates of Landfill Gas Generation at Pollboy Landfill

Based on monitoring results, the mean rate of gas flaring at the facility for 2011 was 238m³/hr.

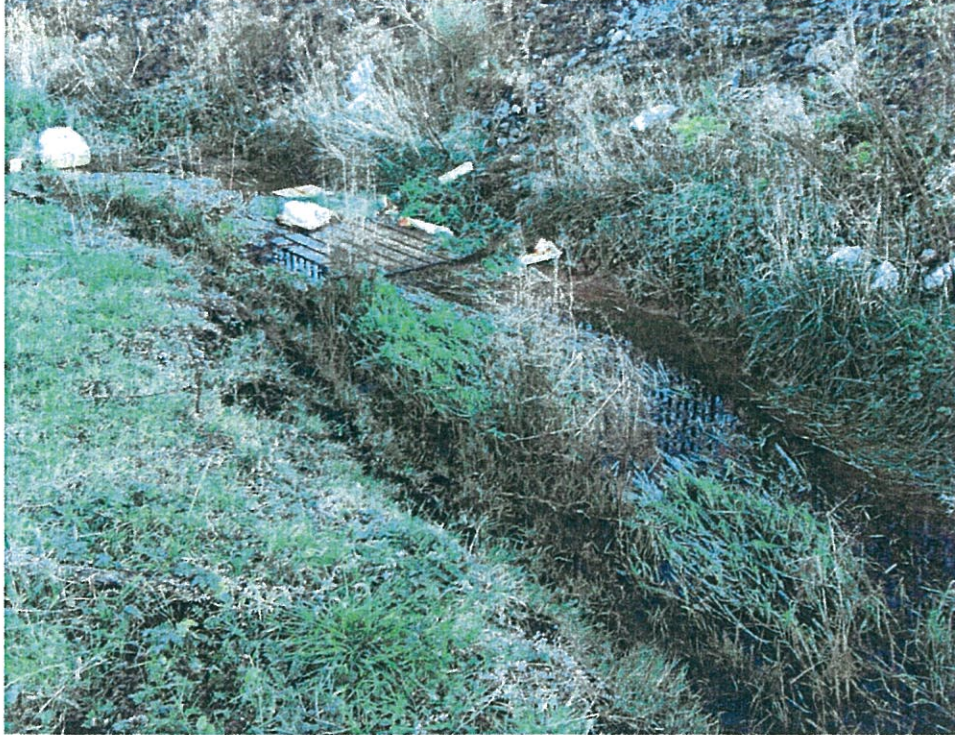
Photo 1: Evidence of litter and also discoloration of water in drain running alongside the civic waste facility.

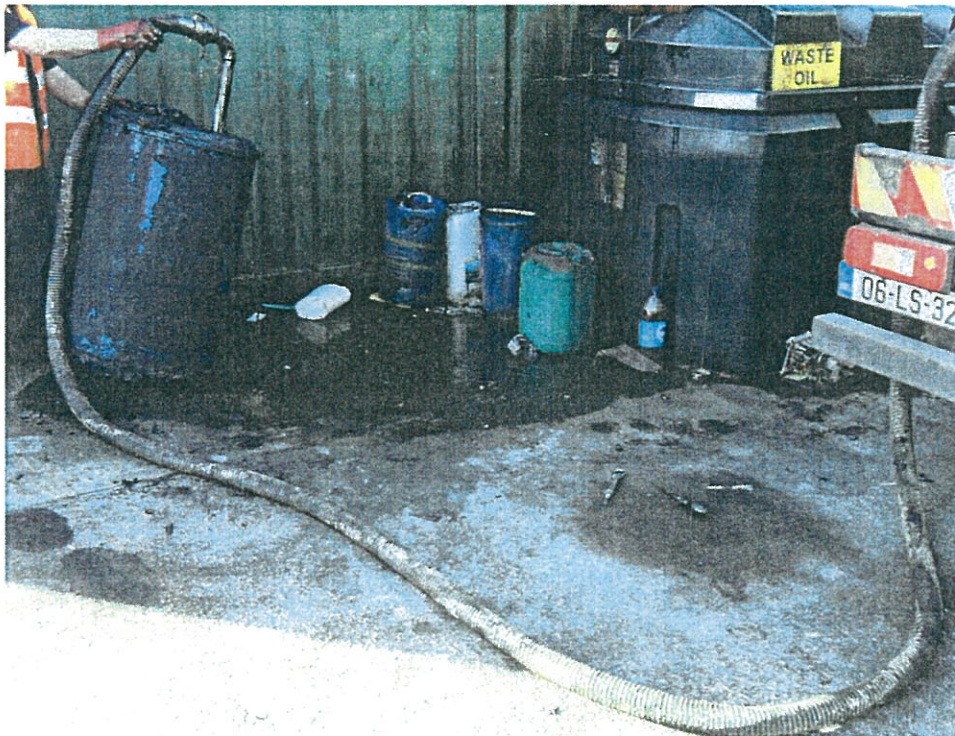
Photo 2: Spillages of oil noted at the waste oil storage area of the civic waste facility.

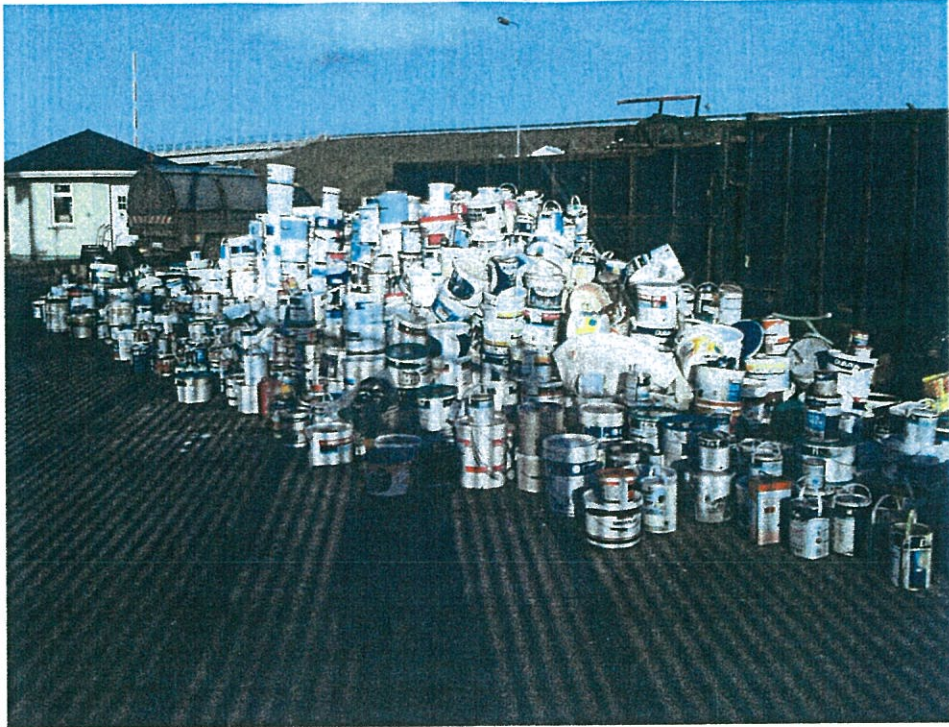
Photo 3: Significant number of paint cans stored at the civic waste facility.
