# Annual Environmental Report 2011 Belturbet Landfill WL 92-1

Document Title	Annual Enviro	Annual Environmental Report 2011					
	Belturbet Land	Belturbet Landfill WL 0092-1					
Document ID	CCC-04-02-20	CCC-04-02-2011					
Revision	Status	Author	Issue Date				
01	Draft	BK	30/03/12				
02	Checked By	CB/ SF	30/03/12				
03	Final Issue	BK/CB	30/03/12

# ENVIRONMENTAL MONITORING REPORT FOR BELTURBET LANDFILL W0092-01

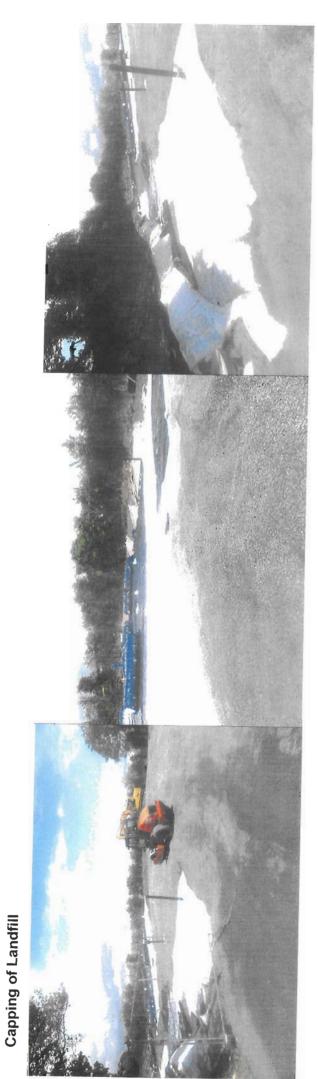
This landfill underwent the process of final capping during 2011. Monitoring boreholes were drilled as part of the capping works and are being monitored as per the waste licence. The following plates depict the capping process and final landfill which clearly shows the drilled monitoring boreholes.

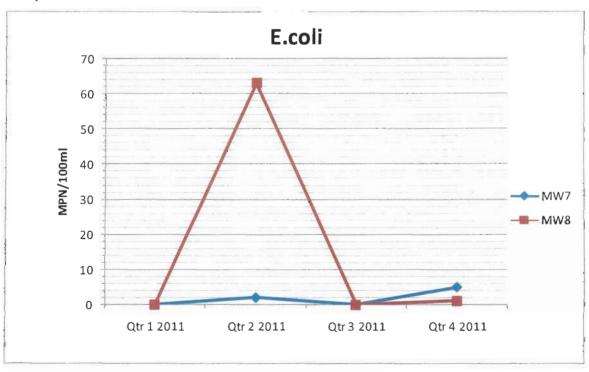
Graph 5.2

As detailed in the above graphs, there were numerous ground water exceedances at this landfill during 2011.

- Ammonia: Elevated levels of this parameter were prevalent during 2011.
   Levels such as those recorded are not unusual in a mature landfill such as this. Levels will gradually decrease as the landfill matures.
- Chloride: This parameter is a strong indication of contamination from a landfill source.
- Conductivity: Elevated levels of this parameter are commonly associated with pollution of an organic nature and therefore may be attributed to the landfill.
- E.Coli: The exceedance in this parameter is attributed to the capping process at this landfill. During the process, numerous wells were left unsealed and contamination from external sources may have occurred.
- Total Coliforms: Exceedances in this parameter are attributed to the natural decomposition of the organic materials in this landfill.

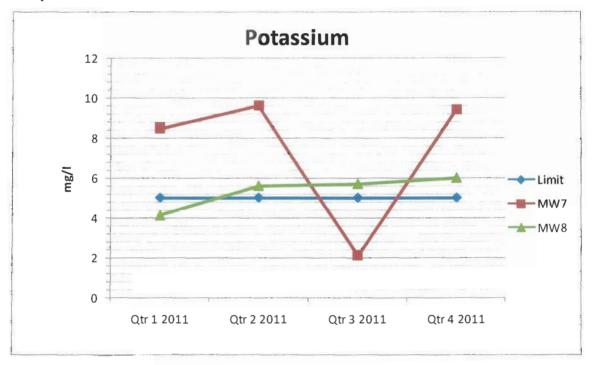
Graph 5.7

Potassium: Elevated levels of potassium can be associated with landfill contamination but it can also be associated with contamination from agricultural sources such as fertilizers. Therefore direct contamination from the landfill cannot be concluded.

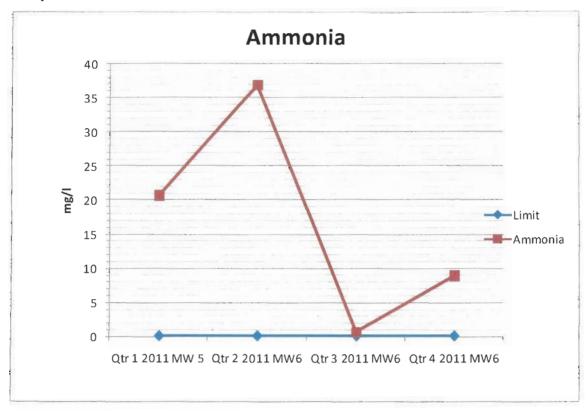
Graph 5.8

Monitoring Well MW5 is sampled for Leachate during quarter one of 2011. However after capping of the landfill the well was found to be dry and so a sample was obtained form Well MW6 for the remainder of the year.

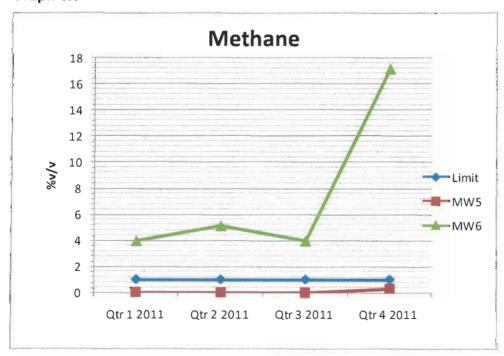
Graph 6.0

Exceedances in both Carbon Dioxide and Methane were recorded during 2011 at well MW6. These exceedances however are typical of a mature landfill.
