**BALLEALLY LANDFILL,  
BALLEALLY, LUSK,  
CO. DUBLIN**

**ANNUAL MONITORING REPORT:**

**Report Period: January 2011 – December 2011**

**WASTE LICENCE REF. NO. W0009-03**

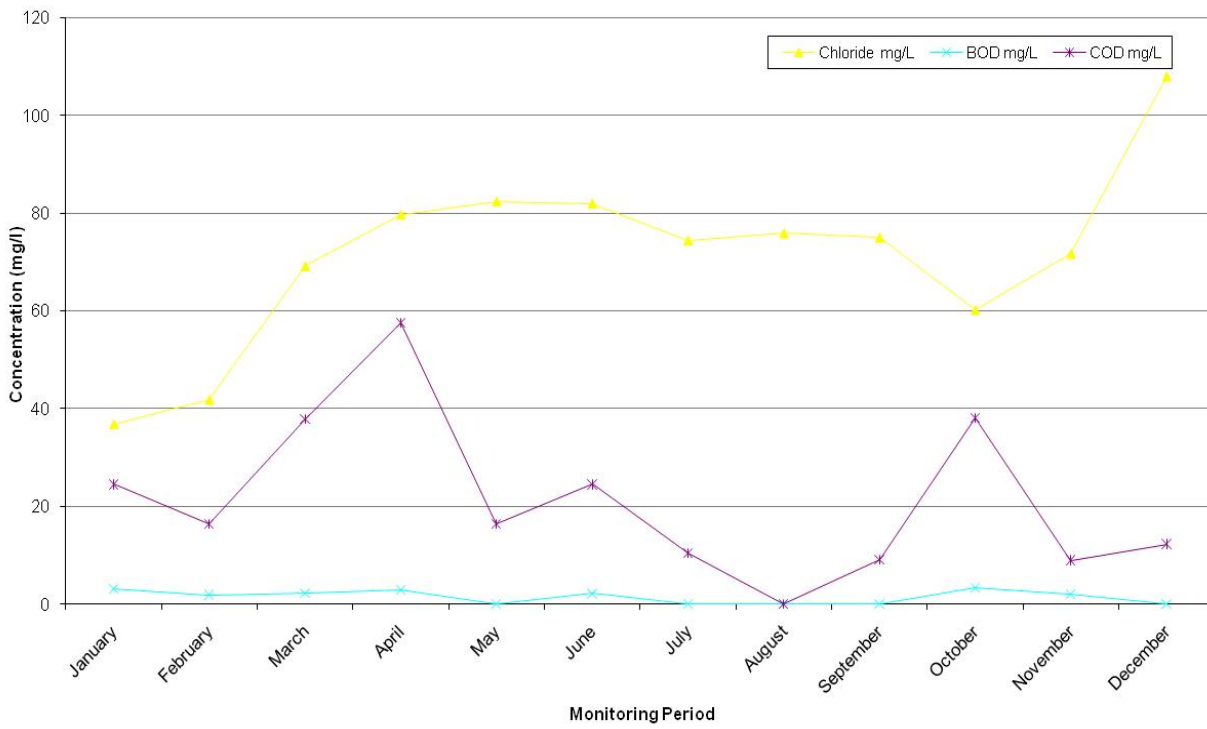
Figure 3.1: CD1 Monthly Monitoring Results

Monthly monitoring at CD1 shows that chloride results varied through the reporting period with a sharp increase in Decembers results. Results were observed higher in quarter 1 and fell during quarter 2 and quarter 3, only to increase again in quarter 4. BOD results remained constant through the reporting period. COD results fluctuated during the reporting period with a spike in quarter 2 and 4 before returning to more normal levels during December (Figure 3.1).

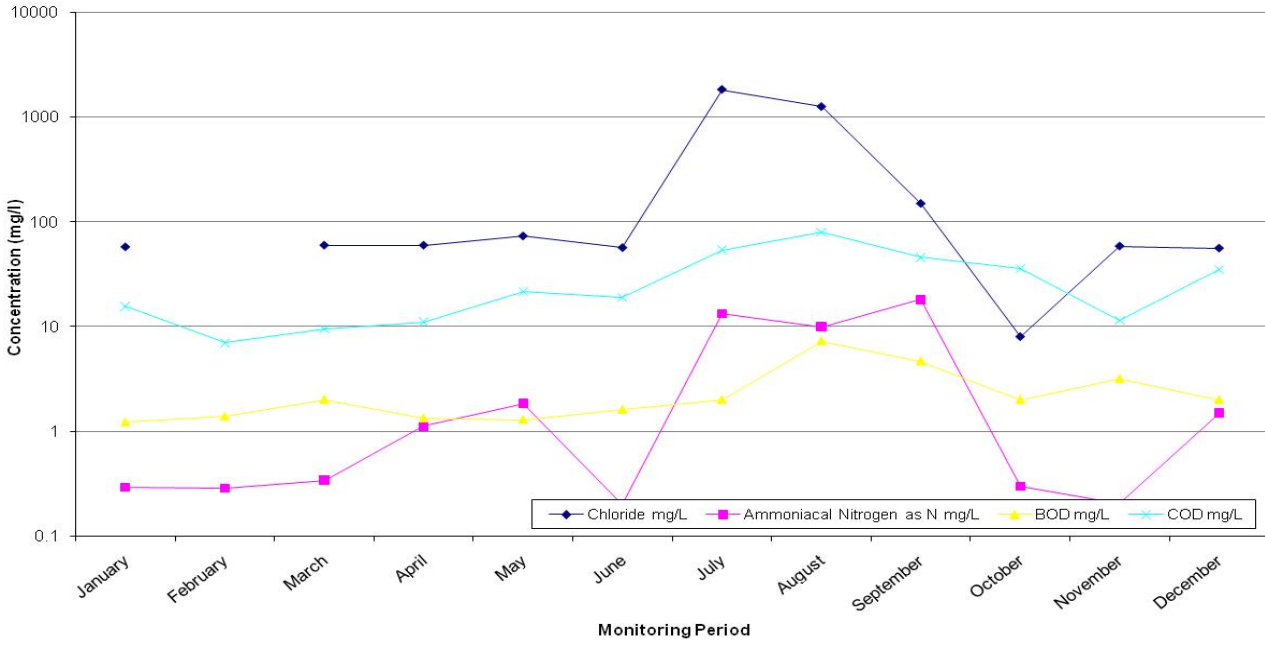
Figure 3.6: Monthly Monitoring Results for S3

For the monthly S3 sample analysis (Figure 3.6), stable COD results for the majority of the annual monitoring were observed. July August and September were all recorded above the MAC levels (40 mg/l). BOD is also under the MAC (5 mg/l) during the reporting period. There is a slight variability also noted in the Chloride results, with July and August recorded above the MAC (250 mg/l Cl).

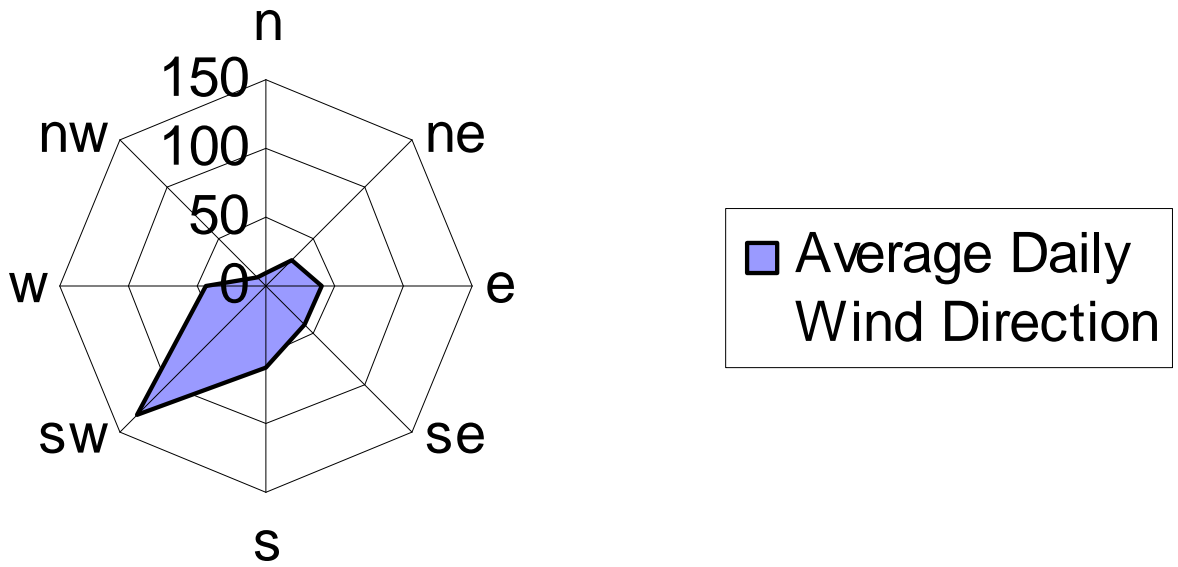
Figure 3.19: Rose Diagram of Average Wind Direction at Dublin Airport

The winds are predominantly West, South Westerly in direction, as illustrated in the Roas Diagram, Figure 3.19.
