**BORD NA MÓNA ENERGY LIMITED**

**Annual Environmental Report 2011  
Clonbullogue Ash Repository  
Waste Licence W0049-02**

**March 2012**

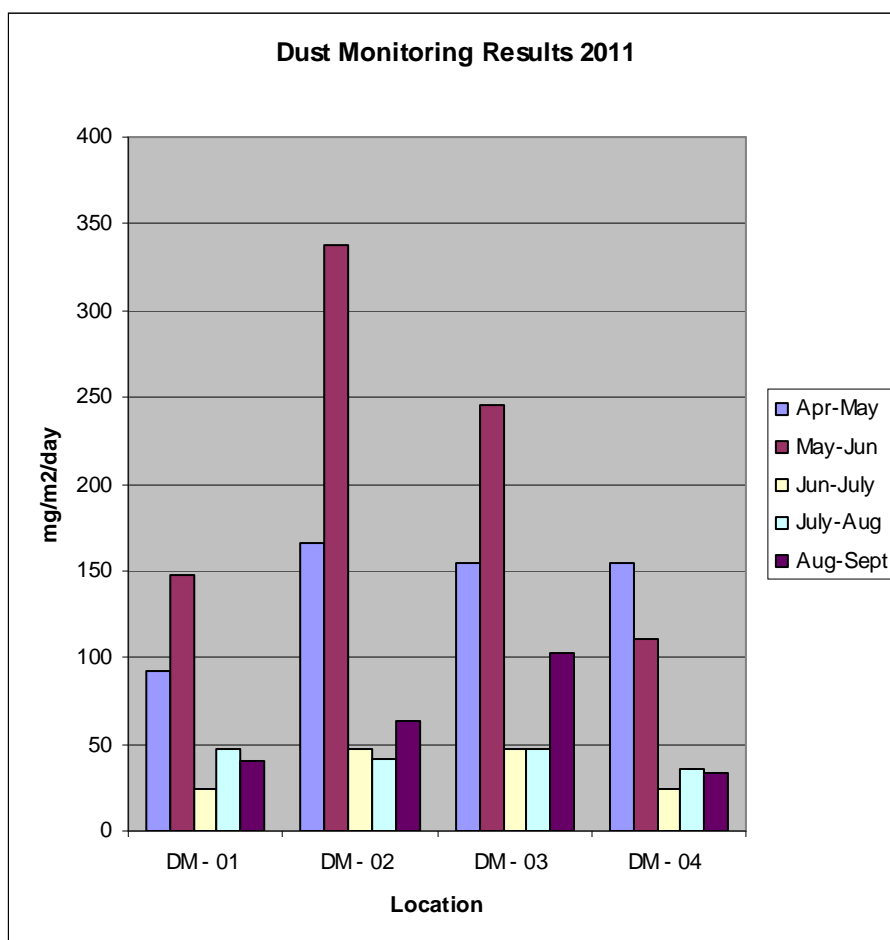
## **Dust Monitoring Results**

Dust Monitoring Results 2011				
Sample Period	DM - 01	DM - 02	DM - 03	DM - 04
Apr-May	92	166	155	155
May-Jun	148	338	246	111
Jun-July	24	47	47	24
July-Aug	47	42	47	36
Aug-Sept	40	63	103	34

**Note:** Emission Limit Value = 350 mg/m<sup>2</sup>/day. There were no dust non-compliances or complaints of a dust nuisance during the reporting period.

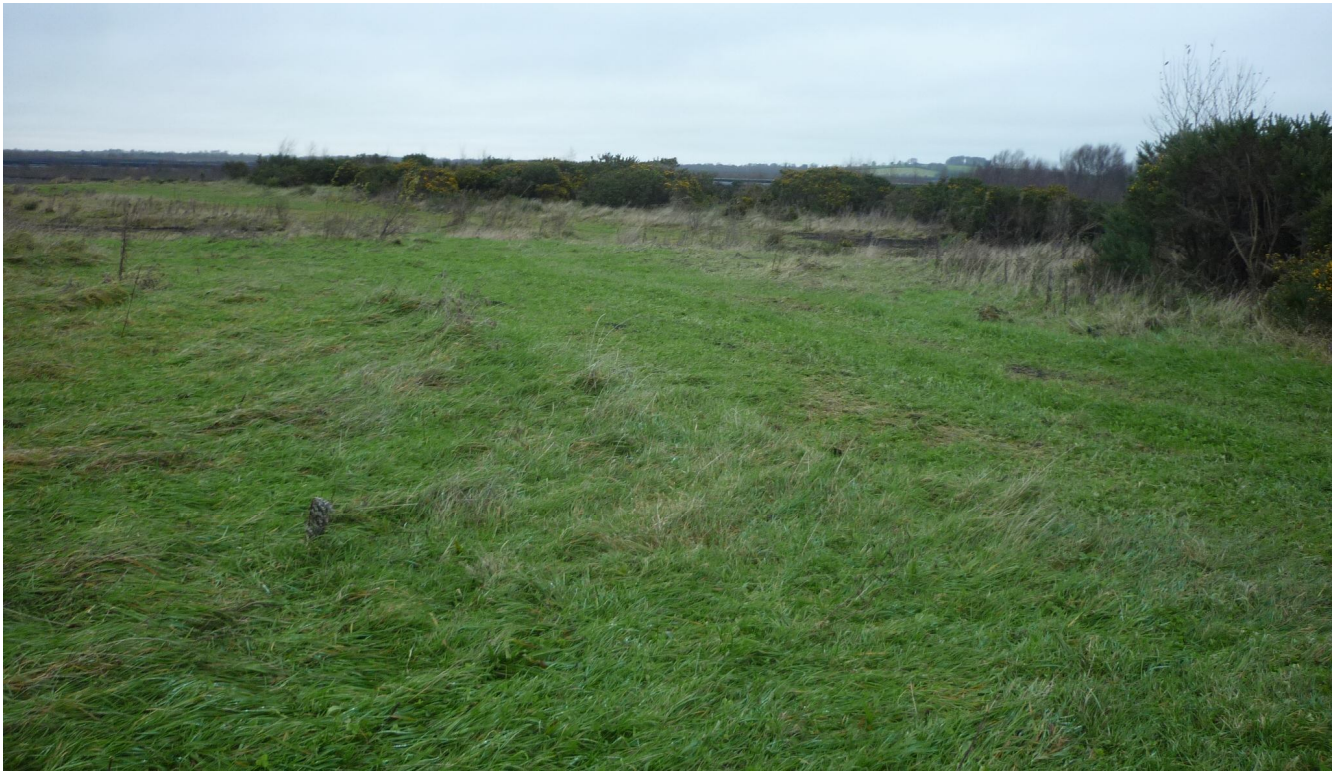
Figure 1. View of typical meadow-type sward (GS2) in foreground with Gorse scrub (WS1) in background of Cell 1.

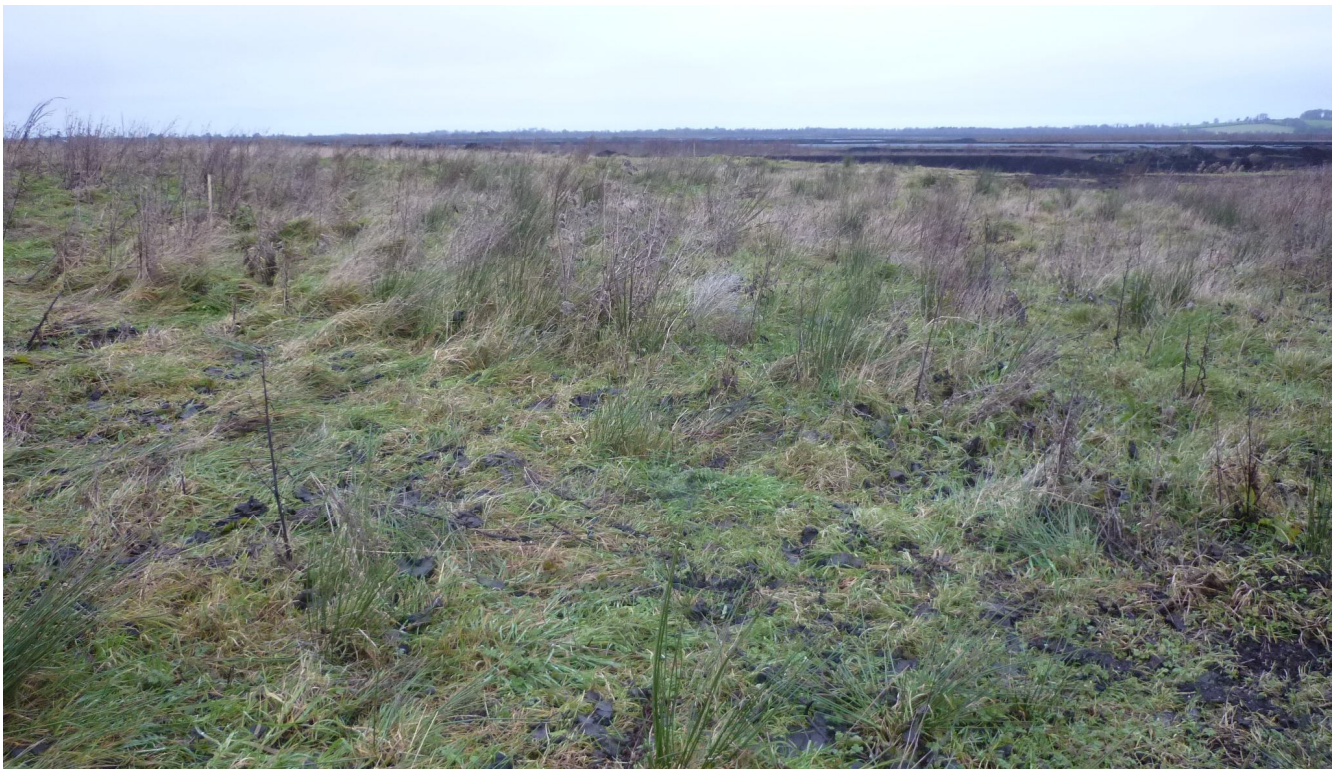
Figure 2. A somewhat more diverse sward in Cell 2.

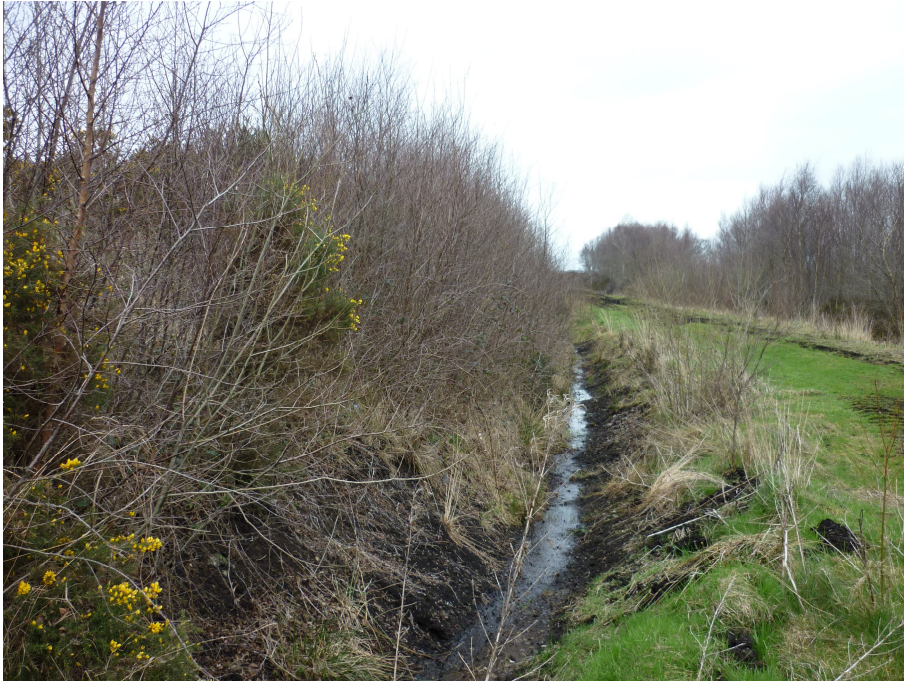
Figure 1 – Cell 1 Eastern Embankment

In the years after the final capping of Cell 1 native plants have colonised large areas of the embankments. The Eastern embankment of Cell 1 is heavily colonised with native Birch 'Behula Pendula' and native Gorse 'Ulex Europaesus'. Grass growth is also well established on the embankments. The northern and southern embankments also have large areas of dense vegetation.

The photographs below illustrate the large amount of growth present on the embankment slopes.

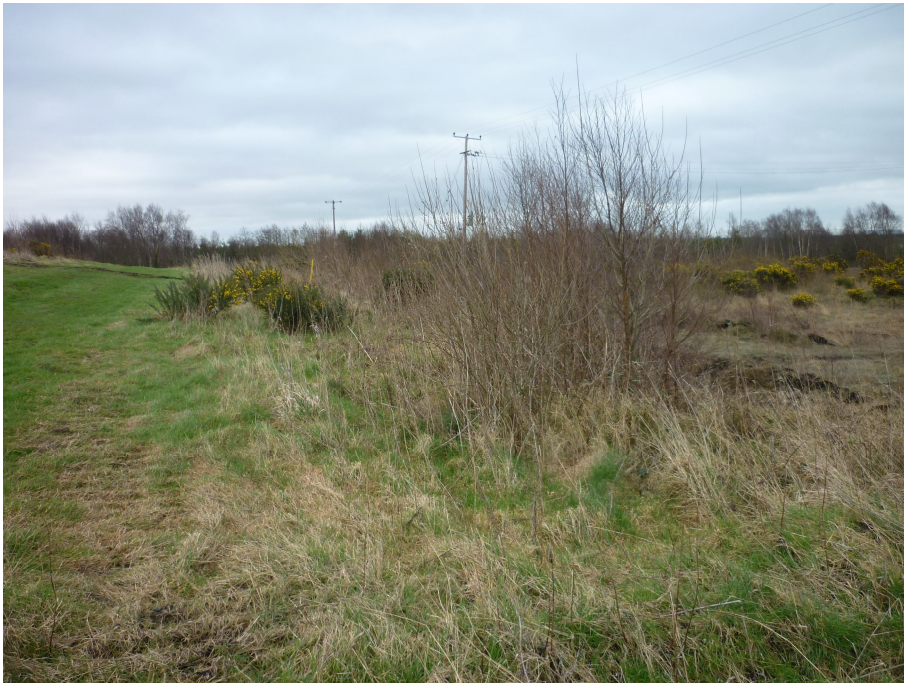
Figure 3 – Cell 2 Southern Embankment

In the years after the final capping of Cell 2 native plants have colonised large areas of the embankments. The southern embankment of Cell 2 is heavily colonised with native firs. Grass growth is also well established on the embankments.

The photographs below illustrate the large amount of growth present on the embankment slopes.

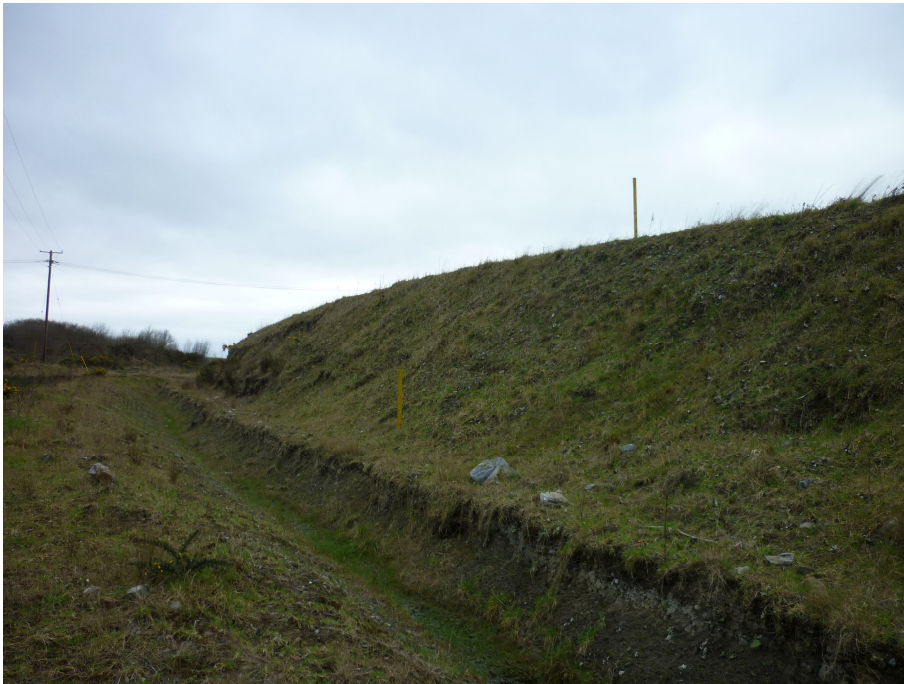
Figure 5 – Cell 3 Southern Embankment

The embankments of Cell 3 have only been in position for 3 years and as yet have not been colonised to the same extent as Cell 1 and Cell 2. Native plants are beginning to establish on the embankments and this will increase over the coming years.

The photographs below illustrate the condition of the embankments at present. Overall the embankments are in good condition. There are no slippages and no signs of erosion over the area.

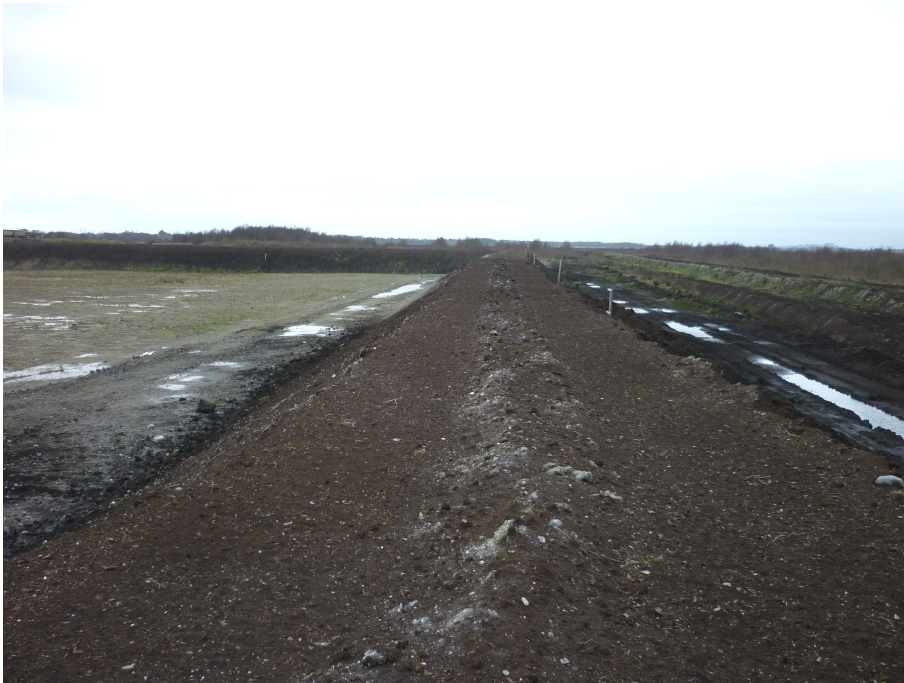
Figure 7 – Cell 4 Southern Embankment

The embankments of Cell 4 have only been in position for less than 1 year and have not been fully completed. Small works are still to be completed on the eastern end of the embankment.

The photographs below illustrate the condition of the embankments at present. Overall the embankments are in good condition.
