Limerick Gas Works Remediation

Environmental Impact Statement

Report Number 1021927/R/07

March 2012

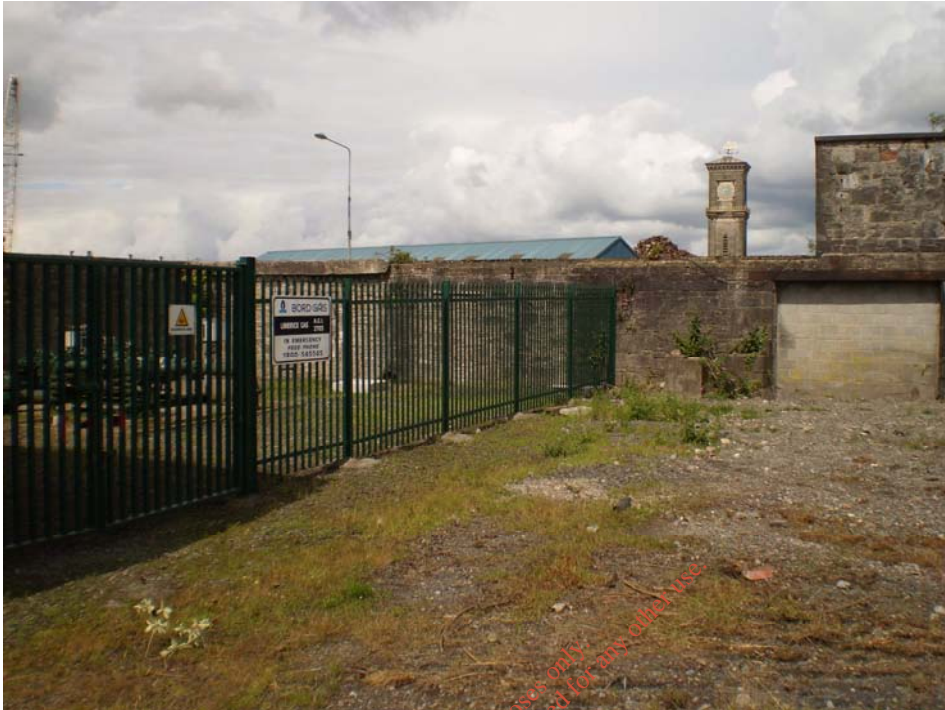
Photo 1) AGI site

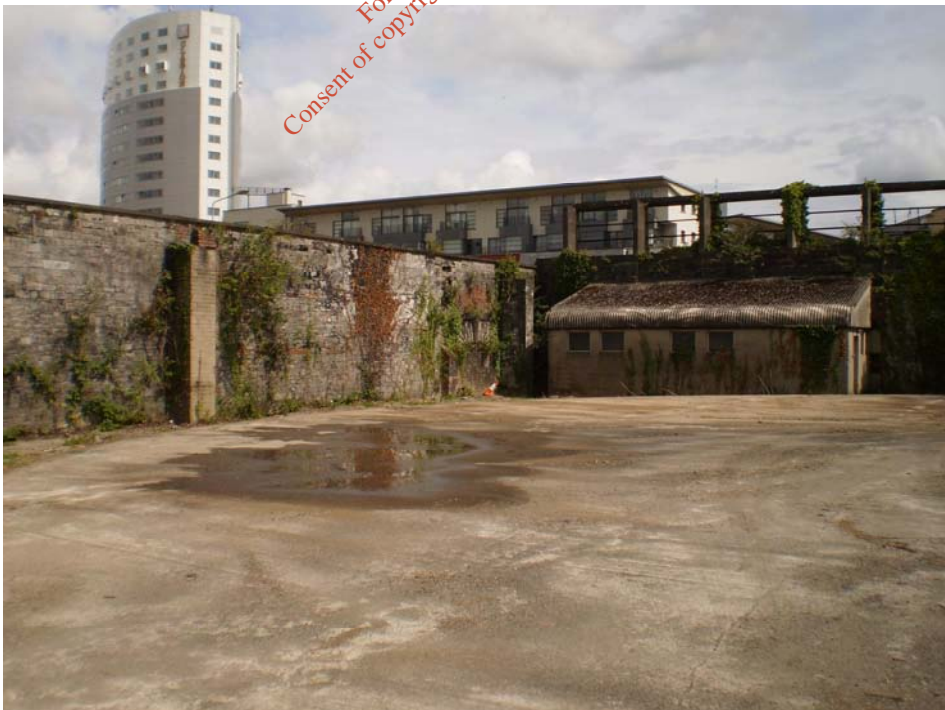
Photo 2) Gasholder 2 and Groverner house

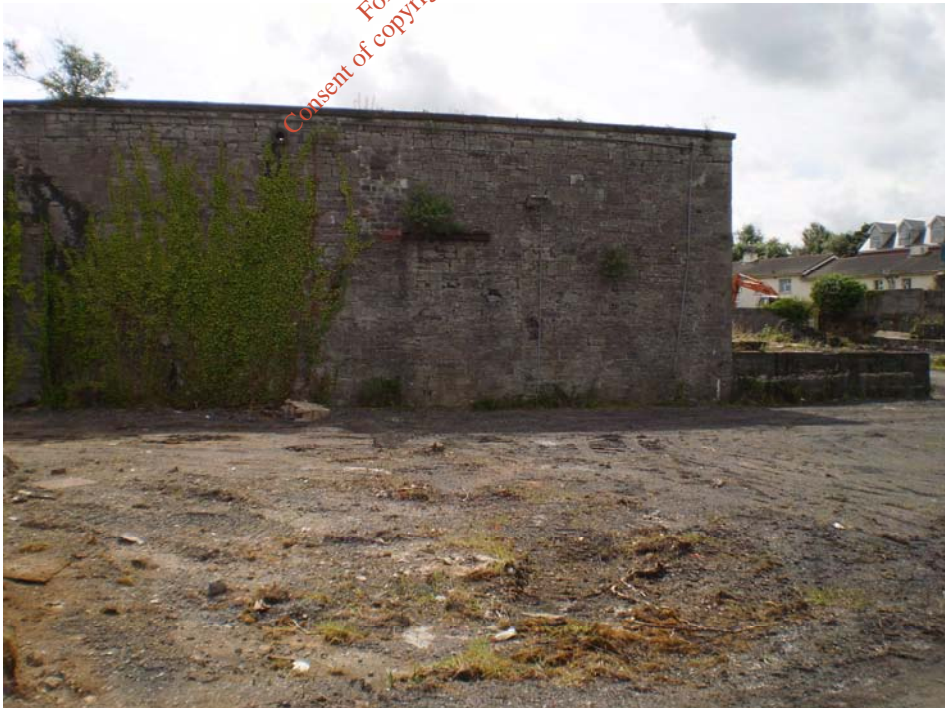
Photo 4) Back wall of booster house

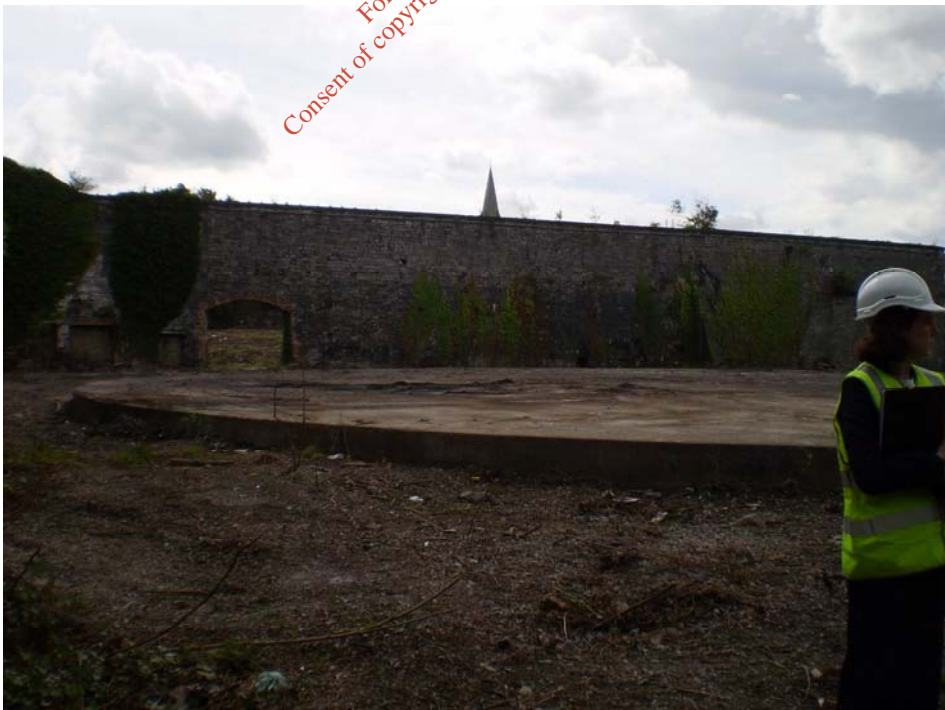
Photo 6) Gasholder 2

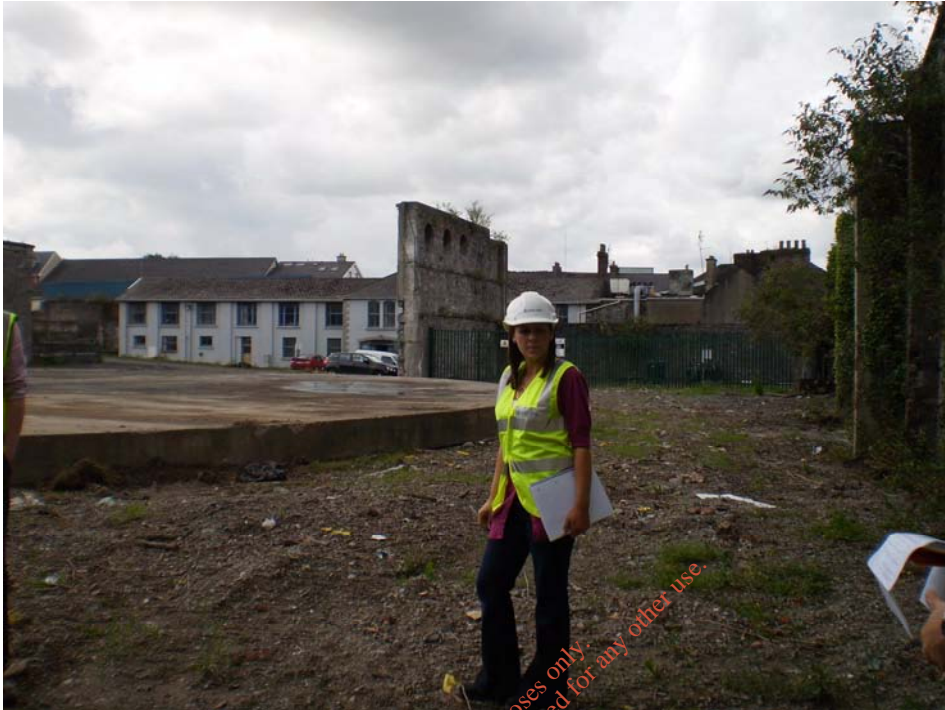
Photo 7) Gas holder 2 and AGI

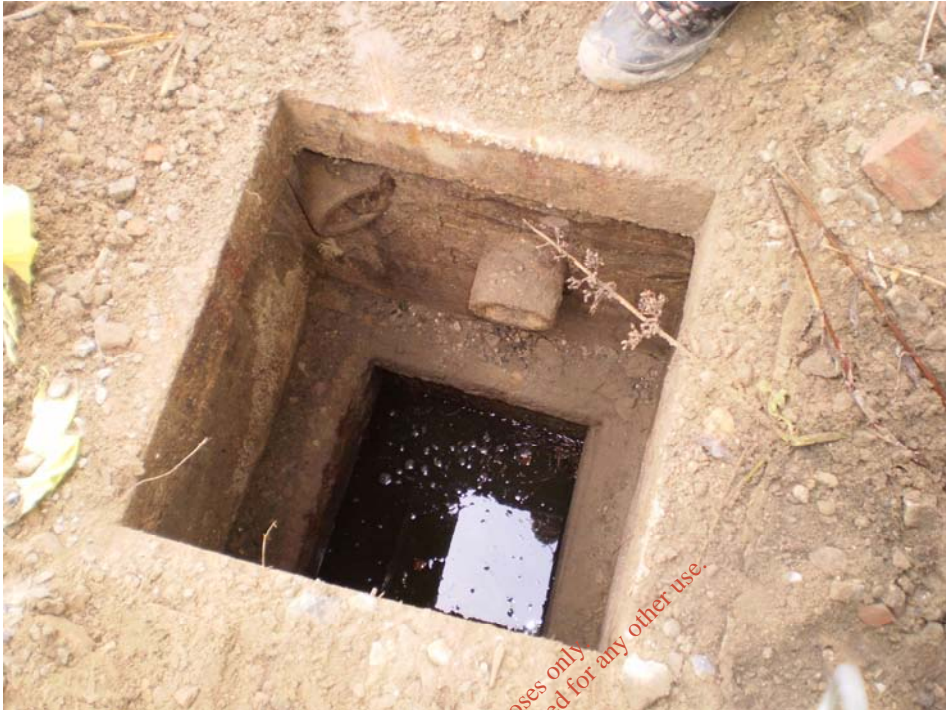
Photo 9) Inside manhole

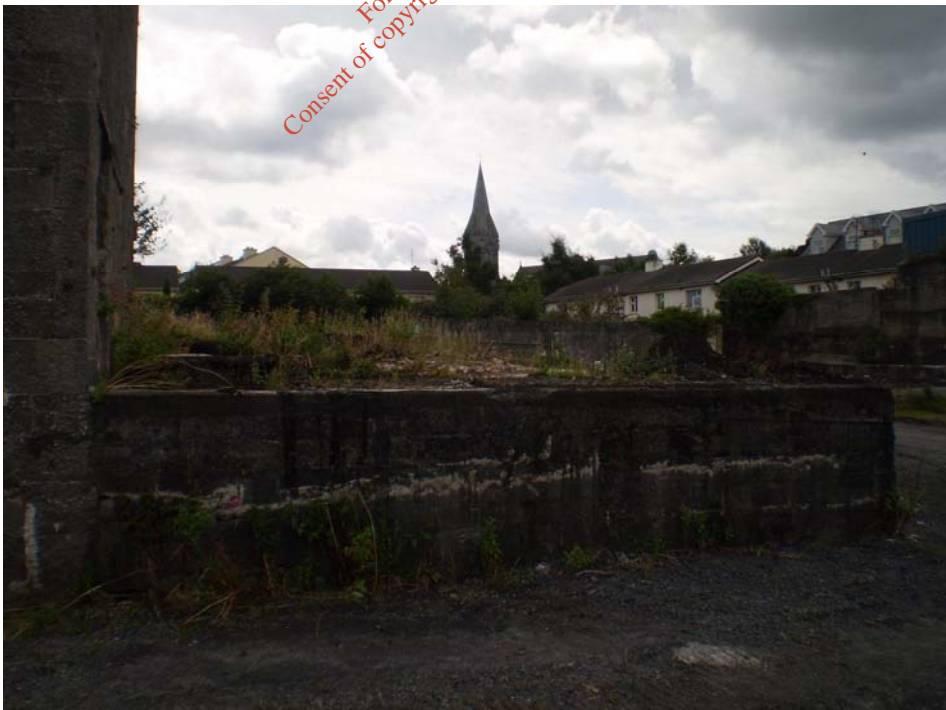
Photo 10) Booster house slab

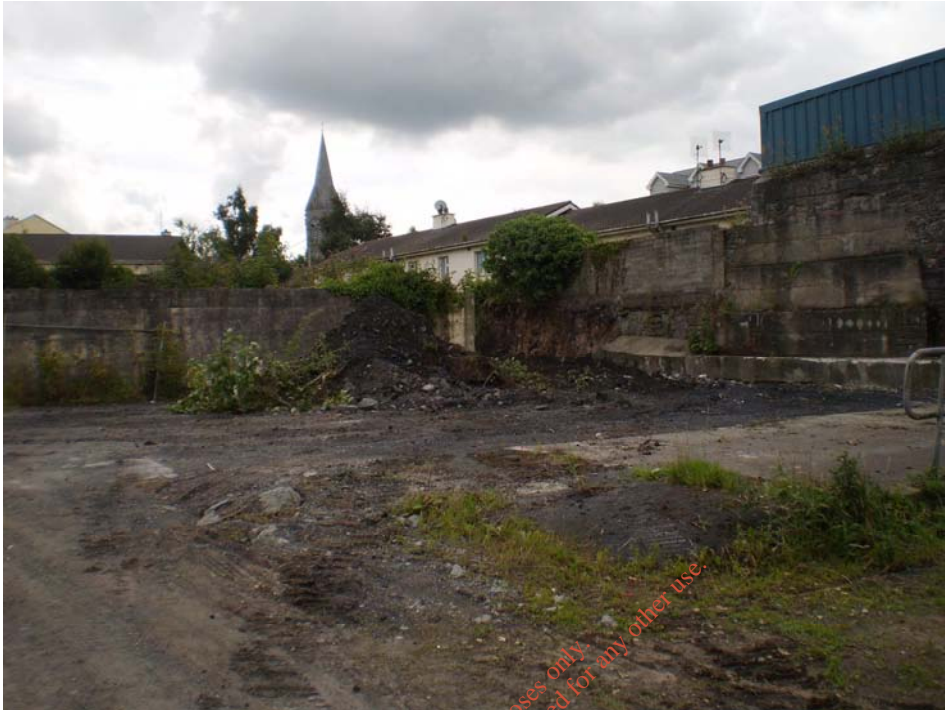
Photo 11) Corner of tank 1 bund

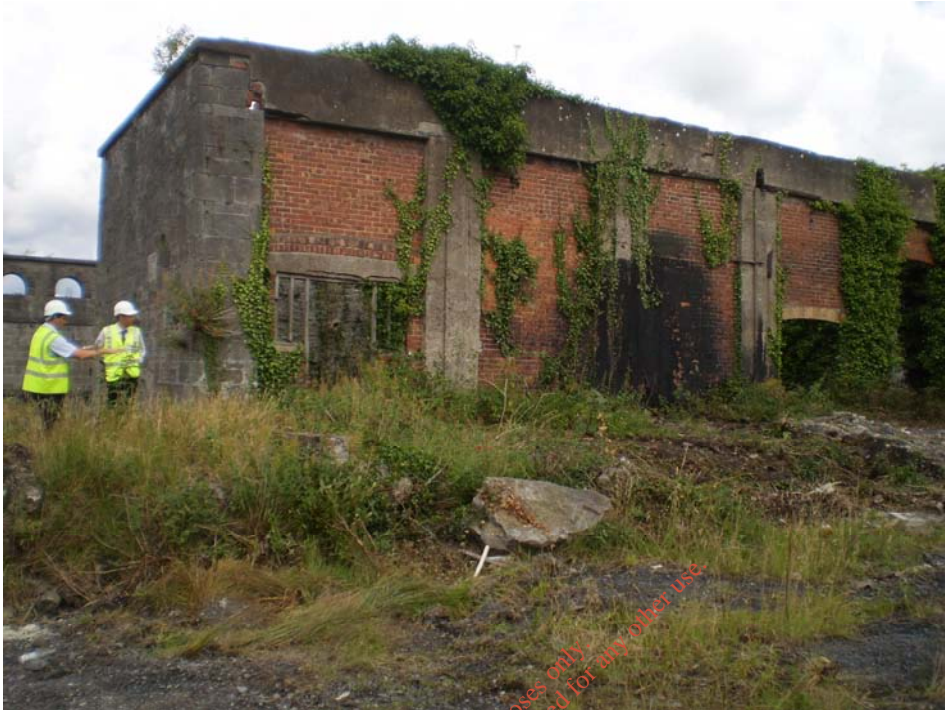
Photo 13) Booster house

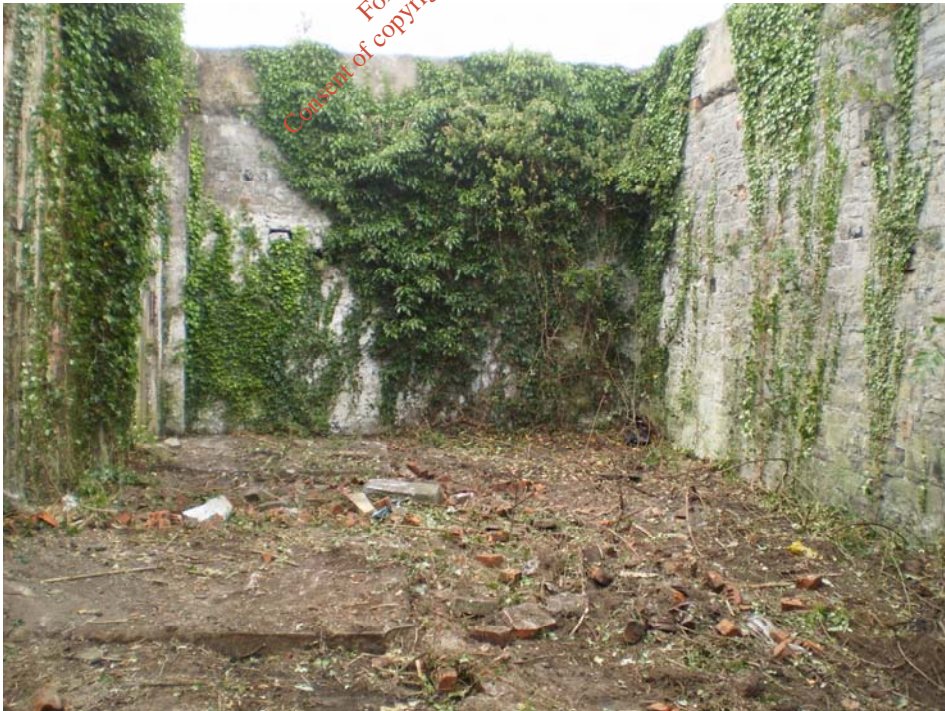
Photo 14) Inside booster house

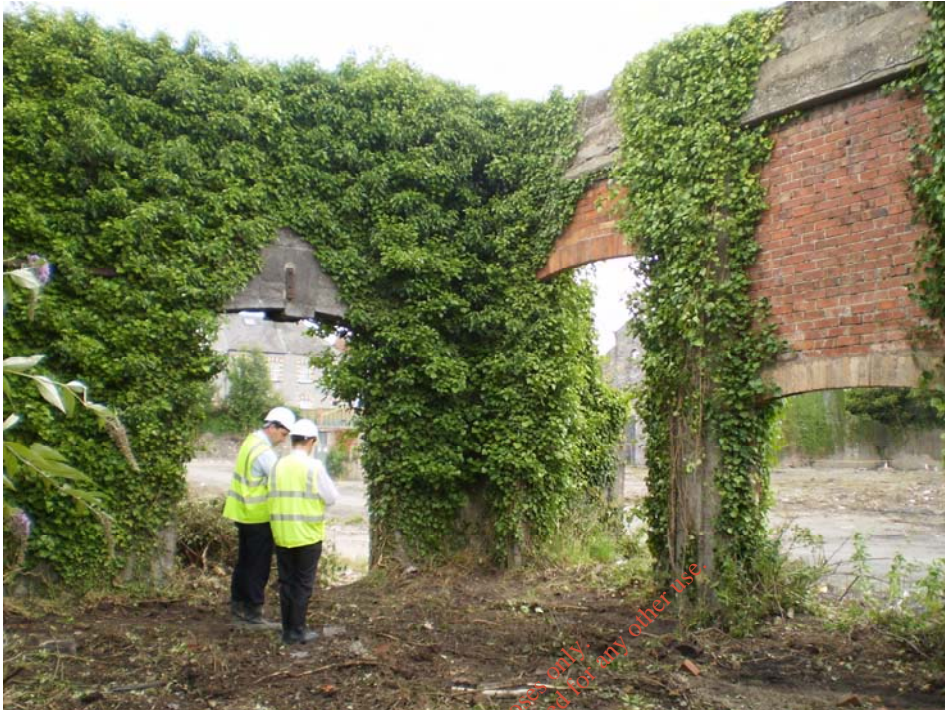
Photo 15) Inside Booster house

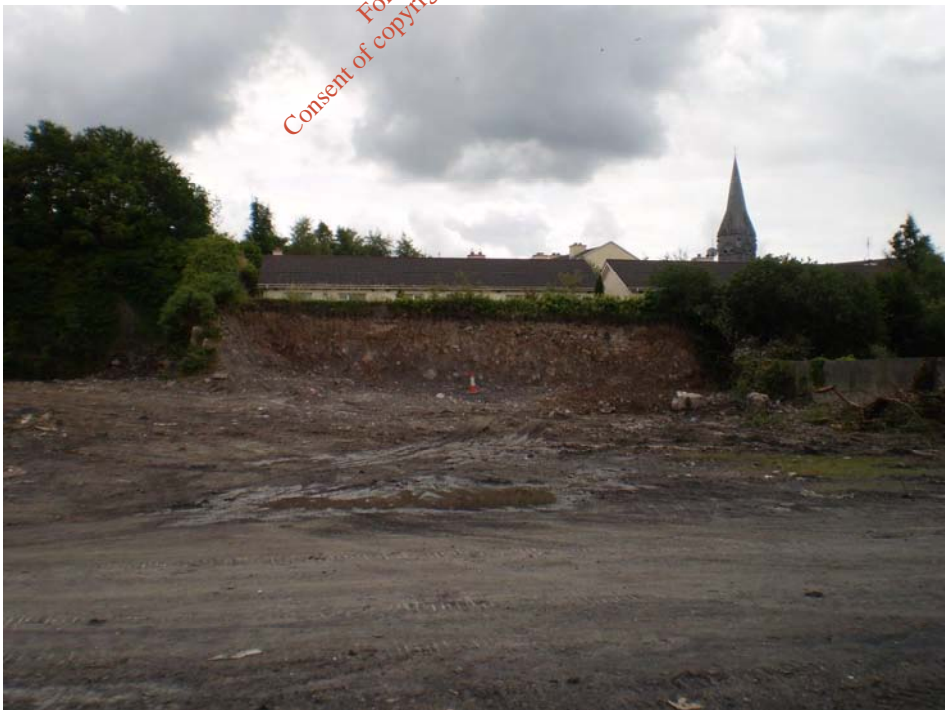
Photo 16) Excavated wall

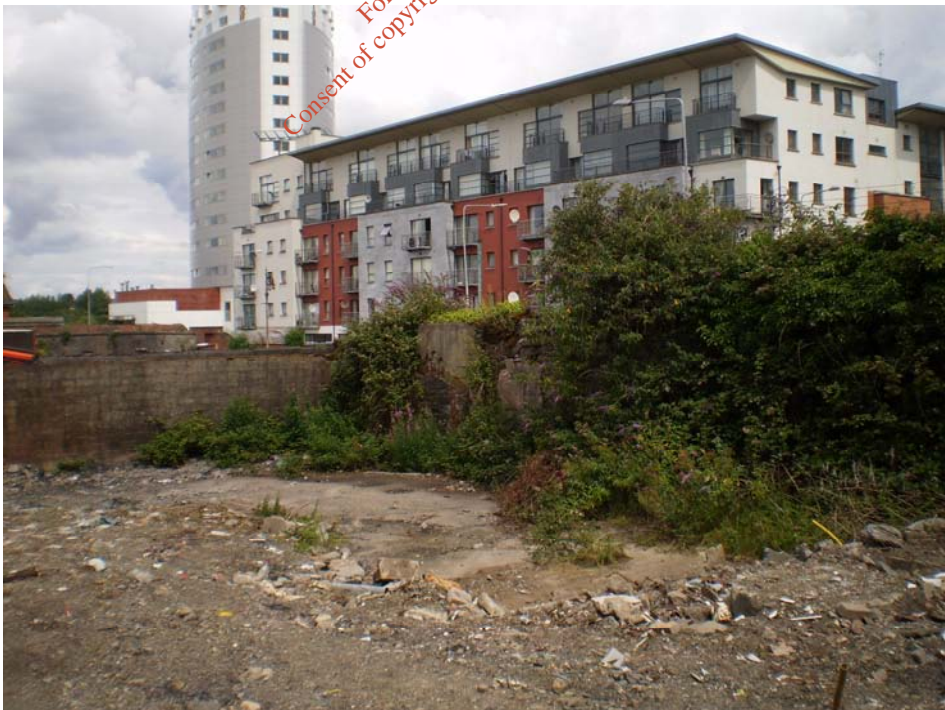
Photo 22) Gasholder 1

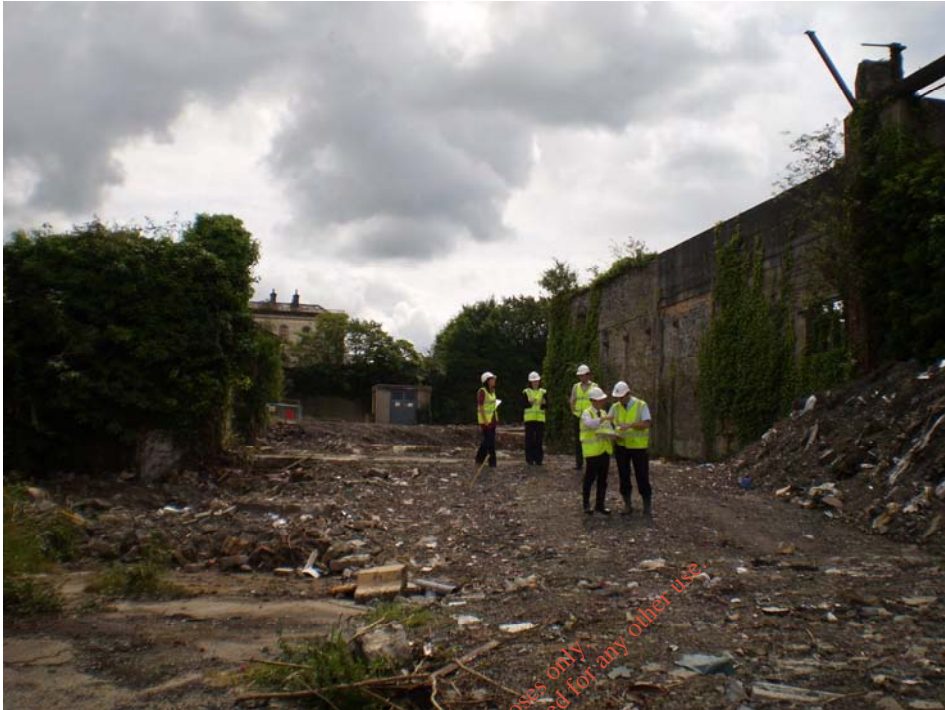
Photo 23) Former retort area

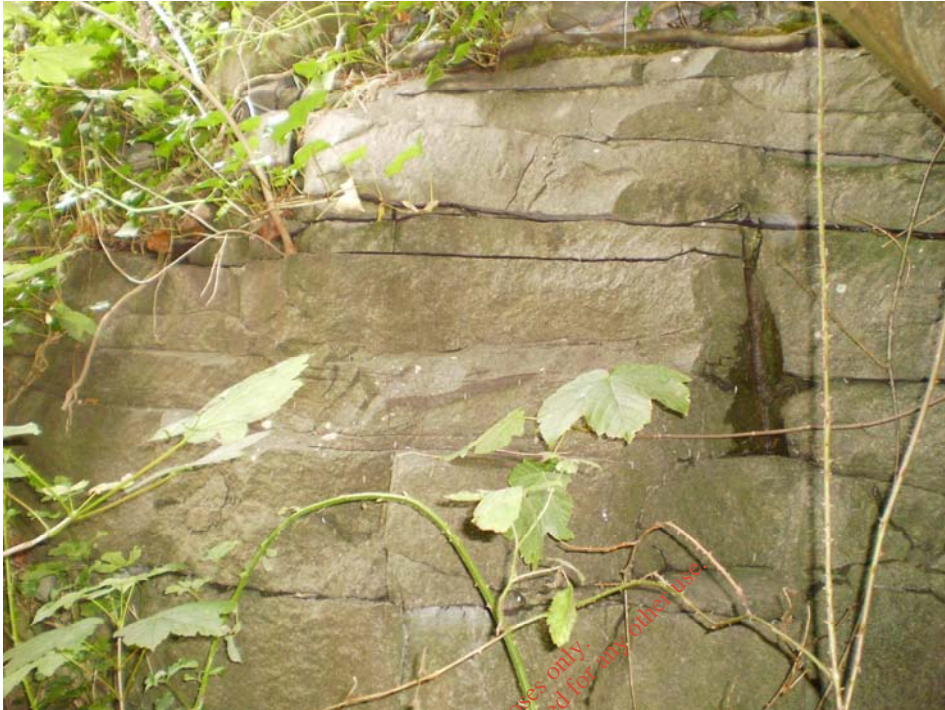
Photo 31) Limestone behind No. 5 stores

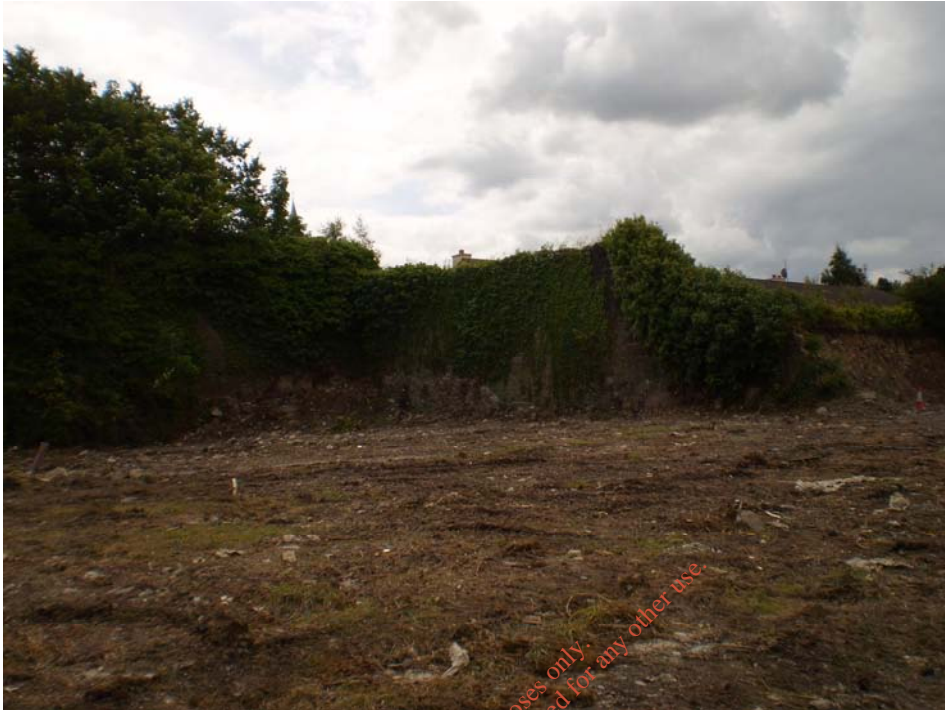
Photo 33) Gasholder 3

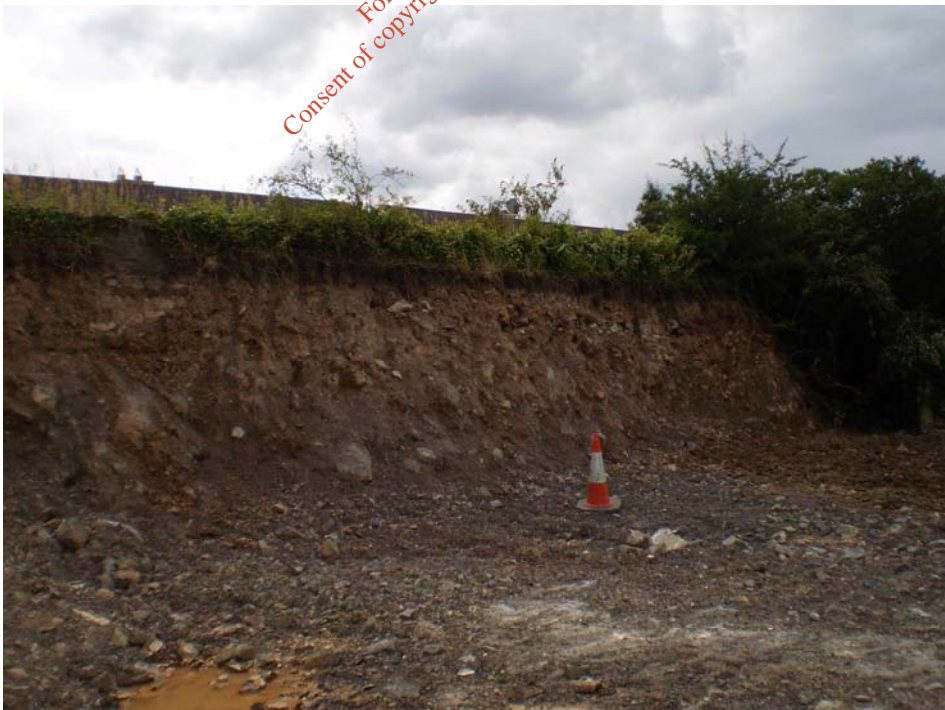
Photo 34) Exposed wall

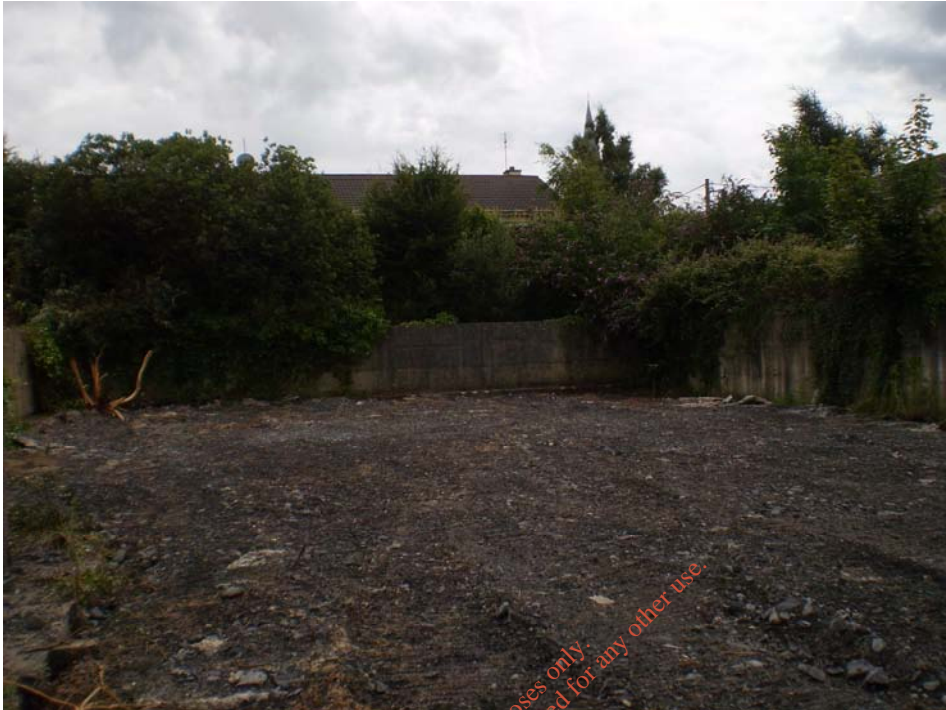
Photo 35) Tank 1 bund

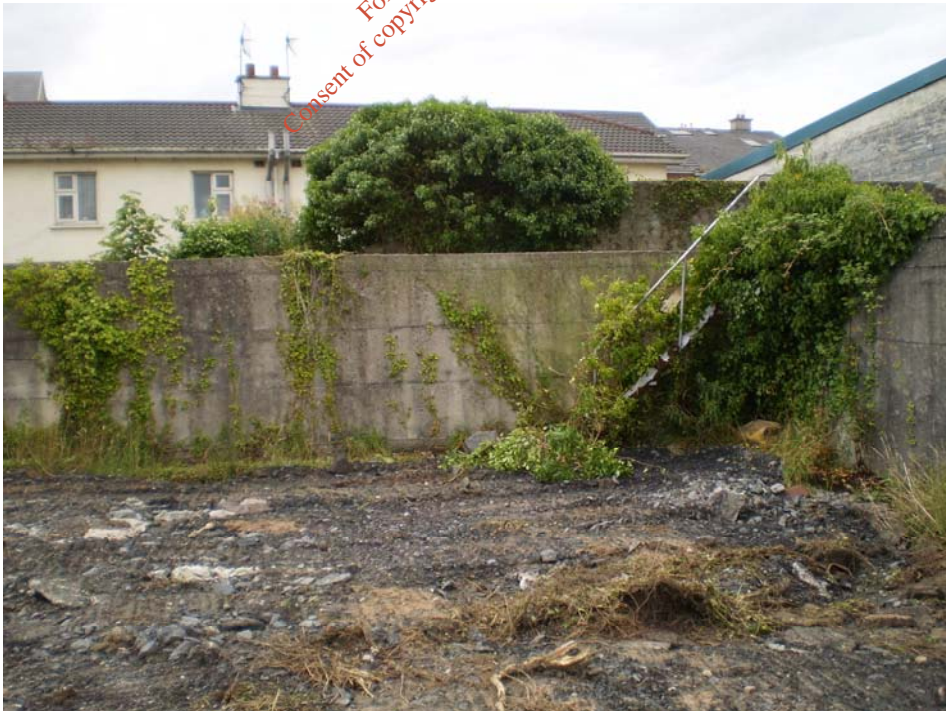
Photo 36) Tank 1 bund

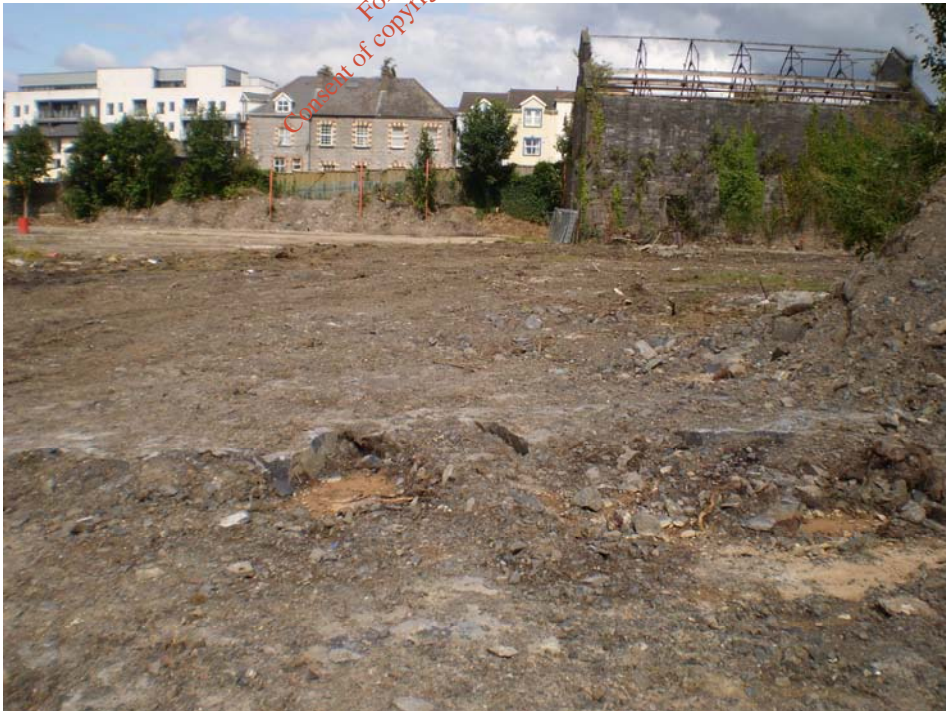
Photo 38) Exposed limestone bedrock

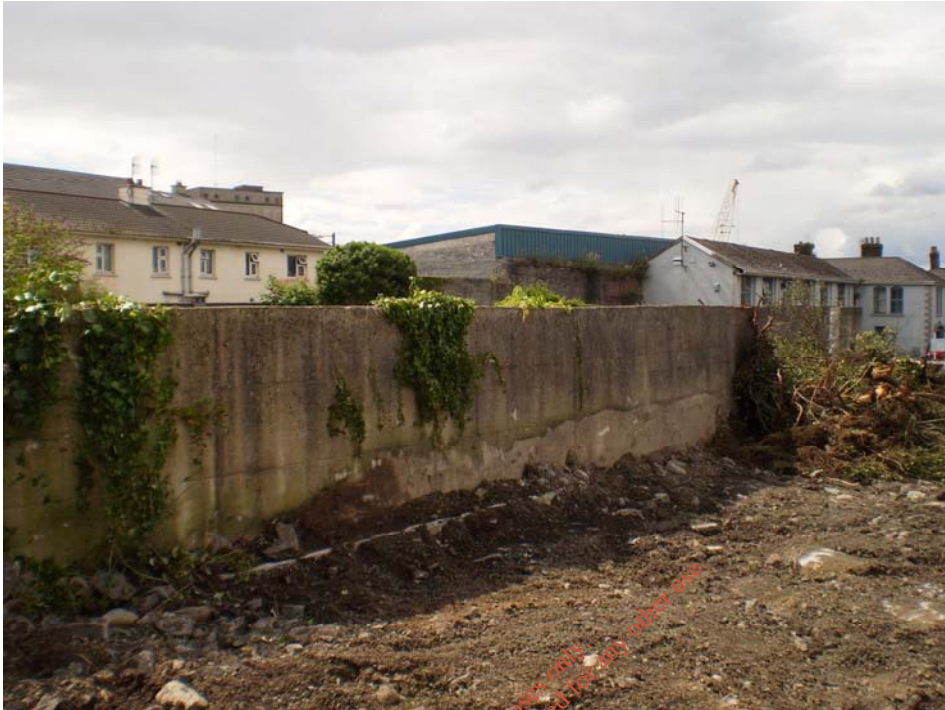
Photo 39) Tank 1 bund exterior
