**Former Gasworks  
Dock Road, Limerick**

**Quantitative Risk Assessment,  
Options Appraisal and Remediation**

Report No. 1021927/R/03

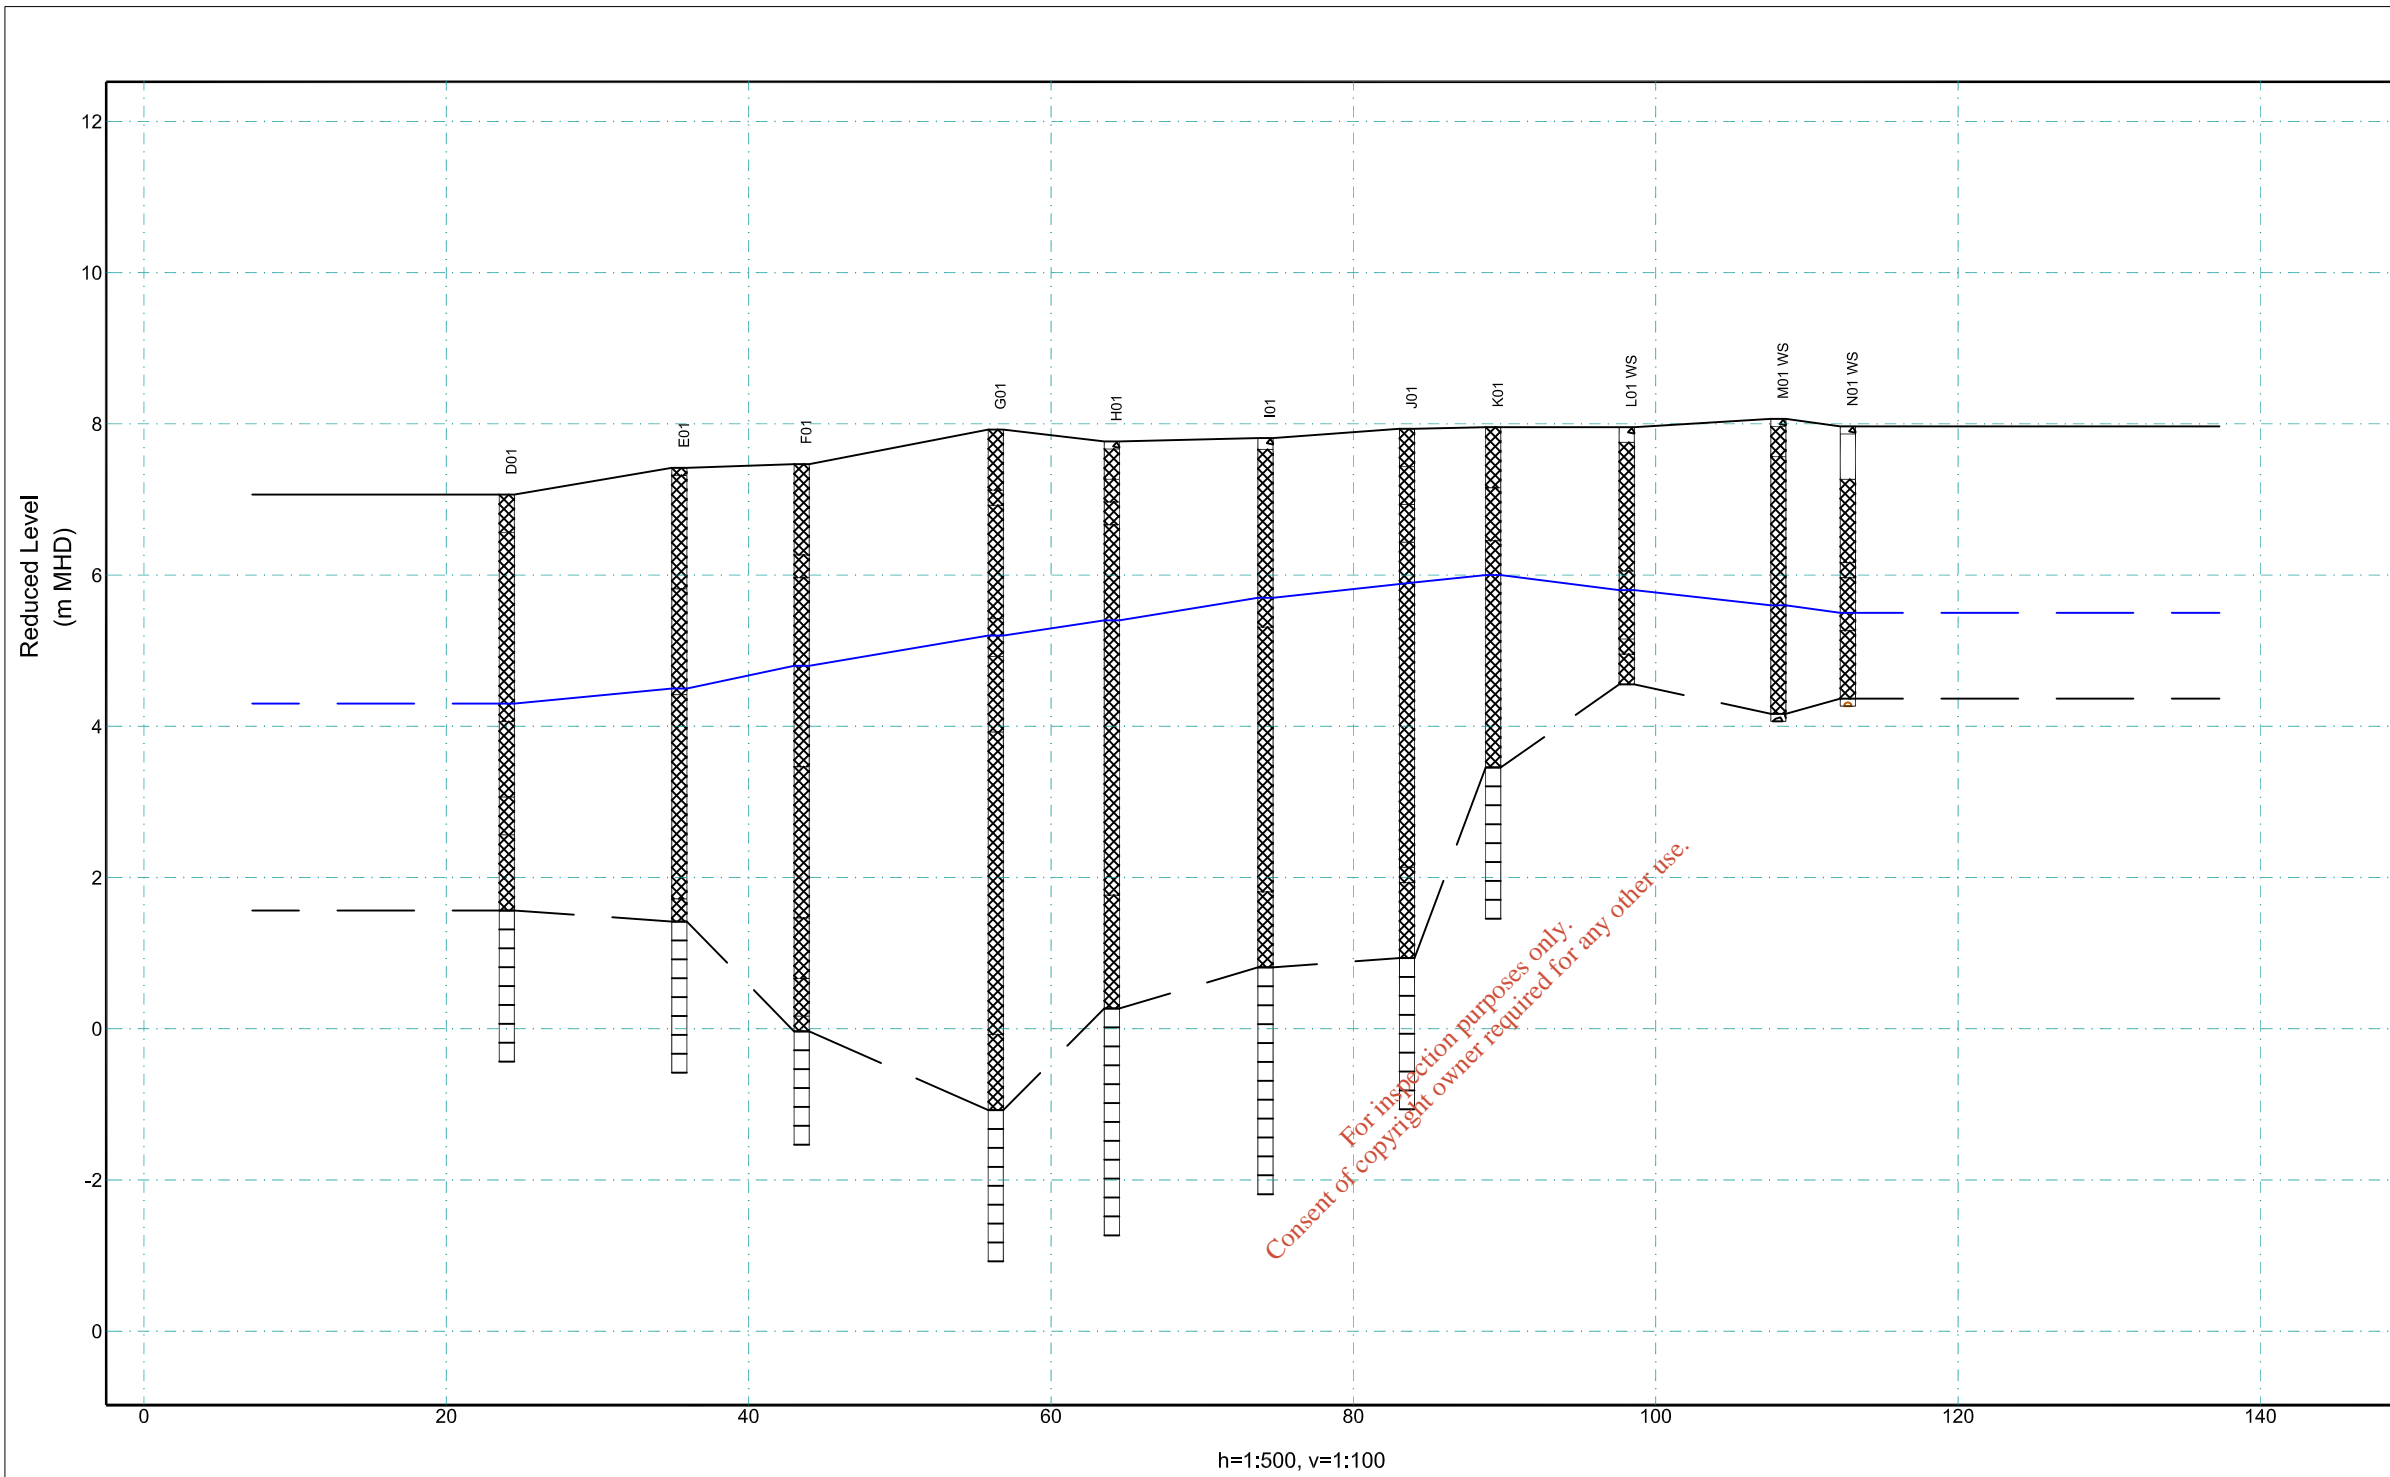
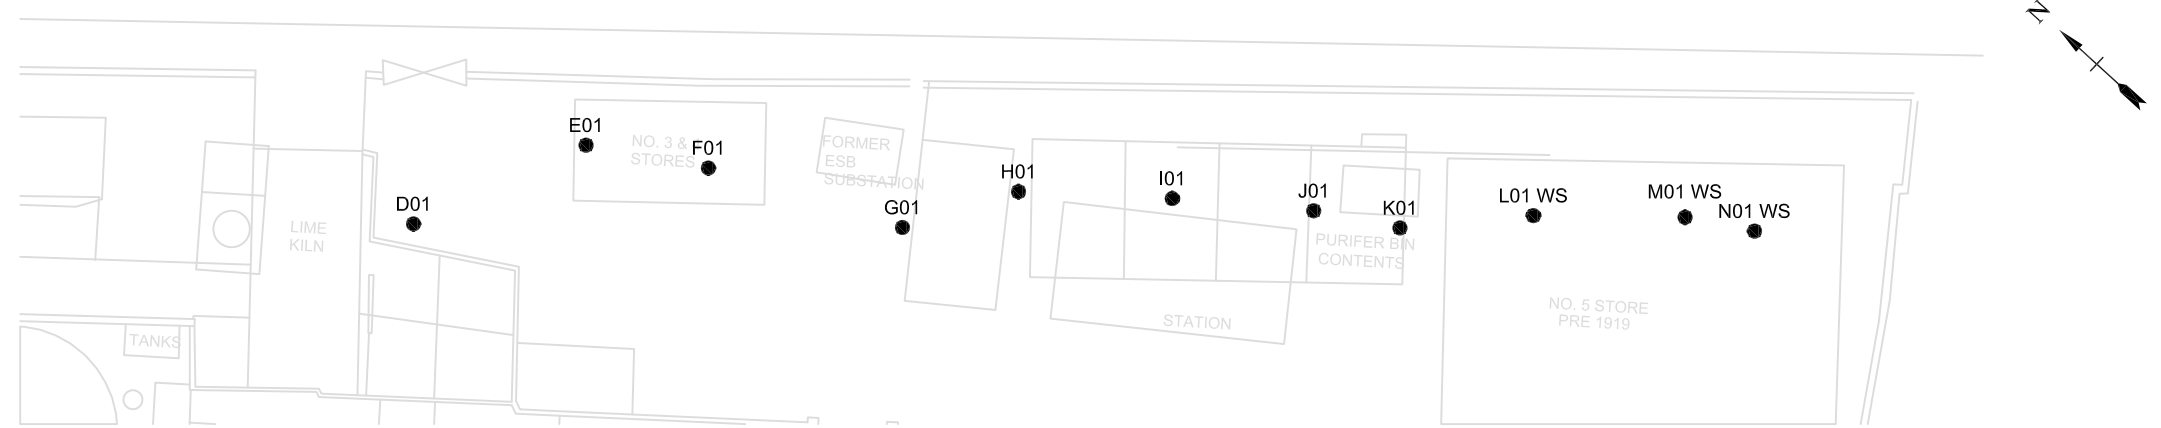
Figure 4a) D1 - N1

MADE GROUND		Ground Level
	CONCRETE		Made Ground Boundary
	GRAVEL		Groundwater Level
	COBBLES		
	LIMESTONE

An extensive former quarry is known to be present over the eastern half of the site as indicated on Figures 4, 5, 11 and 12. The quarry is up to 10m deep and backfilled with predominantly cohesive material. Free product is present at its base (grid cells F03, F06, F07, G04, G05, G06, G07, H06, I06 and I07). The quarry is shown as extending outside the boundary of the site in historical maps which appeared to be confirmed during the characterisation investigation as the edge of the quarry could not be located near the O'Curry Street boundary.

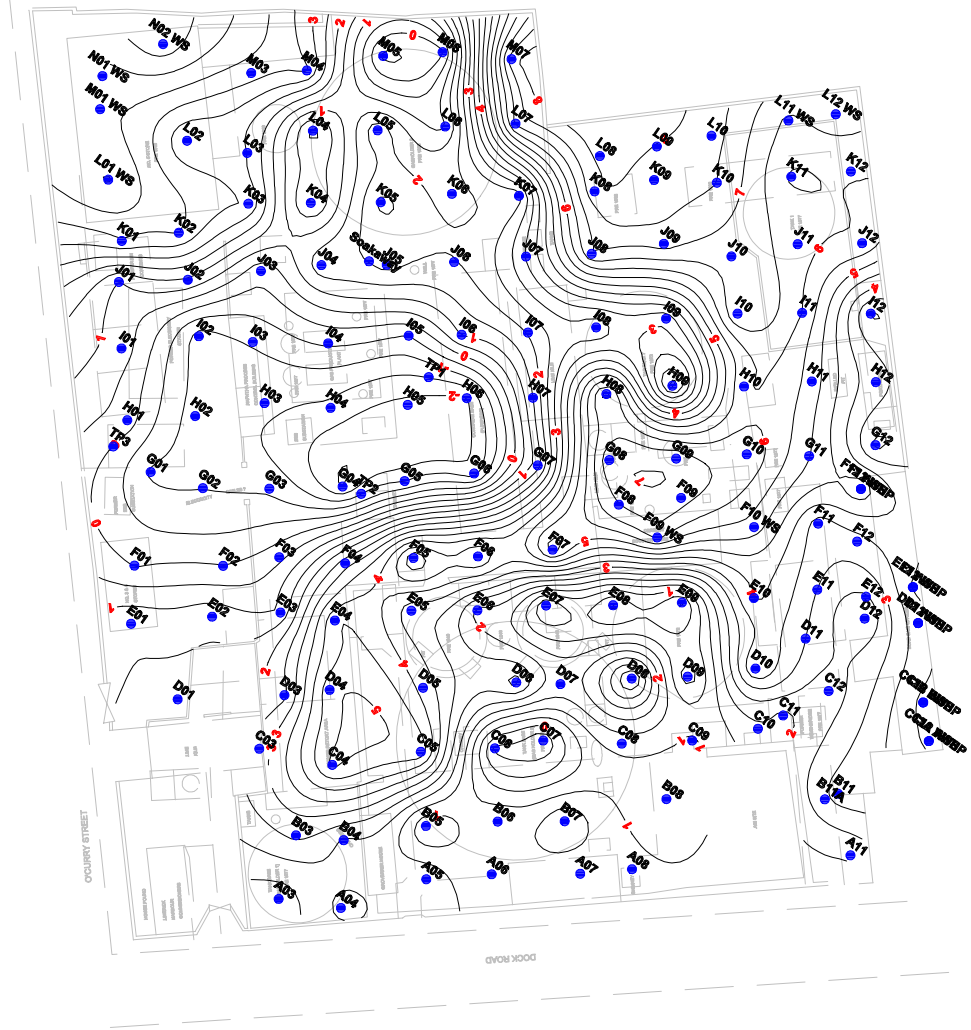
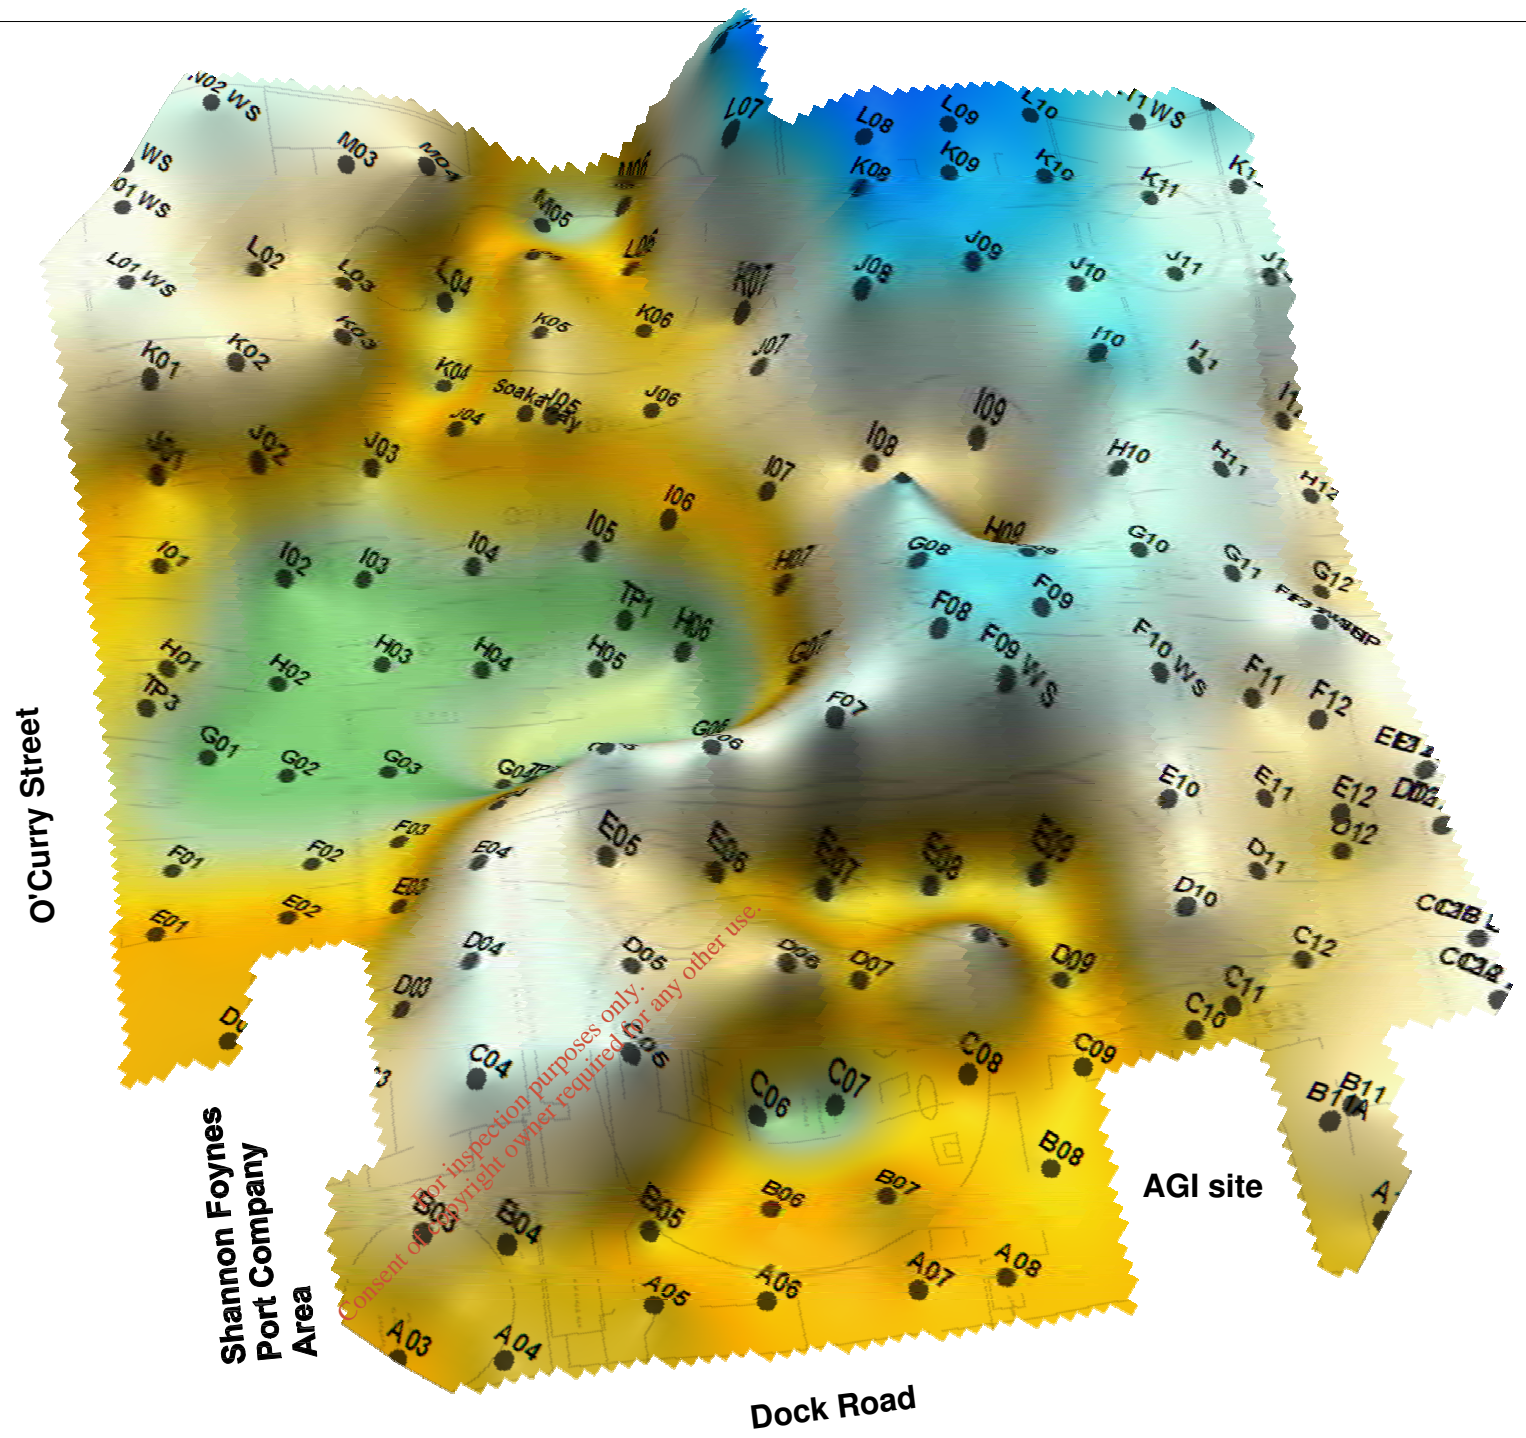
Approximate rock head contours (m MHD)

Approximate Rock head level (m MHD)

The bedrock surface was found to be very uneven due to previous quarrying activities and excavation for underground tanks and tank foundations. The natural slope of the bedrock is from approximately 8m MHD near the southern corner (Cell L08) to 1m MHD at the north western boundary with Dock Road (Cell A6). Rockhead was encountered at a maximum depth of 10m bgl (-2.5m MHD) in cell G4 at the base of the former quarry which is shown on the historical map for 1872. The quarry appears to have a steep face to the north-west, with its base rising more gently to the east. Rock head was encountered at ground level at the sites eastern to southern boundaries and in cells I10, J09, K08, K09, K10, L08, L09 and L10, Figure 5 shows the topography of rock-head.

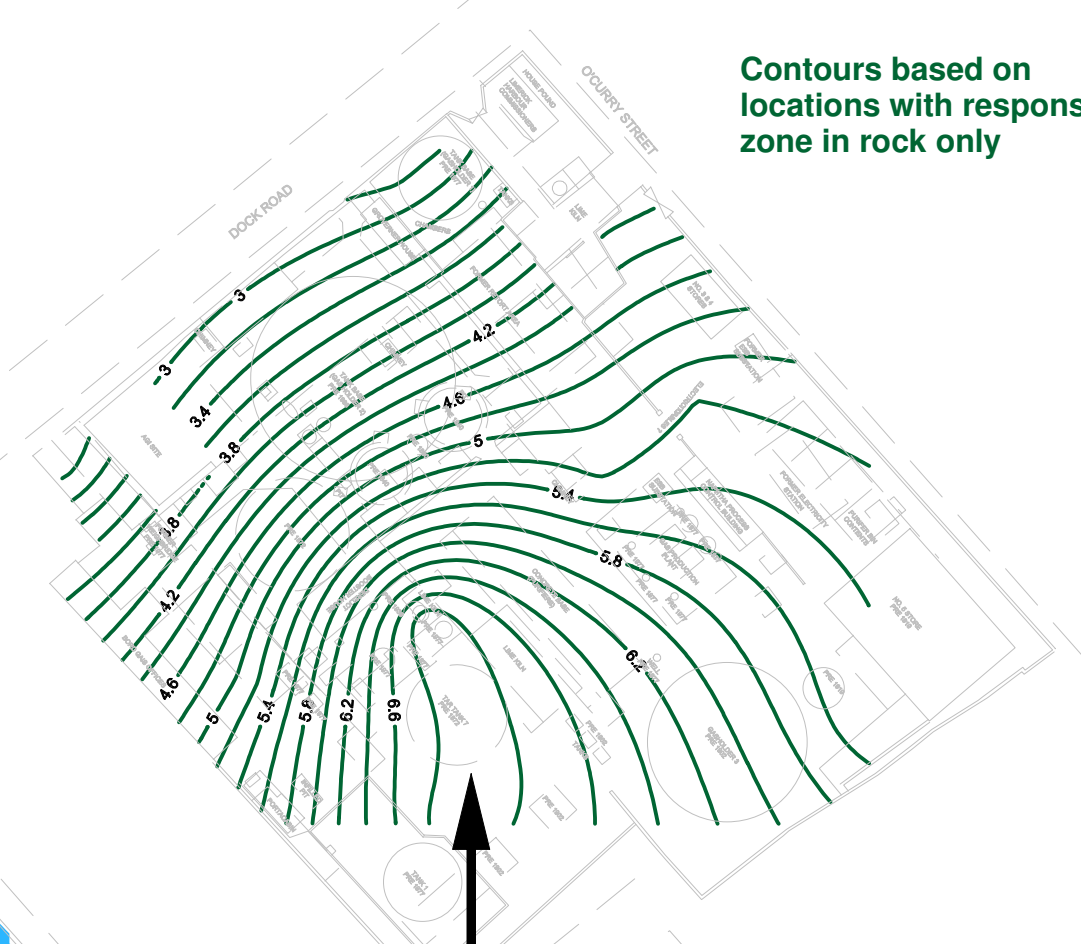
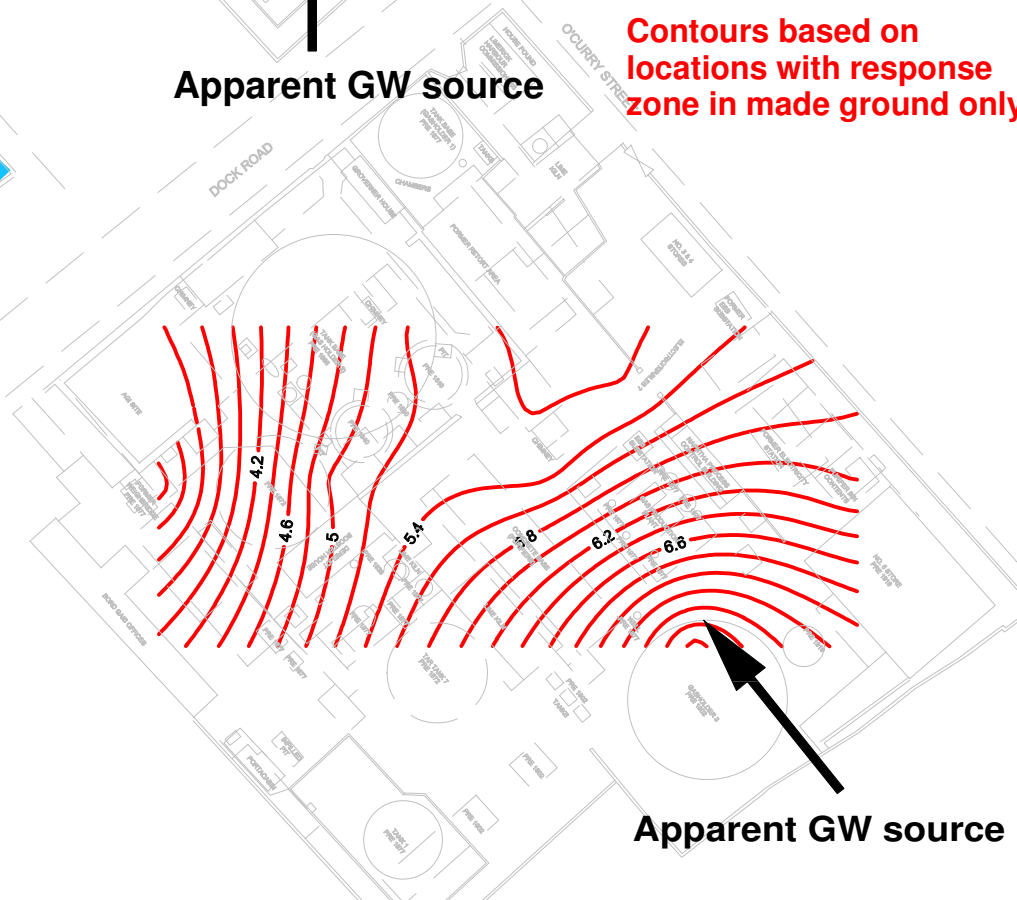
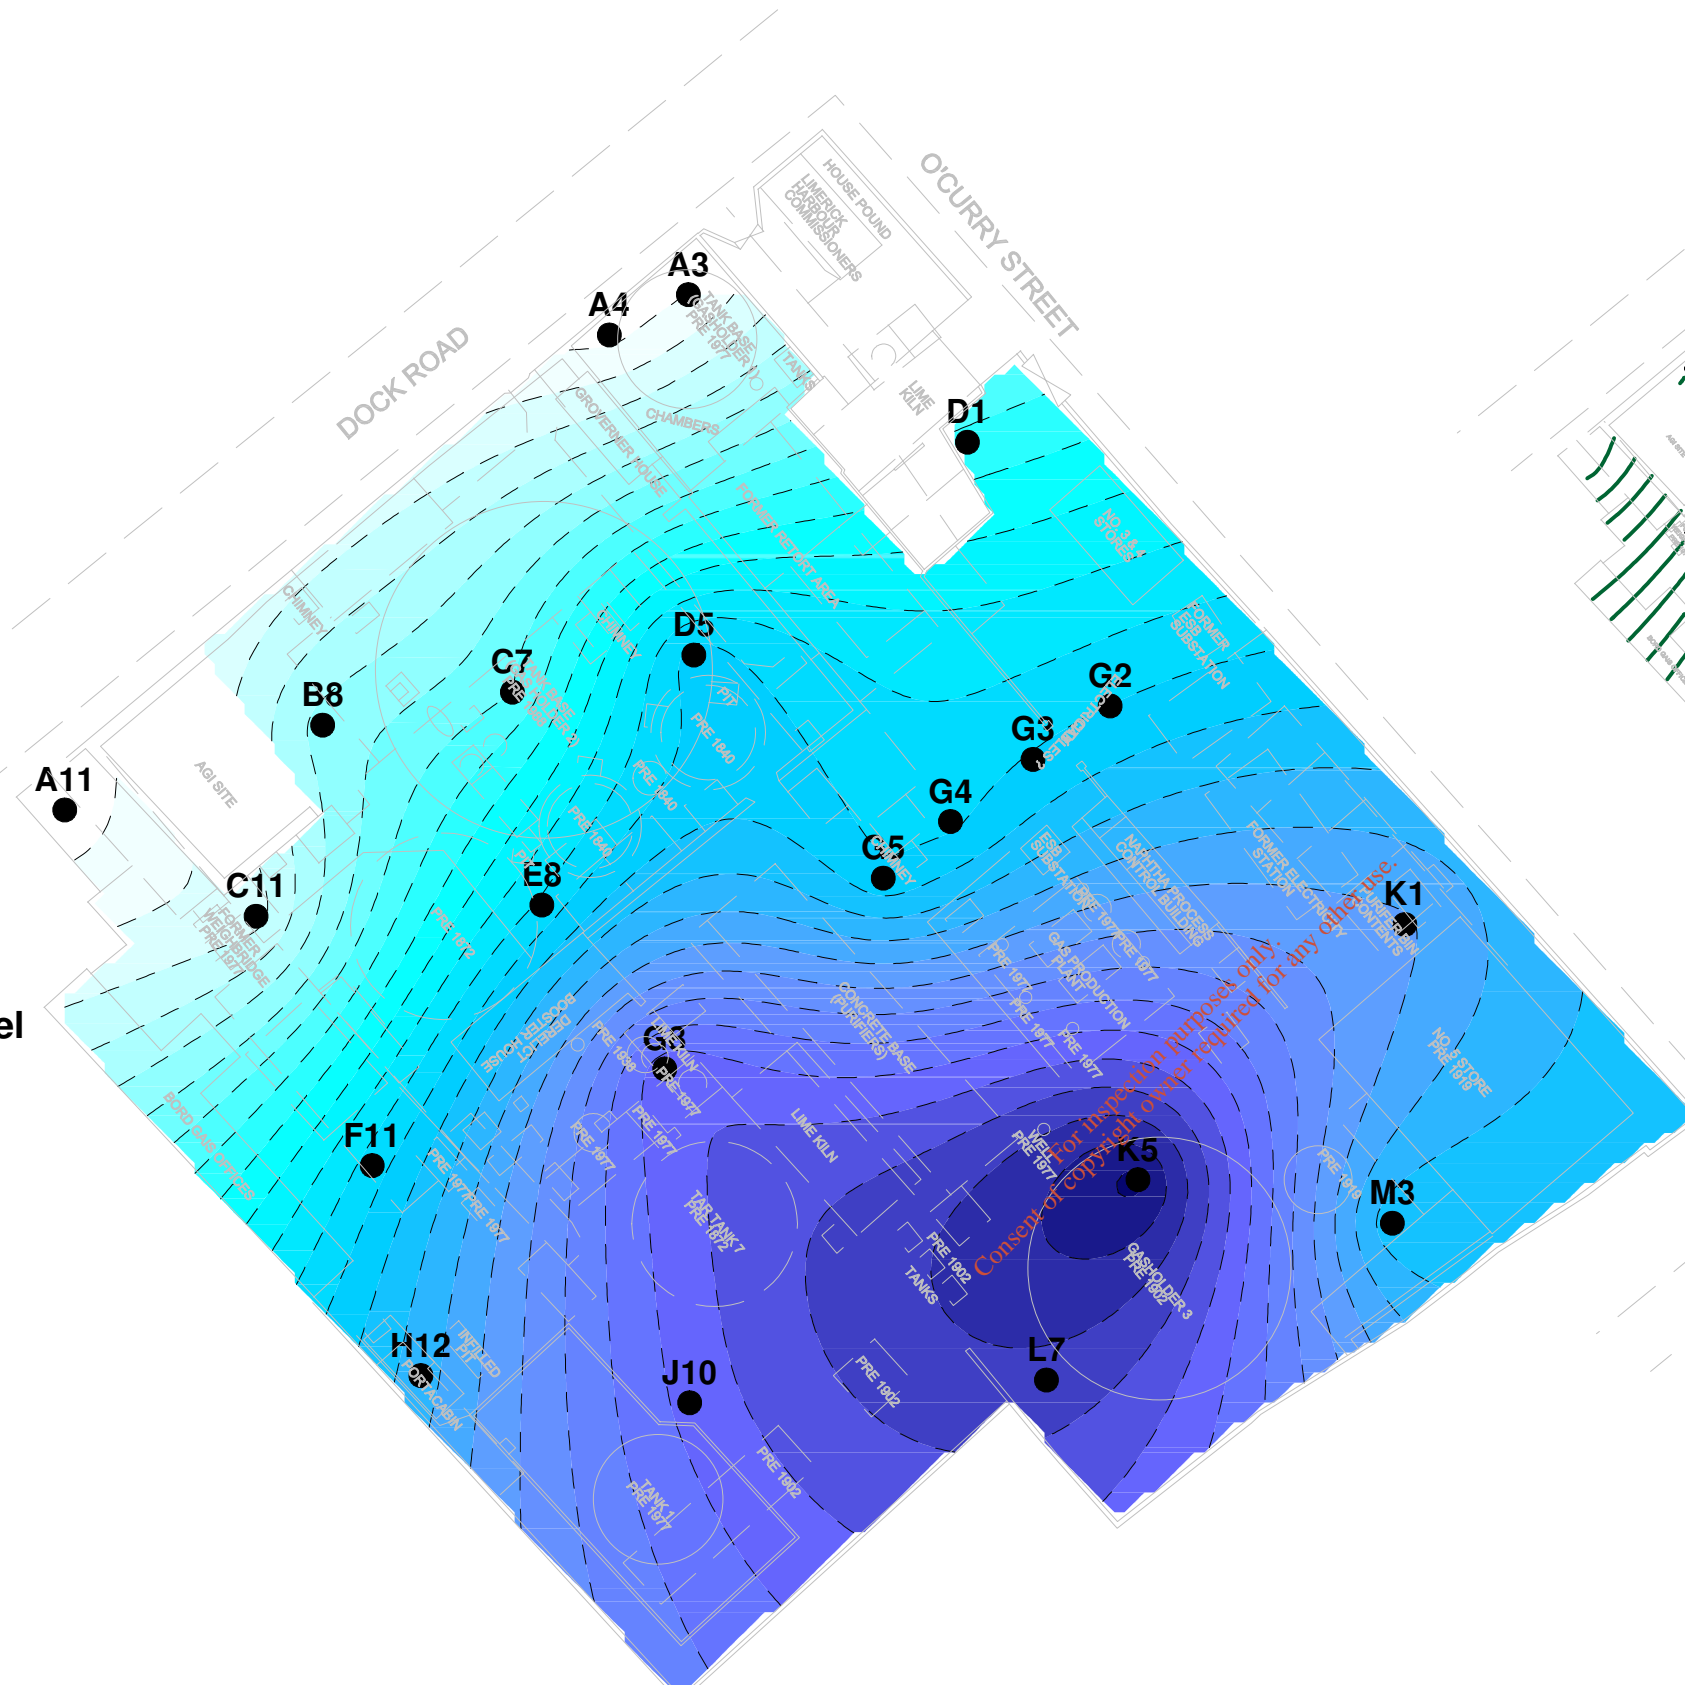
Groundwater Level  
(m MHD)

Contours based on  
locations with response  
zone in rock only

Apparent GW source

Contours based on  
locations with response  
zone in made ground only

These plots have been produced using data obtained from the groundwater monitoring visit undertaken on 10-11/12/2009. Contours were plotted using the Kriging method based upon a 1m x 1m grid

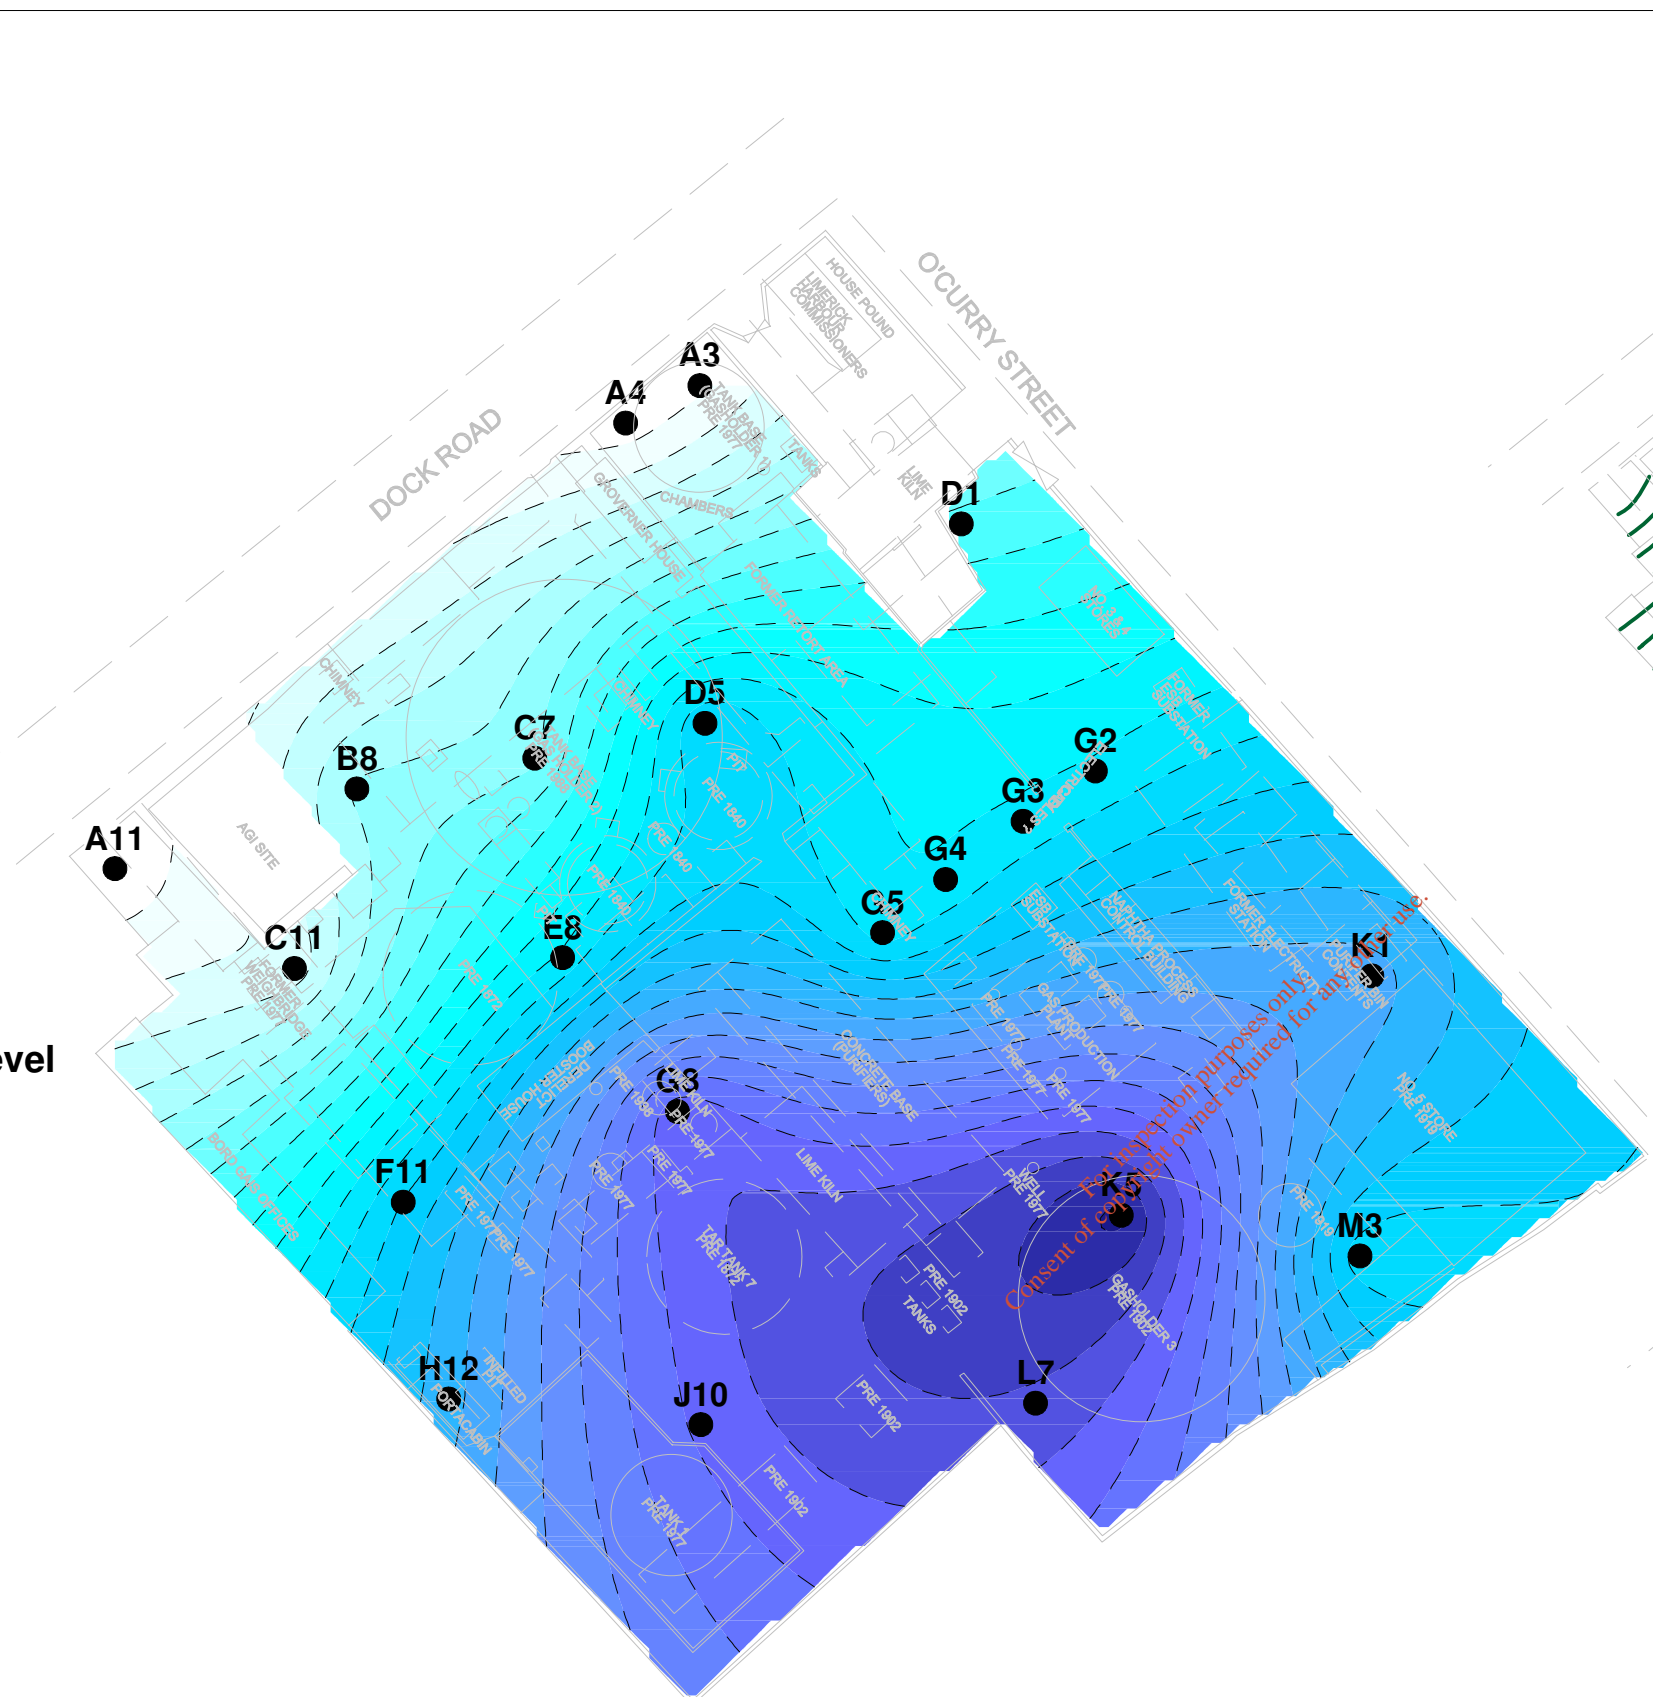
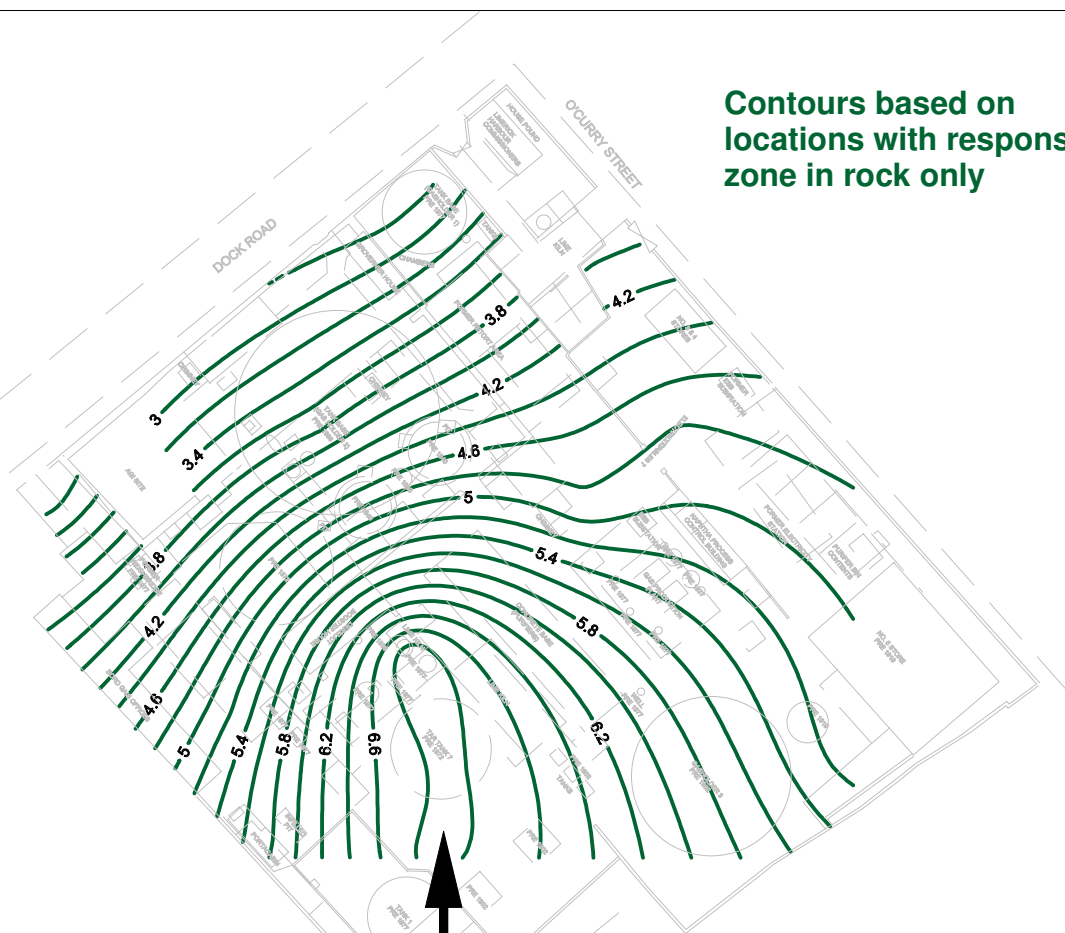
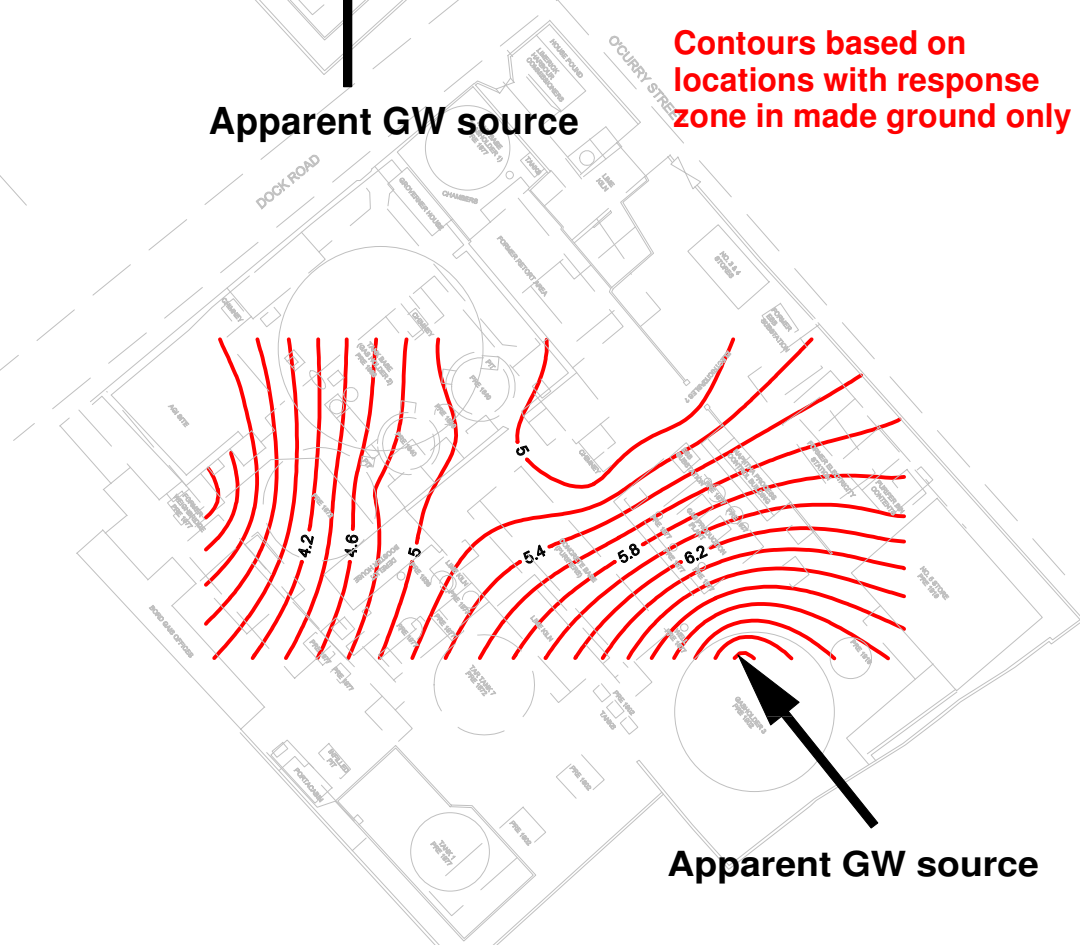
Groundwater Level  
(m MHD)

Contours based on  
locations with response  
zone in rock only

Contours based on  
locations with response  
zone in made ground only

These plots have been produced using data obtained from the groundwater monitoring visit undertaken on 14-15/01/2009. Contours were plotted using the Kriging method based upon a 1m x 1m grid

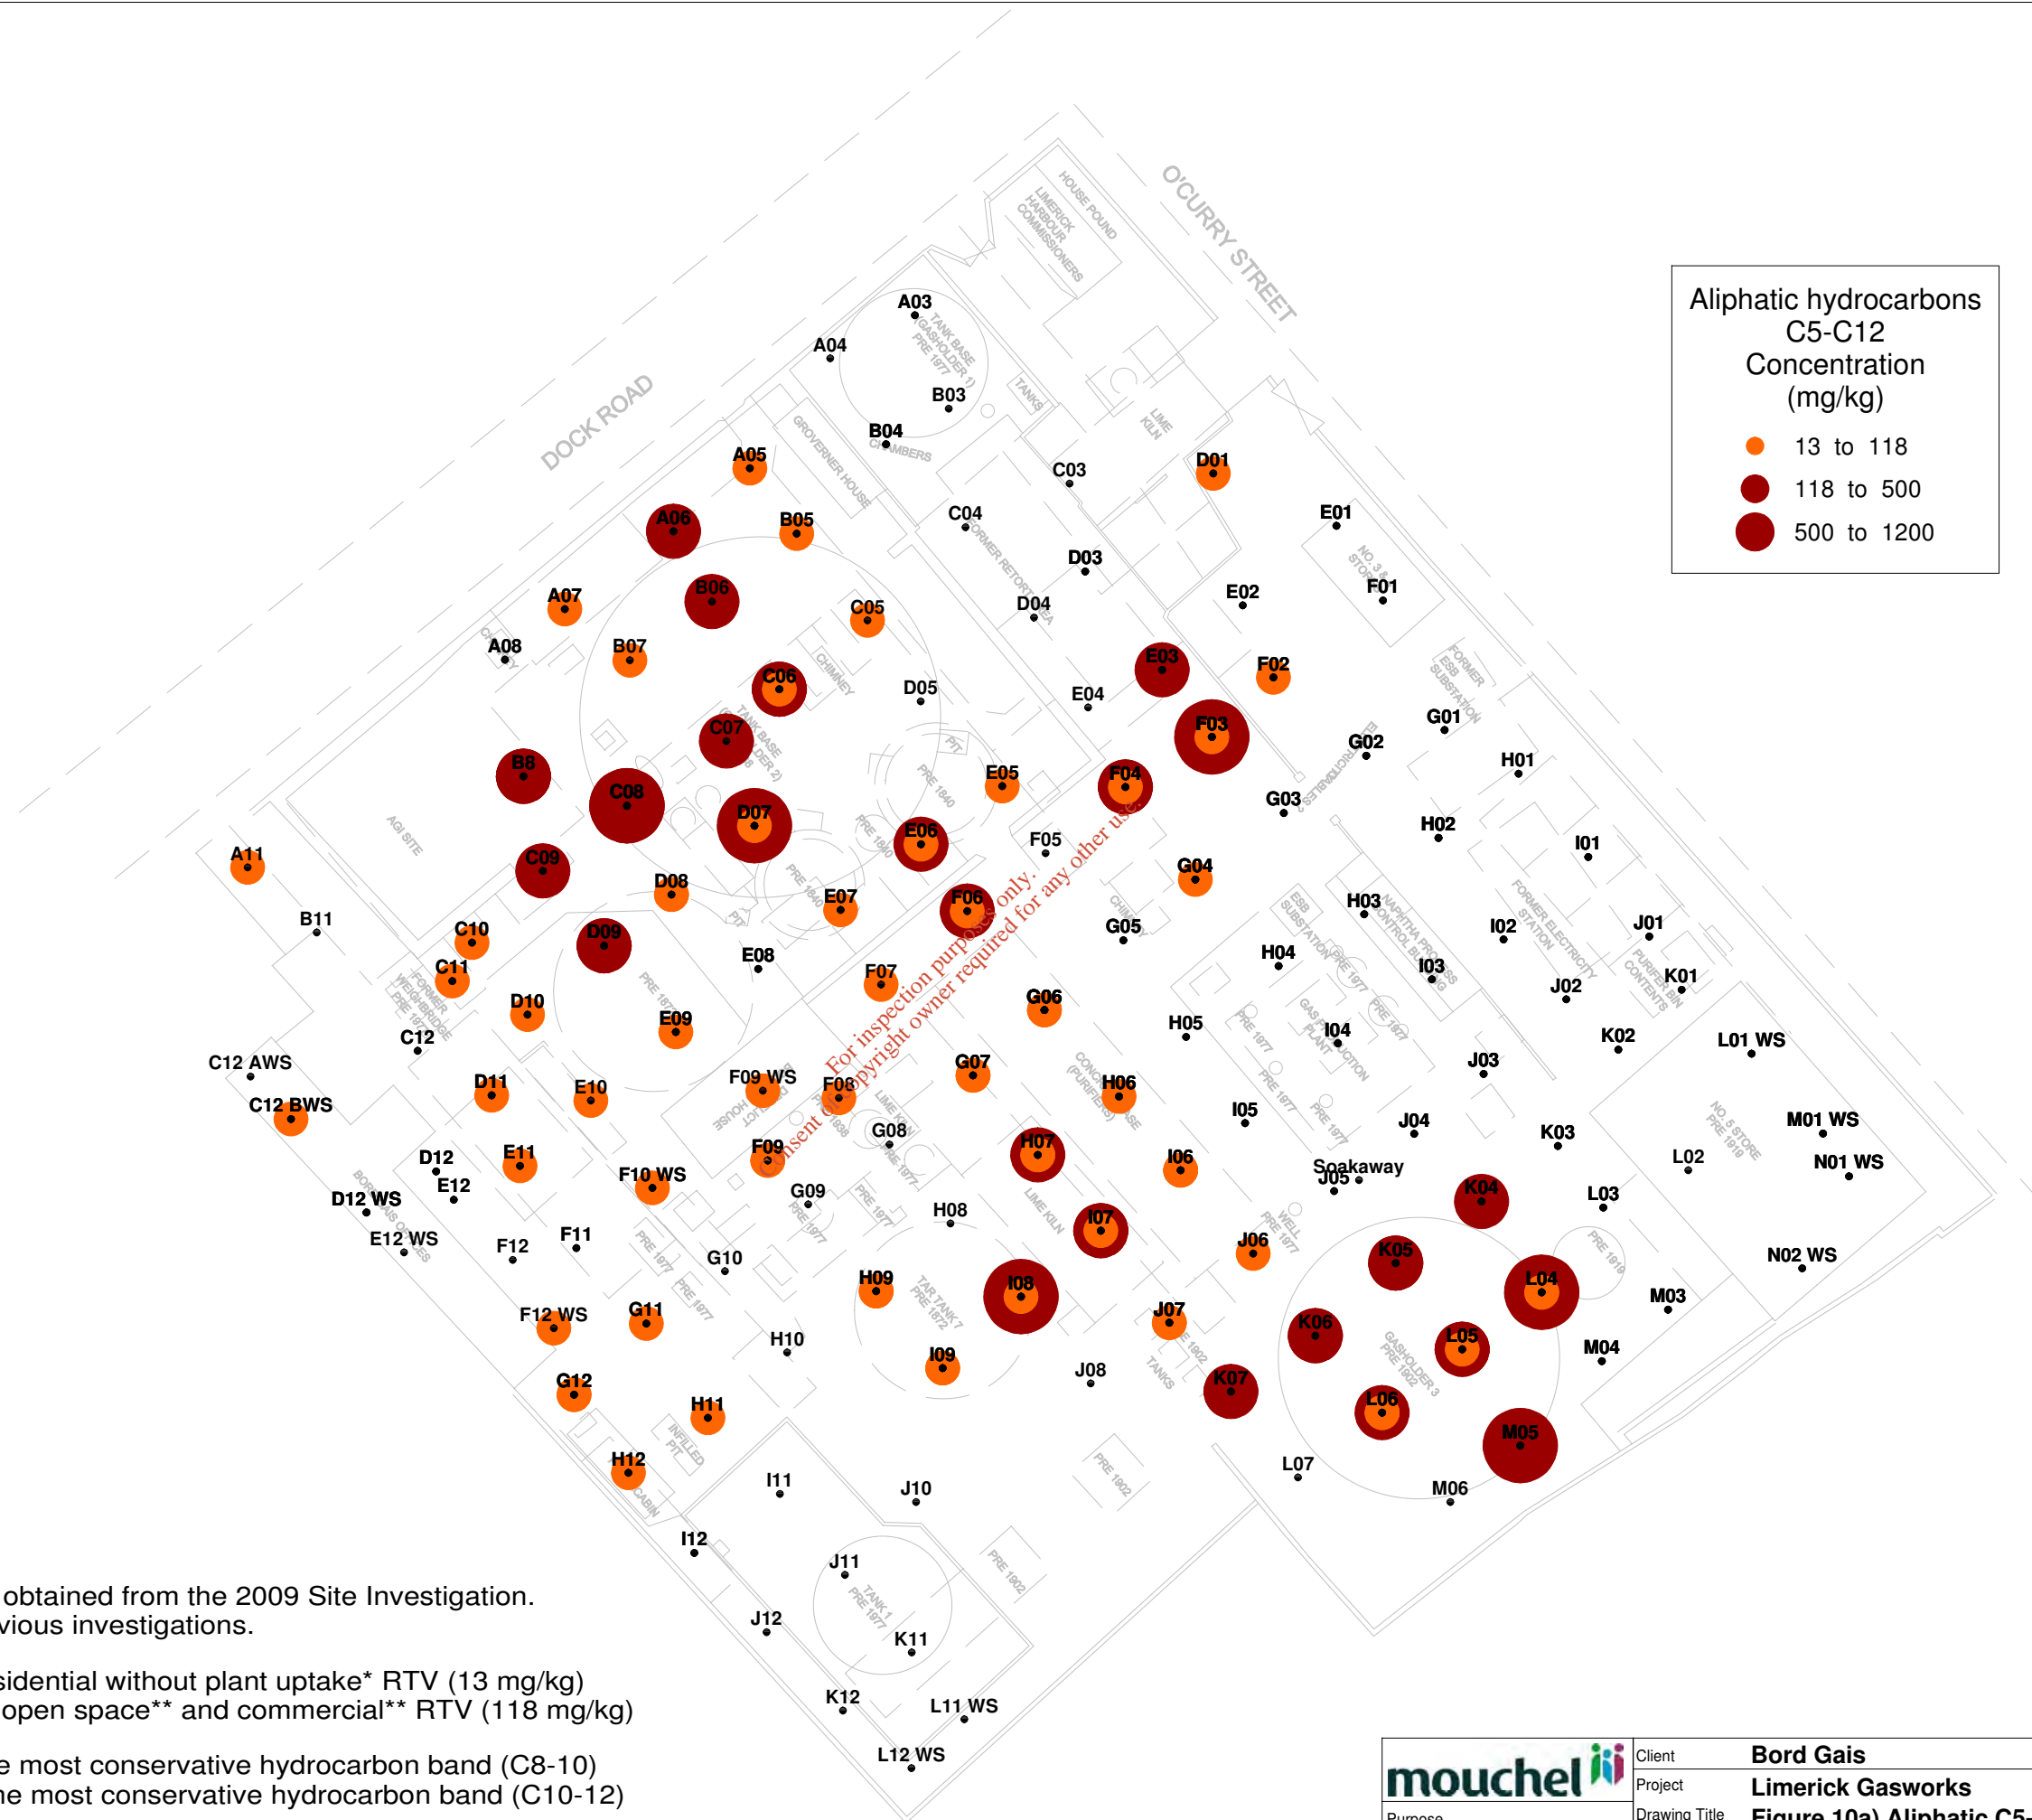
This plot was produced using data obtained from the 2009 Site Investigation. No data was included from the previous investigations.

Locations in orange exceed the residential without plant uptake\* RTV (13 mg/kg)  
Locations in red exceed the public open space\*\* and commercial\*\* RTV (118 mg/kg)
