**Former Gasworks  
Dock Road, Limerick**

**Quantitative Risk Assessment,  
Options Appraisal and Remediation**

Report No. 1021927/R/03

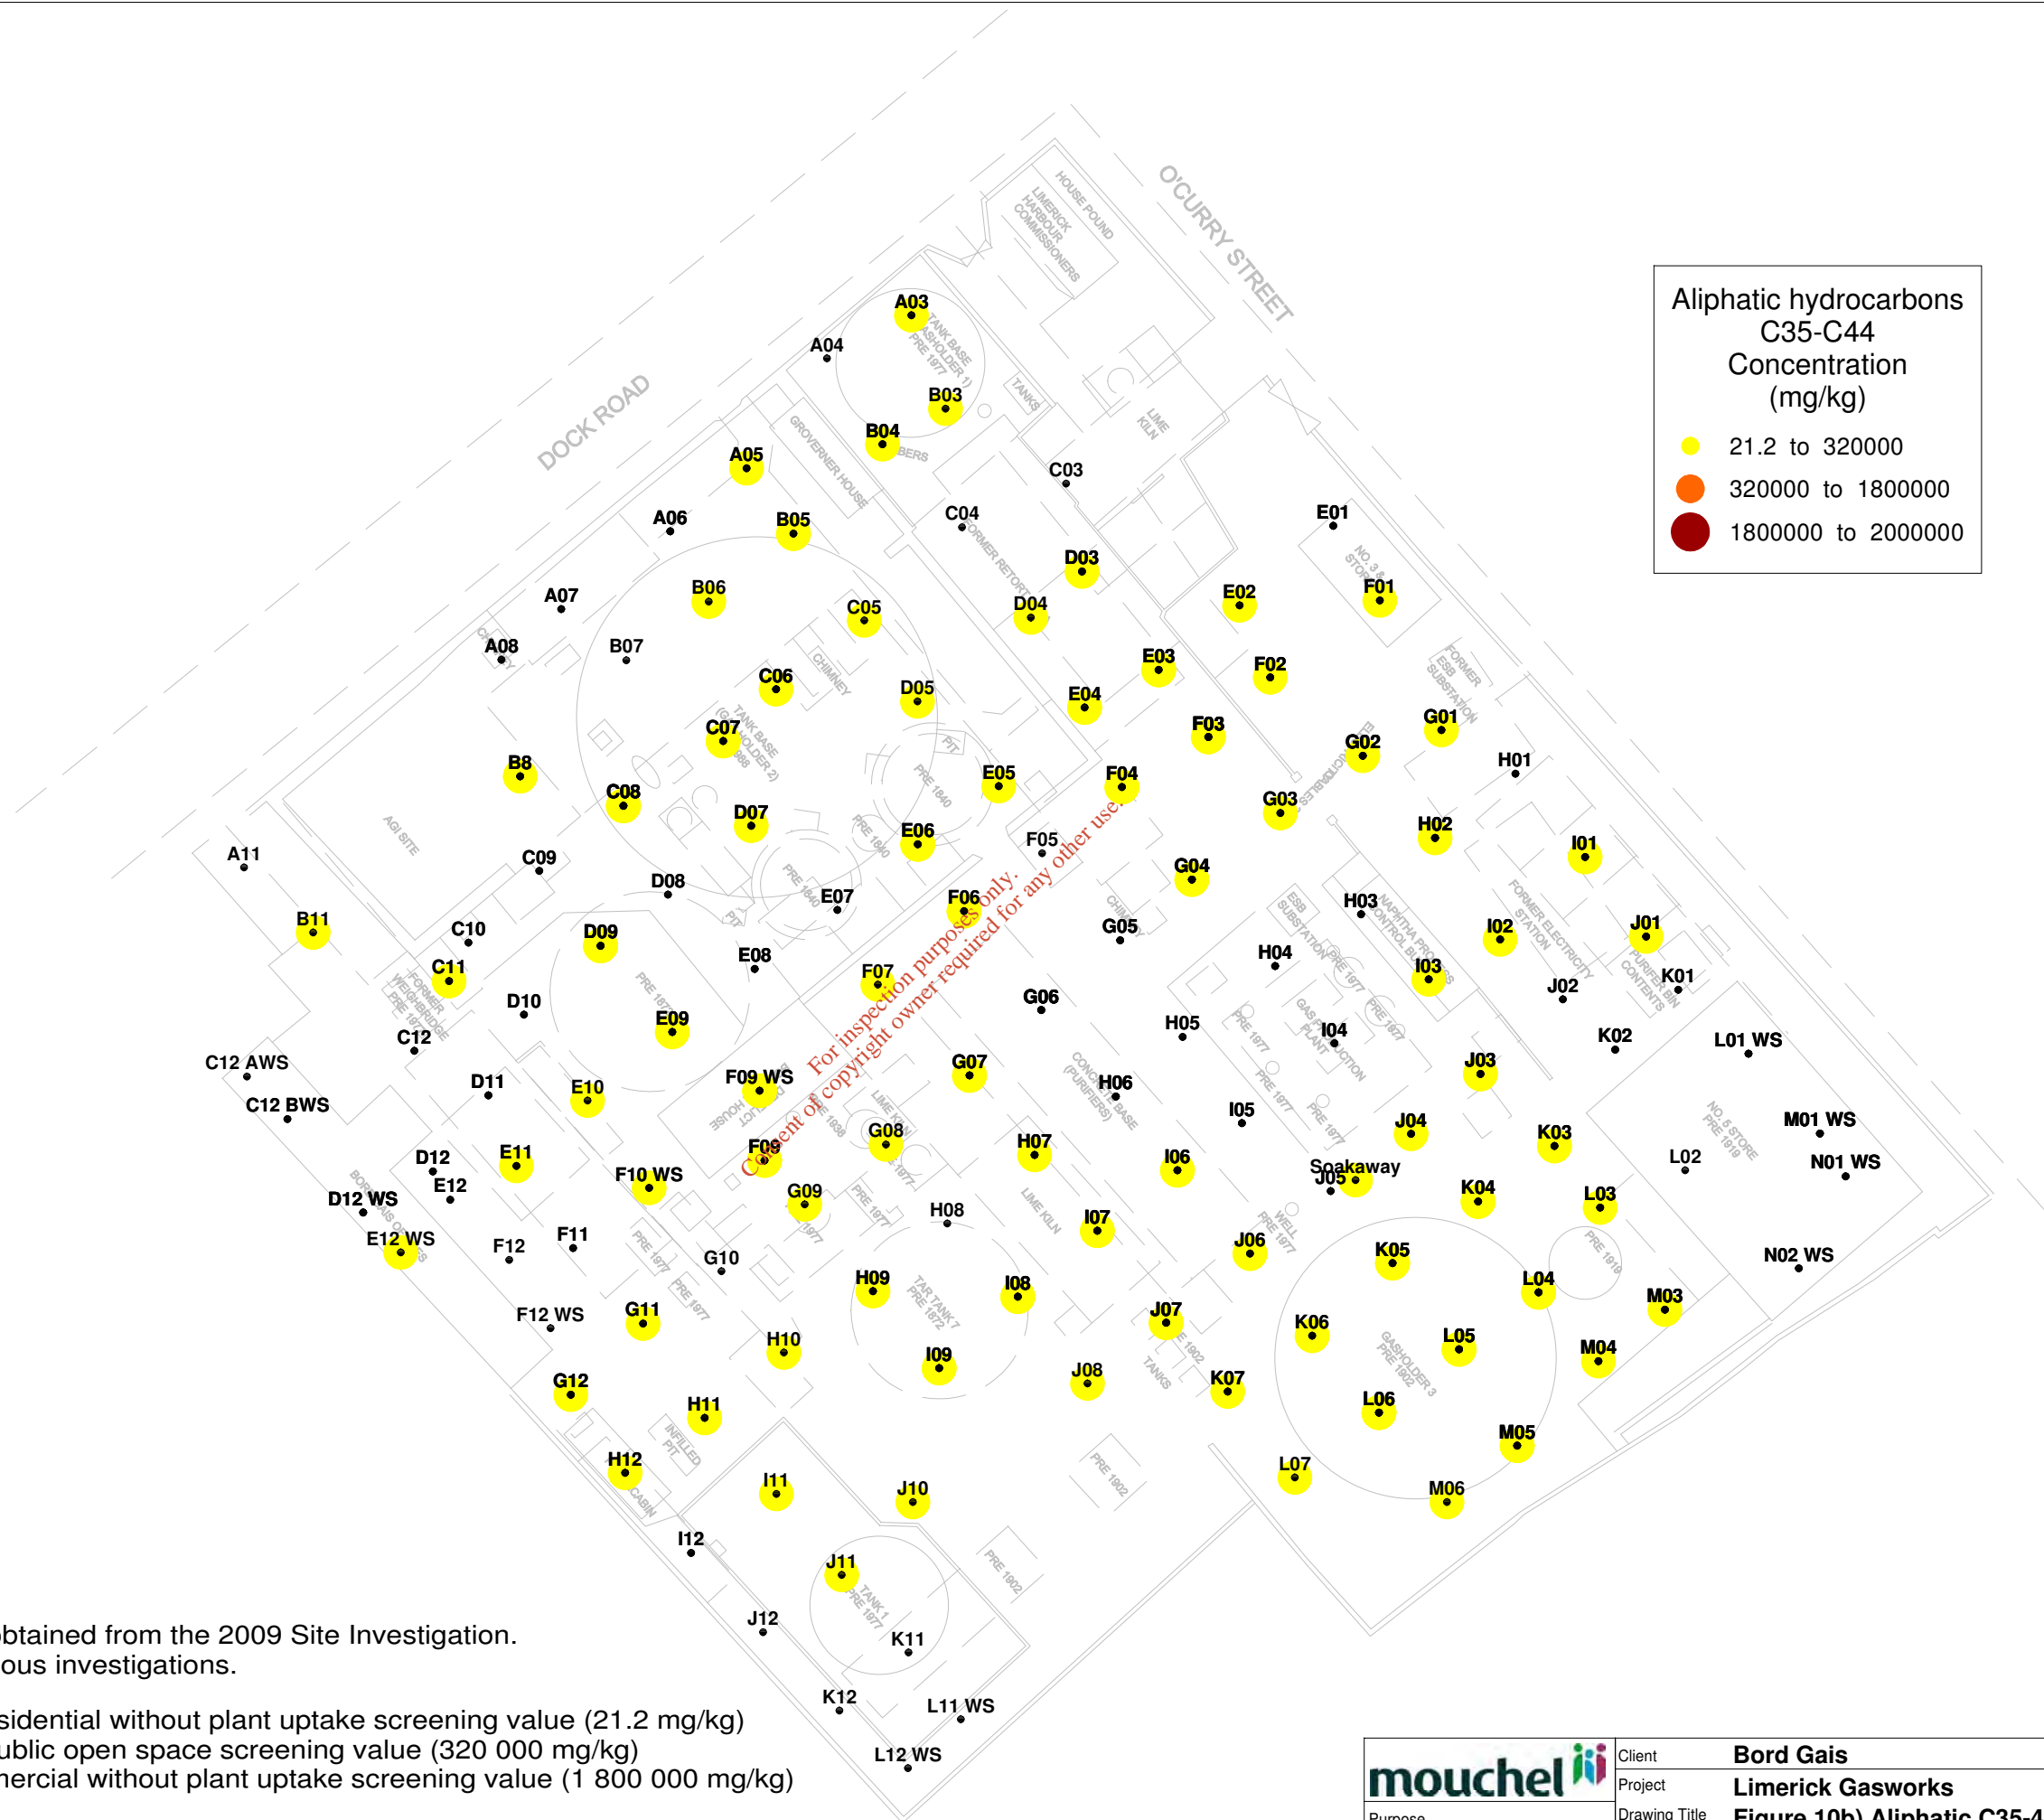
Client	<b>Bord Gais</b>		
	Project	<b>Limerick Gasworks</b>		
Purpose	Drawing Title	<b>Figure 10b) Aliphatic C35-44</b>		
<b>Information</b>	Scale	Issuing Office	Drawing Number	Version
	<b>Not to scale</b>	<b>Ellesmere Port</b>	<b>1021927/R03/010b</b>	<b>A</b>
	Telephone	<b>0151 356 5555</b>

This plot was produced using data obtained from the 2009 Site Investigation.  
No data was included from the previous investigations.

All locations in yellow exceed the residential without plant uptake screening value (21.2 mg/kg)  
All locations in orange exceed the public open space screening value (320 000 mg/kg)  
All locations in red exceed the commercial without plant uptake screening value (1 800 000 mg/kg)

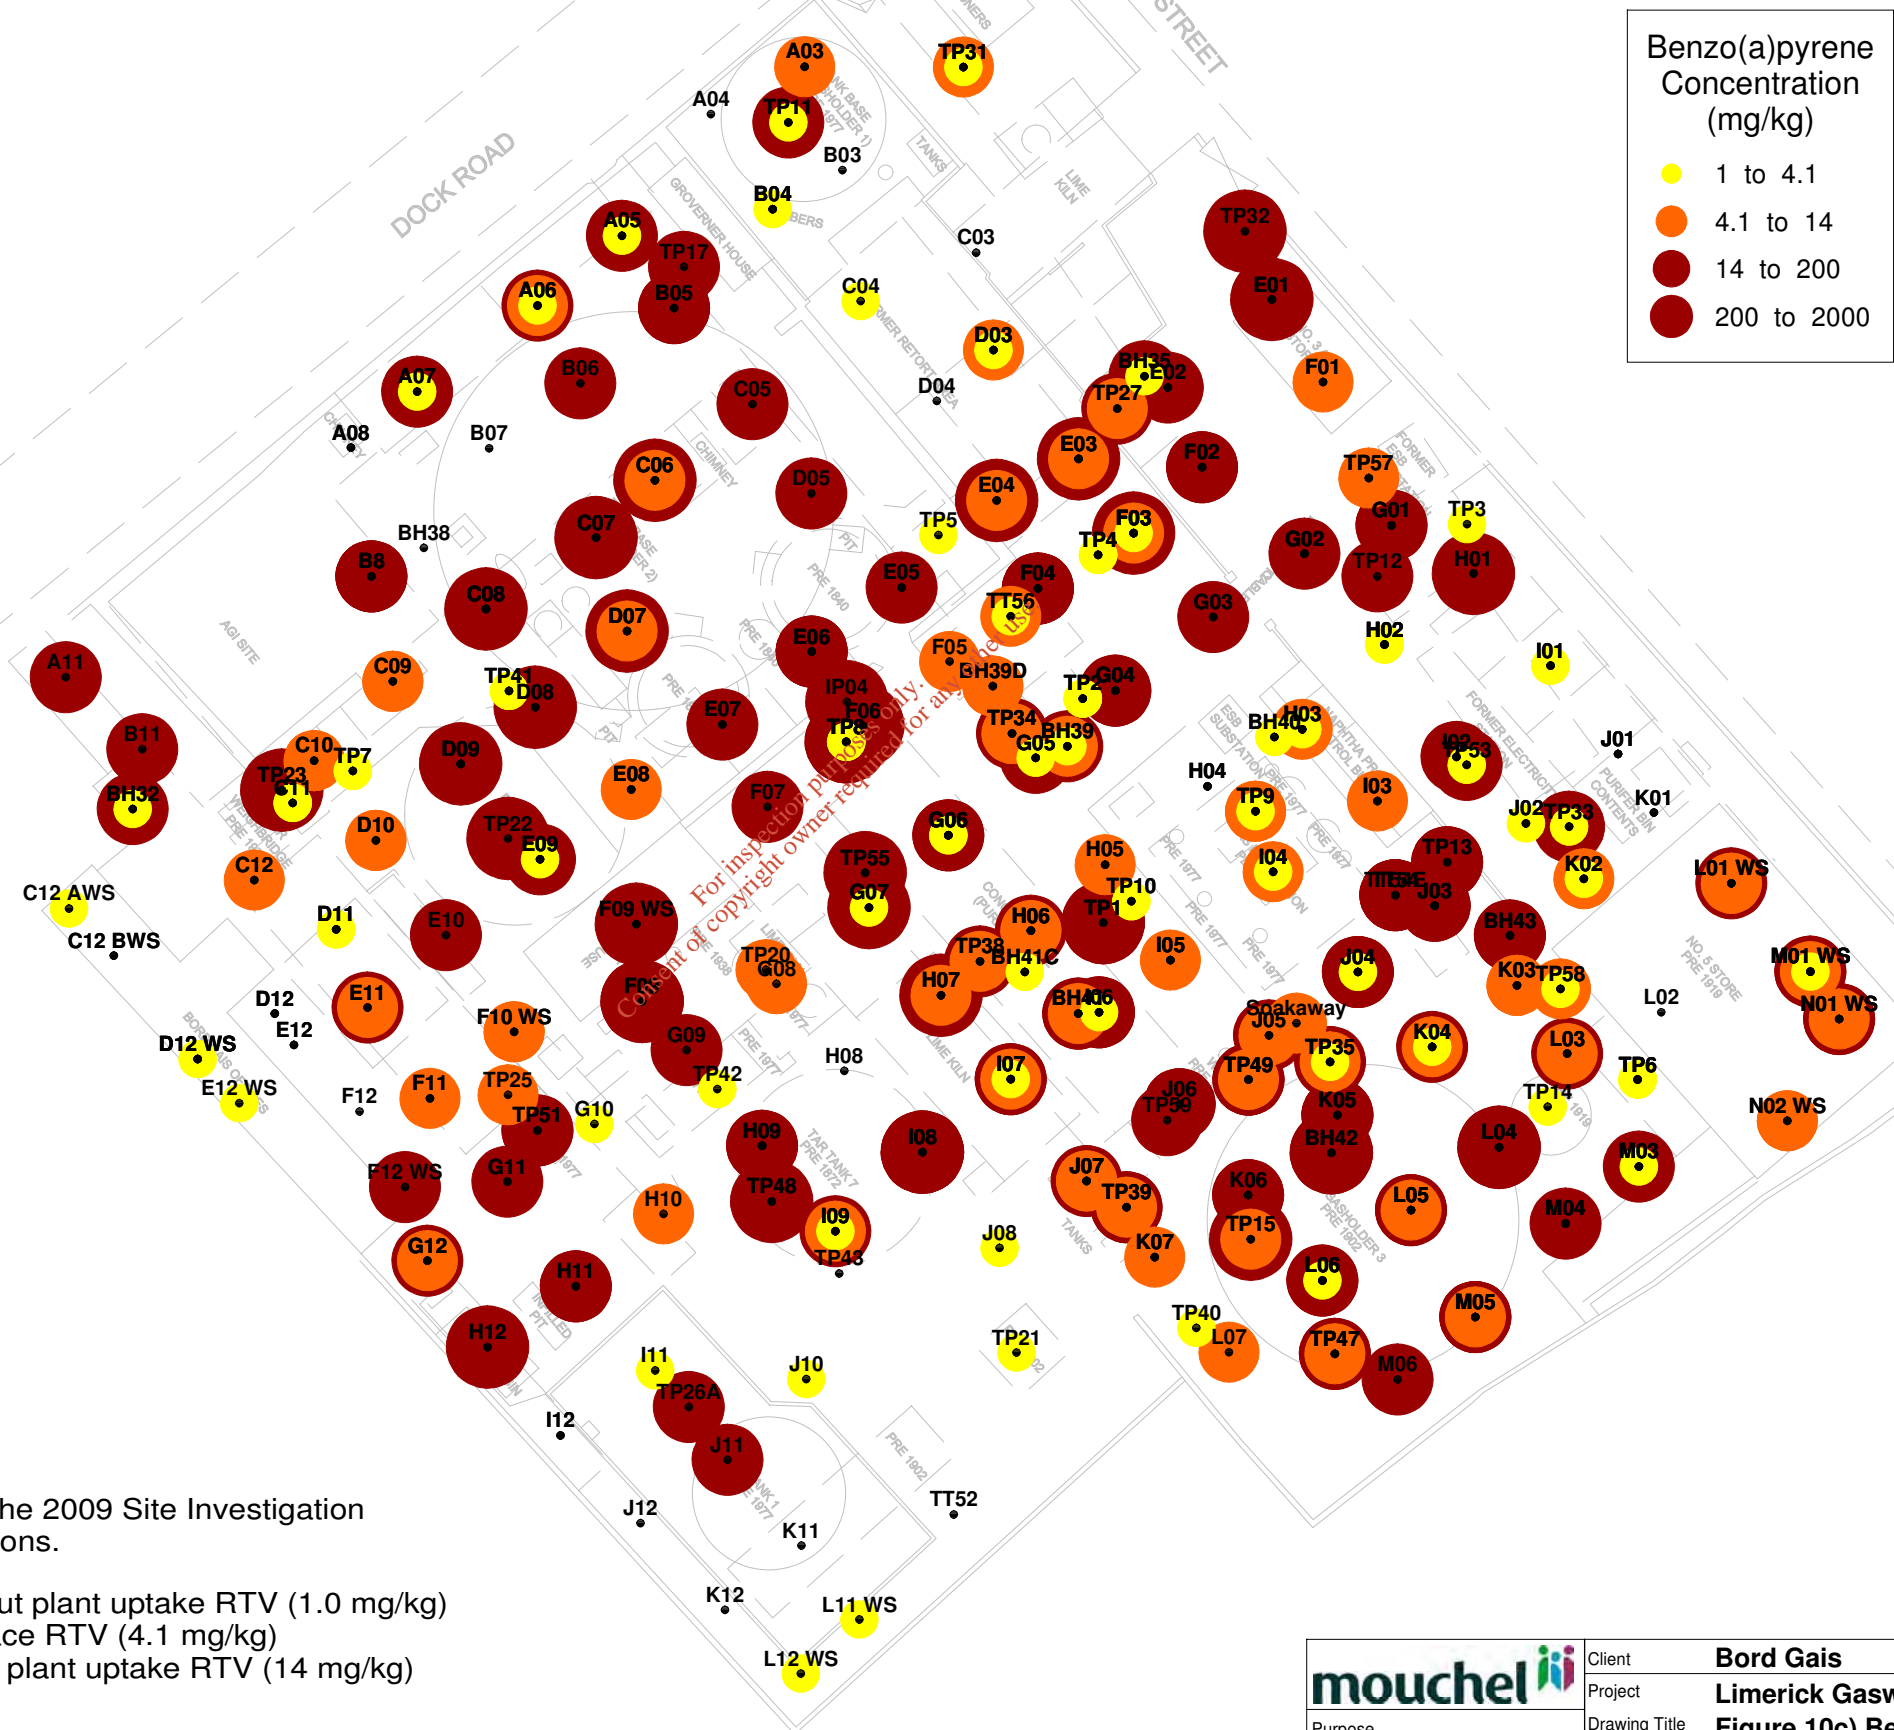
Client	<b>Bord Gais</b>		
	Project	<b>Limerick Gasworks</b>		
Purpose	Drawing Title	<b>Figure 10c) Benzo[a]pyrene</b>		
Scale	Issuing Office	<b>Ellesmere Port</b>	Drawing Number	Version
	Telephone	<b>0151 356 5555</b>	<b>1021927/R03/010c</b>	<b>A</b>

This plot was produced using data obtained from the 2009 Site Investigation and where applicable from the previous investigations.

All locations in yellow exceed the residential without plant uptake RTV (1.0 mg/kg)  
 All locations in orange exceed the public open space RTV (4.1 mg/kg)  
 All locations in red exceed the commercial without plant uptake RTV (14 mg/kg)

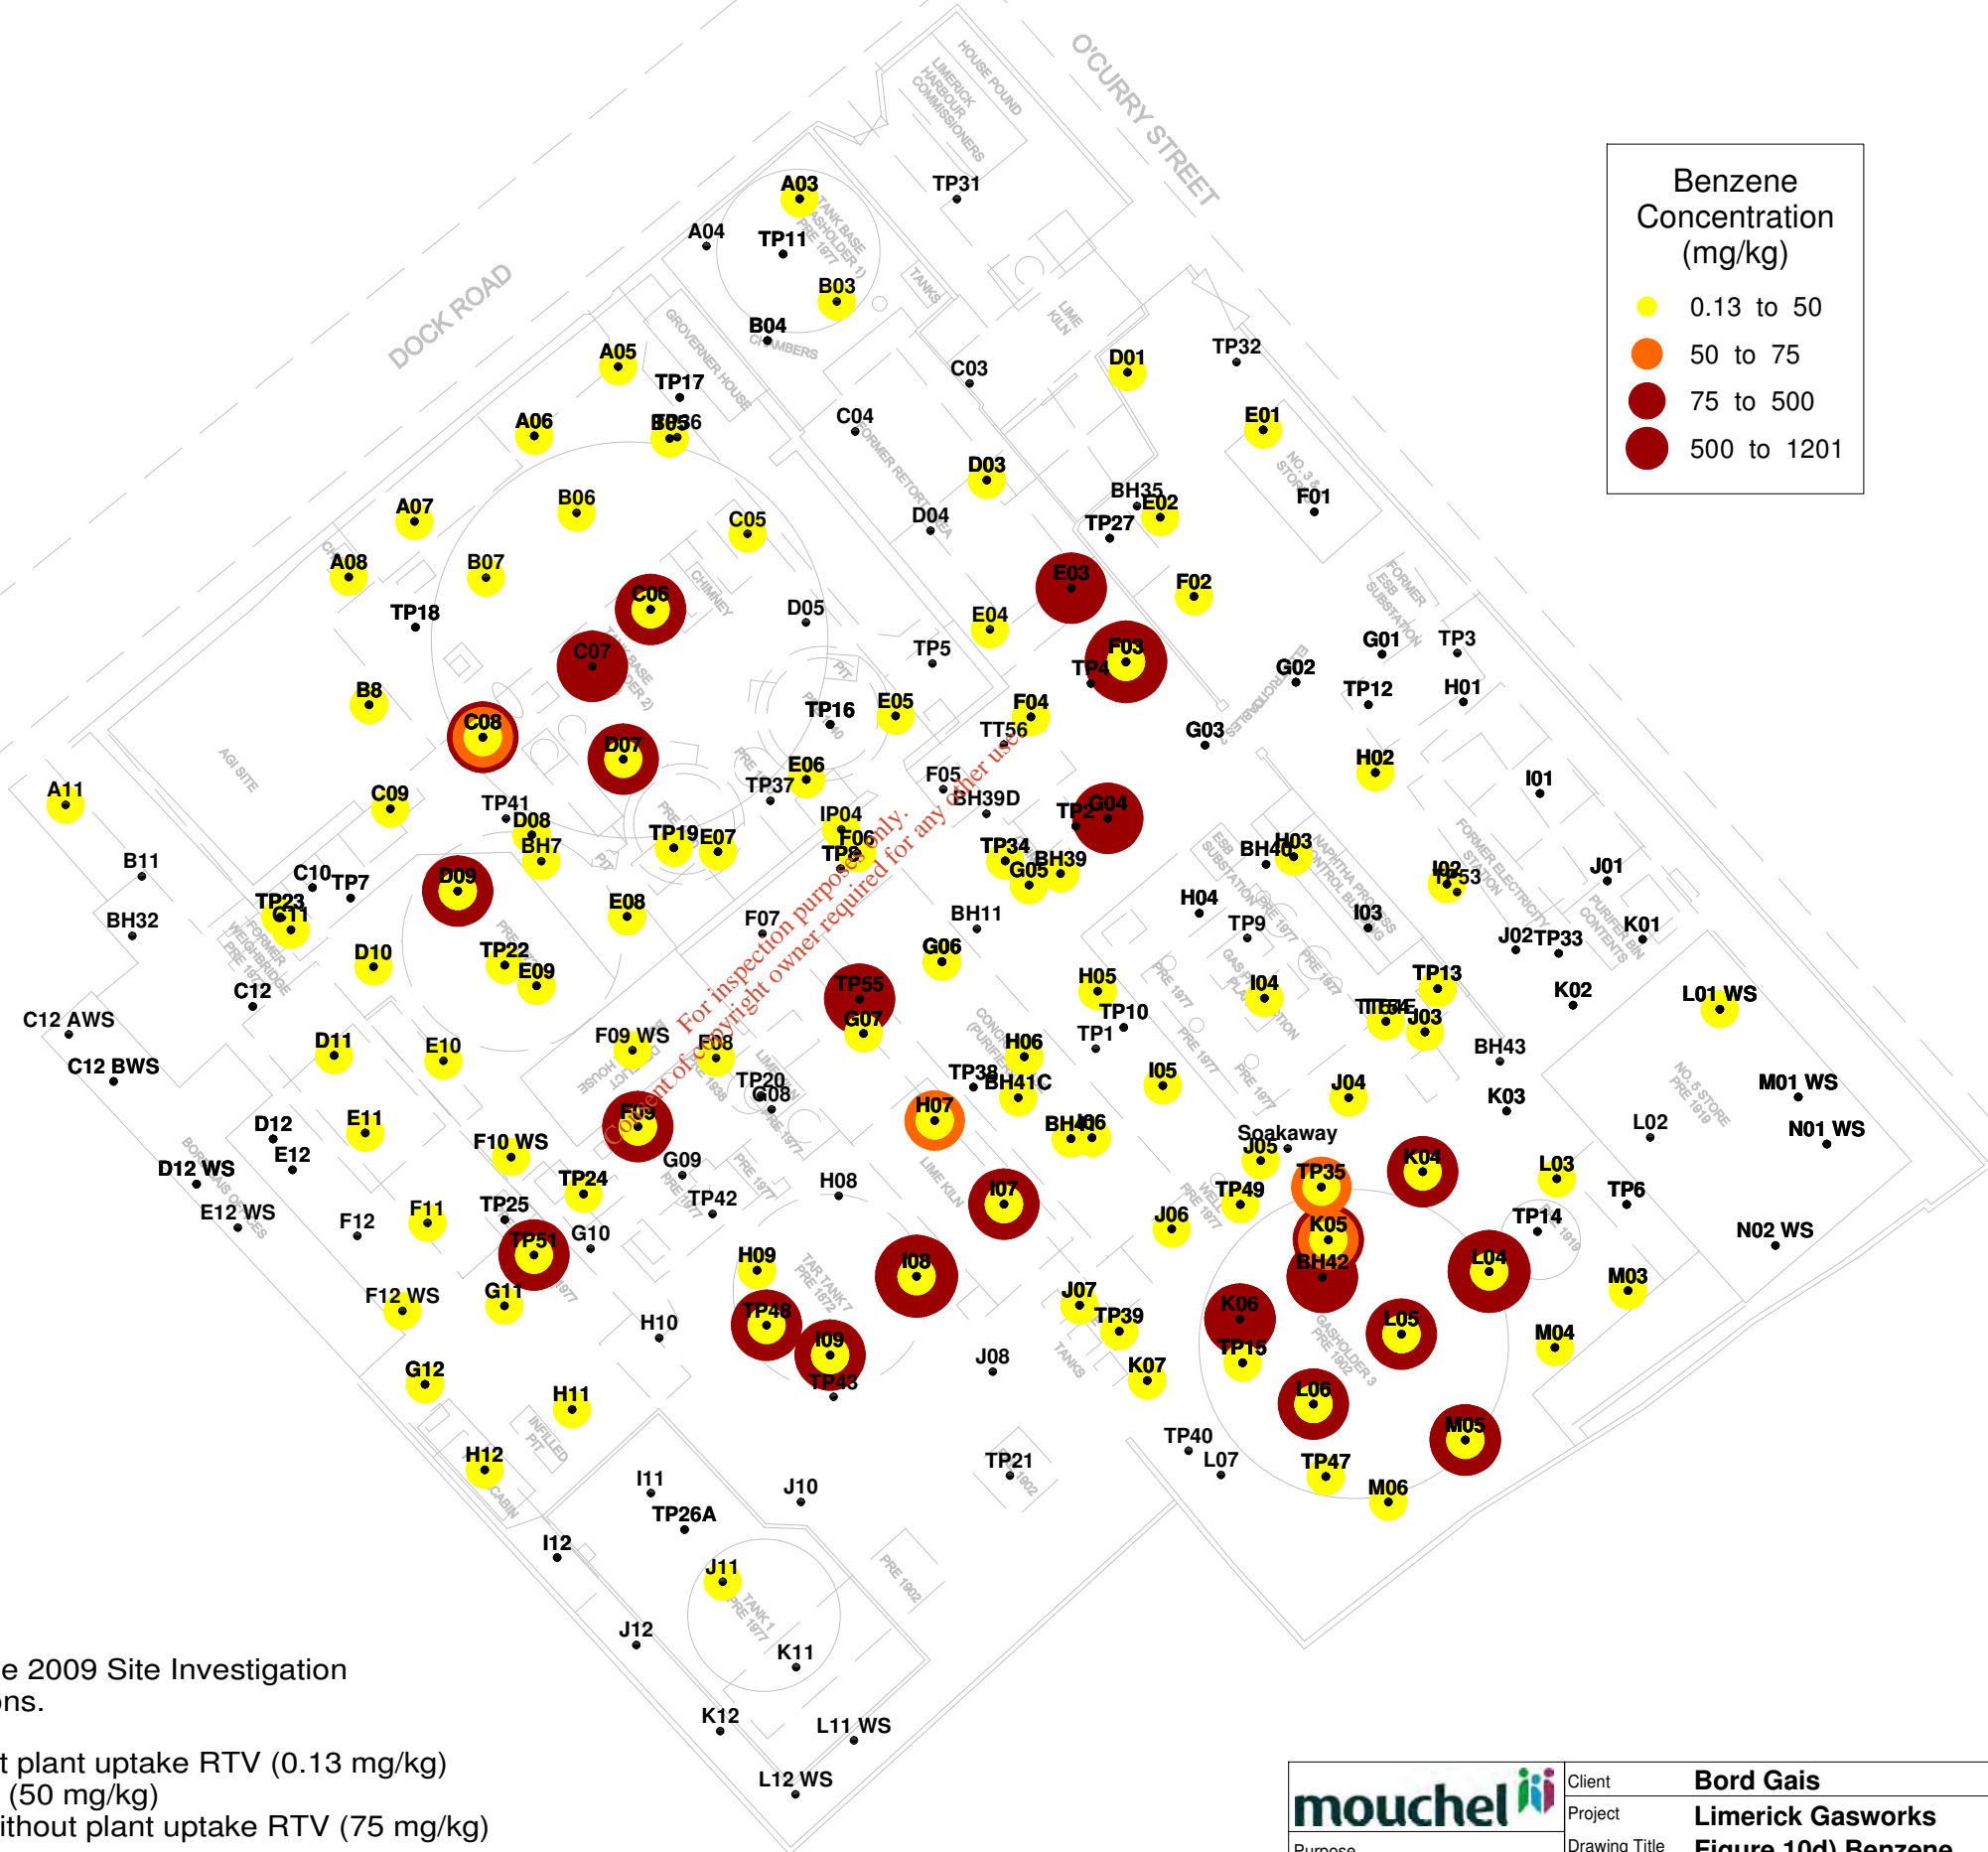
This plot was produced using data obtained from the 2009 Site Investigation and where applicable from the previous investigations.

All locations in yellow exceed the residential without plant uptake RTV (0.13 mg/kg)  
 All locations in orange exceed the commercial RTV (50 mg/kg)  
 All locations in red exceed the public open space without plant uptake RTV (75 mg/kg)

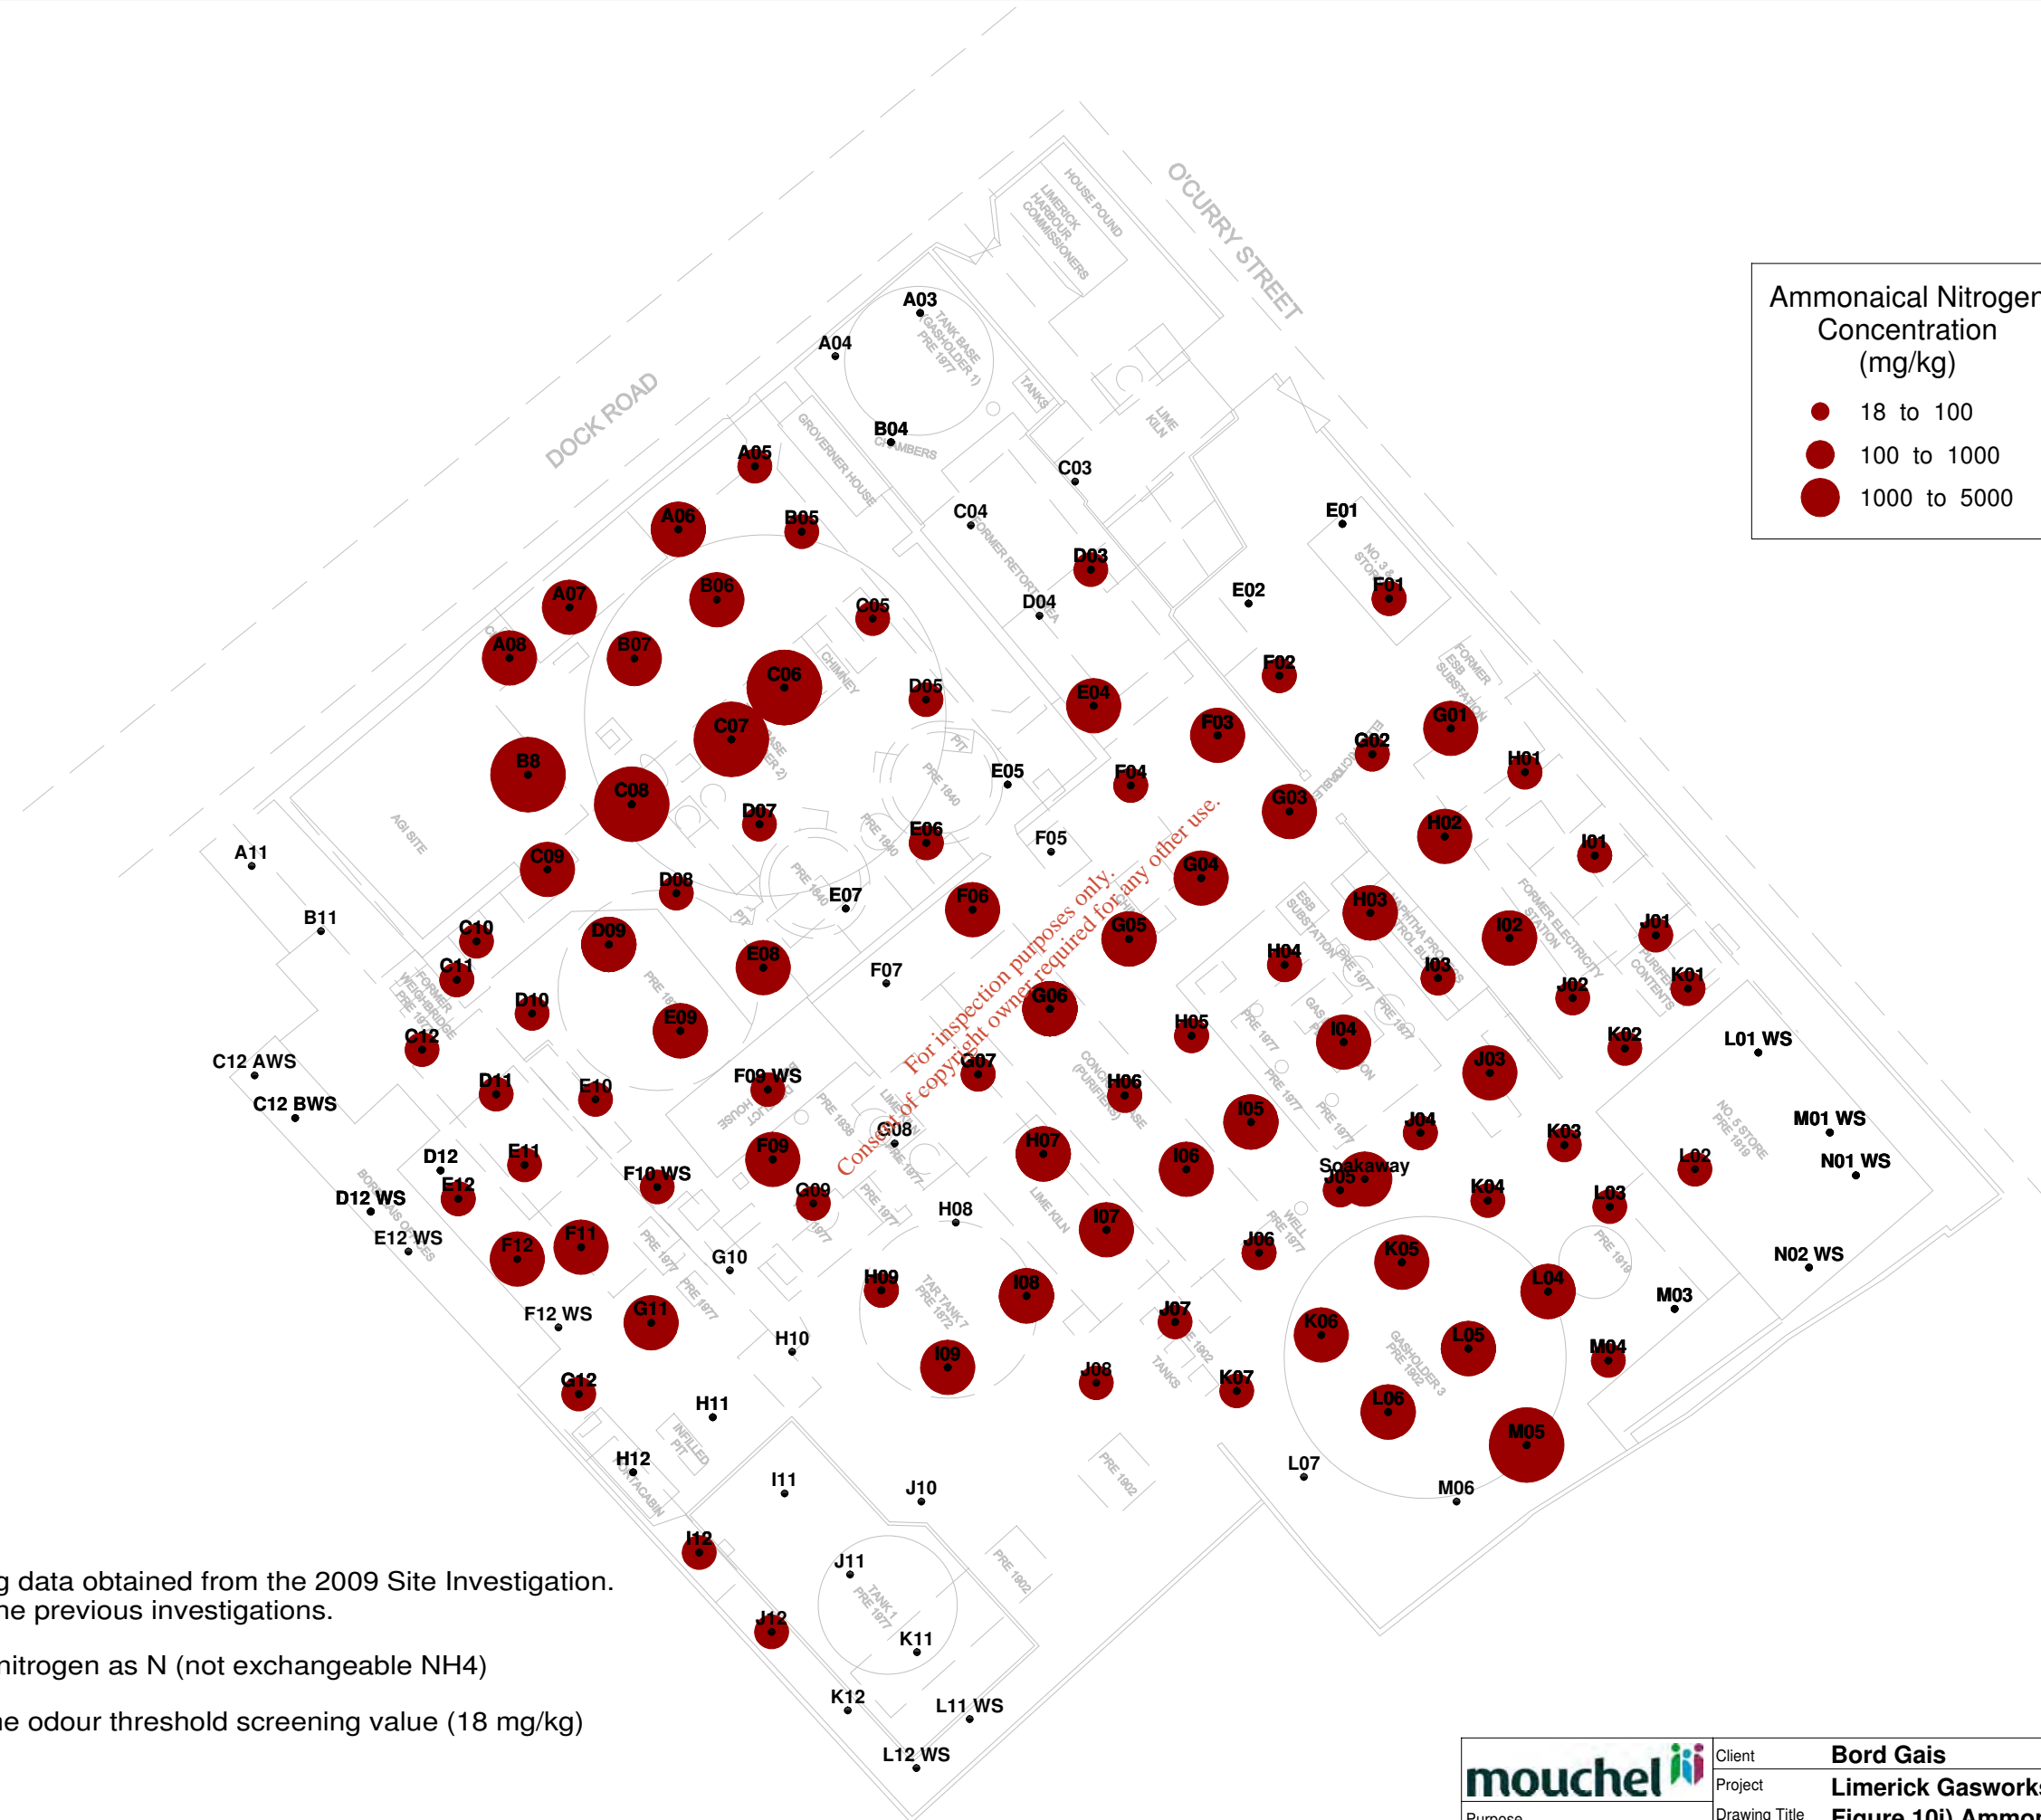
This plot was produced using data obtained from the 2009 Site Investigation. No data was included from the previous investigations.

Results are for ammonia nitrogen as N (not exchangeable NH4)

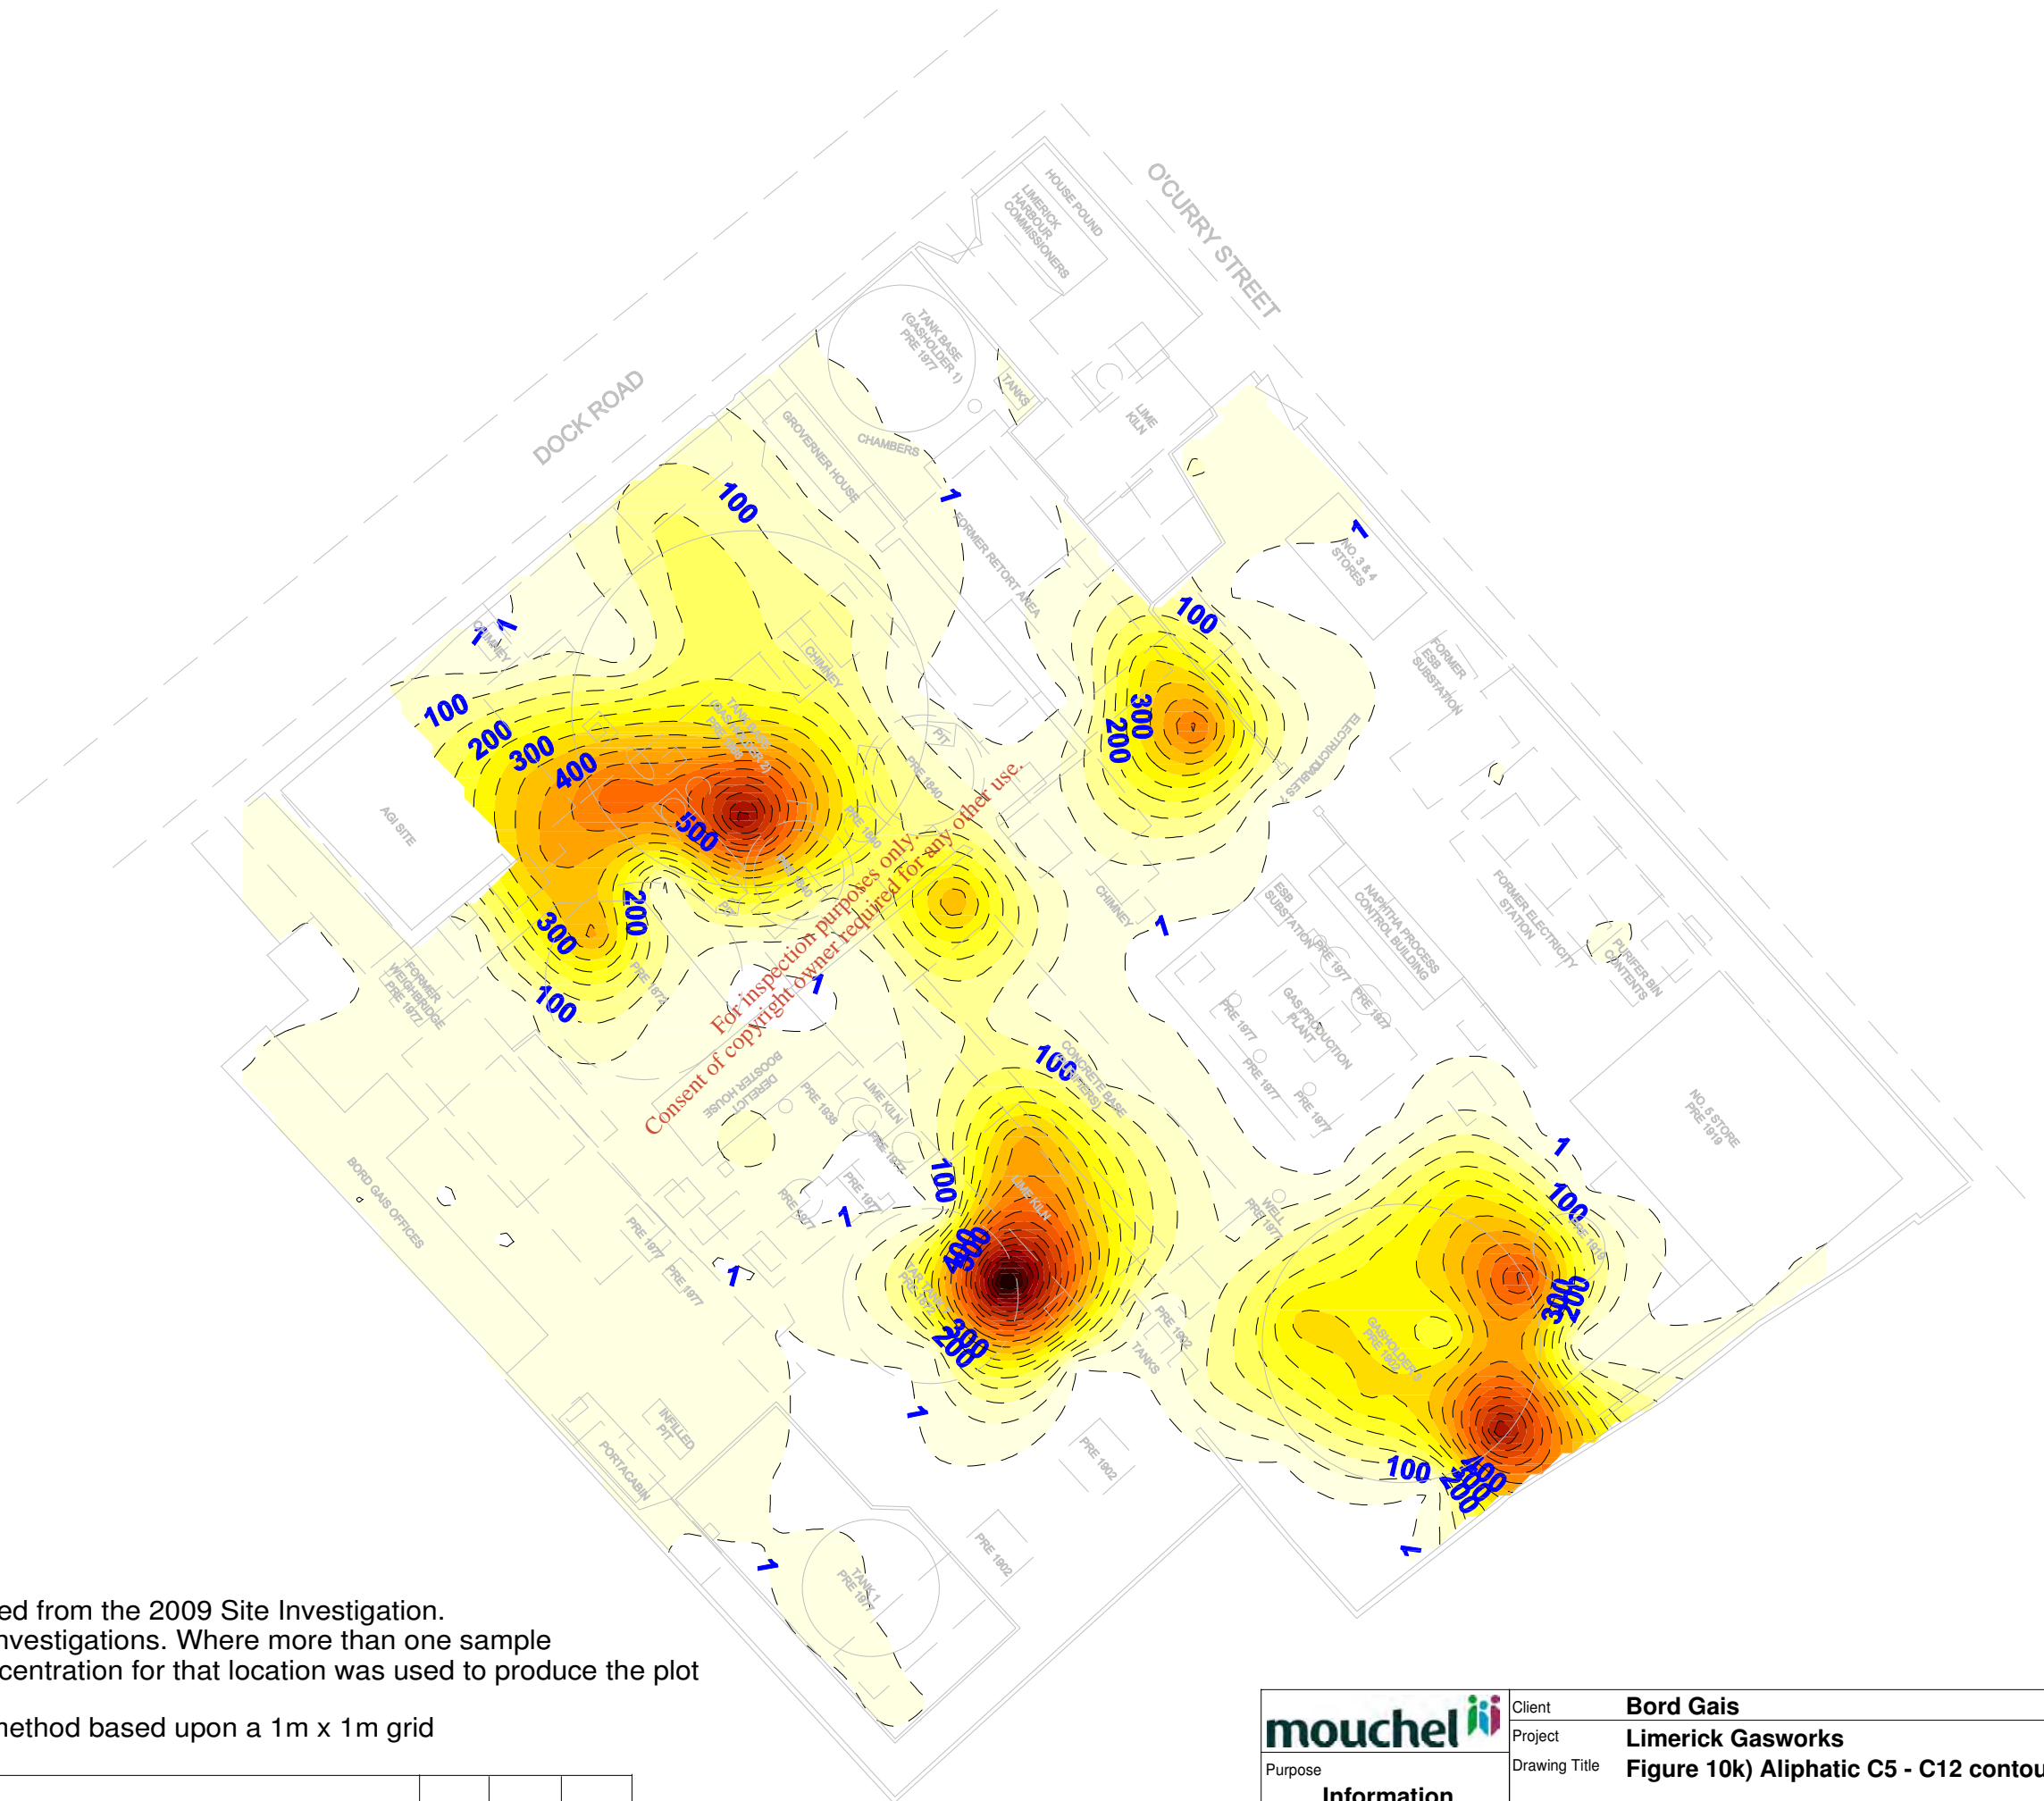
**Aliphatic C5-C12  
Concentration  
(mg/kg)**

This plot was produced using data obtained from the 2009 Site Investigation. No data was included from the previous investigations. Where more than one sample was obtained from a hole the highest concentration for that location was used to produce the plot

Contours were plotted using the Kriging method based upon a 1m x 1m grid

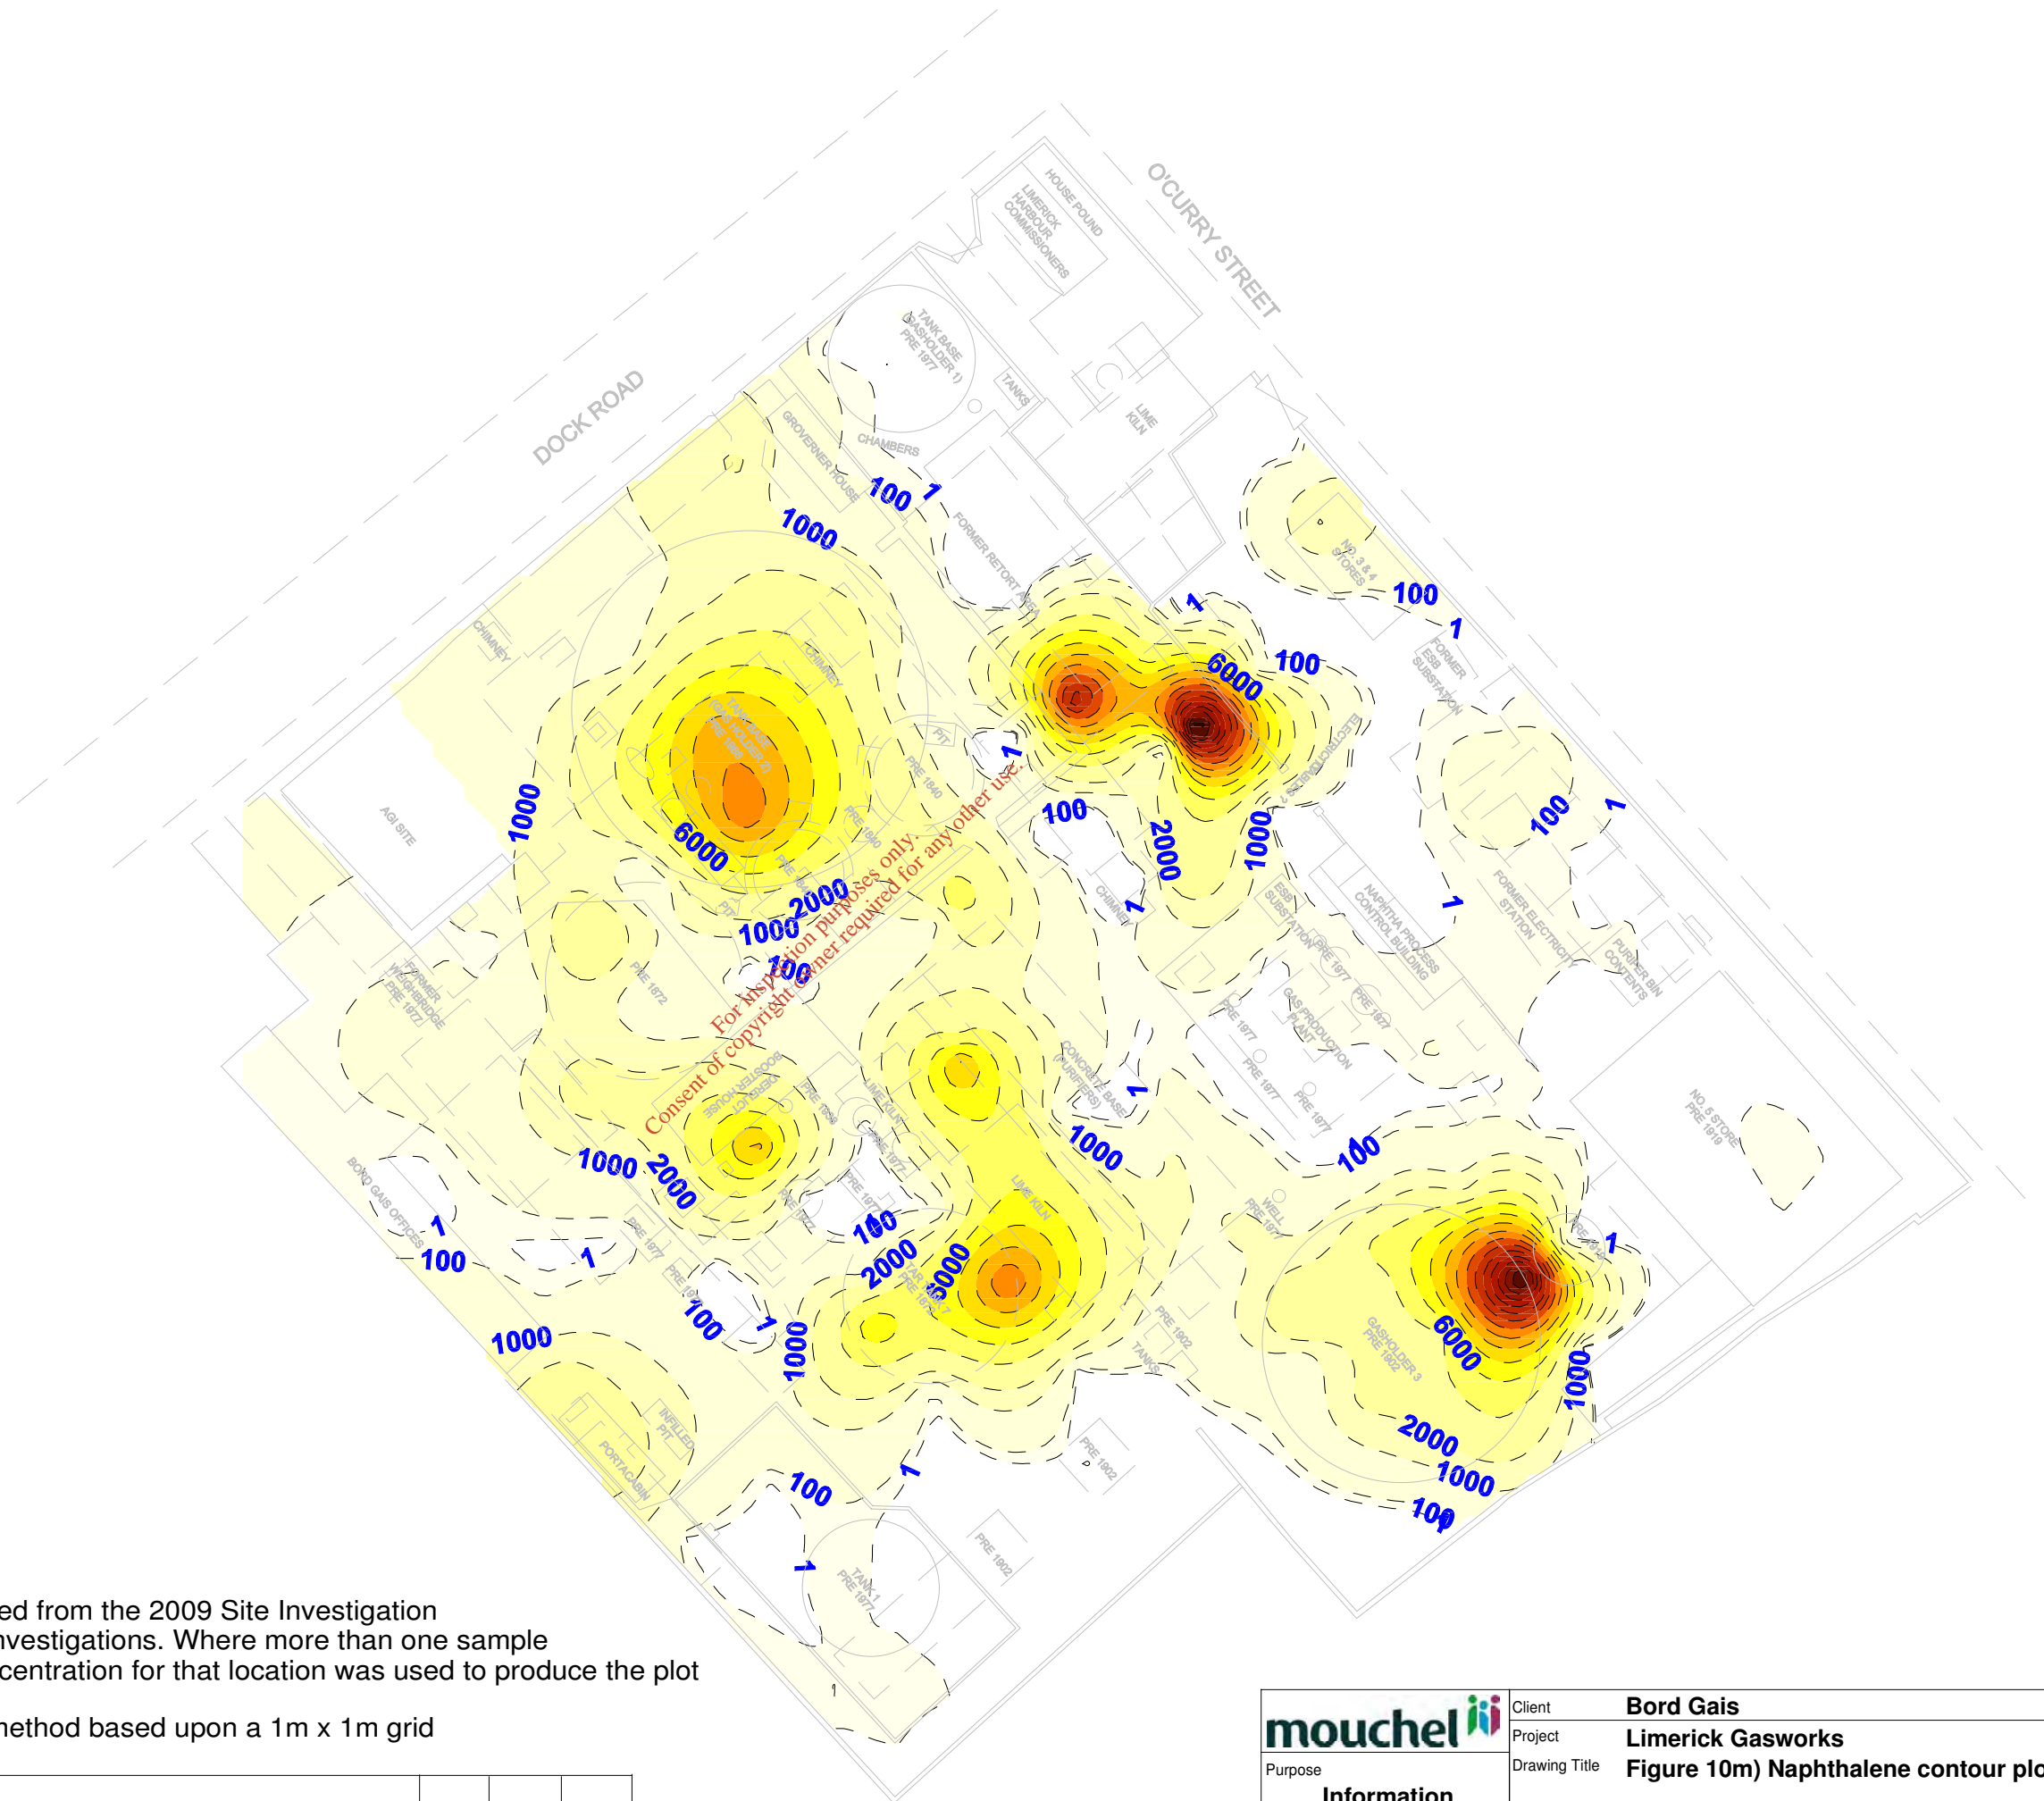
**Naphthalene Concentration (mg/kg)**

This plot was produced using data obtained from the 2009 Site Investigation and where applicable from the previous investigations. Where more than one sample was obtained from a hole the highest concentration for that location was used to produce the plot

Contours were plotted using the Kriging method based upon a 1m x 1m grid
