KINSALE ROAD LANDFILL SITE

Waste Licence Register No: W0012-03

Annual Environmental Report

January 2011 ó December 2011

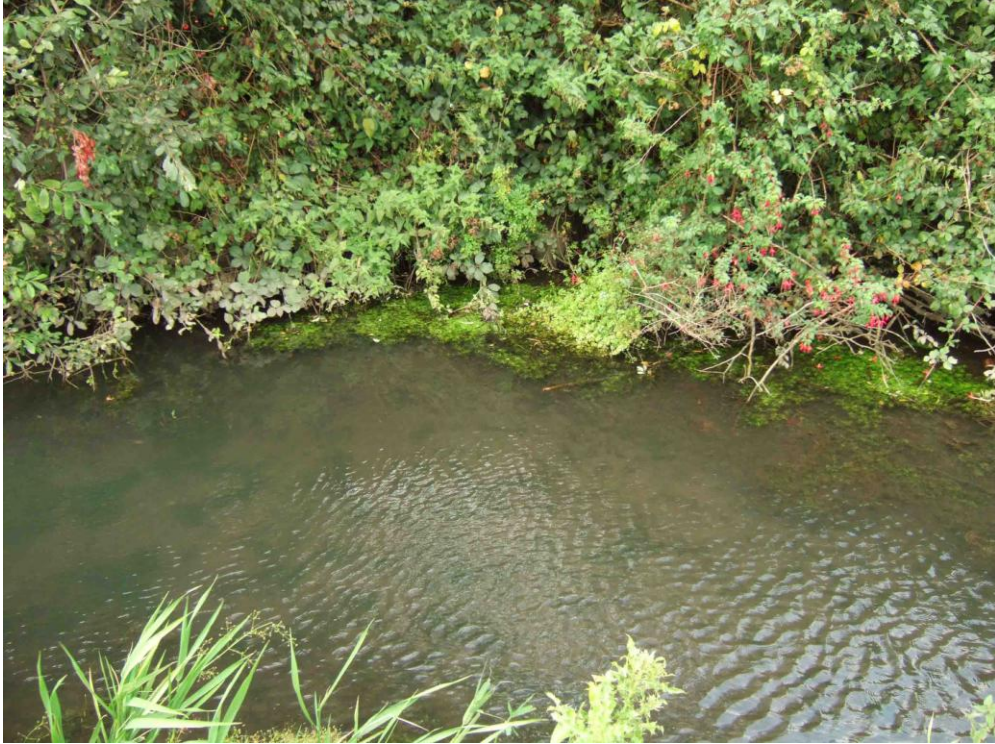
Plate 1 Trabeg River: Site A - 23-09-2011

There was no perceptible flow at the site, and it retained a muddy bottom which had a loose cover of filamentous green algae (~5%) (Plate 1). Water was slightly turbid. The near total cover of Water Starwort (*Callitriche* sp.) of 2010 was now confined to the margins where it ranged from 15-20% cover on the left bank and ~5-10% cover along the right bank. Small amounts of Water plantain (*Alisma plantago-aquatica*) and Hemlock water dropwort (*Oenanthe crocata*) were also noted. These conditions are similar or slightly improved on last year. Net-sweeps through the aquatic vegetation and surface sediment were dominated by chironomid midge larvae (Tanypodinae with some *Chironomus*), with occasional, *Asellus*, juvenile Water boatmen (Corixidae sp.), snails (*Lymnaea peregra*), *Baetis* and stickleback. Overall, while the flow conditions and substrate were not suitable for assigning a Q-value, the conditions would point to a Q-rating of around Q2 to Q2-3, i.e. similar to last year.

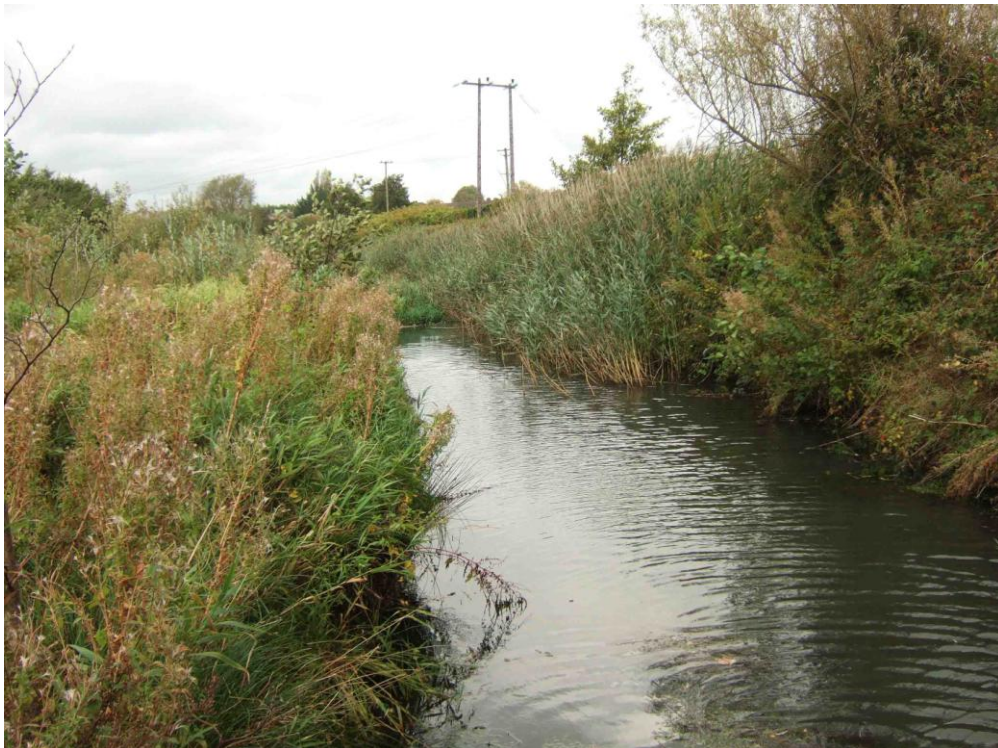
Plate 2 Trabeg River: Site B (view of channel) 23-09-2011

This site is like Site 1 in being a very slack flow site dominated by a muddy bottom and also with a slight cloudiness in the water on the day. There was no out-gassing from the muddy sediment noted at the time. In-channel submerged plant cover was lower than in 2010 with just 5-10% cover of *Callitriche* sp. Filamentous green alga was locally abundant on the sheltered margins of the left bank, while a narrow-leaved pondweed (*Potamogeton* sp.) was also noted at the site. *Apium* occurred occasionally at the margins. The left bank was dominated by Willow, backing bramble, grass, occasional hedge bindweed and Water figwort, with clumps of *Phalaris* at the water's edge. Common reed (*Phragmites*) was present on the same side of the channel about 30m upstream (Plate 2). The right bank included a range of herbaceous species including *Phalaris*, hard rush (*Juncus inflexus*), thistle, *Angelica*, great willow herb (*Epilobium hirsutum*) and water pepper (*Persicaria hydropiper*). Scattered small willow were also present.

Nets-weeps through submerged vegetation and the sediment surface were dominated by *Asellus*, with frequent juvenile water boatmen (Corixidae), *Lymnaea peregra* and planorbid snails, chironomid midges (*Chironomus* and Tanypodinae) and an unidentified leech. Like Site A, the conditions were unsuitable for Q-ratings,

because of the muddy substrate and almost standing water conditions. Conditions were similar to last year and Q-rating of Q2 to Q2-3 is suggested.

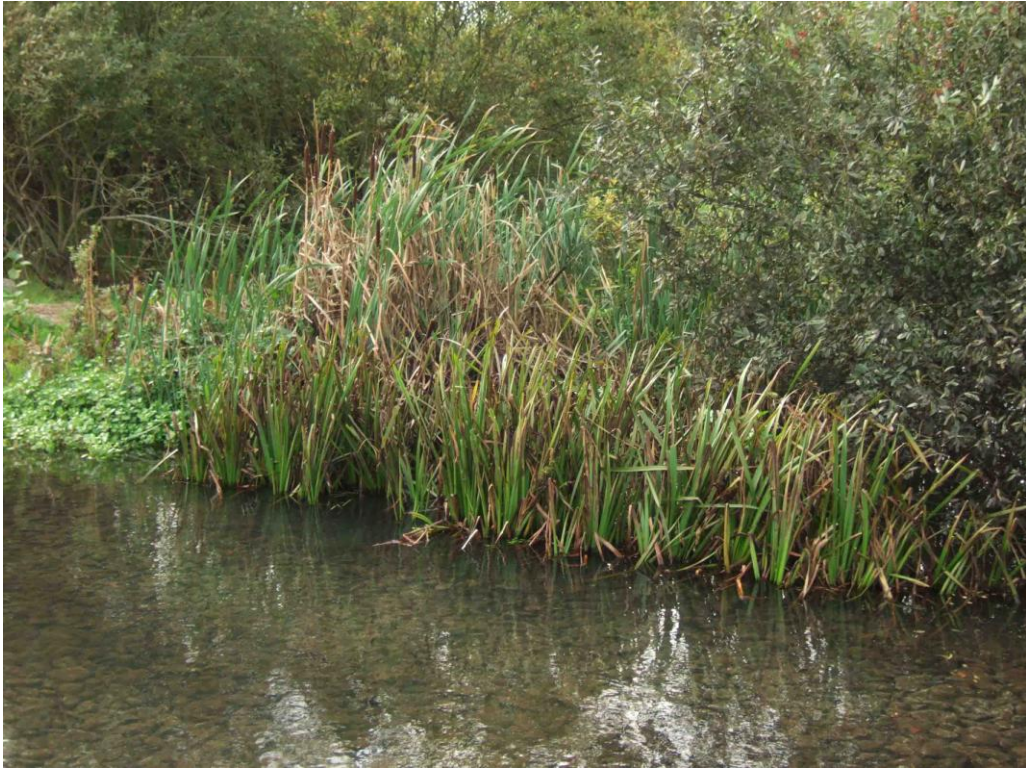
Plate 3 Tramore River: Site C (view upstream) showing emergent *Sparganium* and *Typha* blocking the channel. Note new cobble at ford in the foreground. 23-09-2011

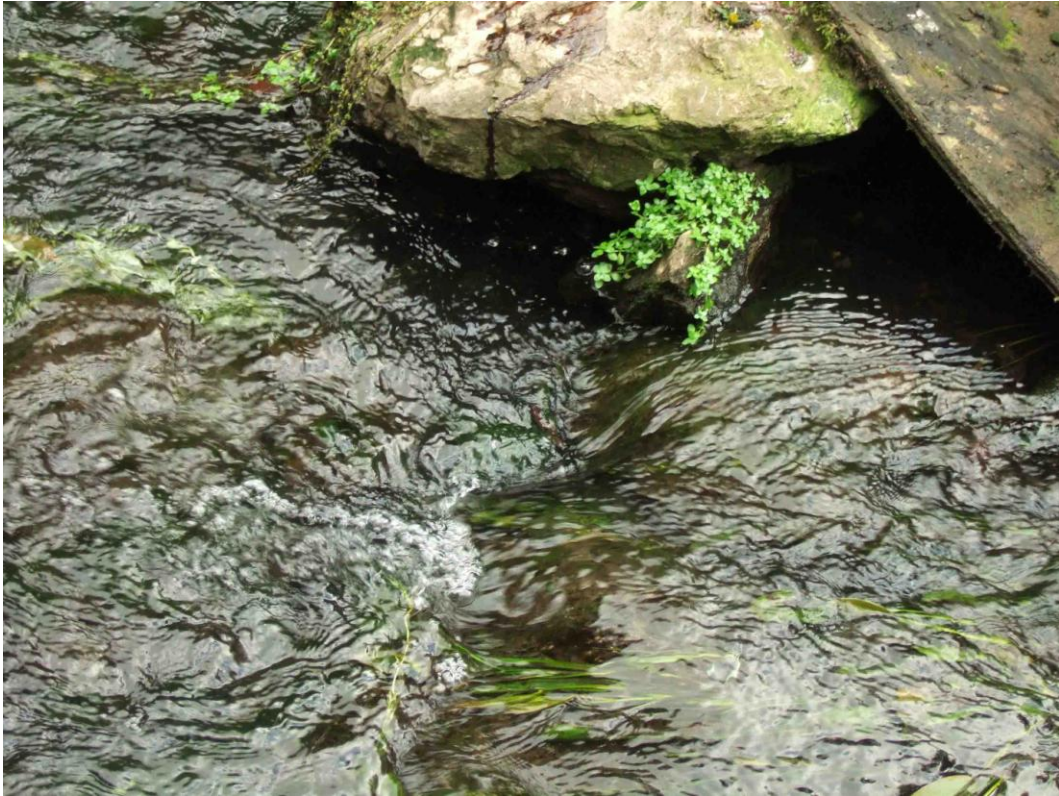
Plate 5 Tramore River: Site D (view of submerged 'weir') 23-09-2011.

The sampling point is at a constriction in the river where the channel flows over a small loose limestone boulder weir (Plate 5) immediately downstream of a sluggish stretch, which was dominated by Broad-leaved Pondweed (80-90% cover) and Fool's watercress (*Apium nodiflorum*) 5-10% cover. The left bank margin had a loose stand of *Typha* and Woody nightshade (*Solanum dulcamara*), while the left bank proper had nettle, great willow herb, Himalayan balsam (*Impatiens glandulifera*) and grass backed by willow and alder. The right bank was dominated by grass, Great Willowherb (*Epilobium hirsutum*) nettle and hedge bindweed backed by willow and alder. About 5-10% filamentous green algal cover (*Cladophora*) are common on the stones of the semi-submerged 'weir', *Callitriche stagnalis* was also present on the weir.

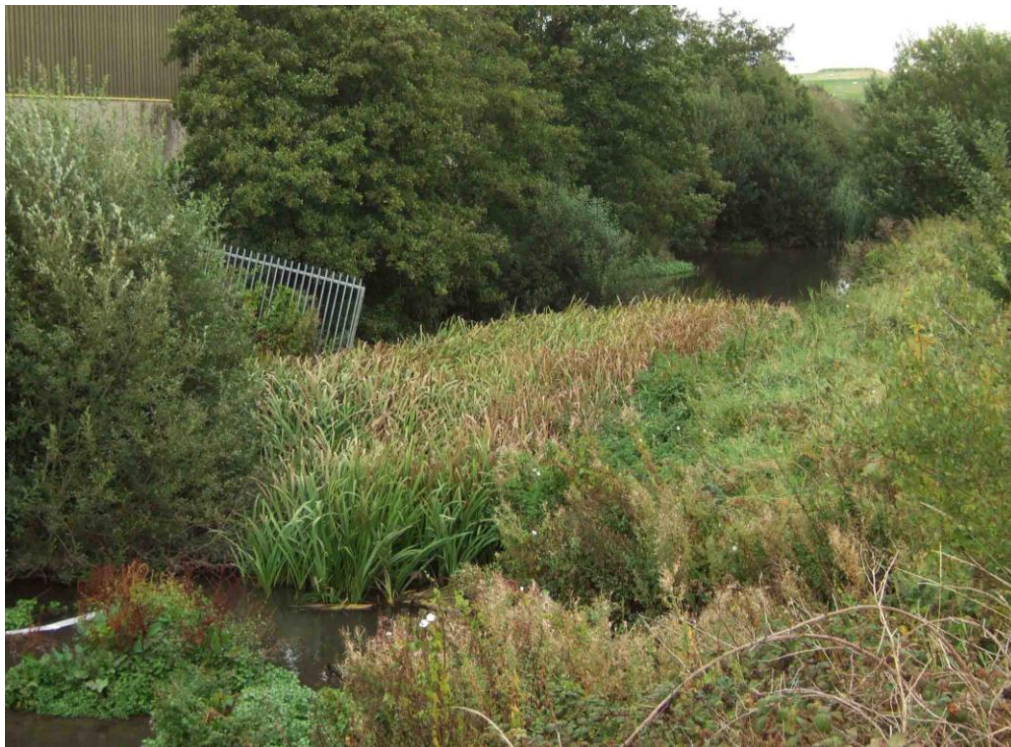
Plate 6 Tramore River: Site E (view d-s to kick-sampling point, showing heavy in-channel growth of *Typha* and *Sparganium*) 23-09-2011

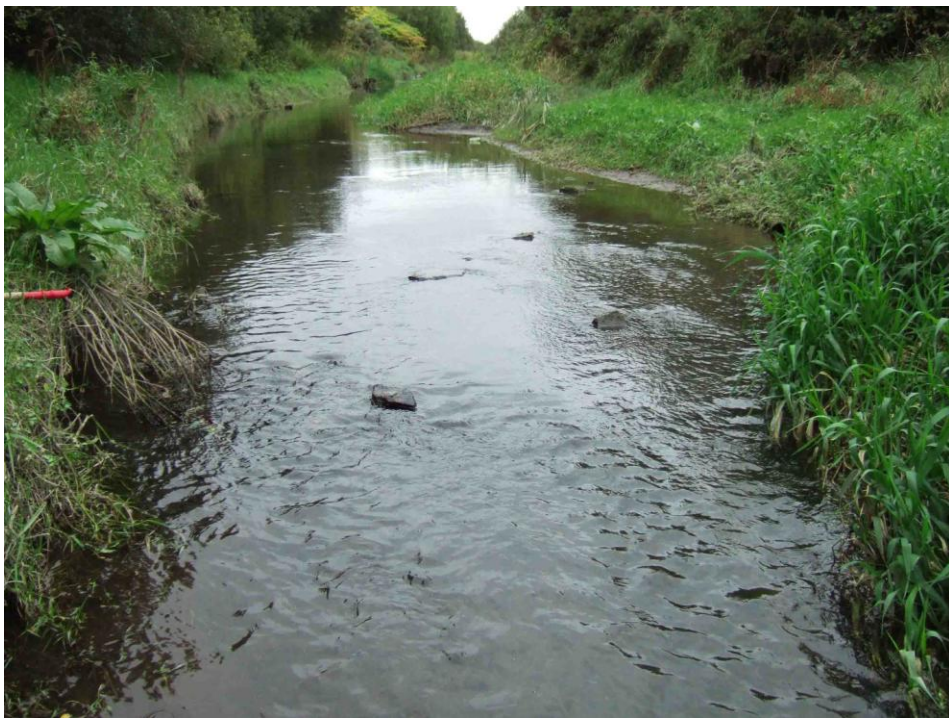
Plate 8 Tramore River Site F: kick-sampling site (23-09-2010)

This site was 150m to 200m downstream of the confluence of the Tramore and Trabeg Rivers. Samples were taken in short riffle where the channel narrows and where the substrate comprises silted large pebble/small cobble and gravel in a moderate to moderately swift turbulent flow (Plate 8). There was about 20-25% loose cover of the estuarine alga *Enteromorpha* on the substrate. Marginally the right bank had *Apium nodiflorum* and grass backed by Willow, while the left margin also had *Apium* backed in places by dense *Phalaris* with gorse bramble and grass higher up on the bank. Horned Pondweed (*Zannichellia palustris*), which was locally abundant at and downstream of the site in 2010 was not noted in 2011.

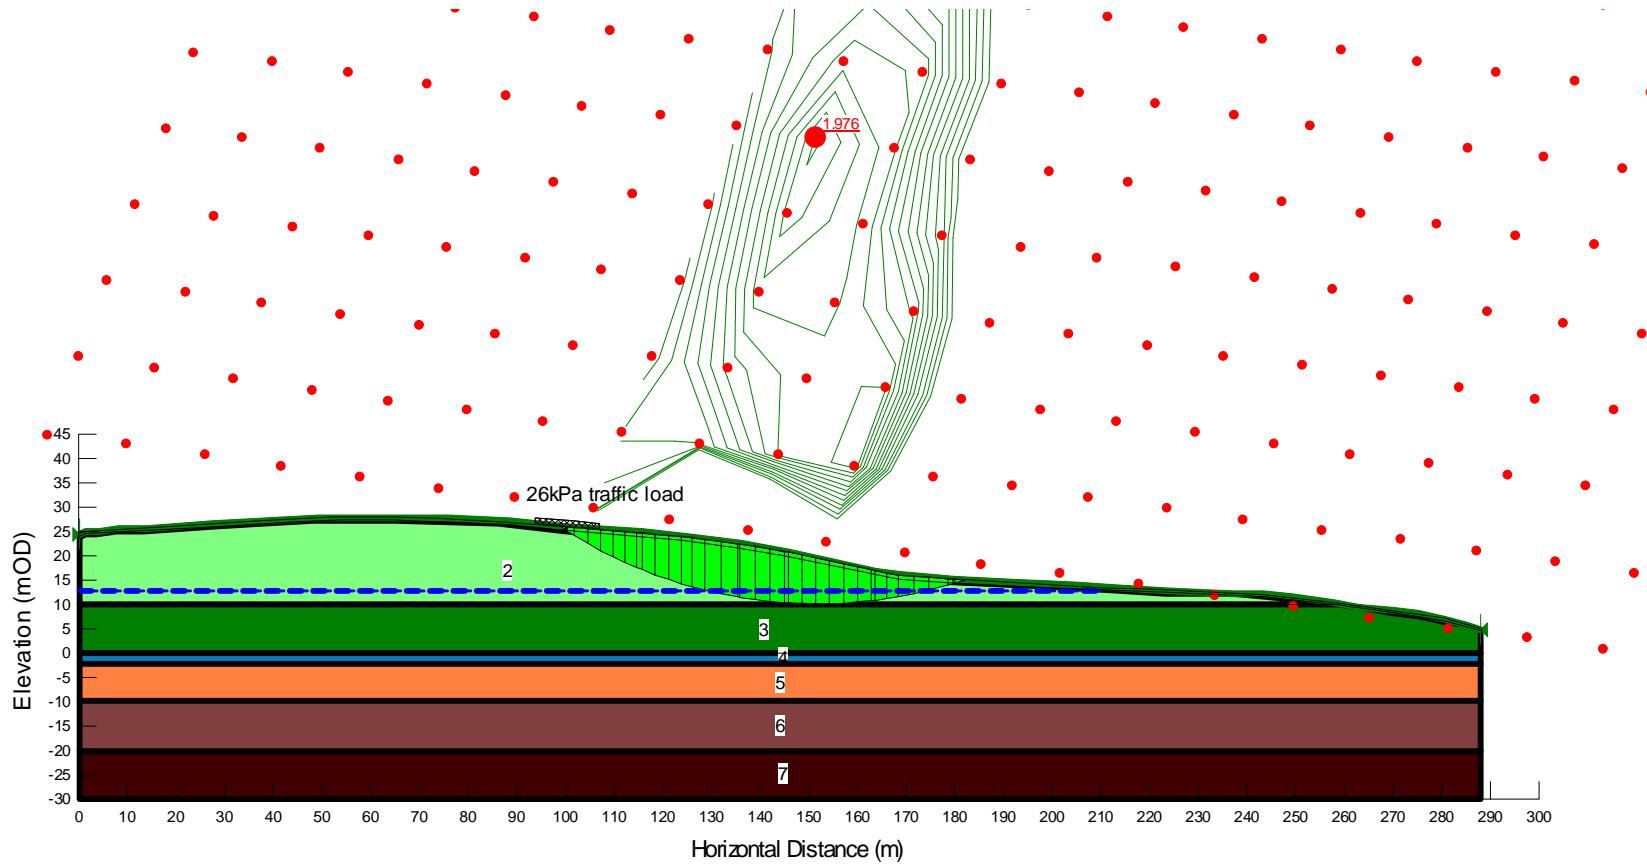
Slope name	Leachate Level at toe of slope (mAOD)	Morgenstern-Price FoS	Bishop FoS	Janbu FoS	Slip Length (m)	Slip type & location
Section A-A	13.0	1.98	1.98	1.90	80	Deep rotational slip through clay capping and waste

Figure 3.1: Typical slope failure for Section A-A (Morgensten-Price Method) for Groundwater Level of 13m AOD.

Material #:	1	Description:	Clay Cap	Model:	MohrCoulomb	Wt:	18	Cohesion:	3.2	Phi:	23.2	Piezometric Line:	0
Material #:	2	Description:	New Waste	Model:	MohrCoulomb	Wt:	9.5	Cohesion:	8	Phi:	12	Piezometric Line:	1
Material #:	3	Description:	Old Waste	Model:	MohrCoulomb	Wt:	11	Cohesion:	7.1	Phi:	17.6	Piezometric Line:	0
Material #:	4	Description:	Peat	Model:	MohrCoulomb	Wt:	14	Cohesion:	0	Phi:	12	Piezometric Line:	0
Material #:	5	Description:	Silty Clay	Model:	MohrCoulomb	Wt:	19	Cohesion:	0	Phi:	20.8	Piezometric Line:	0
Material #:	6	Description:	Glacial Till	Model:	MohrCoulomb	Wt:	20	Cohesion:	0	Phi:	26.4	Piezometric Line:	0
Material #:	7	Description:	Bedrock	Model:	Bedrock	Piezometric Line:	0
