**Re: Killurin Landfill Site, Waste License W0016-02
Annual Environmental Report 2011.**

Killurin Landfill
W0016-02

Annual Environmental Report 2011

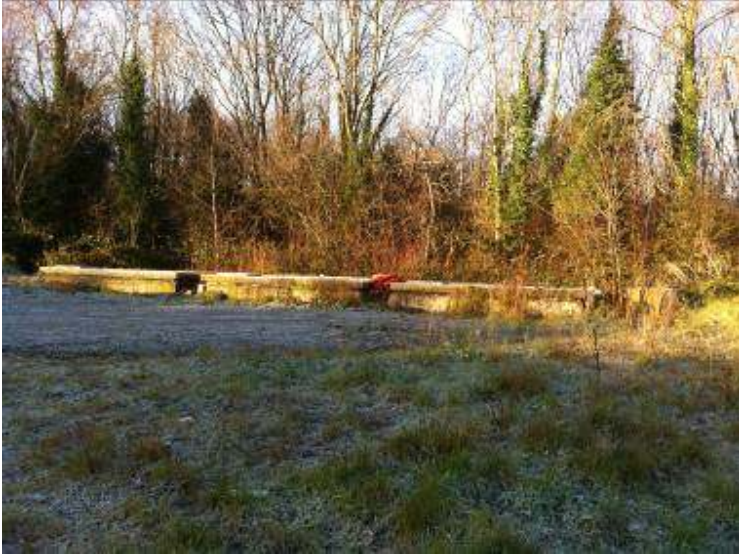
TANK 2.

The results of the tests indicated that the water levels in LST2 and LST3 fell by 2 – 4 mm respectively . No Seepage from the tanks were observed on the external tank walls during the test. Both these tanks are deemed to have passed the integrity test and are deemed fit for storing leachate.

The LST s were drained and inspected. Some of the seals in LST 1 and LST 2 were not pointed with cement mortar, however the bitumen seal were found to be intact. The mortar should be replaced to maintain the integrity of the seals.

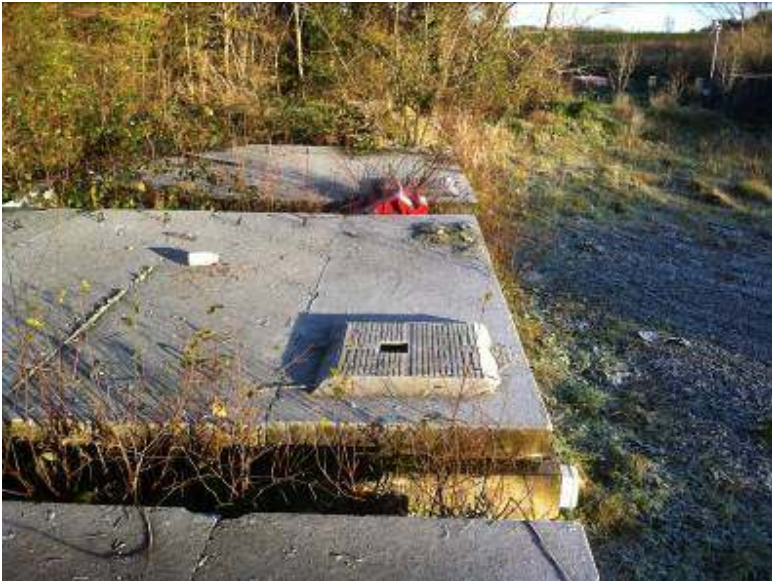
TANK 1

Operational restrictions precluded the testing procedure being applied to LST 1. Therefore I cannot categorically certify that the condition of this tank is appropriate for the storage of leachate . However the tank was constructed similiary to LST 2 and LST3, at the same time, by the same company, using the same method. Based on the results of the integrity tests on LST2 and LST3, and considering the similar physical condition of LST 1 to the other tanks, I consider that it is reasonable to assume to LST 1 is also fit for storing leachate as the other tanks pass the test.

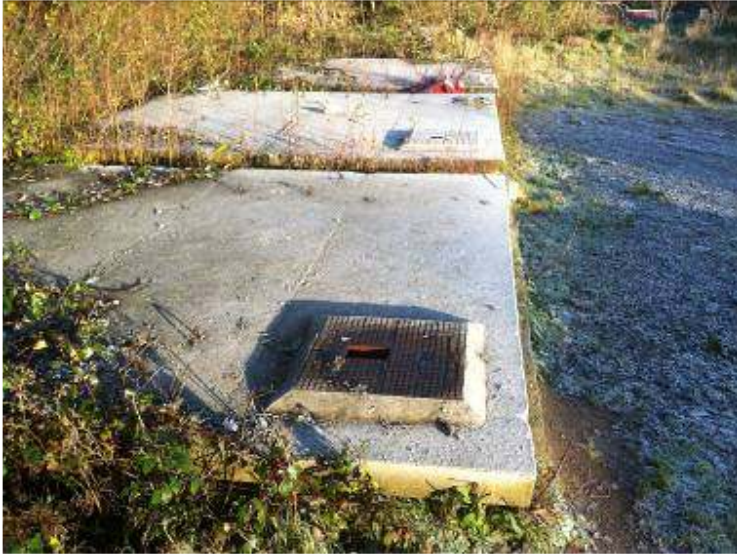
TANK 3.

There is some damage to the external north western corner of LST 3, where a thin layer of concrete has broken away. There are no cracks or deterioration of the concrete around the damaged area.

A small amount of damaged concrete was noted on the upper north western corner of LST 3. This damage should be made good.
