Environmental Risk Assessment for Unregulated Waste Disposal Site

Tier 2 Exploratory Investigation

Townspark East, Lismore Landfill

Tier 2 Landfill Assessment
Townspark East, Lismore,
Co. Waterford

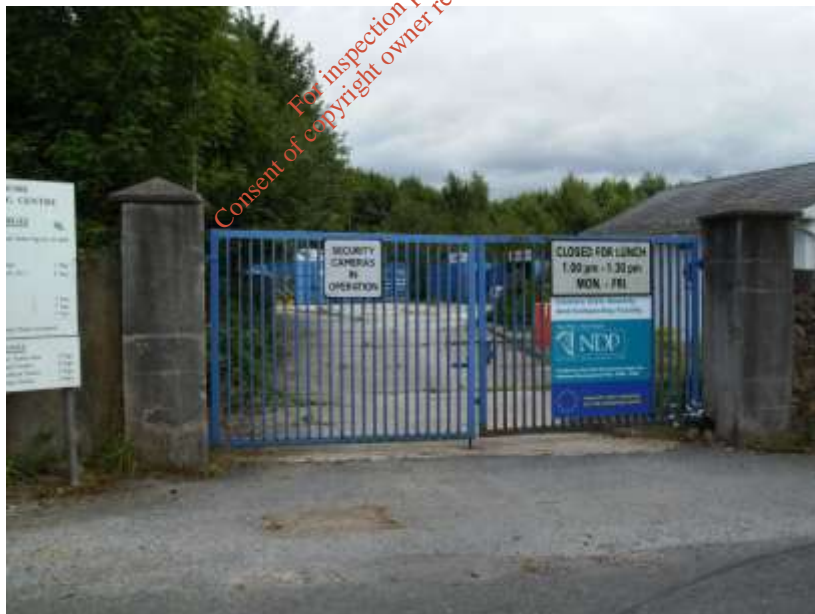
Figure 2.1: Historic Landfill, Townspark East, Lismore

The trial pit survey was undertaken on Thursday 2nd September 2010. The Environment Section hired a 12ton Komatsu track mounted 360° excavator and operator which was suitable for travelling on uneven terrain and with a reach of 6-8 mbgl. Figure 2.1, gives an indication of the civic amenity facility and site located at Townspark East, Lismore and also highlights the trees and woodland in the background.

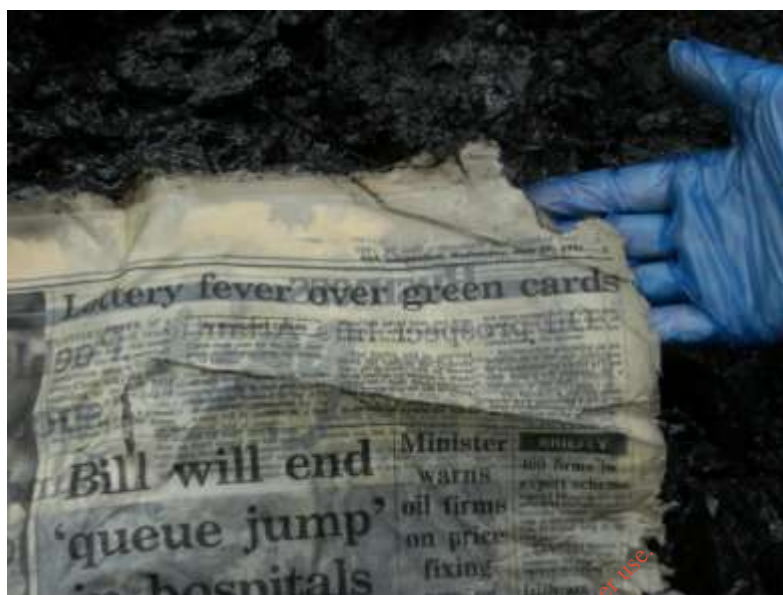
Figure 2.2: Irish Independent 1991

During the trial pit survey, technical staff interestingly located a section of the Irish Independent newspaper dated the 29th May, 1991. Figure 2.2 highlights this particular discovery. Leachate was

encountered in the following trial pits, TP-3, TP-5 & TP-7. Please see appendix C in relation to laboratory results.

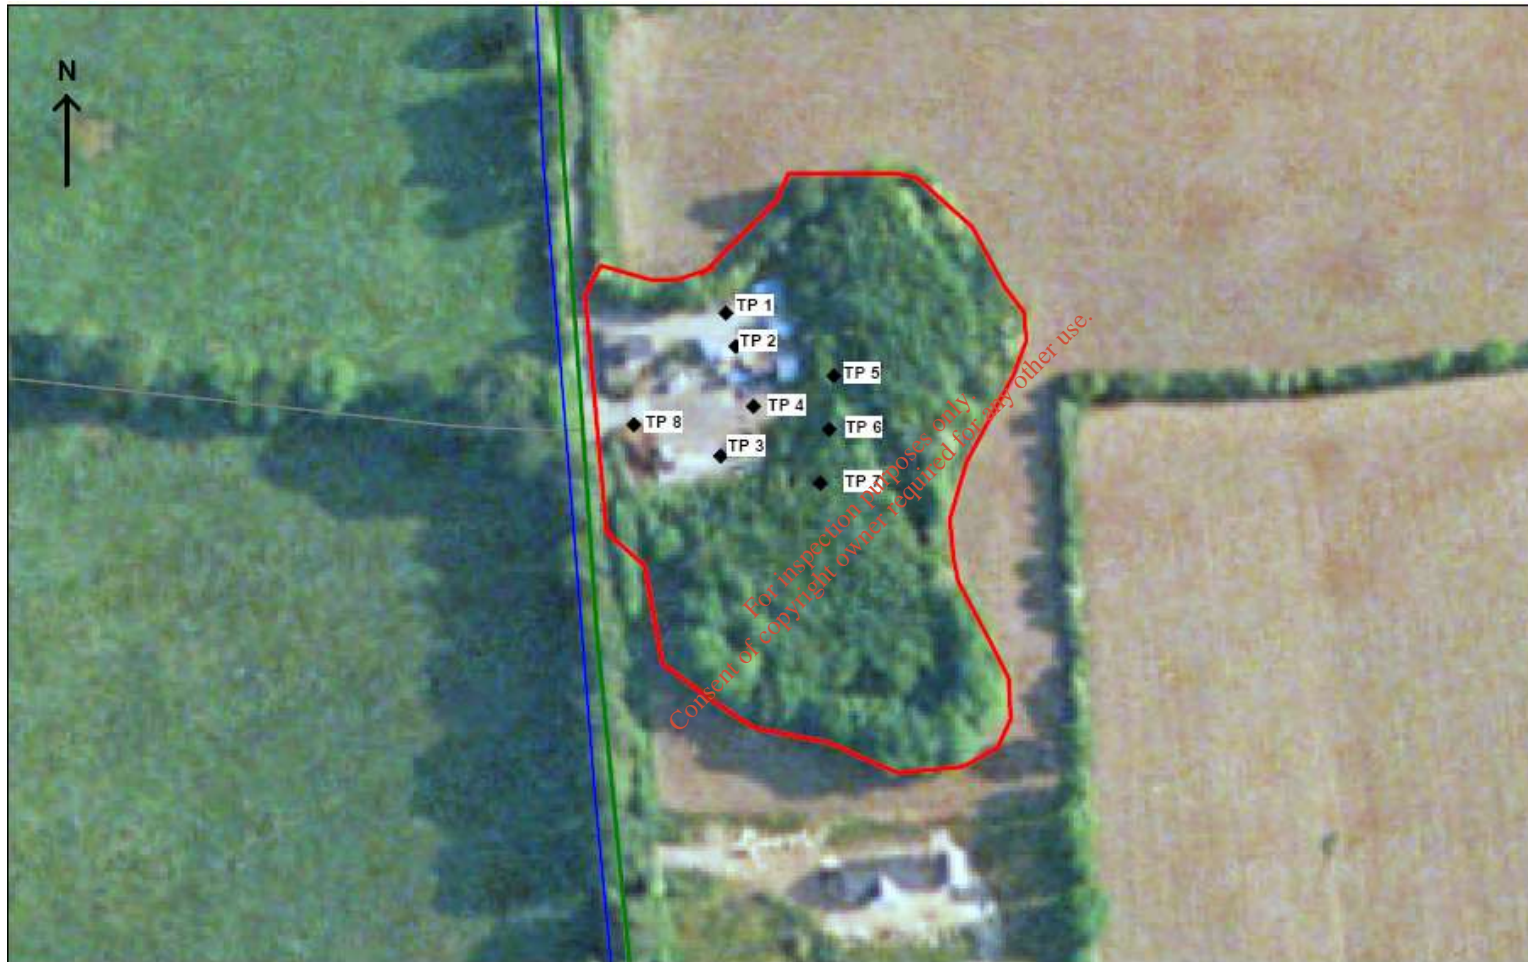
<p>Environment Section Aoife O'Flaherty Executive Engineer</p>	<p>Waterford County Council Historic Landfill Lismore</p>	<p>Waterford County Council, Davitt's Quay, Dungarvan, Co. Waterford.</p>	<p>Map Title Trial Pit Locations</p>
--	--	---	---

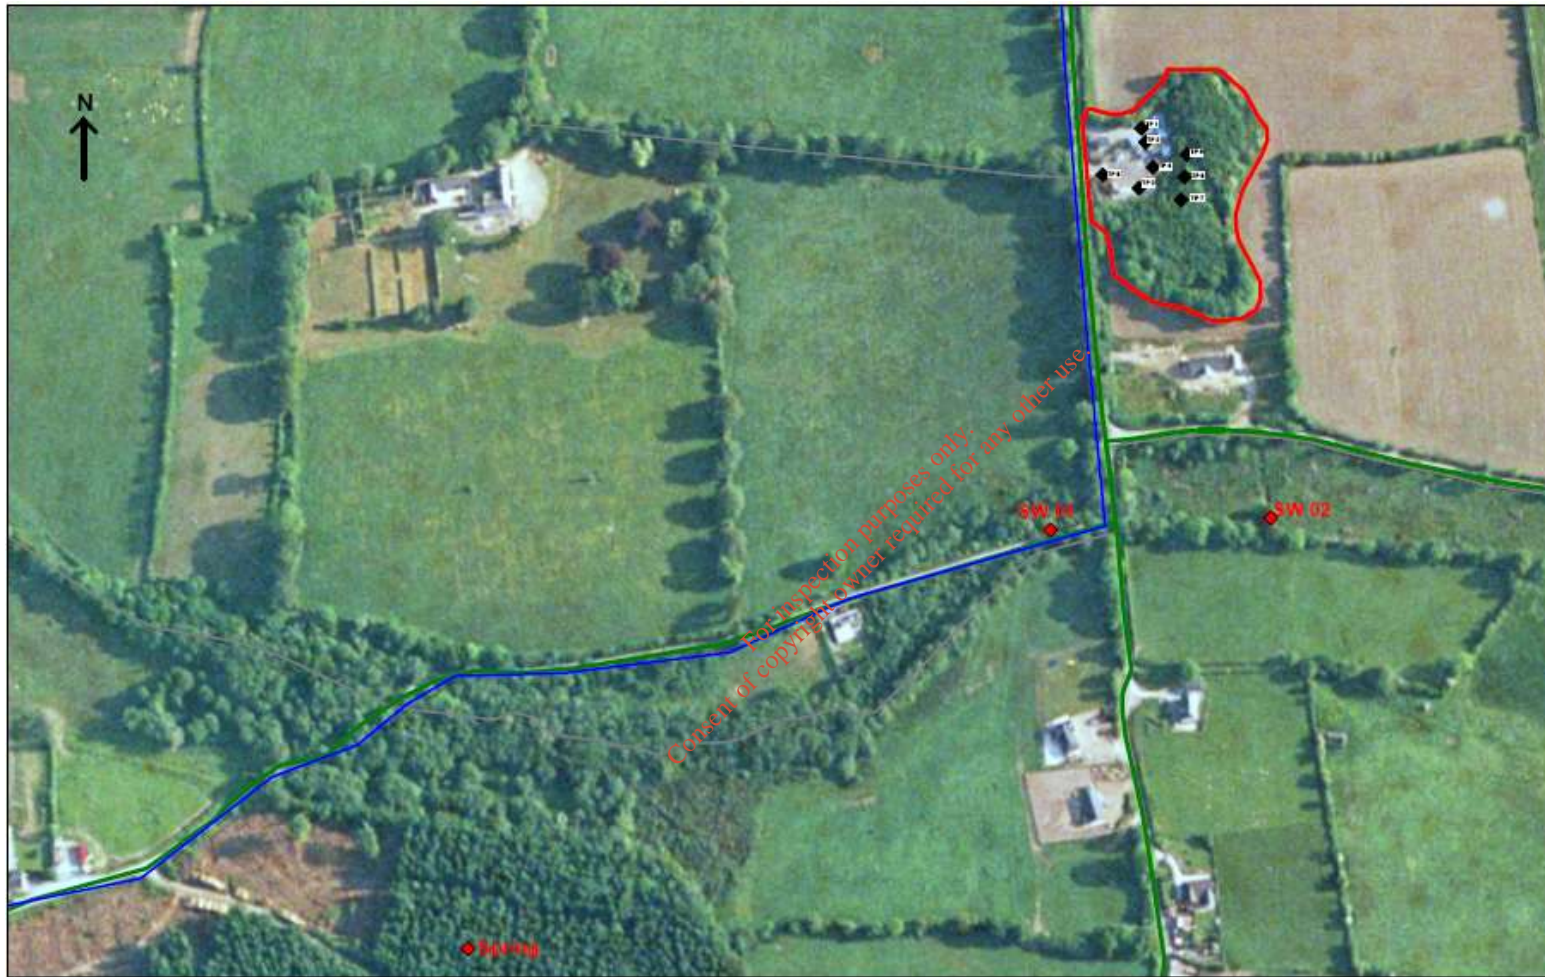
Environment Section Aoife O'Flaherty Executive Engineer	Waterford County Council Historic Landfill Lismore	<u>Map Title</u> Surface Water Sampling Locations
---	---	---

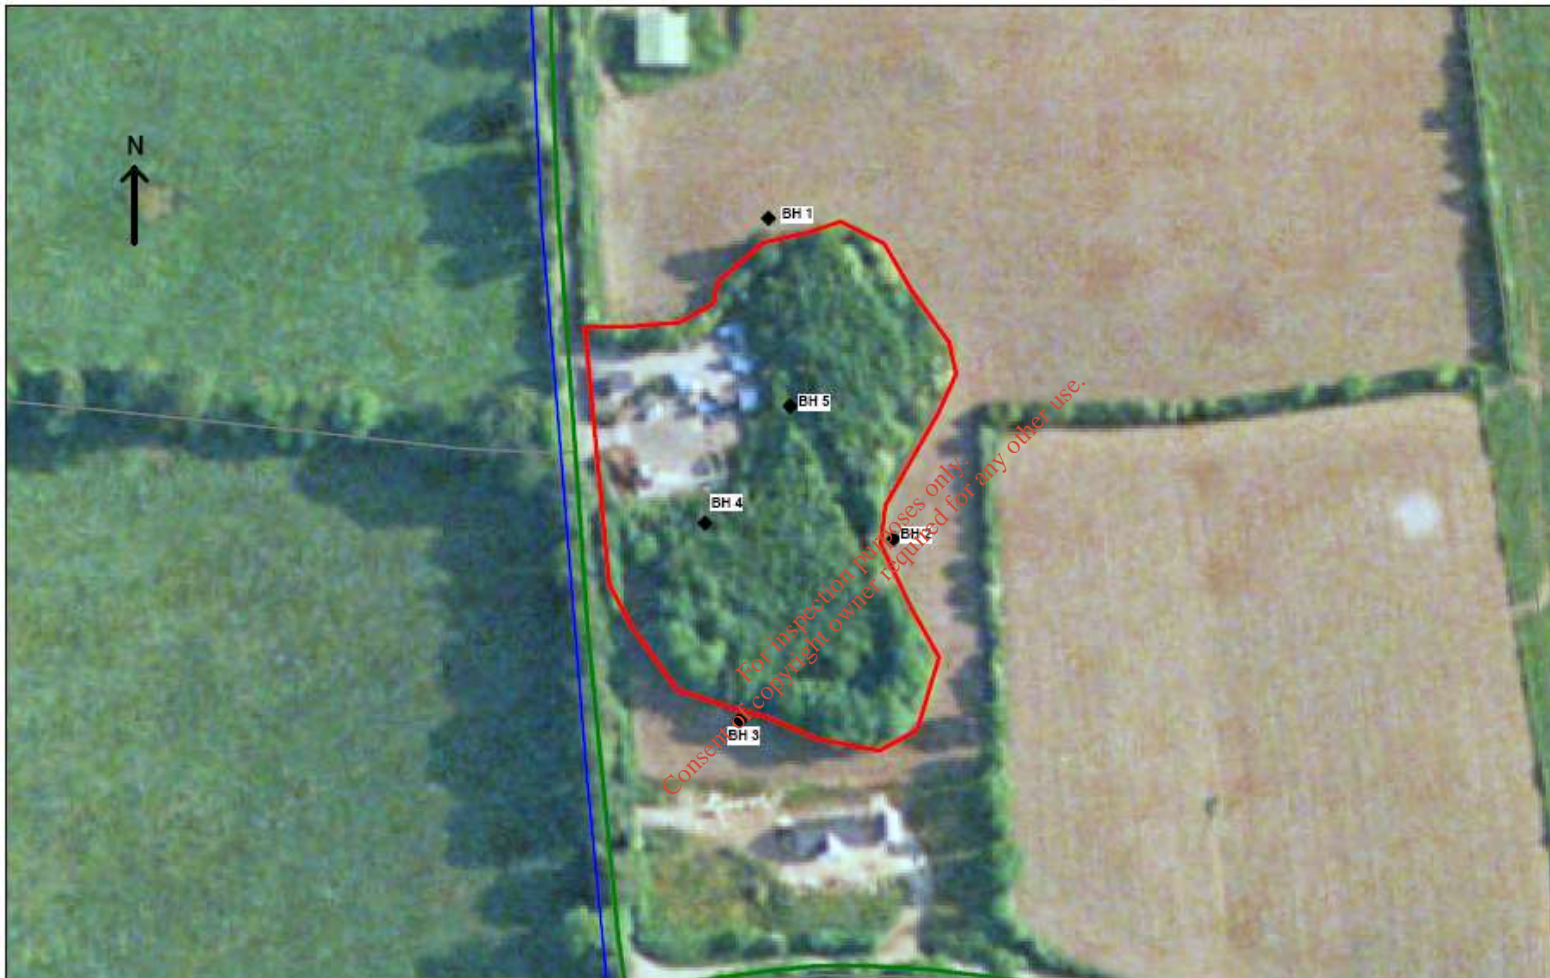
<p>Environment Section Aoife O'Flaherty Executive Engineer</p>	<p>Waterford County Council Historic Landfill Lismore</p>	<p>Waterford County Council, Davitt's Quay, Dungarvan, Co. Waterford.</p>	<p><u>Map Title</u> Bore Hole Locations</p>
--	--	---	--

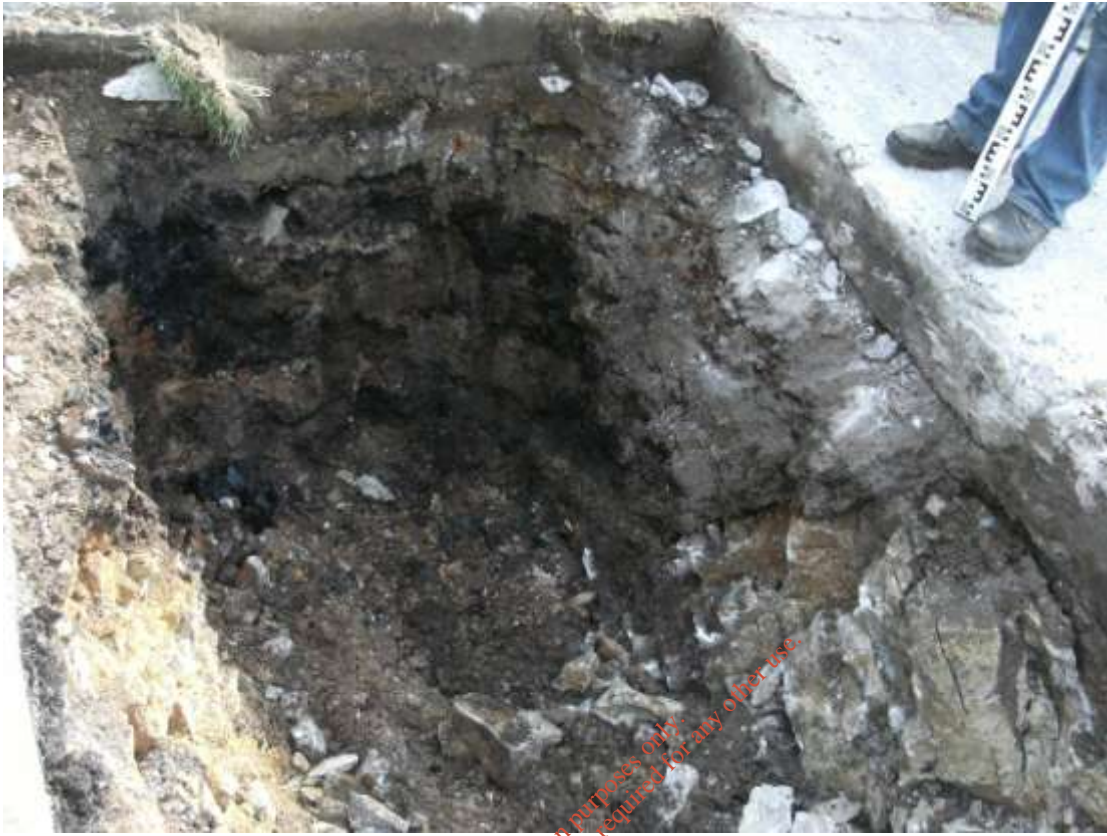
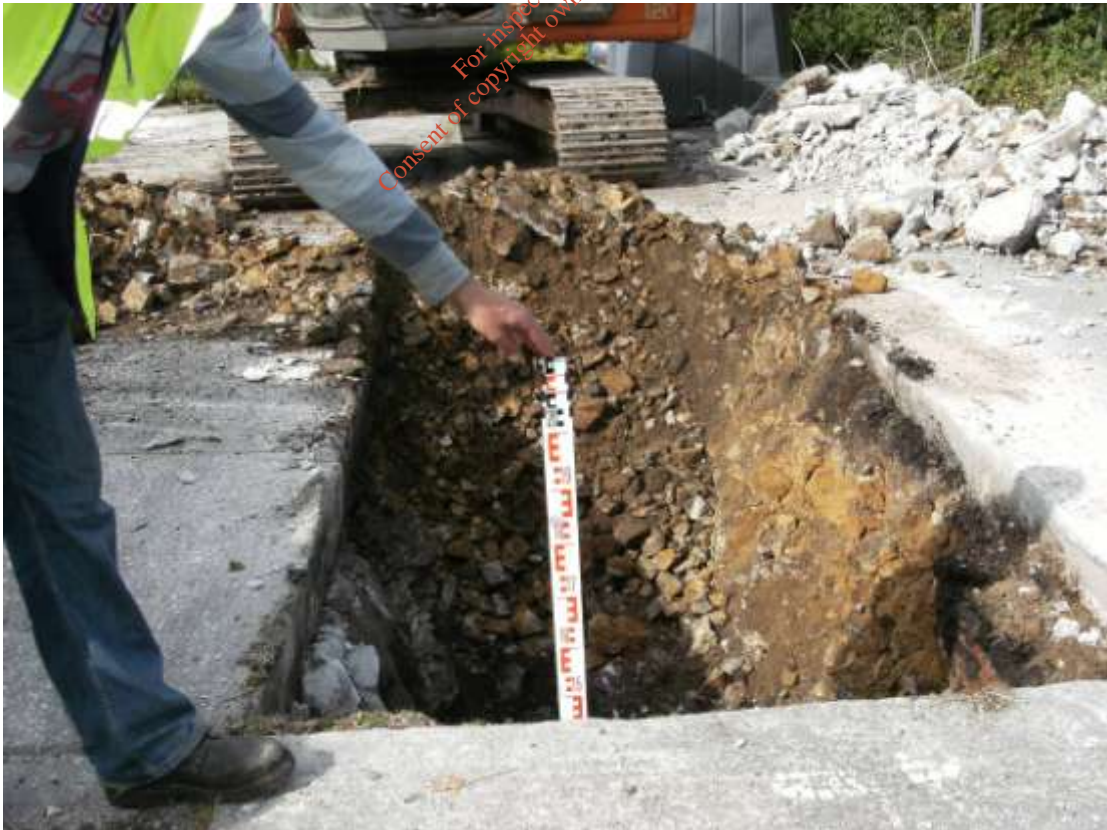
Trial Pit No. 1
Project Lismore Historic Landfill Exploratory Investigation		Co- Ordinates IX 04549 ITM 96465		Date 2 nd September 2010	
Location Townspark East, Lismore		Dimensions 1.7x3.9x1.5m		Method/ Plant 12 Tonne 360° Hitachi Excavator	
Samples & In Situ Testing				Strata Description	
Depth (m)	Type/ Sample	Depth (m)	Water (m)	Legend	
		0.25		----- ----- -----	Concrete Pad (0.0 – 0.25m)
0.5				~ ~ ~ ----- ~ ~ ~	Mainly bedrock and sandy soil. Edge of waste body visible.
1.0				~ ~ ~ ----- ~ ~ ~	
1.5		1.5		----- -----	End of trial hole
2.0				----- -----	Original strata clay.....
2.5					
3.0					
Remarks:				Logged By: Aoife O’Flaherty E.E. Liam Ahearne A.E. Daniel Devine

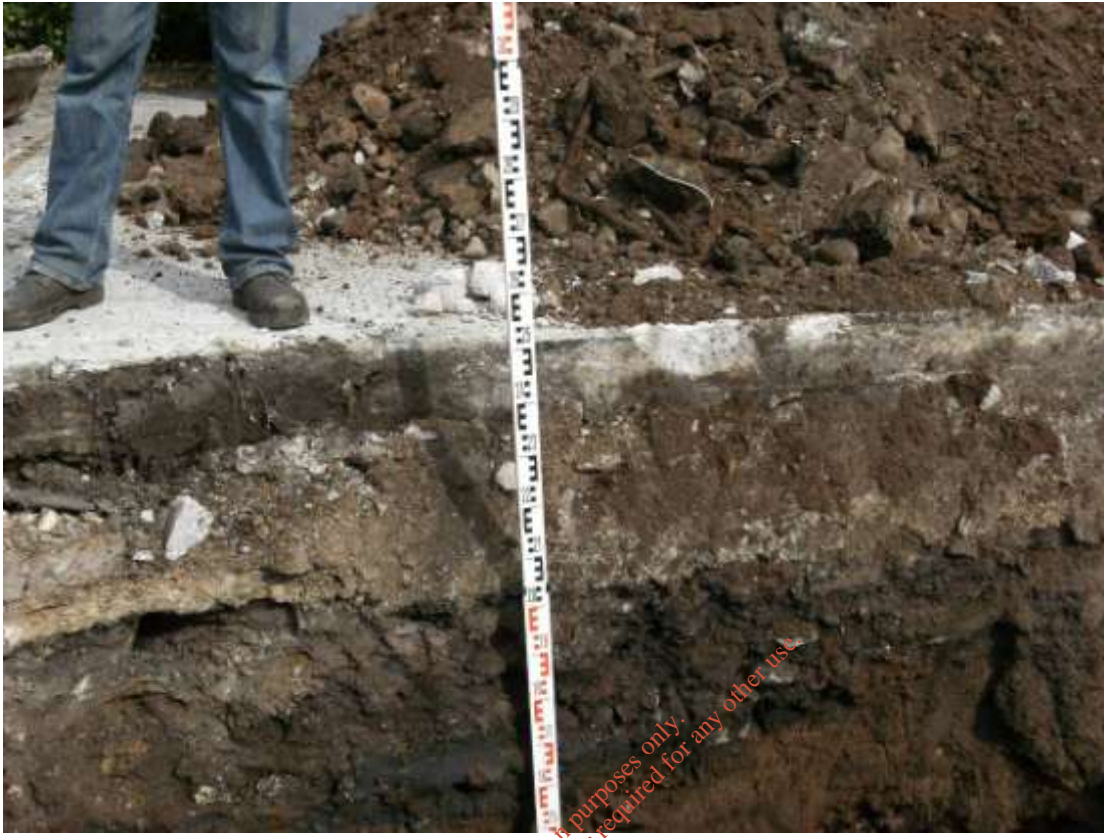
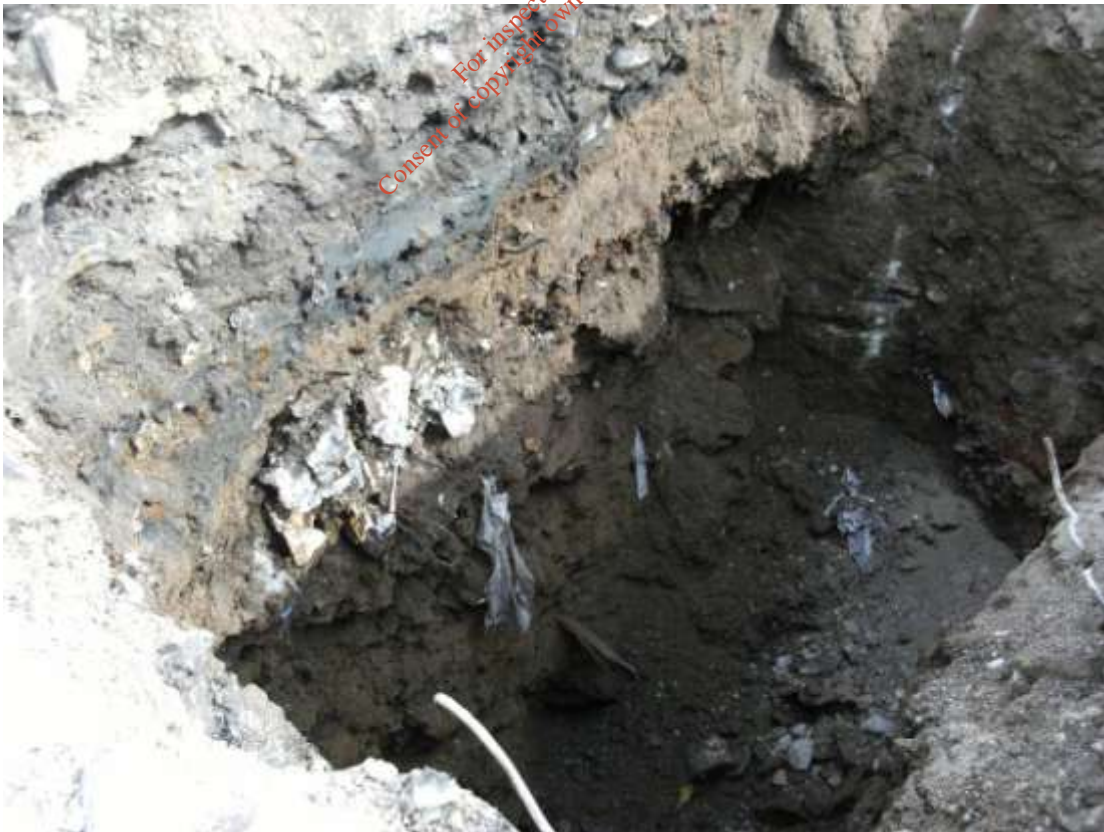
Trial Pit No. 2
Project Lismore Historic Landfill Exploratory Investigation		Co- Ordinates IX 04479 ITM 96397		Date 2 nd September 2010	
Location Townspark East, Lismore		Dimensions 3.7x2.1x3.1m	Method/ Plant 12 Tonne 360° Hitachi Excavator		
Samples & In Situ Testing					Strata Description
Depth (m)	Type/ Sample	Depth (m)	Water (m)	Legend	
0.5		0.3		----- -----	Concrete Pad (0.0 – 0.3m)
		0.6		~ ~ ~ ----- ~ ~ ~	Fill Material
1.0				----- ~ ~ ~ ----- ~ ~ ~	Start of Waste
1.5				----- ~ ~ ~ ----- ~ ~ ~	(Fill Material Consisting of Domestic Waste, Plastic, Steel & Glass Bottles)
2.0				----- ~ ~ ~ ----- ~ ~ ~	
2.5		2.5		----- ~ ~ ~ ----- ~ ~ ~	End of Waste
3.0		3.1		----- ~ ~ ~ ----- ~ ~ ~	Underlying material
				----- ~ ~ ~ ----- ~ ~ ~	End of trial hole
Remarks:					Logged By: Aoife O'Flaherty E.E. Liam Ahearne A.E. Daniel Devine

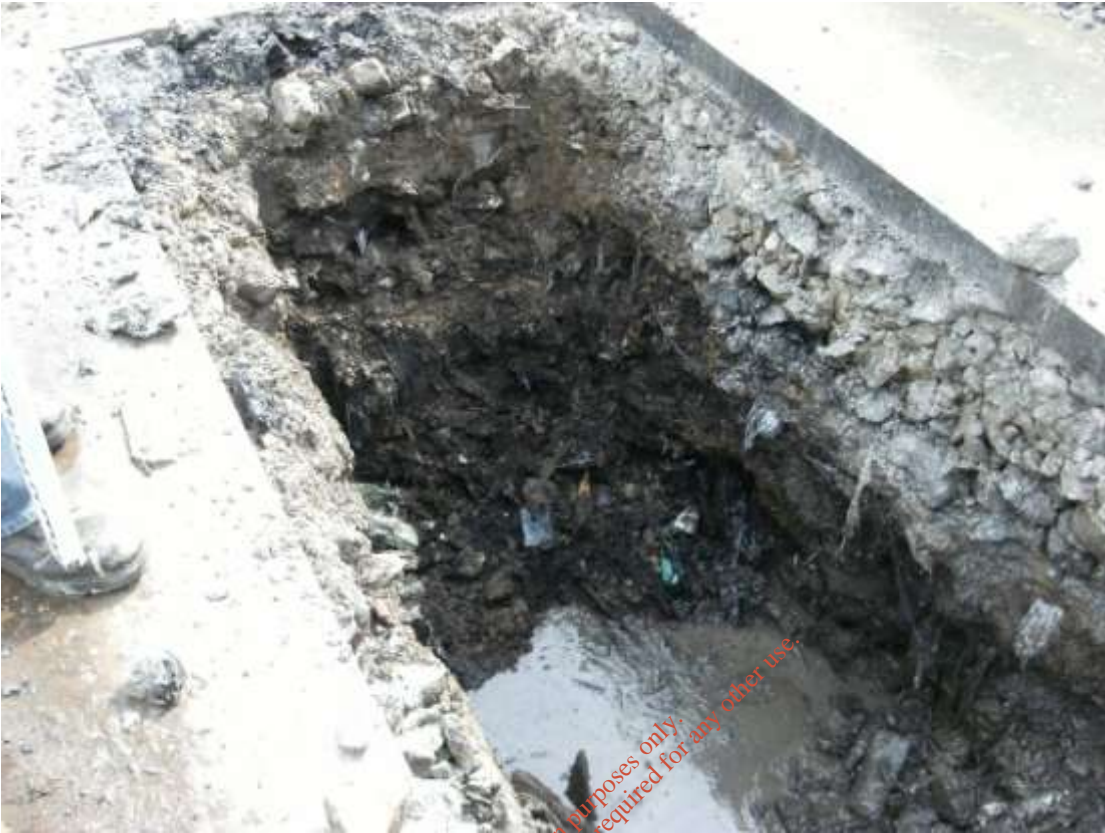
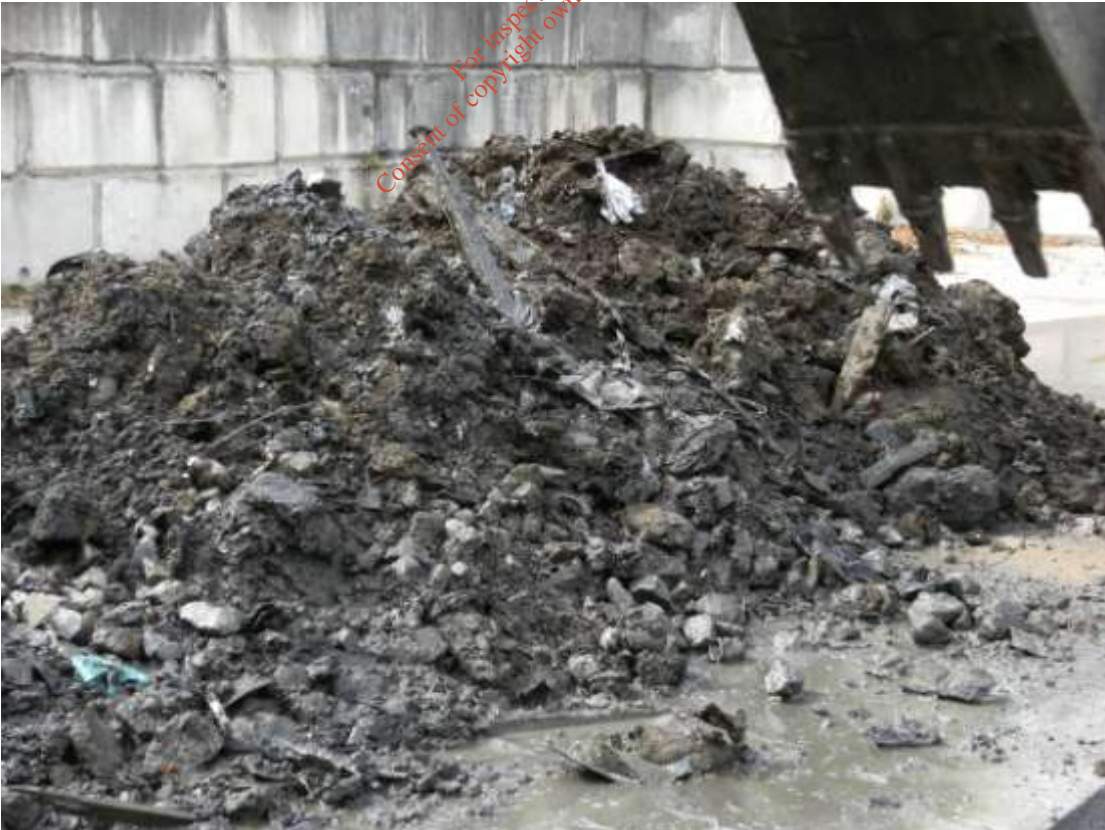
Trial Pit No. 3	
Project Lismore Historic Landfill Exploratory Investigation		Co- Ordinates IX 04513 ITM 96454		Date 2 nd September 2010	
Location Townspark East, Lismore		Dimensions 4.3x1.7x3.18m		Method/ Plant 12 Tonne 360° Hitachi Excavator	
Samples & In Situ Testing					Strata Description
Depth (m)	Type/ Sample	Depth (m)	Water (m)	Legend	
		0.15		-----	Tarmac Surface (0.0 – 0.15m)
0.5				~ ~ ~ -----	Hardcore Fill Material
		0.63		----- ~ ~ ~	Start of Waste
1.0		1.0	1.0	----- ~ ~ ~	Leachate: 1.0m
1.5				----- ~ ~ ~	(Waste consists of Steel, Timber, Plastic and Construction and Demolition material)
2.0				----- ~ ~ ~	
2.5				----- ~ ~ ~	
		2.65		----- ~ ~ ~	
3.0				----- ~ ~ ~	Underlying material
		3.18		----- ~ ~ ~	End of trial hole
				----- - - -	
Remarks:					Logged By: Aoife O’Flaherty E.E. Liam Ahearne A.E. Daniel Devine

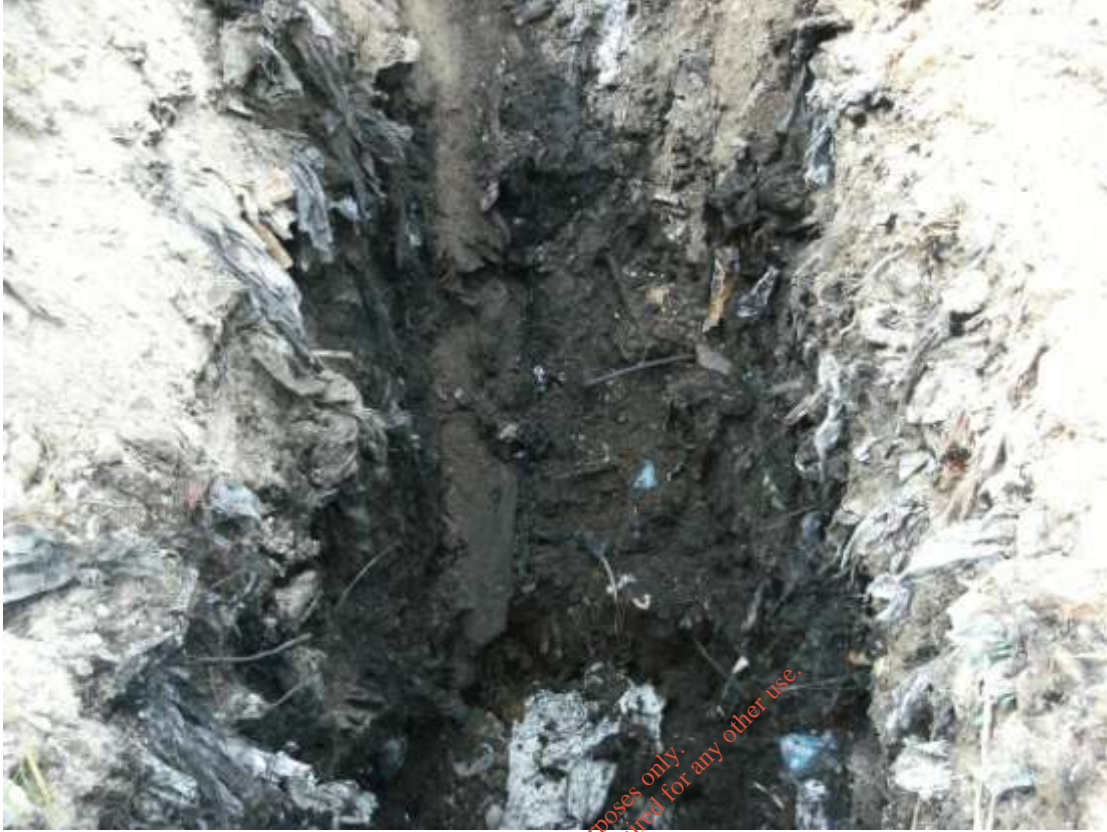
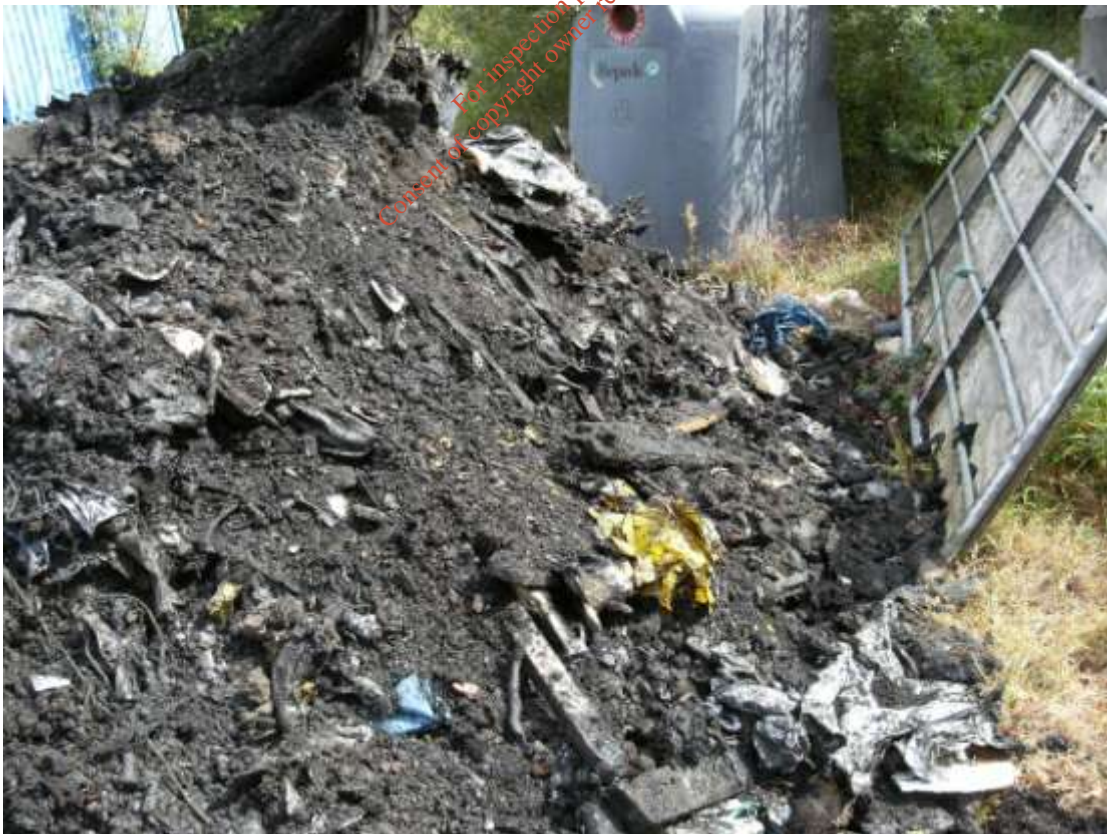
Trial Pit No. 4
Project Lismore Historic Landfill Exploratory Investigation		Co- Ordinates IX 04527 ITM 96468		Date 2 nd September 2010	
Location Townspark East, Lismore		Dimensions 1.5x2.5x3.7m	Method/ Plant 12 Tonne 360° Hitachi Excavator		
Samples & In Situ Testing					Strata Description
Depth (m)	Type/ Sample	Depth (m)	Water (m)	Legend	
		0.3		----- -----	Topsoil (0.0 – 0.3m)
0.5				~ ~ ~ ----- ~ ~ ~	Start of Waste (All Domestic Waste, ELV's and Tyres)
1.0				----- ~ ~ ~ ----- ~ ~ ~	
1.5				----- ~ ~ ~ ----- ~ ~ ~	
2.0				----- ~ ~ ~ ----- ~ ~ ~	
2.5				----- ~ ~ ~ ----- ~ ~ ~	
3.0				----- ~ ~ ~ ----- ~ ~ ~	
		3.7		----- ~ ~ ~ ----- ~ ~ ~ ----- ~ ~ ~ ----- ~ ~ ~	End of trial hole
Remarks:					Logged By: Aoife O'Flaherty E.E. Liam Ahearne A.E. Daniel Devine

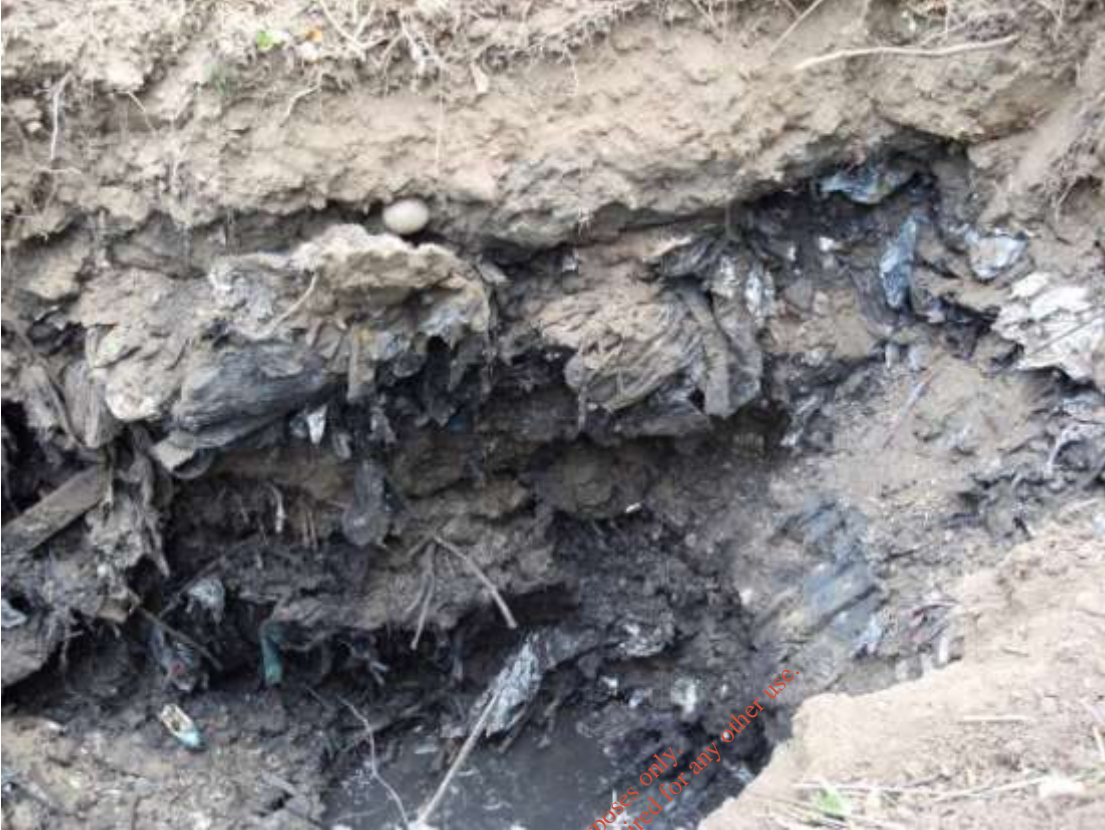
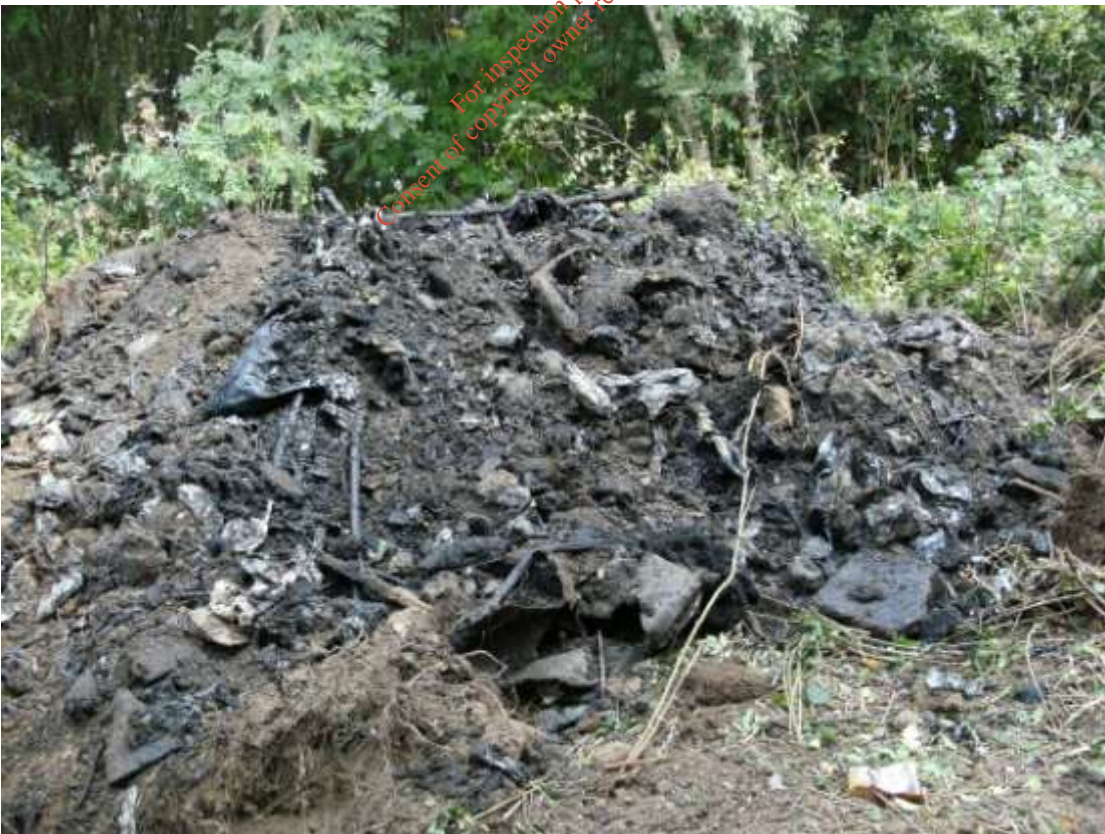
Trial Pit No. 5
Project Lismore Historic Landfill Exploratory Investigation		Co- Ordinates IX 04513 ITM 96485		Date 2 nd September 2010	
Location Townspark East, Lismore		Dimensions 1.5x2.5x2.5m	Method/ Plant 12 Tonne 360° Hitachi Excavator		
Samples & In Situ Testing					Strata Description
Depth (m)	Type/ Sample	Depth (m)	Water (m)	Legend	
0.5		0.5		----- ----- ----- ----- -----	Topsoil (0.0 – 0.5m)
1.0				~ ~ ~ ----- ~ ~ ~ ----- ~ ~ ~ -----	Start of Waste (All Domestic Waste – Largely consisting of Plastic and Timber)
1.5			----- ~ ~ ~ -----		
2.0			----- ~ ~ ~ -----		
2.5		2.5	2.5	~ ~ ~ ----- ~ ~ ~ -----	End of Trial Hole
3.0				----- ----- -----	Leachate: 2.5m
Remarks:					Logged By: Aoife O’Flaherty E.E. Liam Ahearne A.E. Daniel Devine

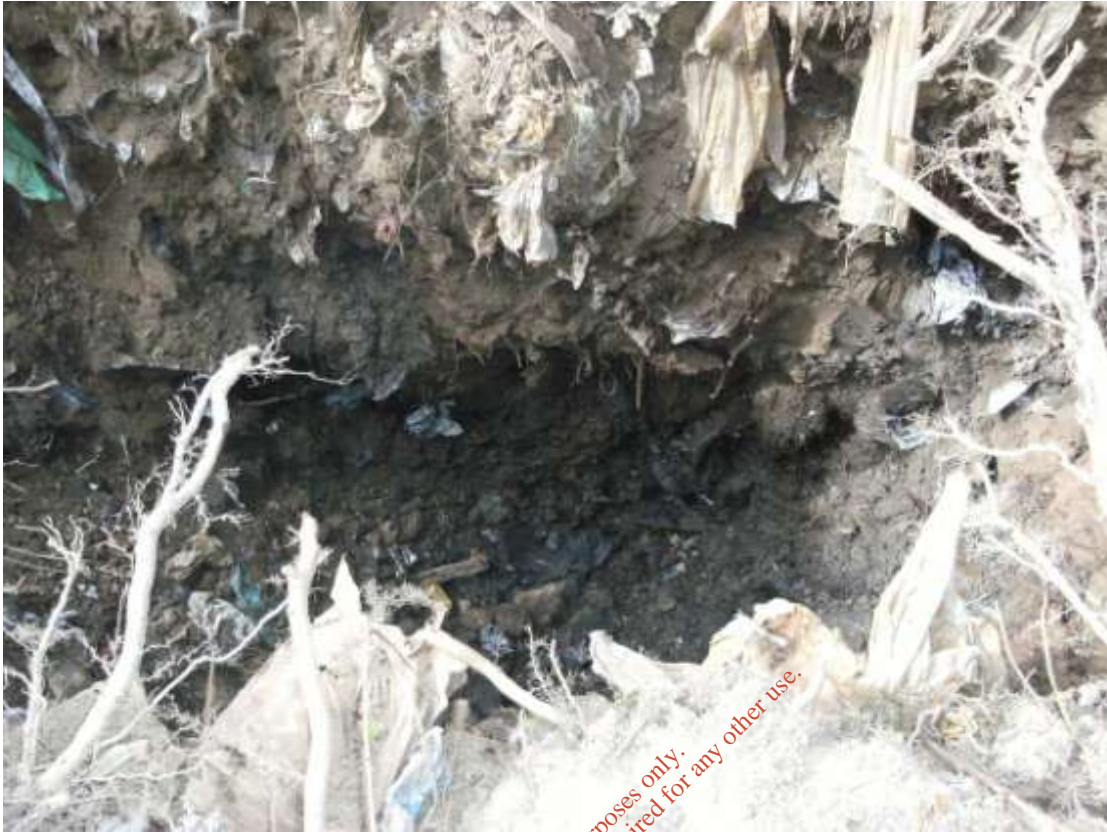
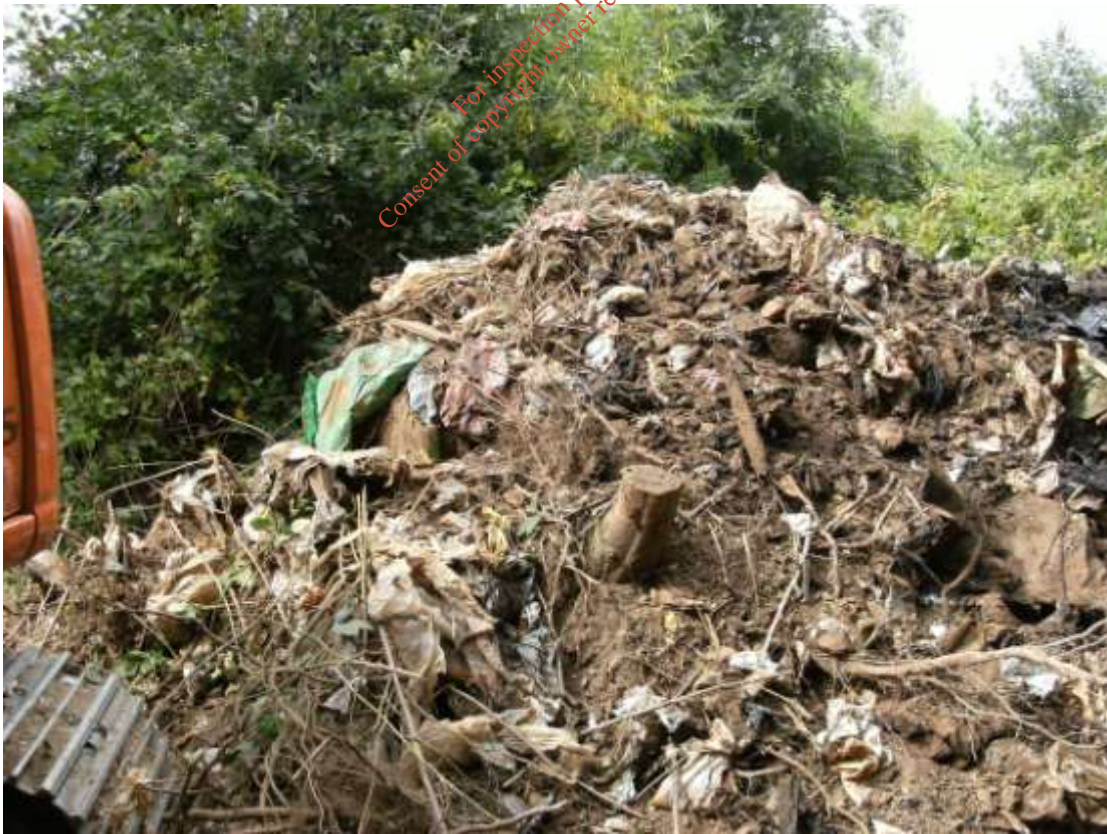
Trial Pit No. 6	
Project Lismore Historic Landfill Exploratory Investigation			Co- Ordinates IX 04547 ITM 96469		Date 2 nd September 2010	
Location Townspark East, Lismore			Dimensions 1.5x4.0x3.0m		Method/ Plant 12 Tonne 360° Hitachi Excavator	
Samples & In Situ Testing					Strata Description	
Depth (m)	Type/ Sample	Depth (m)	Water (m)	Legend		
		0.3		----- -----	Topsoil (0.0 – 0.3m)	
0.5				~ ~ ~ ----- ~ ~ ~	Start of Waste (All Domestic Waste)	
1.0			----- ~ ~ ~ -----			
1.5			----- ~ ~ ~ -----			
2.0			----- ~ ~ ~ -----			
2.5			----- ~ ~ ~ -----			
3.0		2.8		----- ~ ~ ~ ----- ----- ----- -----	End of trial hole	
Remarks:					Logged By: Aoife O’Flaherty E.E. Liam Ahearne A.E. Daniel Devine

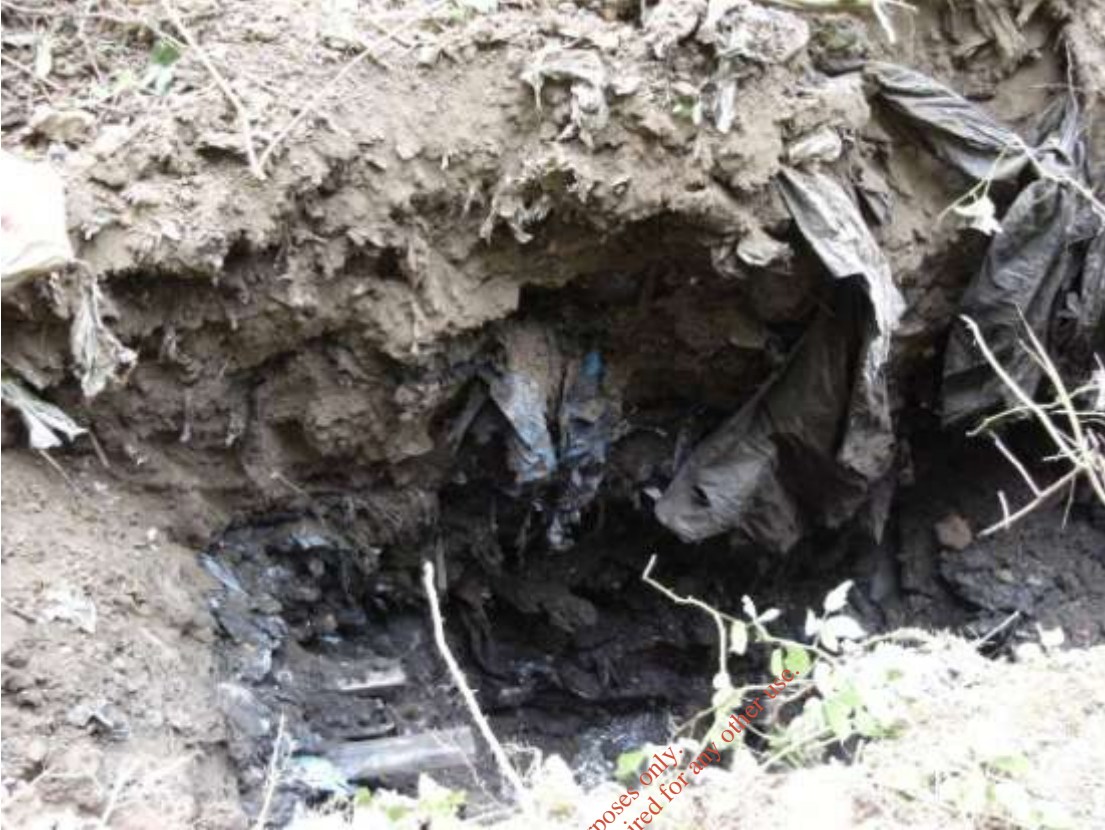
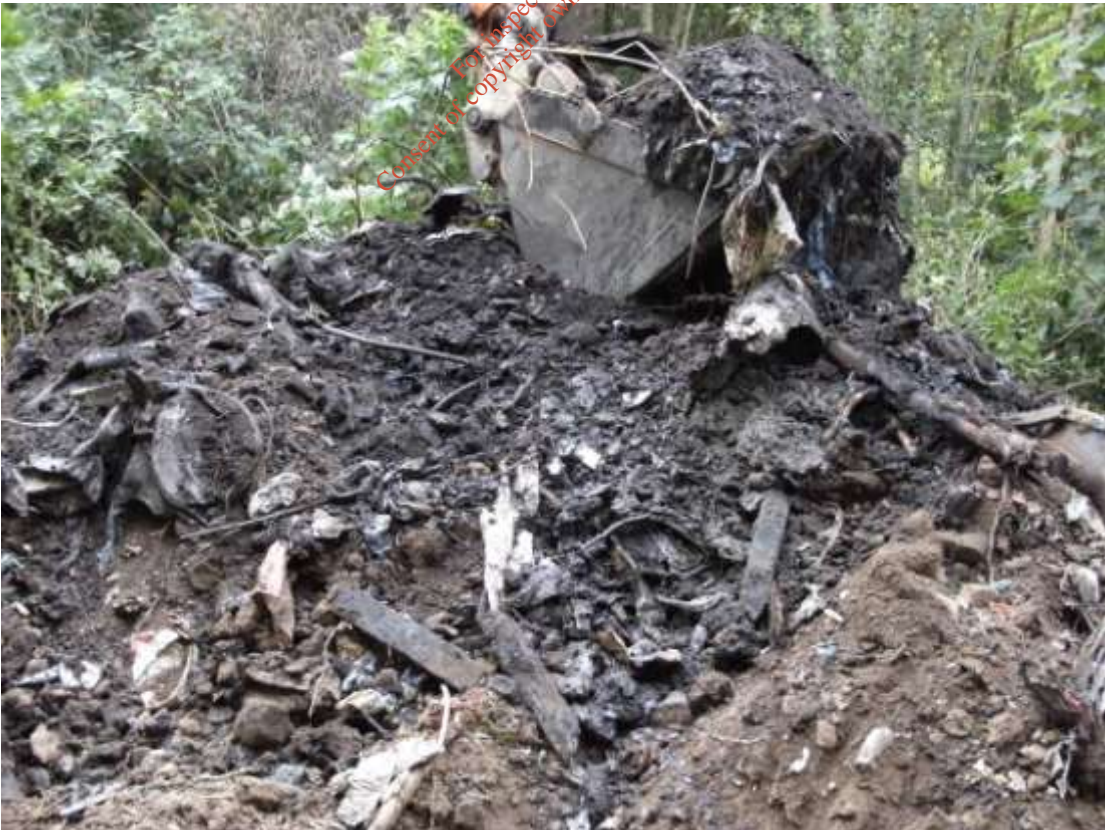
Trial Pit No. 7	
Project Lismore Historic Landfill Exploratory Investigation			Co- Ordinates IX 04552 ITM 96458		Date 2 nd September 2010	
Location Townspark East, Lismore			Dimensions 3.5x1.5x3.0m		Method/ Plant 12 Tonne 360° Hitachi Excavator	
Samples & In Situ Testing					Strata Description	
Depth (m)	Type/ Sample	Depth (m)	Water (m)	Legend		
0.5		0.6		----- ----- ----- ----- -----	Topsoil (0.0 – 0.6m)	
1.0				~ ~ ~ ----- ~ ~ ~ ----- ~ ~ ~	Start of Waste	
1.5				~ ~ ~ ----- ~ ~ ~	(All Domestic Waste – mainly plastic)	
2.0			2.2	----- ~ ~ ~ -----	-----Leachate: 2.2m-----	
2.5		2.5		~ ~ ~ ----- ~ ~ ~		
3.0		3.0		----- ~ ~ ~	End of Trial Hole	
Remarks:					Logged By: Aoife O’Flaherty E.E. Liam Ahearne A.E. Daniel Devine

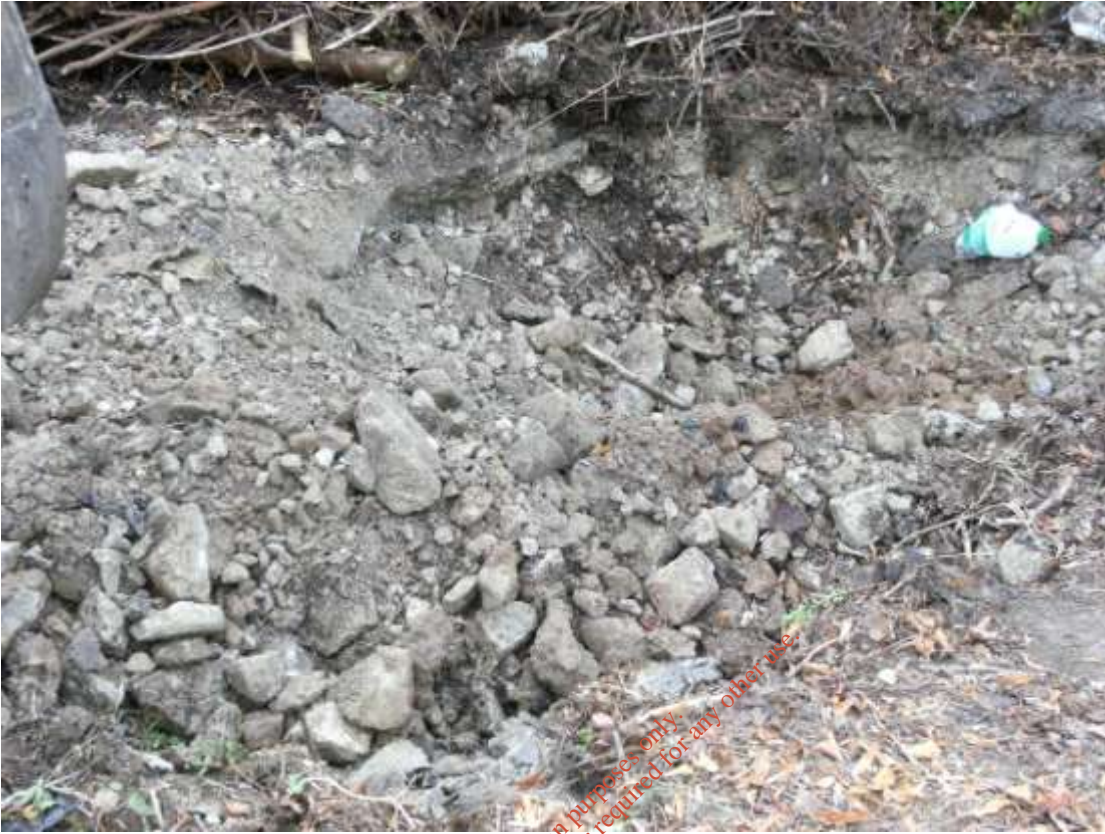
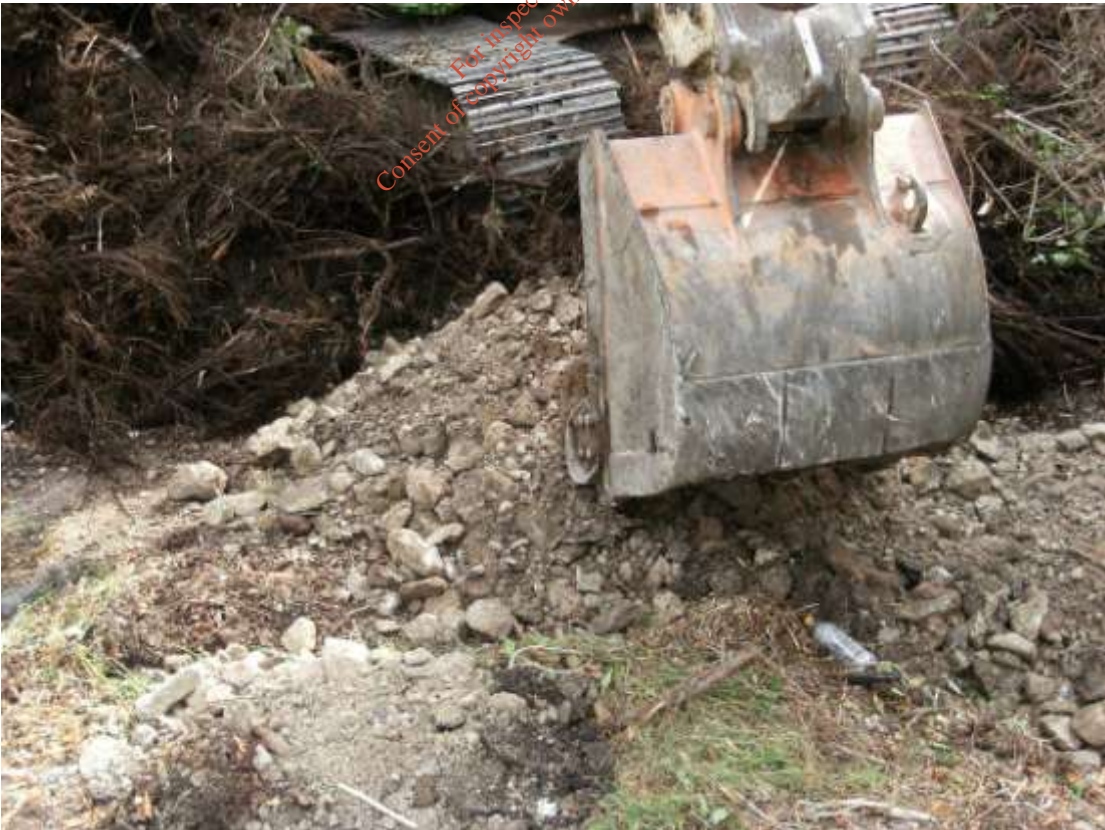
Trial Pit No. 8
Project Lismore Historic Landfill Exploratory Investigation		Co- Ordinates IX 04501 ITM 96452		Date 2 nd September 2010	
Location Townspark East, Lismore		Dimensions N/A		Method/ Plant 12 Tonne 360° Hitachi Excavator	
Samples & In Situ Testing					Strata Description
Depth (m)	Type/ Sample	Depth (m)	Water (m)	Legend	
0.5				- - - - - - - - - - - -	300 mm concrete pad Natural Bedrock
1.0					
1.5					
2.0					
2.5					
3.0					
Remarks:					Logged By: Aoife O’Flaherty E.E. Liam Ahearne A.E. Daniel Devine
