Environmental Risk Assessment for Unregulated Waste Disposal Site

Tier 2 Exploratory Investigation

Townspark East, Lismore Landfill

Tier 2 Landfill Assessment
Townspark East, Lismore,
Co. Waterford

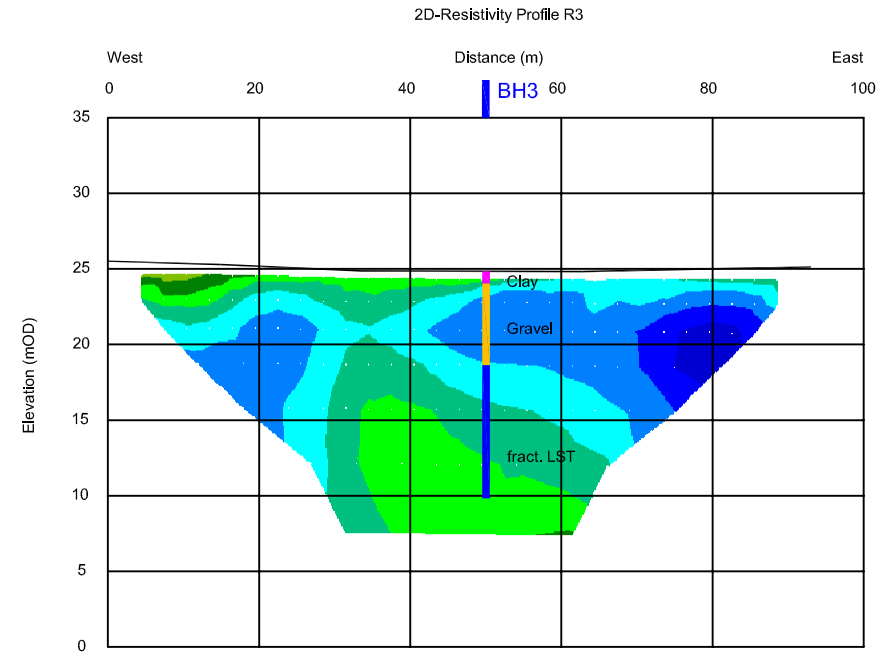
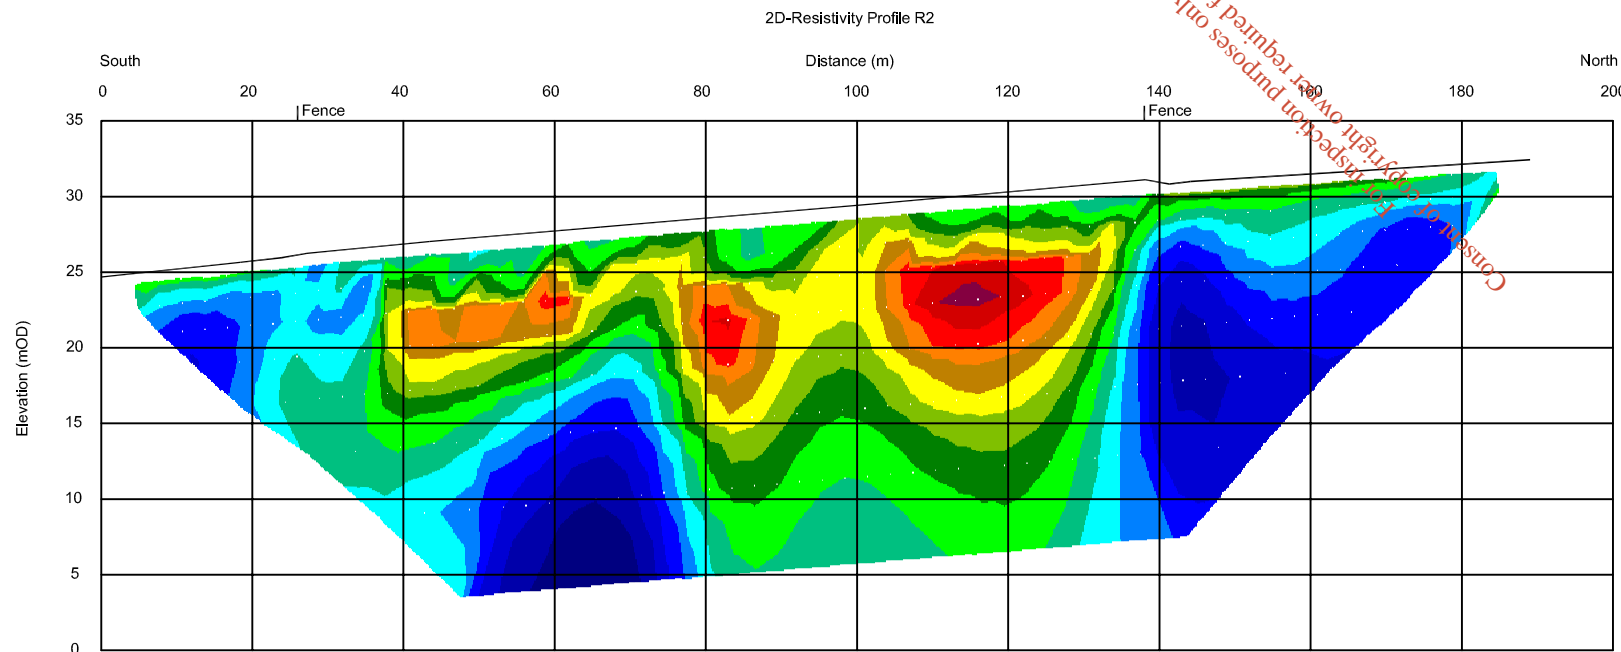
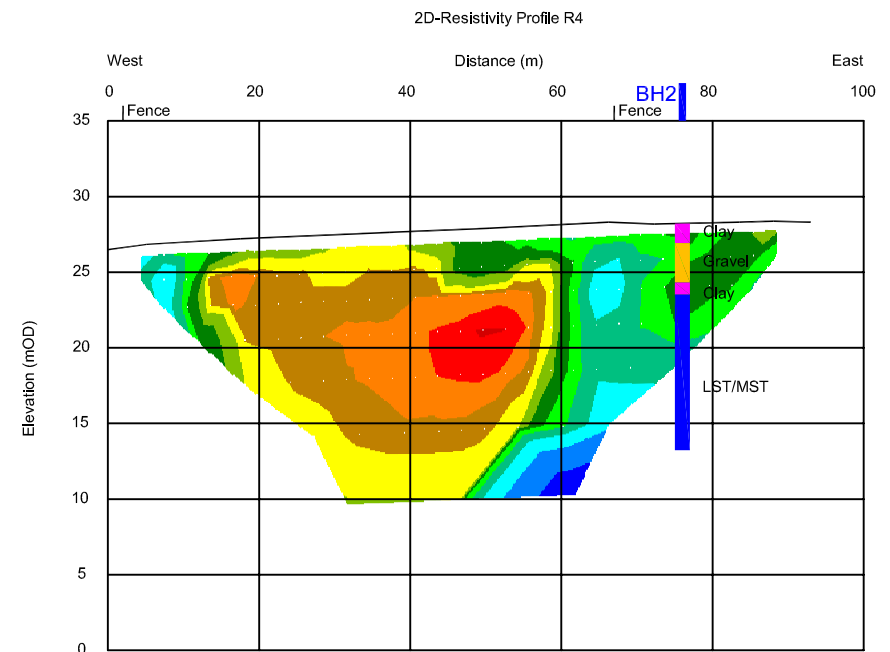
CLIENT	URS/Scott Wilson Ireland
PROJECT	Lismore Landfill Site Geophysical Survey
TITLE	Figure 1: Results of 2D-Resistivity Survey

Model Values 2D-Resistivity (Ohmm)

2.0	6.3	20.0	63.2	200	632	2000	6325
-----	-----	------	------	-----	-----	------	------
