Pollboy Landfill

Annual Environmental Report (AER) 2012

March 2013

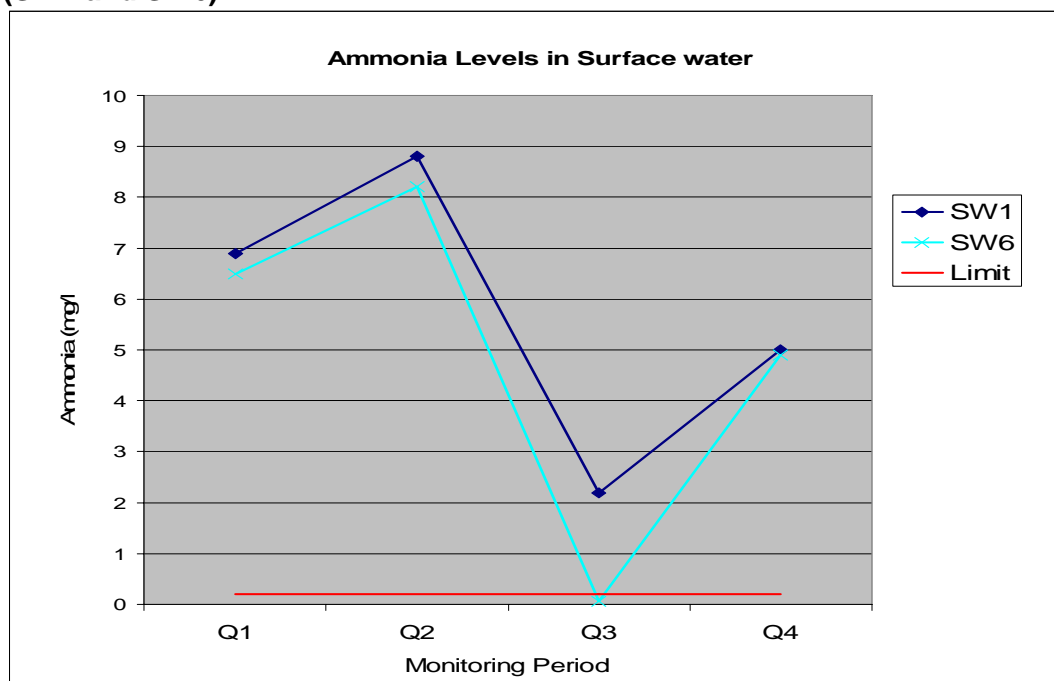
Figure 4.1: Elevated Ammonia Levels in Surface Water for the Reporting Period (SW1 and SW6)

Levels of ammonia were above the required limit of 0.2mg/l (as set out in S.I. 278, 2007) at surface water sampling point SW1 throughout the four sampling periods in 2012. The ammonia level at surface water sampling point SW6 decreased to below the limit of 0.2mg/l in Q3.

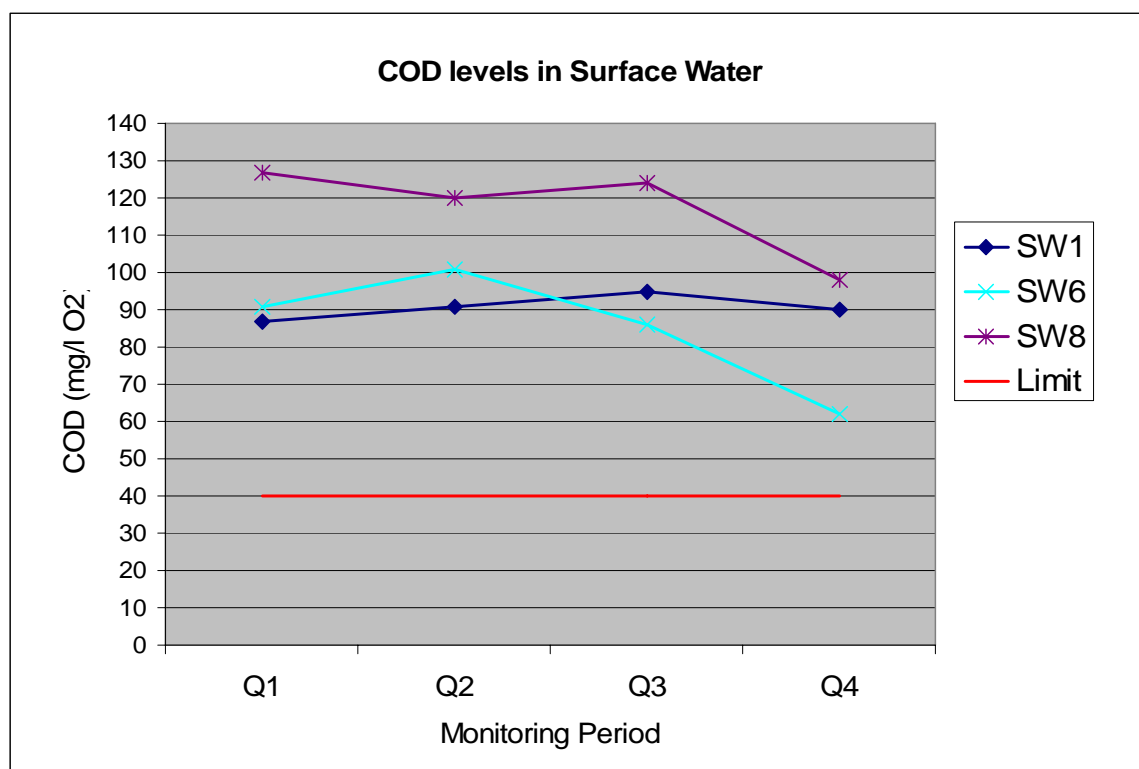
Figure 4.2: Elevated COD Levels in Surface Water for the Reporting Period (SW1, SW6 and SW8)

The levels of COD were also above the required limit of 40mg/l O₂ (as set out in S.I. 294, 1989) at surface water sampling points SW1, SW6 and SW8, throughout the four sampling periods in 2012. **Figure 4.2** shows the COD levels which exceeded the standard limits in surface water sampling points SW1, SW6 and SW8 during 2012.

Levels of pH, suspended solids, BOD, chloride, conductivity and dissolved oxygen were all within the required standard for each sampling quarter with the exception of SW6 which showed a slightly elevated level of BOD of 11 mg/l O₂ in Q2.

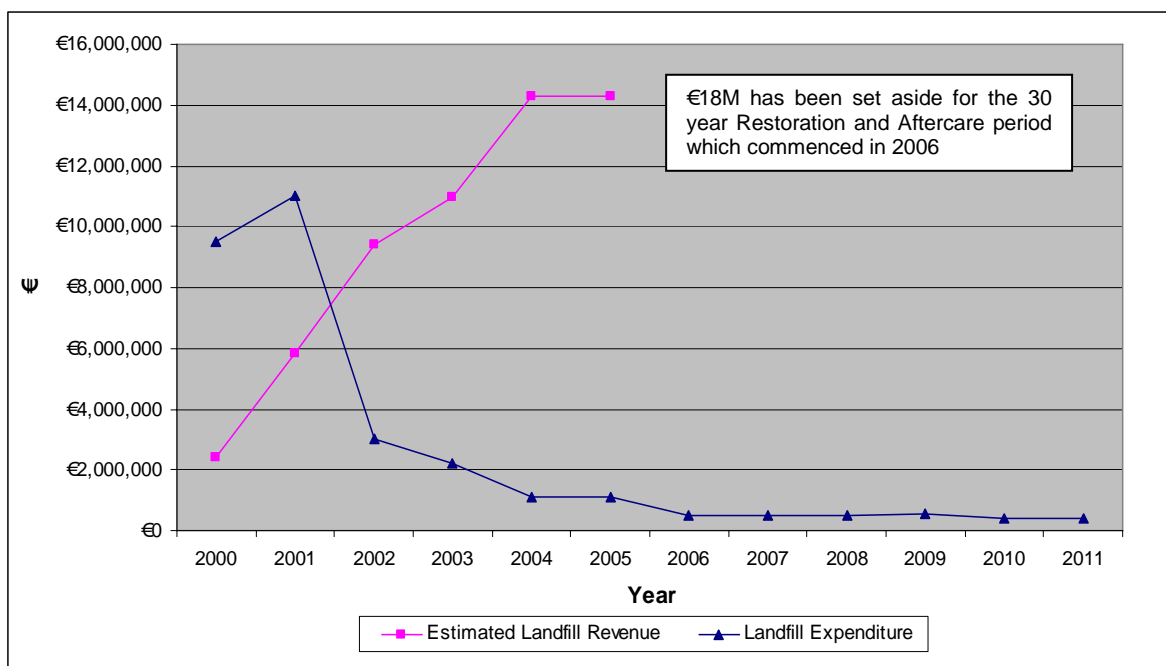
Figure 15.1: Estimated Landfill Revenue V's Landfill Cost (ex. VAT)

Operating Costs for the Civic Amenity Facility in 2012 were **€70,670(ex. VAT)**.

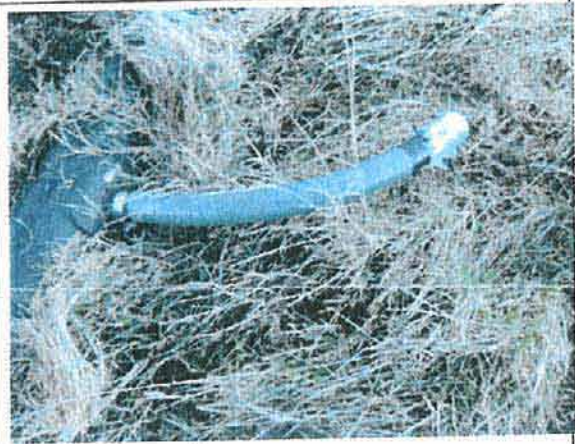
Photo2: Gas line disconnected
