**BALLEALLY LANDFILL  
BALLEALLY, LUSK, CO. DUBLIN**

**ANNUAL ENVIRONMENTAL REPORT 2012**

**WASTE LICENCE REF. NO. W0009-03**

**February 2013**

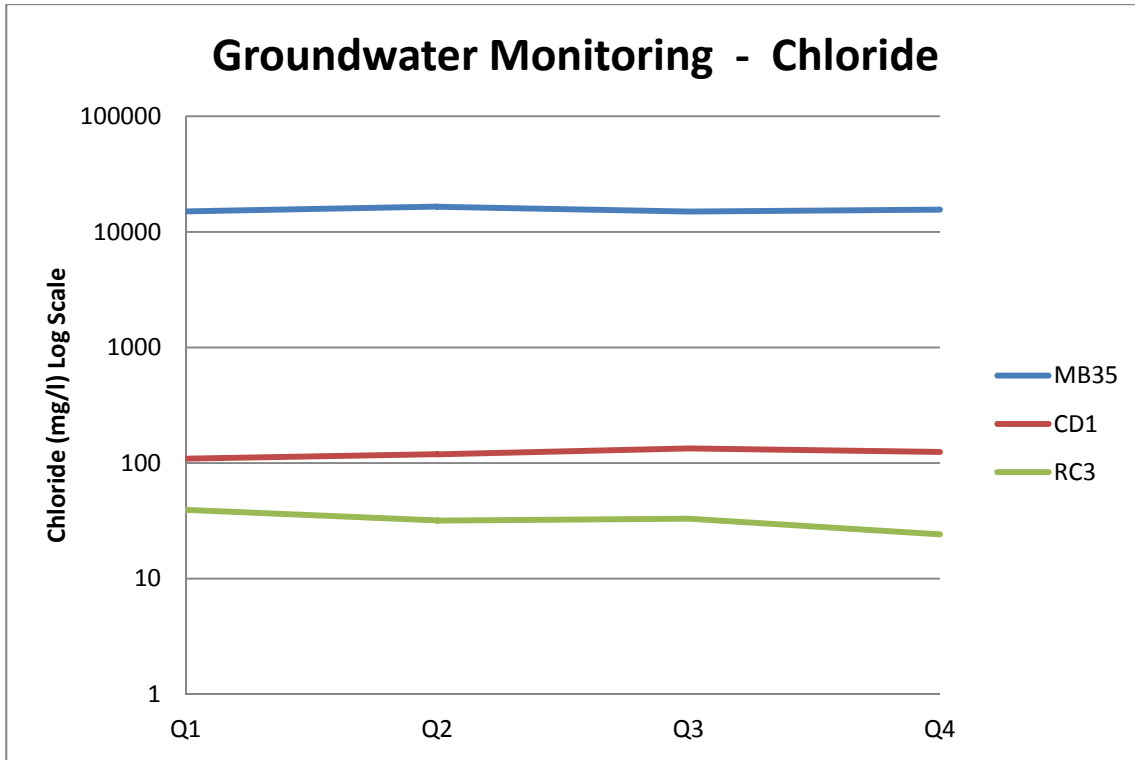
Figure 3.3: Quarterly Chloride Monitoring Results

The quarterly chloride (Figure 3.3) and electrical conductivity (Figure 3.4) plots follow a similar trend to each other. Results from both RC3 and CD1 are broadly similar with elevated chloride and electrical conductivity results found in all samples at MB35.

Both chloride and electrical conductivity levels are lower up-gradient at RC3, increasing slightly on-site at CD1 and then greatly down-gradient at MB35. It is observed that up gradient chloride levels at RC3 are elevated slightly (33-39.3 mg/L) above the IGV level (30 mg/l Cl) during the reporting period except in Quarter 4 where it falls below the IGV level.

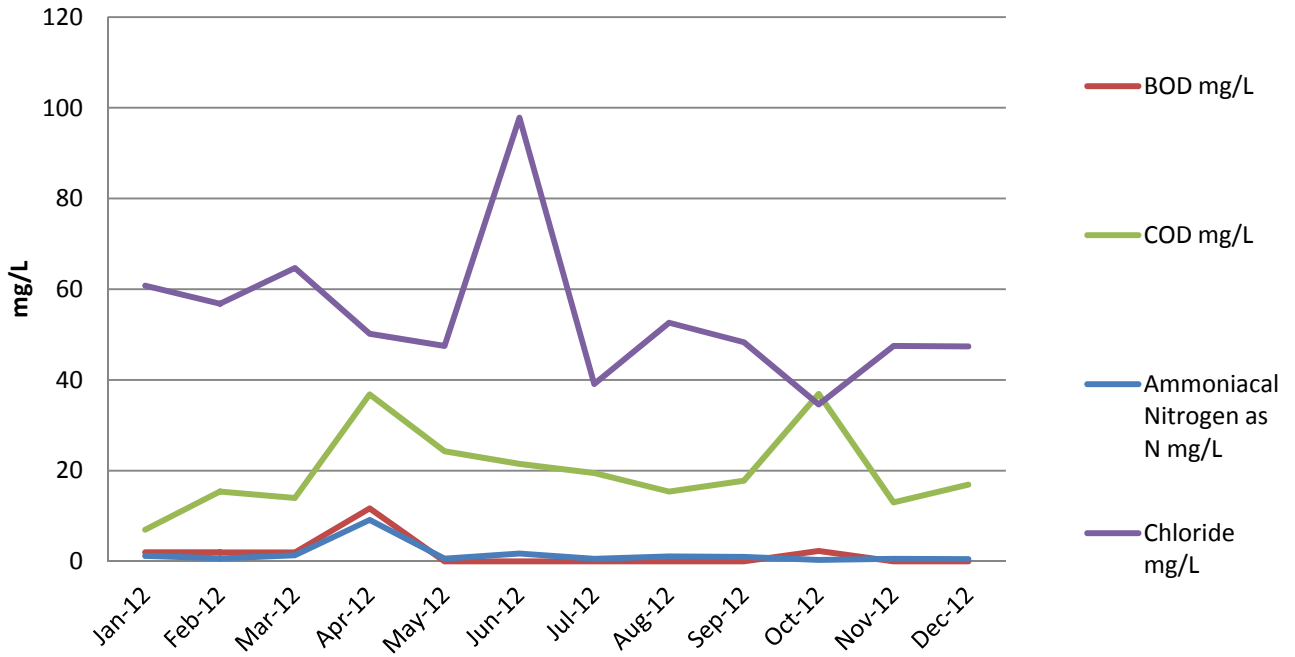
Figure 3.6: Monthly Monitoring Results for S3

For the monthly S3 sample analysis (Figure 3.6), COD and Chloride results were below the MAC in all months. BOD was also under the MAC during the reporting period except in April where a spike in parameters is noted. Ammoniacal N was above the MAC at S3 in every monthly monitoring event for the year.

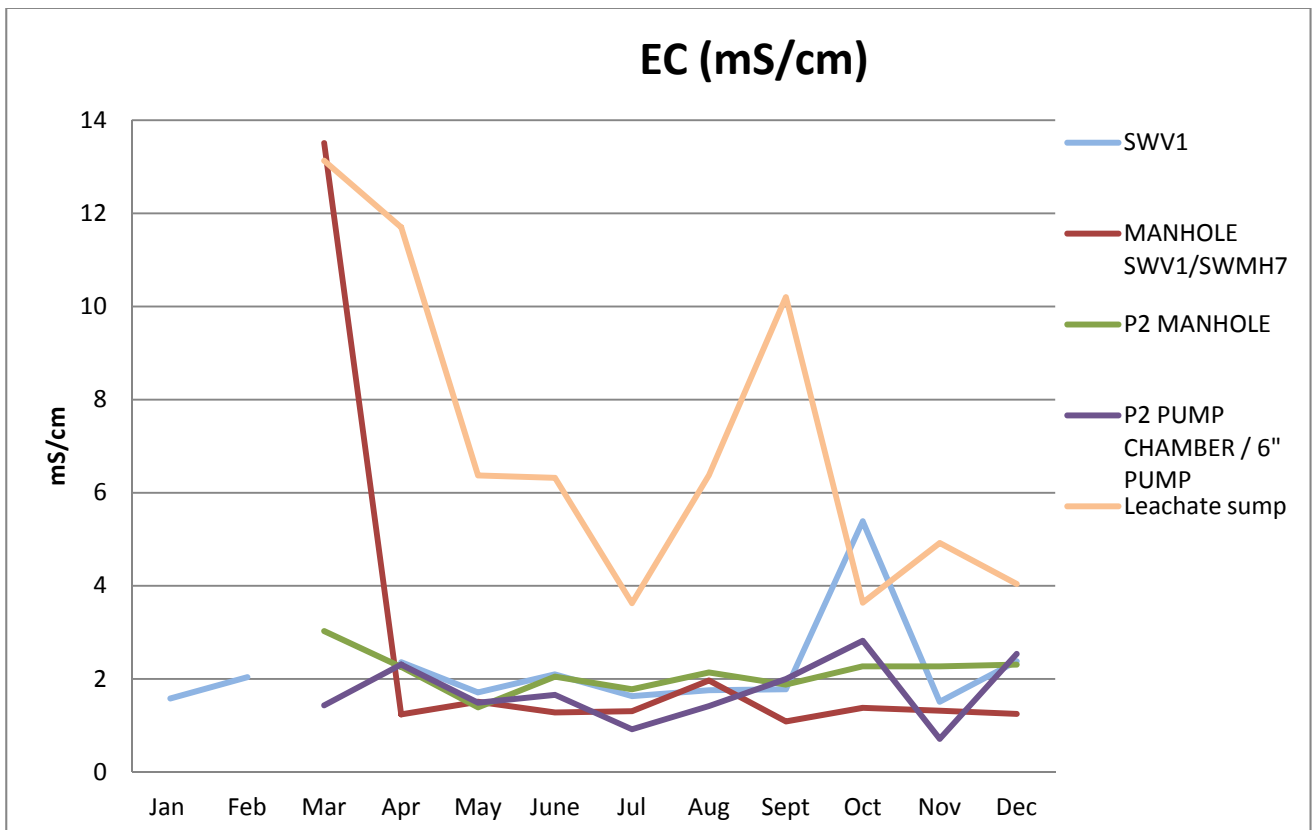
Figure 3.14: EC Levels: Additional SW Locations 2012

A review of surface water contamination is ongoing since August 2011; this review will be the subject of a report that is being prepared for submission to the EPA once sufficient data has been accumulated. This report will detail the investigations and mitigation measures carried out during this review. Four surface water monitoring locations are being monitored on a monthly basis to determine the source of contamination at SWV1. The locations are SWMH7, P2MH, 6" Pump chamber. These results are being presented on a quarterly basis to the EPA. Some trends have been included here. Ammonical N results for the 2012 monitoring period are shown in Figure 3.12. Please note that the results for the leachate sump are shown on the secondary axis. Chloride levels are shown in Figure 3.13 and in this instance both SWV1 and the leachate sump are shown on the secondary axis. EC levels are shown in Figure 3.14.

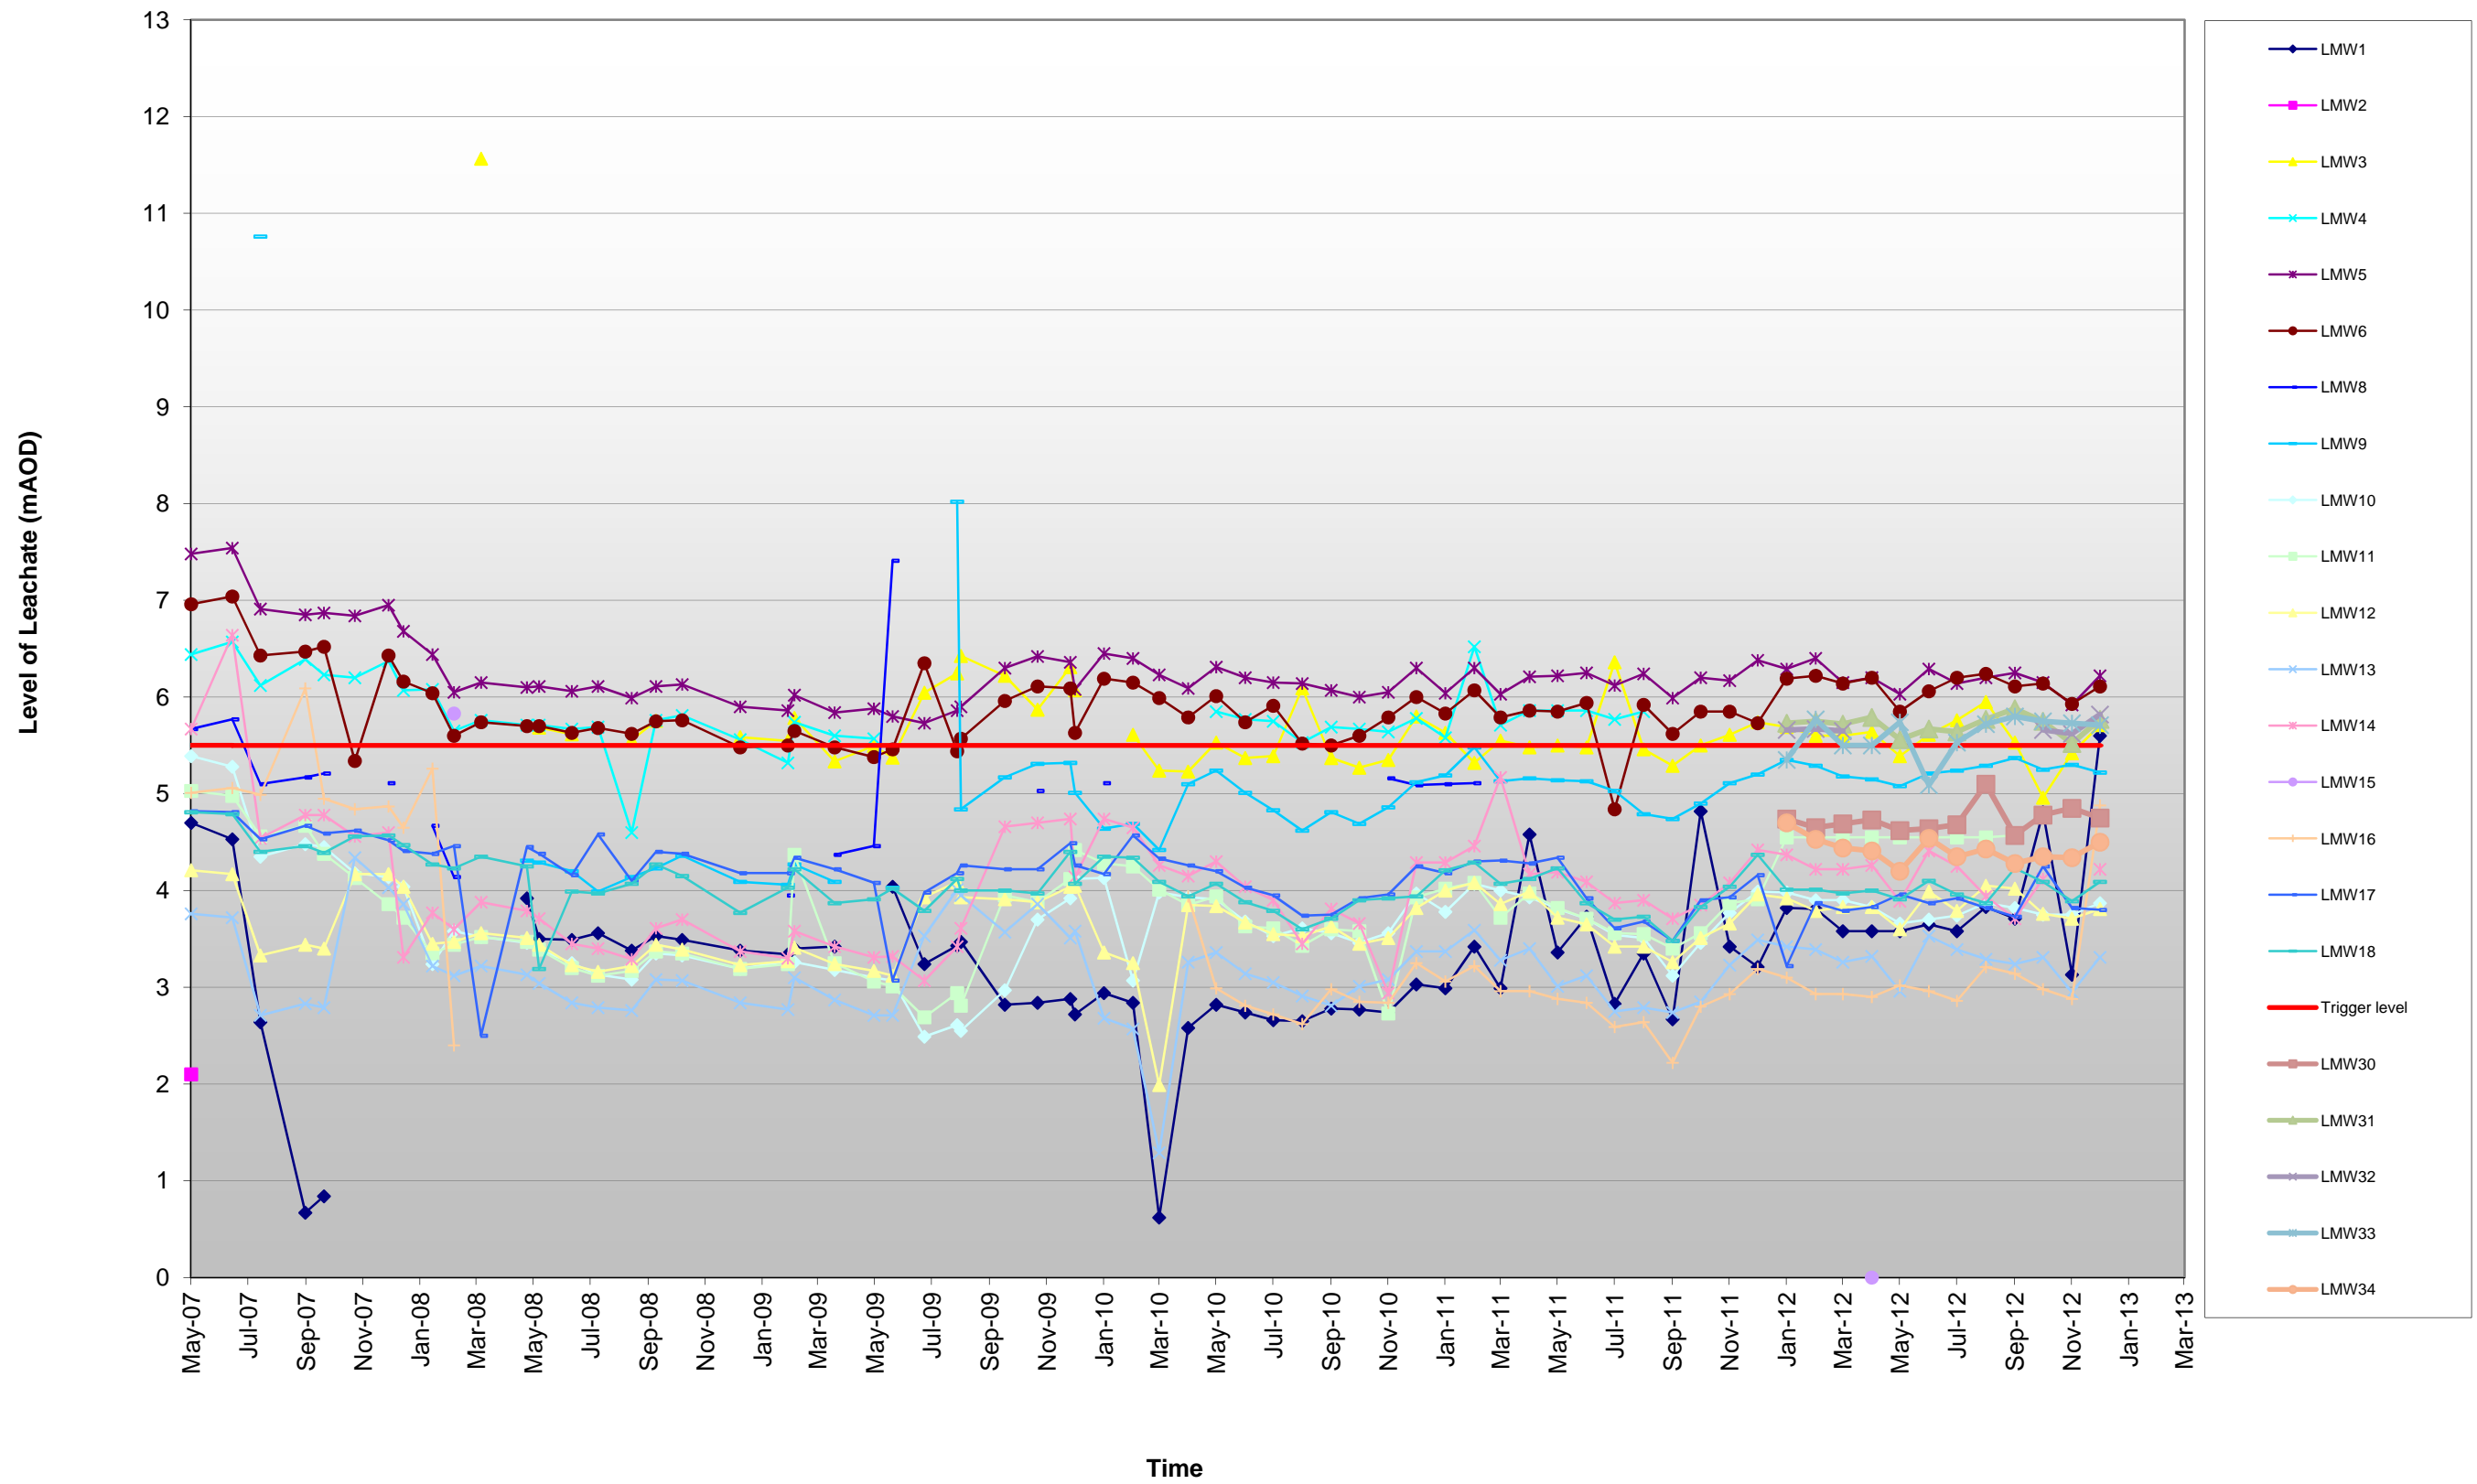
Figure 3.15: Monthly Level of Leachate Recorded in the landfill

It is observed that P1a & P1b are typically fully open and thus the northern and southern leachate lines are fully open. Therefore leachate should not be building up in the body of the landfill.

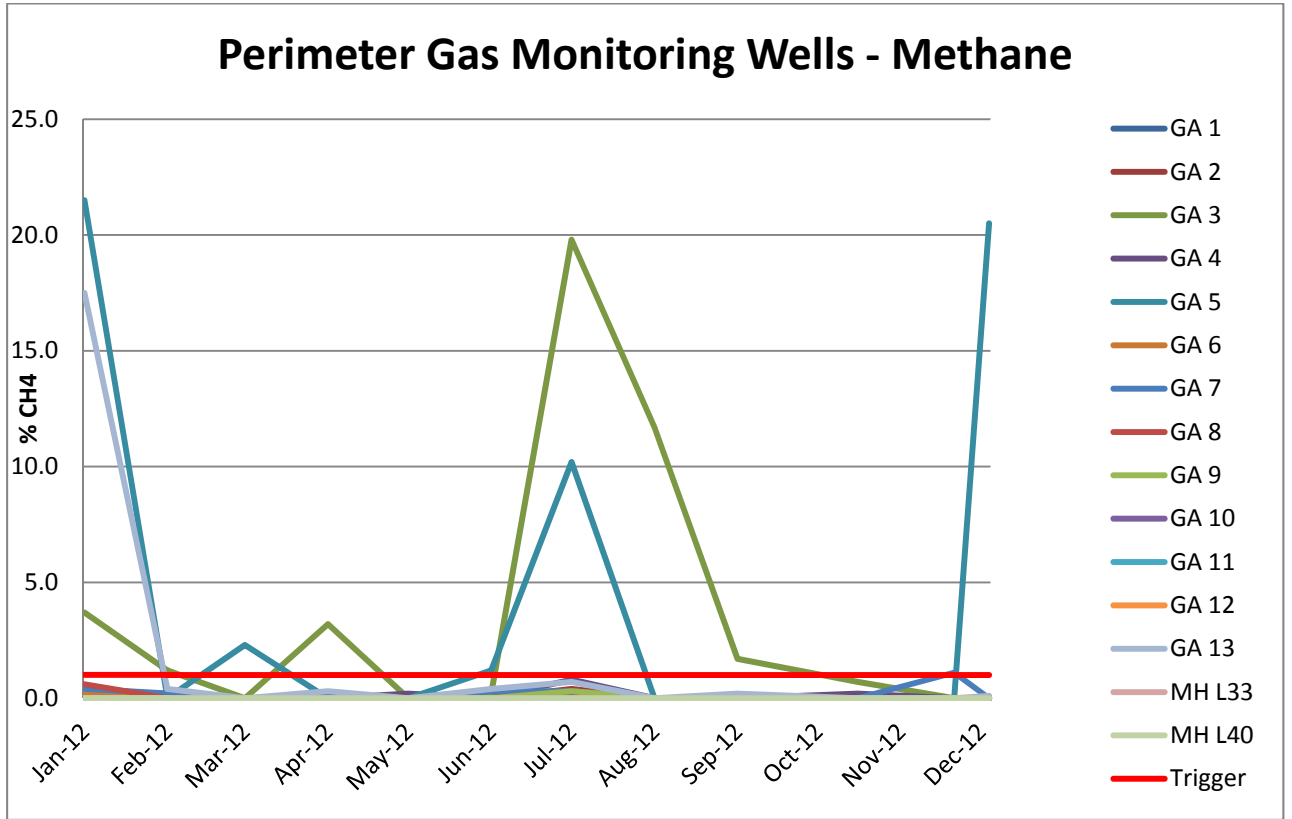
Figure 3.16: Methane Readings at Perimeter Gas Wells

CH<sub>4</sub> results for the 2012 monitoring period were generally below the 1% trigger level (Figure 3.16). However, results elevated above the trigger level at locations GA3 and GA5 and also once at GA13 are noted. These locations are situated along the north and north-eastern corners of the landfill.

During the monitoring period FCC took the proactive approach of monitoring LFG at on-site and off-site locations weekly and they are also monitoring GA5 more frequently. The results of this additional monitoring are retained by FCC on-site and any changes in the trends will be noted. This monitoring is in addition to the licence compliance monitoring being undertaken by FTC.

Additionally FCC are working with Bioverda who manage the landfill gas on-site to effectively balance the gas field and reduce the levels of methane noted in GA5. A number of additional in-waste landfill gas extraction wells have been drilled in the landfill body during the reporting period and have become operational in order to increase LFG abstraction.

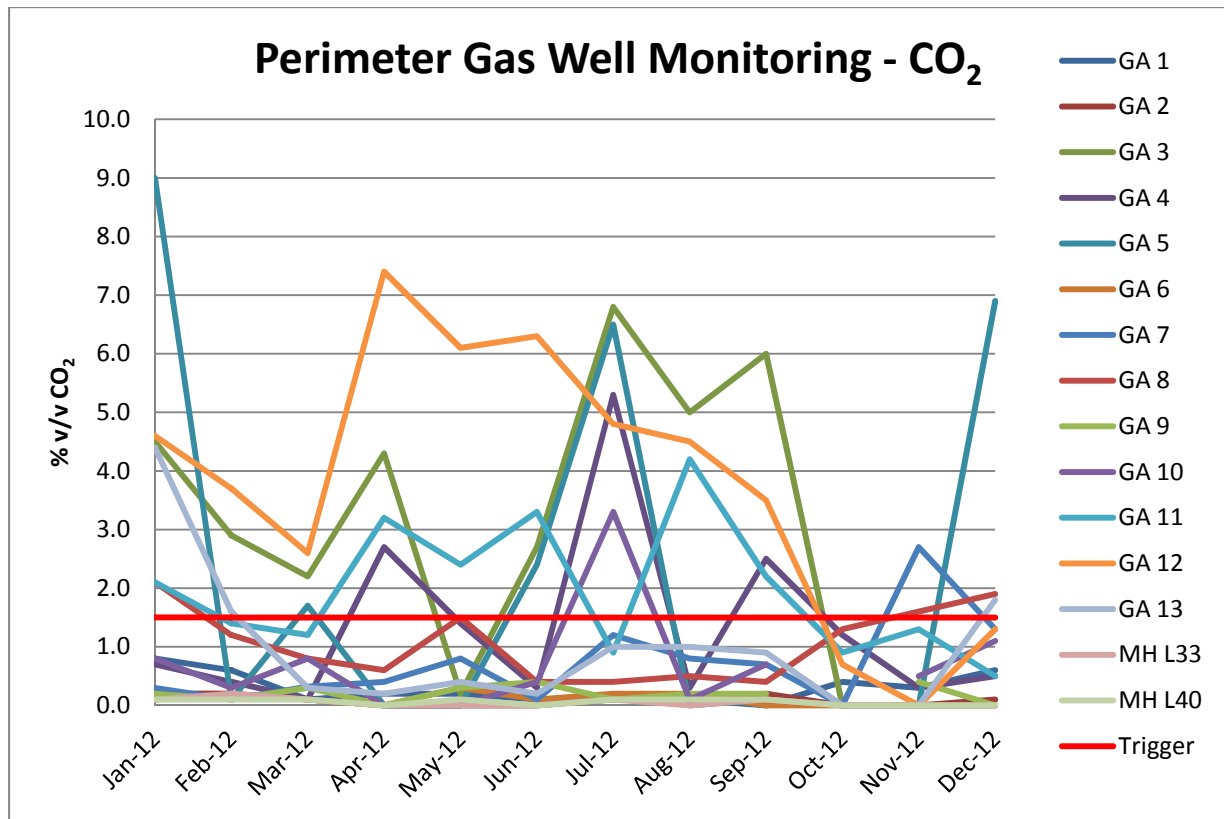
Figure 3.18: Carbon Dioxide Readings at Perimeter Gas Wells

It was seen on a number of occasions across the monitoring locations that the CO<sub>2</sub> level results were elevated above the 1.5% trigger level (Figure 3.18). It is however noted that the general trend towards the end of the year was positive with a number of locations falling below or coming very close to the acceptable level.
