**Enva Ireland Ltd.
Raffeen Ind. Est.
Co. Cork**

W0145-02

**Annual Environmental
Report 2012**

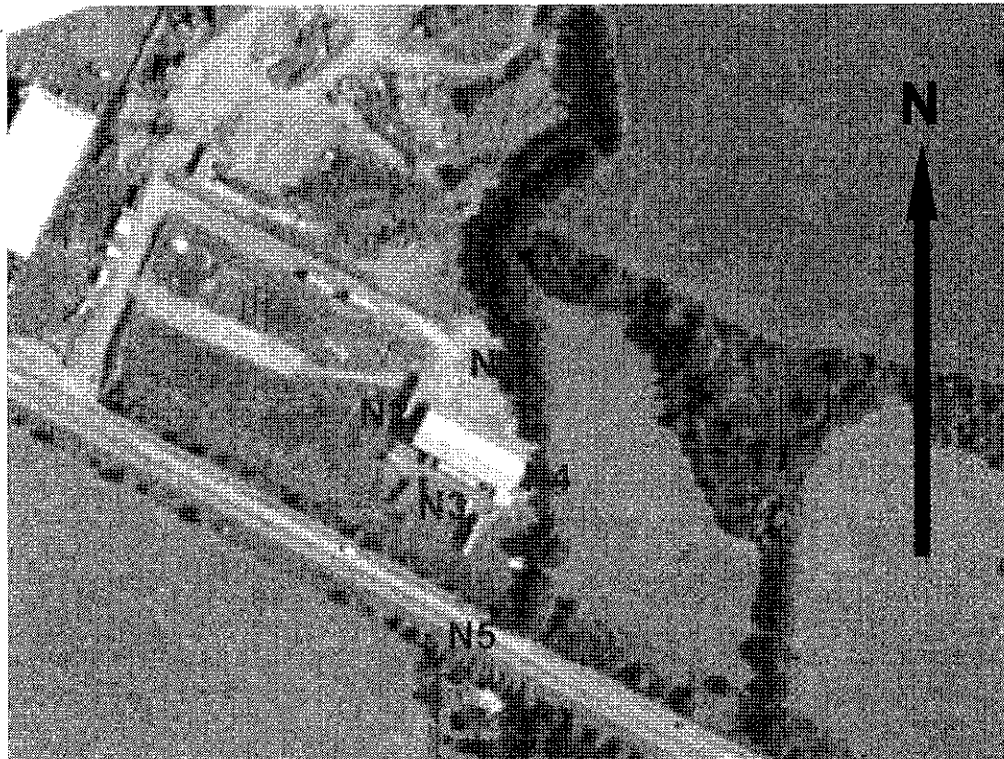
Fig 1 - Diagram of Site Layout- measurement positions shown in red.

The diagram below shows the site, its surrounds and all measurement positions. The adjacent road is also visible. Note: the Enva building was being constructed when this image was produced, and is now slightly larger.

The **Noise Sensitive Location** is N5:

- **N5** is on the southern grass verge of the N28, directly in line with the adjacent house and the ENVA facility.

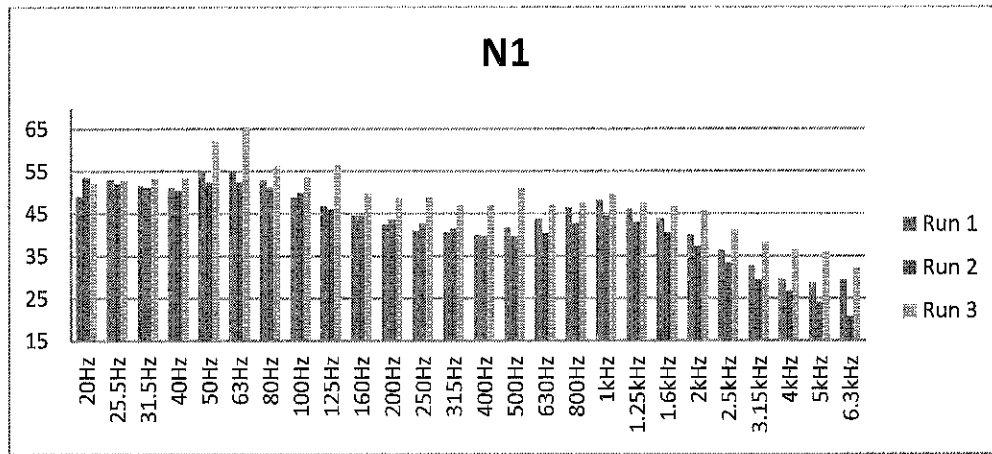
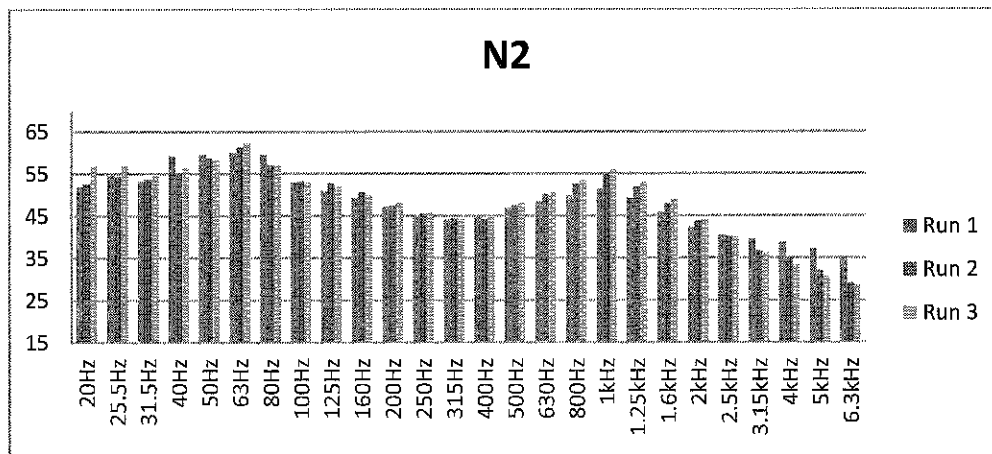
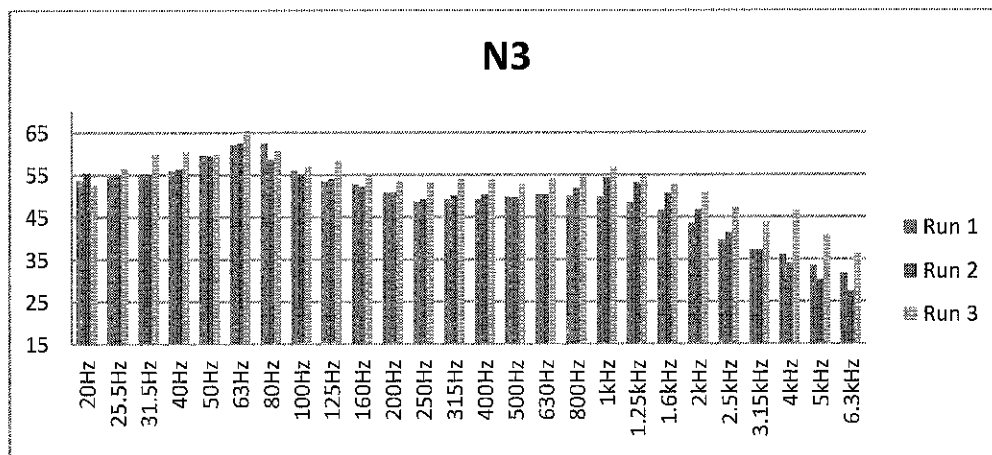
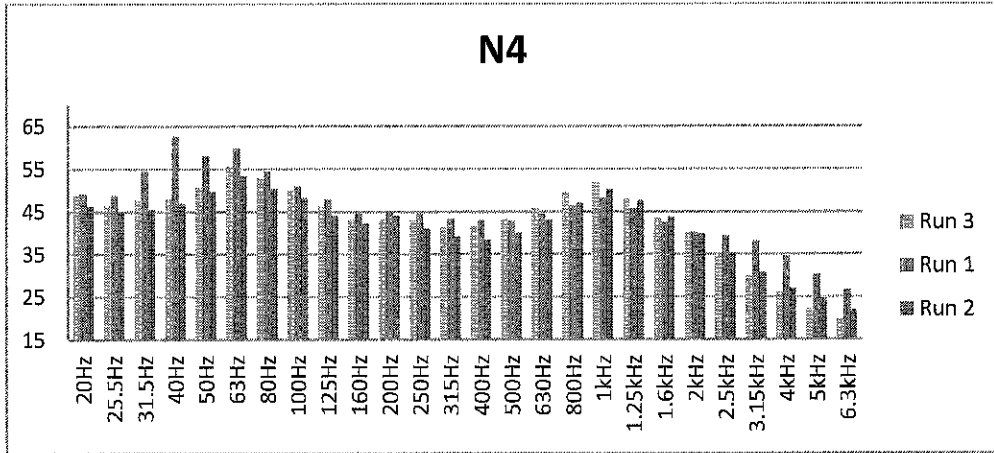
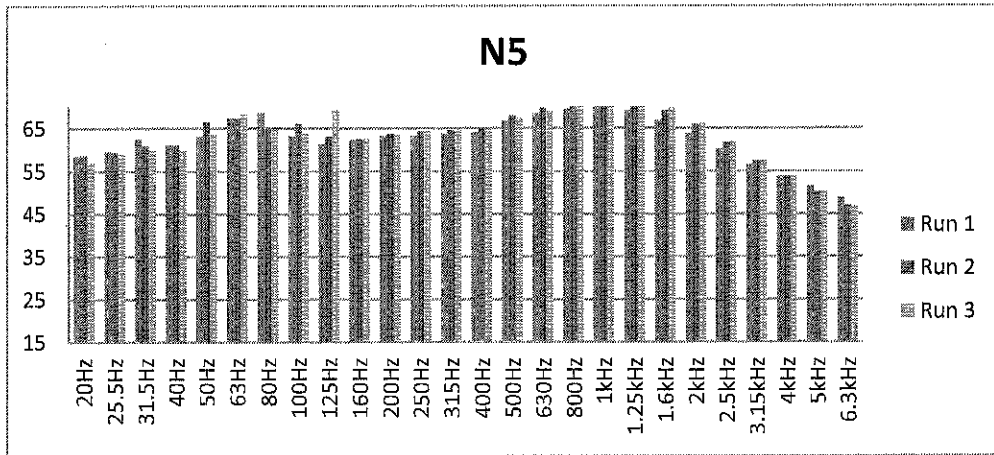
Graphs of 3rd Octave Spectra for the above data.
