Annual Environmental Report 2012

Ballaghveny Landfill, Ballymackey, Nenagh, Co. Tipperary.

North Tipperary County Council. Environment Section, Civic Offices, Limerick Road, Nenagh, Co. Tipperary.

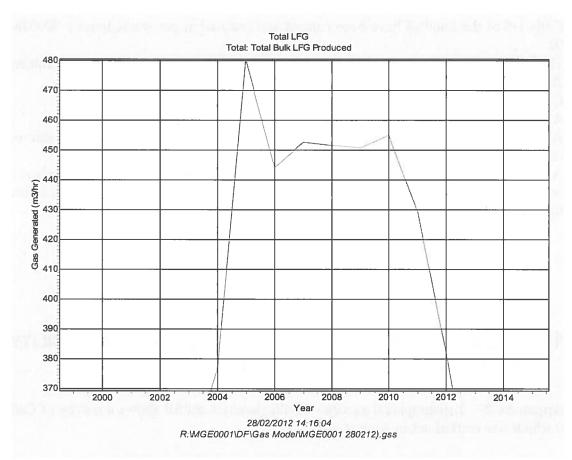
Figure 1: Total Bulk Landfill Generation as estimated by GasSim

Total bulk landfill gas generated in 2012 was estimated to be $382m^3/hr$ as shown in **Figure 1**. This equated to $3,355,488m^3$ of landfill gas generated at the landfill in 2012 as estimated by GasSim. The average volume of landfill gas flared for 2012 was $363m^3/hr$.

The GasSim model was adjusted in February 2012 to correlate with onsite conditions as is best practice. This adjustment also affected previous years gas generation figures. The figure of $315m^3/hr$ reported for 2010 was underestimated as a result $(455m^3/hr \text{ see Figure 1})$.

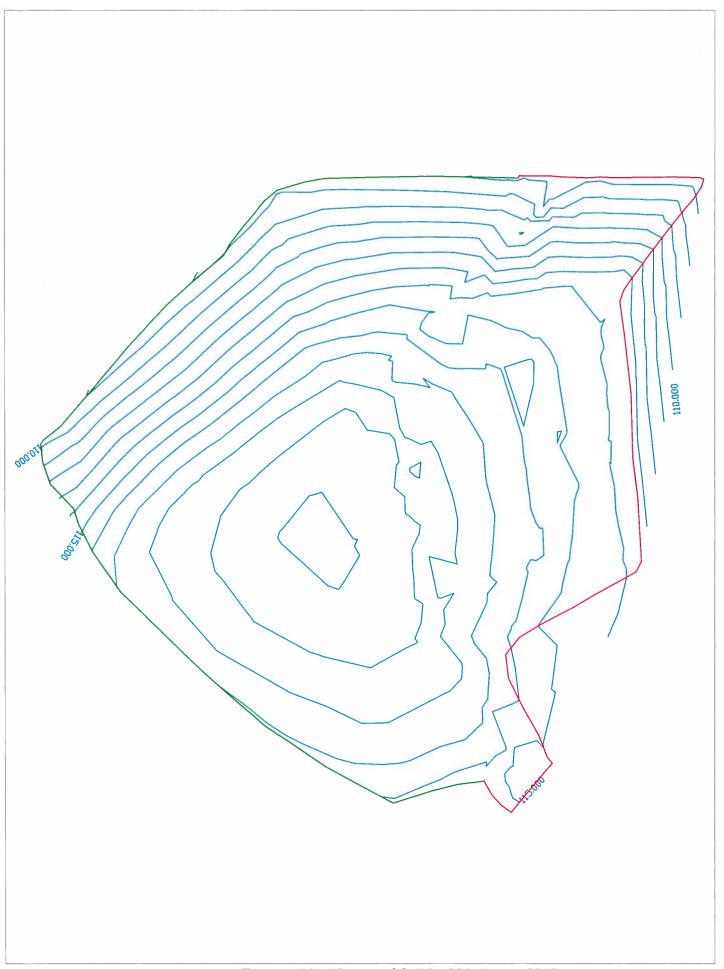
Topographical Survey of Cell 9 - 30th August 2012

The most recent topographical survey of Cell 9 was carried out in August 2012. A proposed filling plan was produced in January 2010 (See appendix 2)

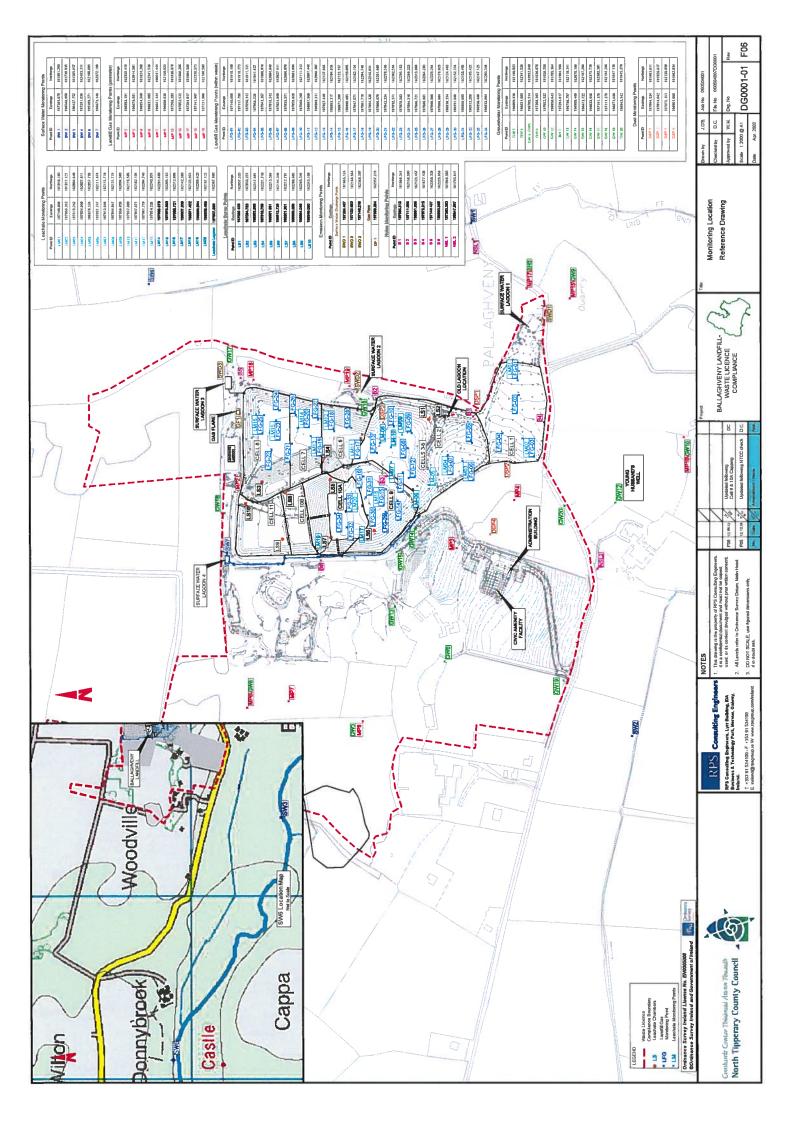
Monitoring Location Reference Map

The following sections summarise the environmental monitoring undertaken at Ballaghveny Landfill Facility during the reporting period. Drawing DG 0001-01, Rev F06 in **Appendix 3** shows the location of all monitoring points. The results and analysis of this monitoring were submitted by North Tipperary County Council to the Agency in the form of four quarterly monitoring reports during 2012/2013. These results are included in **Appendix 4**.
