ANNUAL ENVIRONMENTAL REPORT 2012

DUNGARVAN WASTE DISPOSAL SITE

Waste Licence Register No. W0032-2

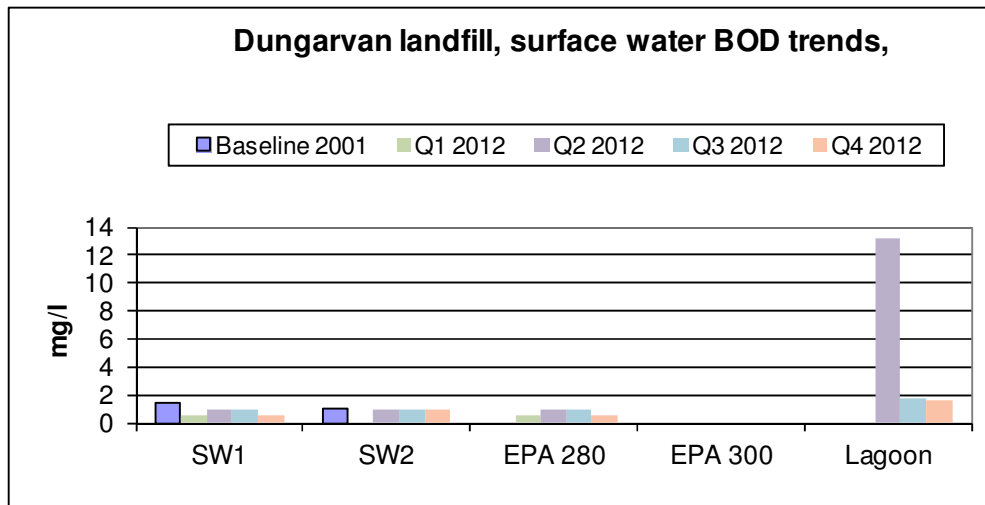
The BOD test is a measure of the amount of oxygen consumed by microorganisms in breaking down organic matter in water. Respiration by phytoplankton or their decay, can also lead to oxygen depletion during the BOD test resulting in a high BOD value. Surface waters supporting fish life should have a BOD value < 4 mg/l BOD.

BOD levels were low at river sites and in the lagoon throughout the year. Other water quality tests were also satisfactory.

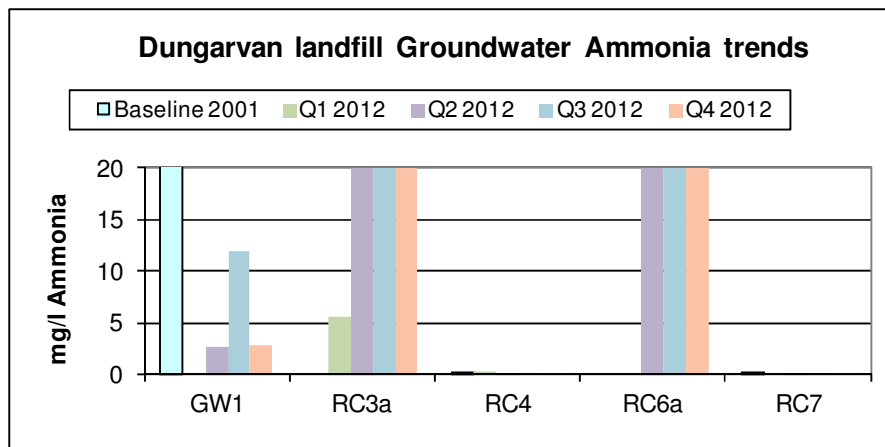
#### Key Parameter – Ammonia

Ammonia was elevated at sites GW1, RC3a and RC6a. RC4 and RC7, outside the landfill area, had relatively low ammonia. RC7 had a high ionic content at times, possibly indicating brackish water intrusion.

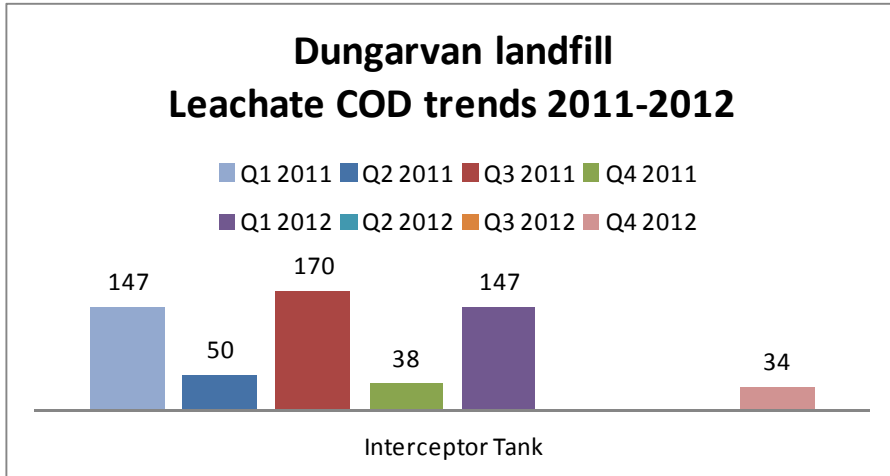
Figure 5.3.2 Leachate COD trends 2011 – 2012

The COD test measures the organic matter in a sample that is amenable to chemical oxidation. The COD test is usually applied to polluted waters and waste-waters.

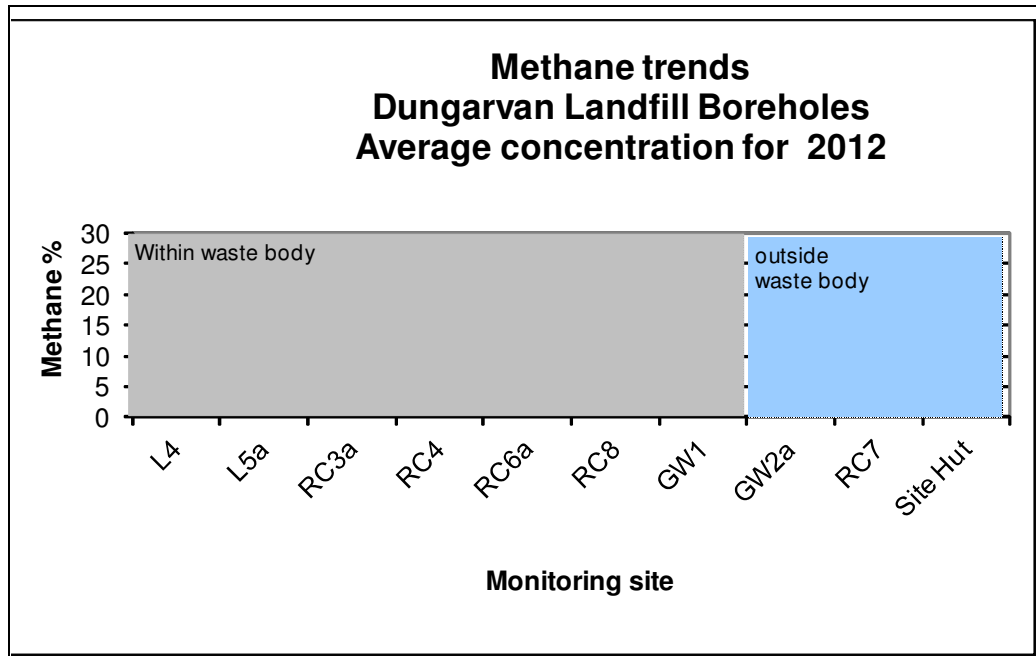
Figure 5.5.1 Methane spatial trends 2012

Relatively low levels of methane were detected at most boreholes within the waste deposit area, and were lower compared to baseline levels in 2001.

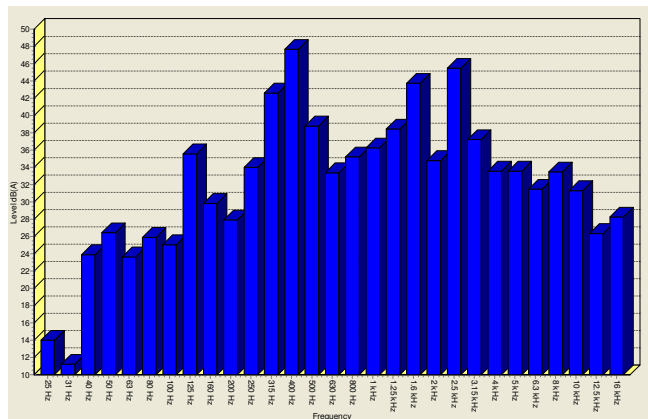
Fig 5.6 Dungarvan landfill noise monitoring 12/12/12, site entrance, octave band analysis, A weighting

Noise level recorded in December 2012 was compliant with the noise emission requirement of 55 dB(A) LAeq (30 mins) and was lower than the baseline level of 54 dB recorded in 1998.

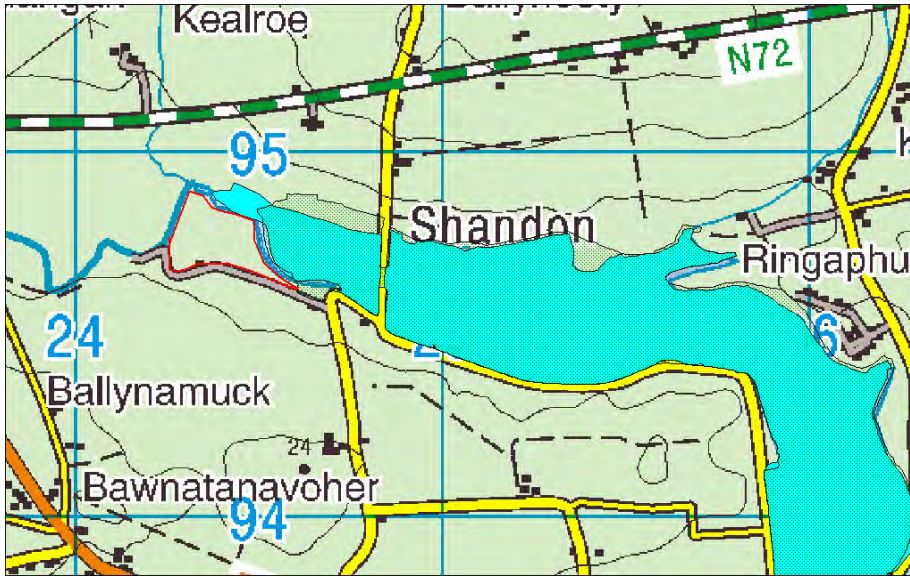
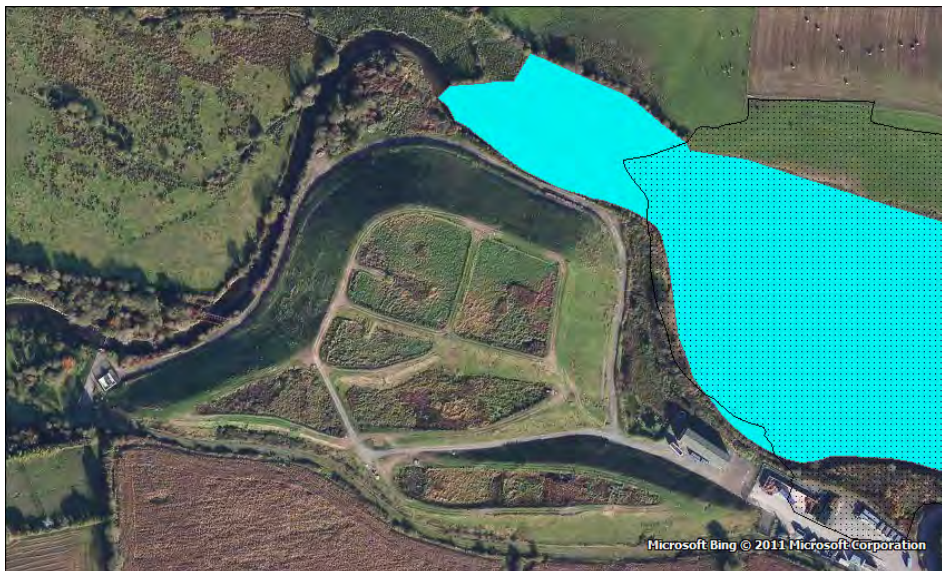
**Figures 1&2 . Location of Dungarvan Landfill in relation to the River Colligan and Ballyneety Bridge showing boundaries of sites designated for nature conservation – Dungarvan Harbour SPA and pNHA**

Dungarvan Landfill site is located at Ballynamuck Middle, Dungarvan, Co Waterford (Figure 1), north-east of the town of Dungarvan. The principal land use around the landfill site is agricultural. The River Colligan flows in a west to east direction along the northern perimeter of the site before flowing beneath a bridge (Ballyneety Bridge) down the River Colligan Estuary into Dungarvan Harbour.

Dungarvan Harbour is a designated Special Protection Area (SPA) under the EU Birds Directive. The designated area (code 4032) covers an area of 1,041 hectares and extends along the River Colligan estuary as far upstream as Ballyneety Bridge. A similar area to the SPA is a designated Ramsar Site (Site Code 835). Appendix 1 details the site synopsis.

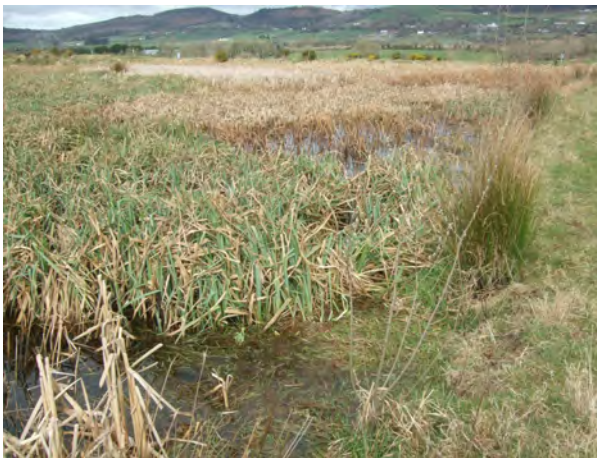
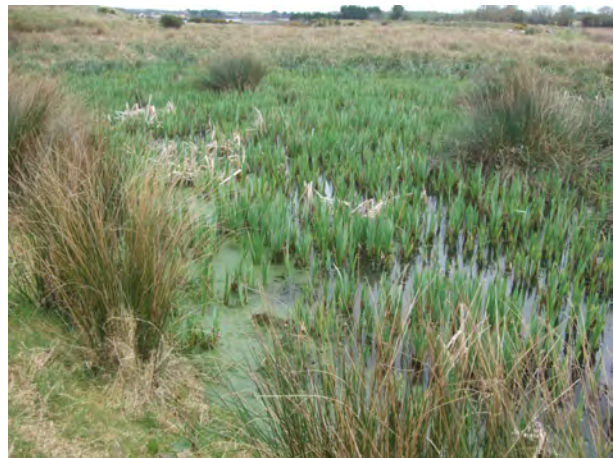
A series of 6 constructed wetlands were established on the landfill cap and are designed to collect and treat residual leachate from the landfill. The wetlands installed in autumn 2008 were planted with a mix of wetland vegetation such as reeds and sedges. Another artificial pond occurs in the south east of the landfill site and supports some submerged and emergent vegetation and has an extensive reedbed behind it. Artificial lakes and ponds occupy approximately 45% of the site area.

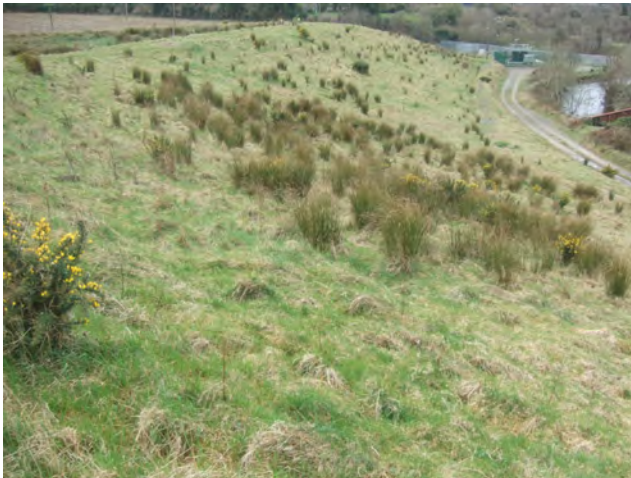
Patches of wet grassland occur on the western and northern side of the site with a frequent presence of *Juncus* species. Wet grassland accounts for 2% of habitat cover.

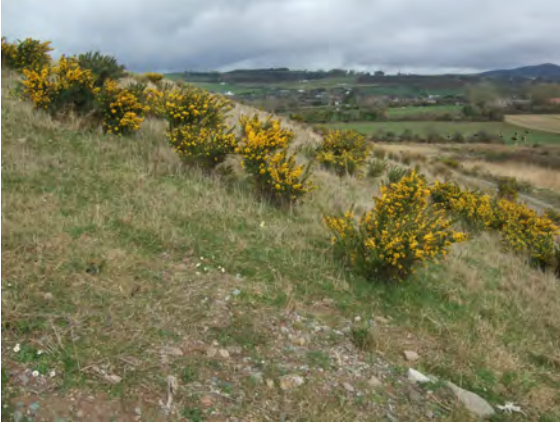
Some small areas of scrub occur around the periphery of the landfill site. The most extensive area of scrub is found on the riverbank along the north-eastern edge of the site. This area has developed from other habitats particularly recolonising bare ground (ED3). A narrow strip of scrub also occurs along the southern boundary. Scrub habitat accounts for 4% of the site area. The ability of Gorse to spread quickly will likely mean a rapid succession from grassland to scrub cover on the landfill cap. The presence of willow around the wetland margins and eastern slopes will also encourage the acceleration of scrub cover.

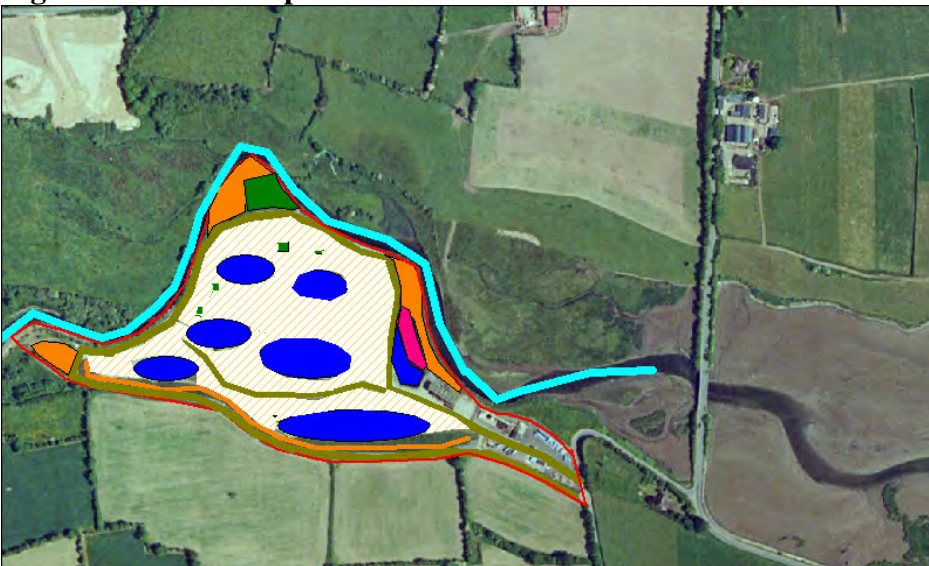
**Figure 3 Habitat Map 2010**

The landfill site is bordered to the north and south by agricultural lands, including improved agricultural grassland (GA1), wet grassland (GS4) and arable crops (BC1). Scrub (WS1) and hedgerows and treelines (WL1 & WL2) occur throughout the agricultural landscape. Upper saltmarsh (CM2) and mud shores (LS4) occur above Ballyneety Bridge (just east of the landfill site). Figure 3 details the habitat cover of the landfill site.

Figures 3 and 4 below illustrate the habitat cover of the landfill site in 2010 and 2013

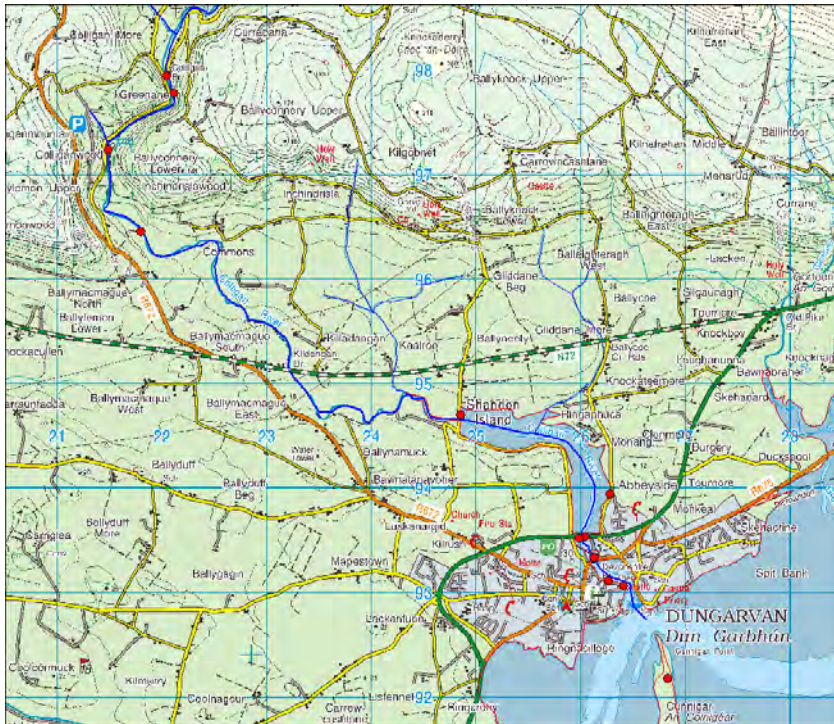
**Figure 5. Evidence of Otter activity along the Colligan River (red dots) based on collection of Otter Spraints from the MISE Otter Survey 2012.**

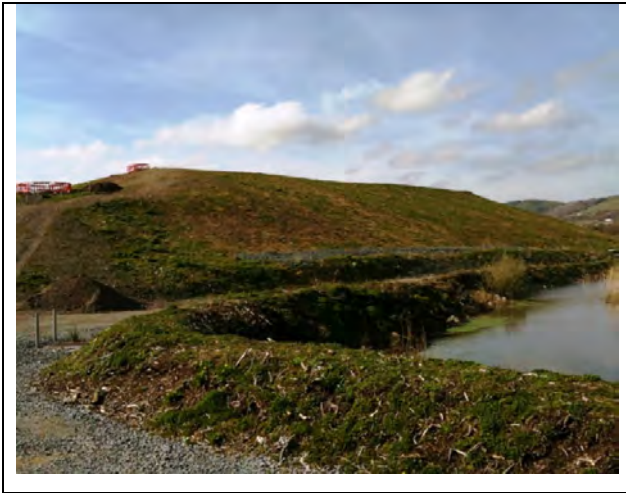
**Development / Infrastructural works summary (completed in previous year or prepared for current year)**

A flare trial was carried out in 2009 to confirm the size of permanent flare required. A closed permanent flare of 100 m<sup>3</sup>/hr capacity was assessed as required, and was installed.

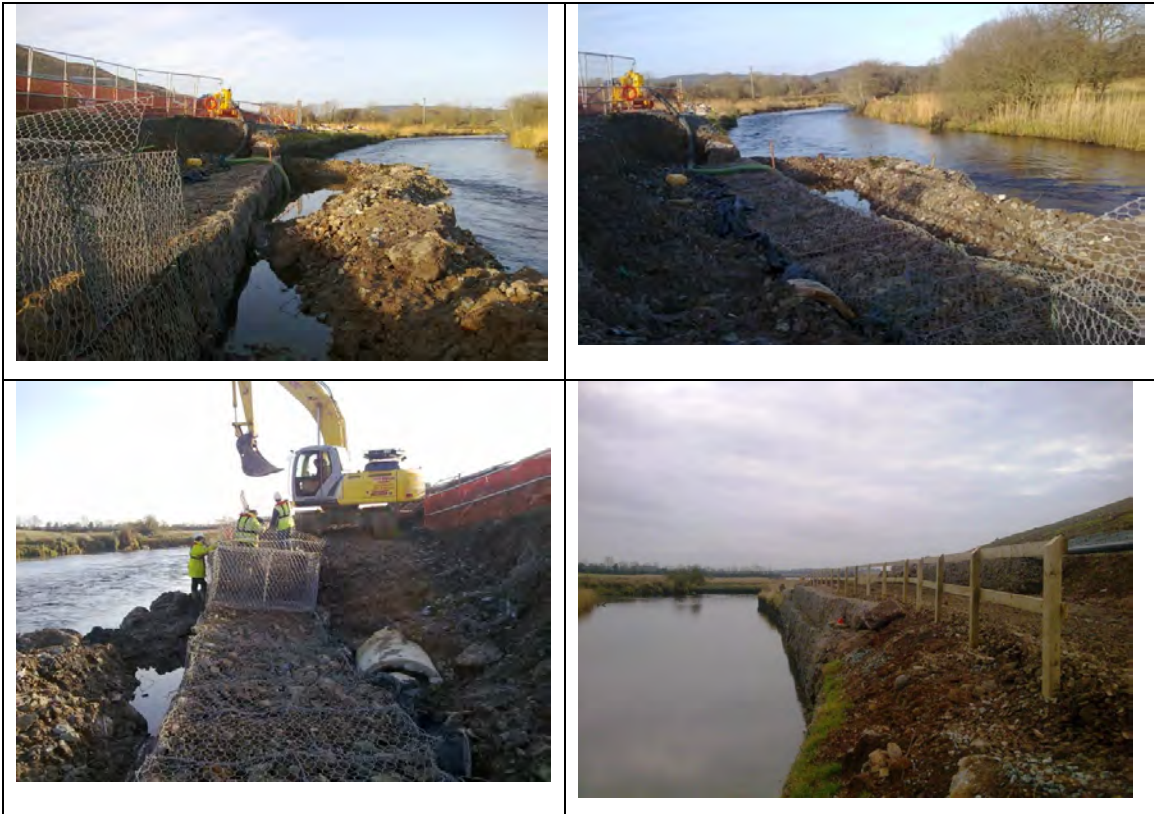
Following the tender and recommendations in the Gas Flare Tender Assessment Report (May 2008), AFS was awarded the tender for the flare and associated works. The gas collection system was completed in June 2009, but the project was then put on hold due to funding

The telemetry system associated with the flare is fully operational and monitoring data referred to in Schedule C.1.2 of the licence can be furnished to the Agency as required. However no data was downloaded during the reporting period. The first set of results will be forwarded to the Agency as part of the Landfill Gas Survey. The licensee will agree a period for residence time also in accordance with Schedule C.1.2. Flare Servicing Reports along with the 2012 EPA Landfill Gas survey are included in **Appendix G**

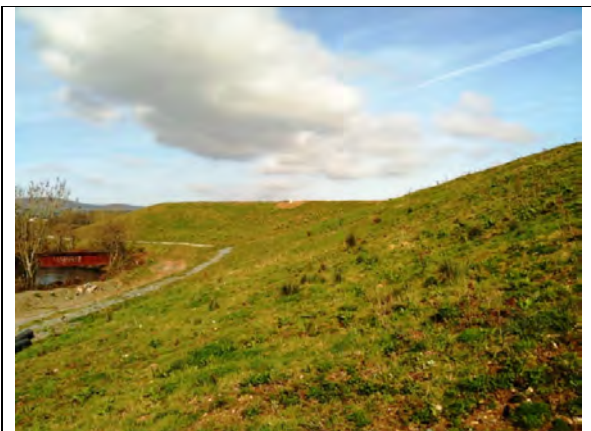
**Objective 1** – To maintain site infrastructure to the standards outlined in Condition 3 of the Waste Licence

**Objective 2** – That no specified emissions from the facility, shall exceed the limit values, set out in Condition 6 and Schedule C of the Waste Licence.

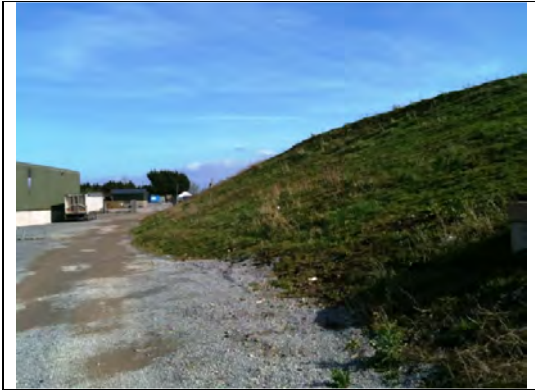
**Objective 3** – To maintain the Monitoring Programme as outlined in Condition 8 and Schedule D of the Waste Licence.

**Target 3.2** – To submit Monitoring Reports to the Agency within the timescale as outlined in Schedule E of the Waste Licence.

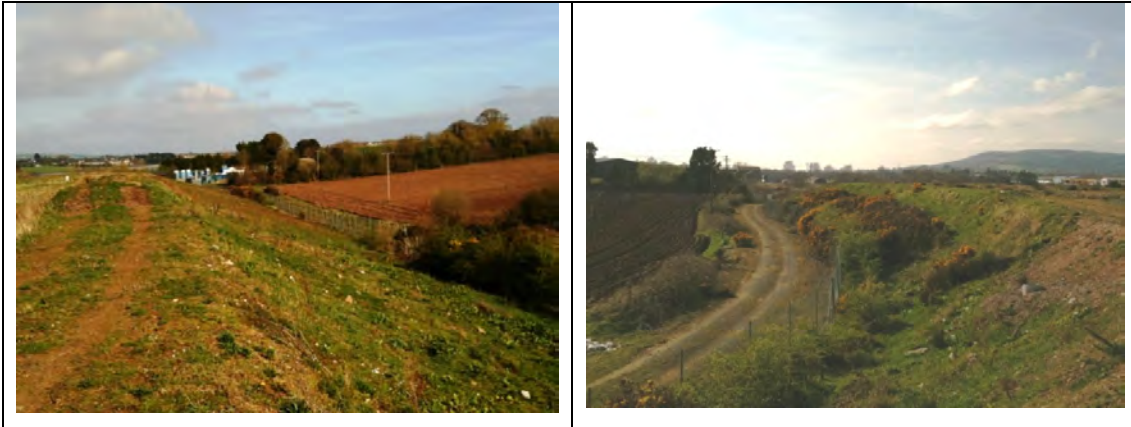
**Objective 4** – To establish good record keeping and that all records are held at the facility office to comply with Condition 10 of the Waste Licence.

**Target 5.1** – Ensure the contingency arrangements as outlined in Condition 9 of the Waste Licence are implemented throughout the year. A document entitled ‘Emergency Response Procedures’ forms the nucleus of the contingency arrangements and is currently with the Agency.
