ANNUAL ENVIRONMENTAL REPORT 2012

TRAMORE WASTE DISPOSAL SITE

Waste Licence Register No. W0075-02

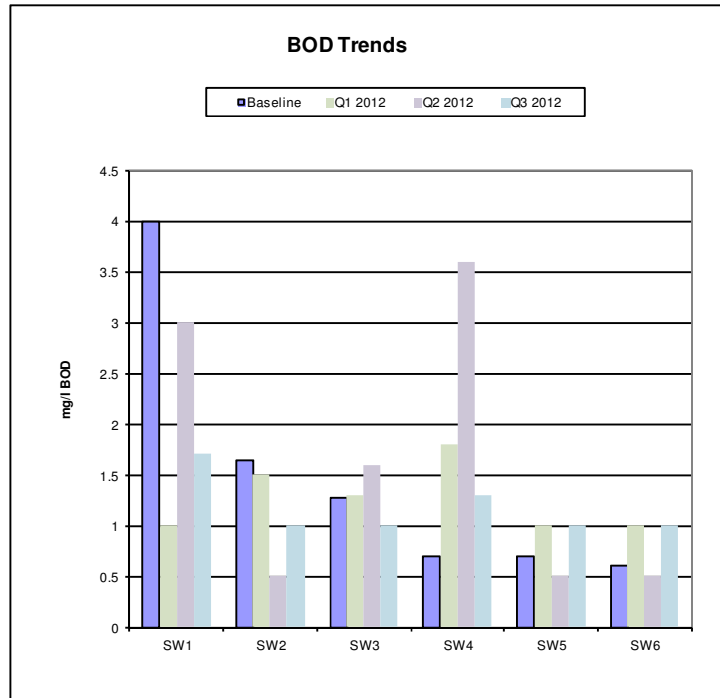
BOD Trends 2012

BOD was generally low at all the surface water sites. There was a slight elevation at SW4 in Q2, likely due to algal activity. BOD was not reported for Q4.

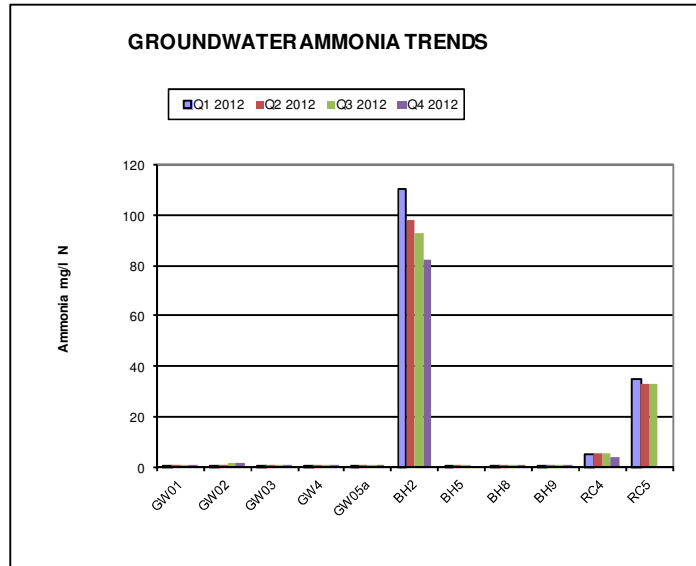
Groundwater ammonia levels 2012

Ammonia levels were high (>5mg/l) in BH2, RC4 and RC5.

Results for 2012 were similar to baseline monitoring in most boreholes, though an increase at BH2 since baseline measurement was evident, likely due to waste degradation activity and concentration of leachate due to landfill capping.

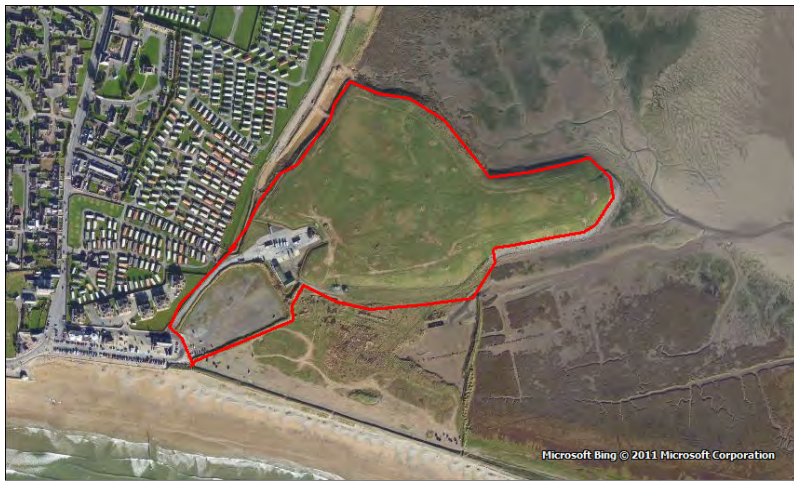
Figure 2. Landfill site boundary

Tramore Landfill site is located to the east of Tramore town at the south-western boundary of the Back Strand. The site encompasses an area of approximately 14ha. (Figure 1). The principal land use around the landfill site is recreational with a caravan and camping park located in Riverstown to the east, the promenade and Tramore Burrows to the south.

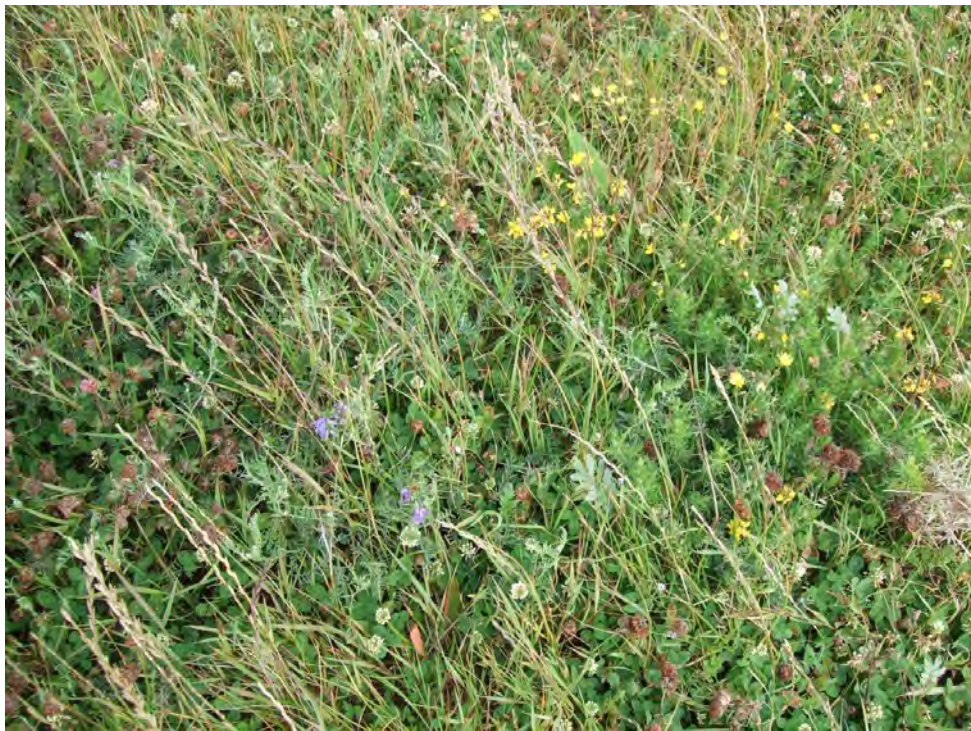
Amenity Grassland now covers the entire landfill cap and is the dominant habitat. Main grassland species are *Agrostis stolonifera* (Common Bent), *Holcus lanatus* (Yorkshire Fog), *Festuca rubra* (Red Fescue), *Anthoxanthum odoratum* (Sweet Vernal Grass), *Alopecurus geniculatus* (Marsh Foxtail), *Lolium Perennae* (Perennial Rye-Grass) and *Bromus hordeaceus* (Soft Brome) with a high occurrence of both Red and White Clover. Other species present include Birds Foot Trefoil, Silverweed, Vetch and Pineappleweed. Table 1 presents a flora species list from 2008 and 2011 and indicates an increase in botanical diversity since the site was seeded in 2008.

Figure 5. Amenity Grassland Habitat Tramore Landfill

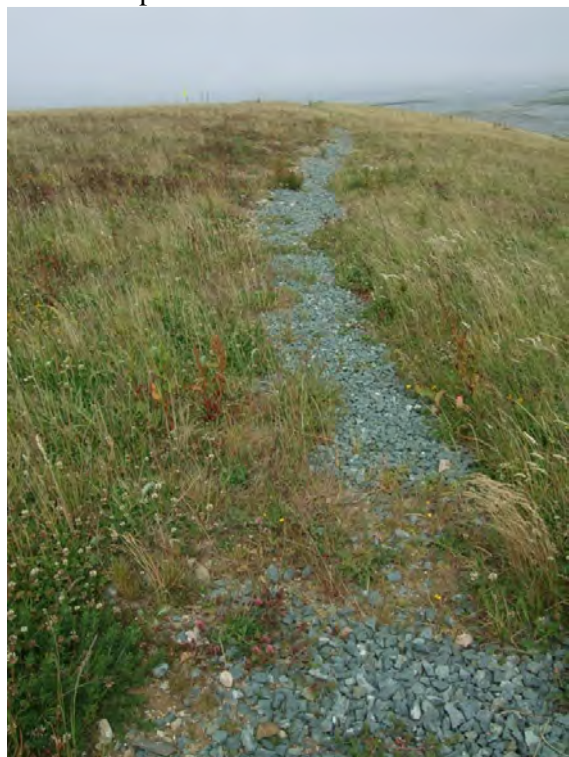
This habitat occurs in a ring around the outer edge of the landfill sloping down to meet the mudflat or saltmarsh at the bottom. It includes the rock armour that has been placed at the bottom of the slope and the gravel path that runs around the perimeter of the site between the emission pipes. This habitat accounts for 4% of the entire site.

Figure 6. Gravel pathway around perimeter of Landfill Site

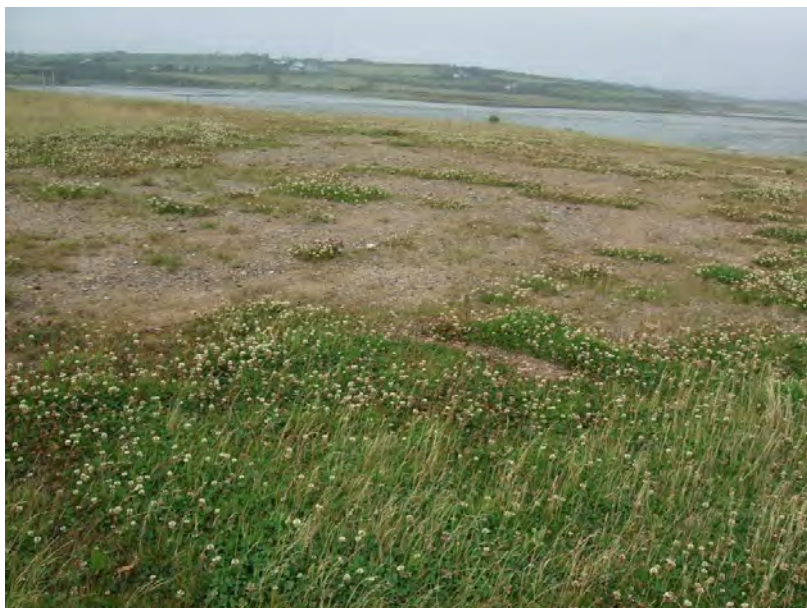
Patches of recolonising bare ground occur throughout the site as a result of workings of machinery on the site. Most of these patches are in the process of re-vegetating and the 2013 site visit noted a decrease in bare ground since 2011. Use of scrambler bikes is deterring revegetation in some spots. This habitat accounts for <1% of the entire site.

**Figure 7. Recolonising Bare Ground
Buildings and artificial surfaces (BL3)**

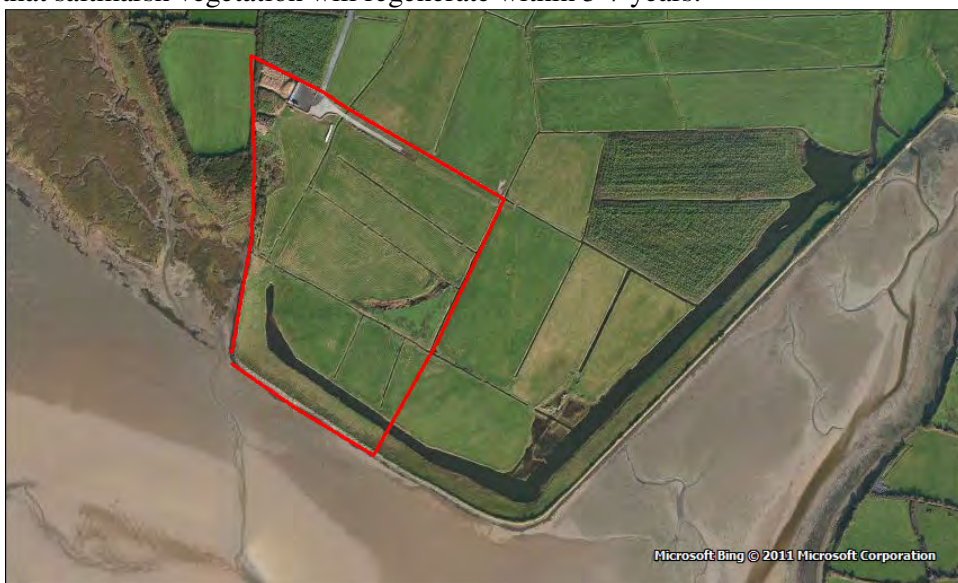
In 2013 22ha of compensatory wetland is being completed at Kilmacleague on former polder land to compensate for saltmarsh lost within the SAC at the landfill site. The lands will be subject to tidal inundation and it is hoped that saltmarsh vegetation will regenerate within 5-7 years.

**Figure 8. Site of compensatory wetland habitat to be completed at Kilmacleague in 2013
Buildings and artificial surfaces (BL3)**

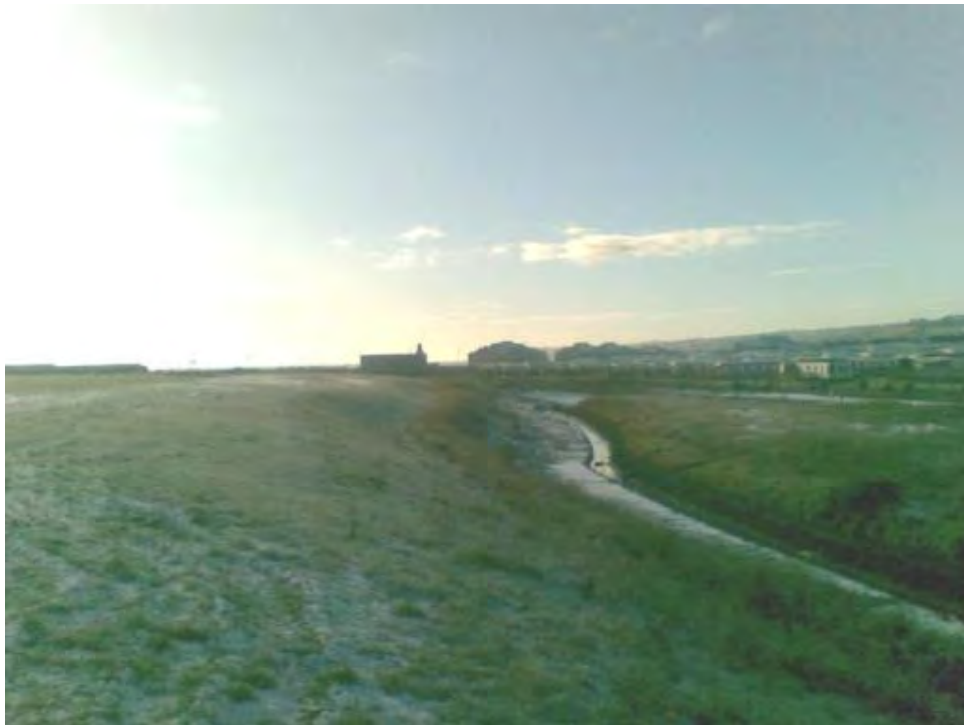
This slope shows no signs of movement or cracking. The surface water drain at the foot of the slope has been cleaned out and the slope here has been flattened at the base. Fencing in this area had been in a state of disrepair and has now been removed. This slope is deemed to be in a stable condition.

Slope Section 1 looking South

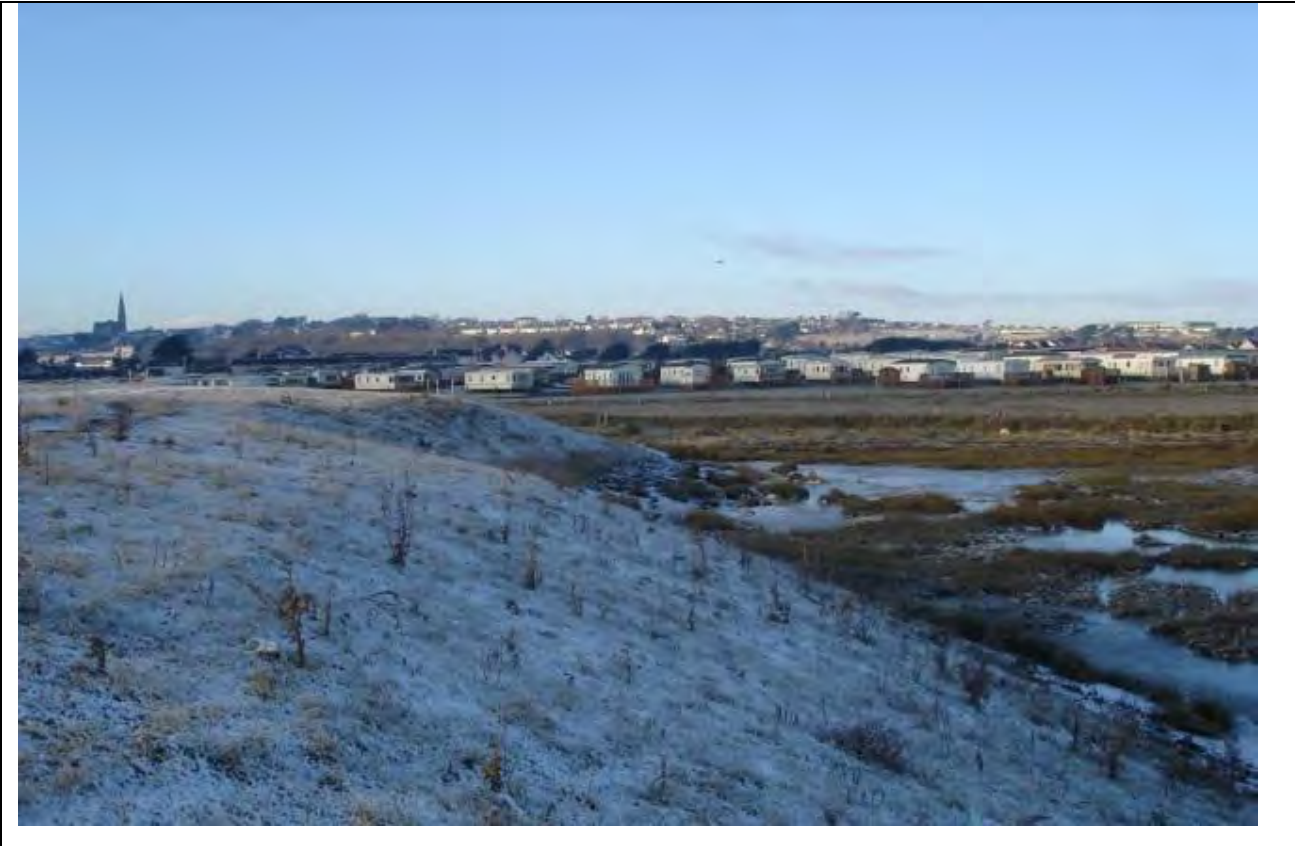
Due to the gradient of the slope, a protective grid was used in portion of the slope to prevent slippage when this slope was being constructed and this has proved to be successful as there are no signs of any movement or cracking . Vegetation on the slope has thrived since the last survey was carried out in December 2007.

Slope Section 2 facing west

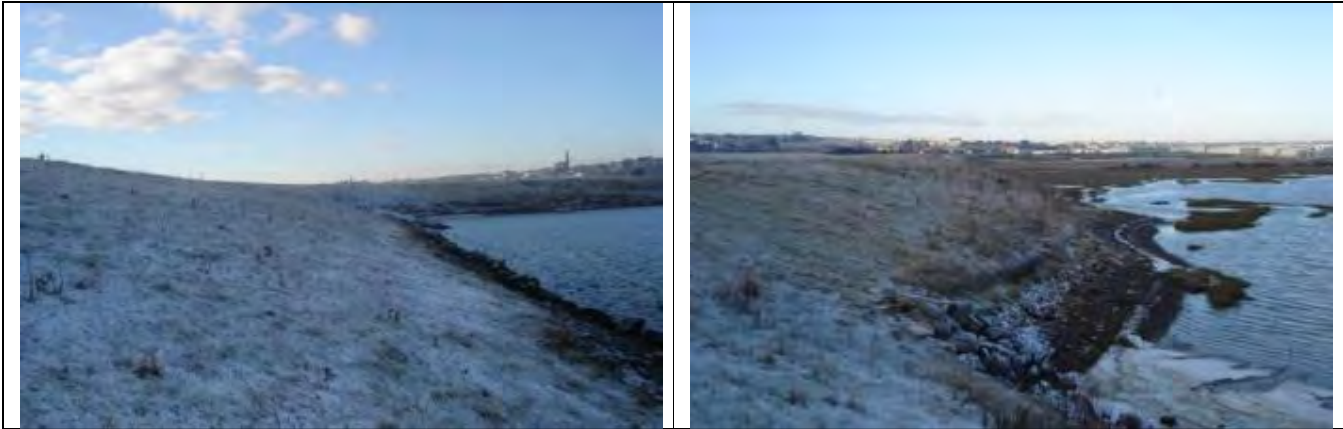
Gabion baskets had previously installed in this area in order to facilitate a reduction of the angle of repose on this slope. The baskets were covered as part of the remediation program. The surface water drain and outfall in this area have now been completed. The outfall pipes have been surrounded by rock armour in order to protect them from the tide. Vegetation on the slope is thriving and the slope is in a stable condition, there is no evidence of any cracking or slope slippage.

Slope Section 3 showing the Surface Water drainage outfall.

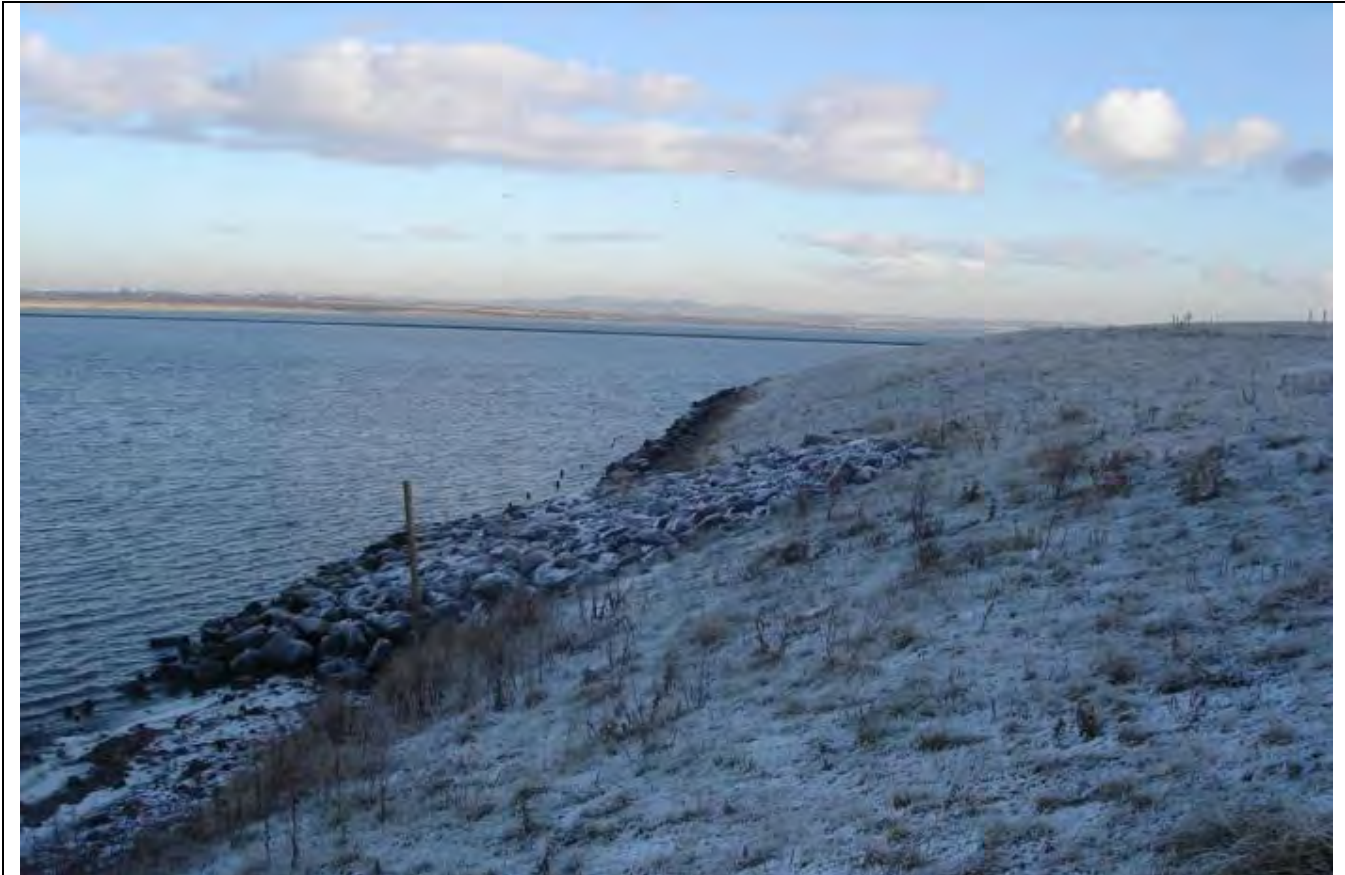
Slope Section 4

Due to the gradient of the slope, a protective grid was used during construction and this has proved to be successful as there has been no cracking or slippage. The protective grid has been augmented by rock armour and the slope is in a stable condition. The litter fencing that was previously in place at the bottom of the slope has been removed. Vegetation in this area is thriving.

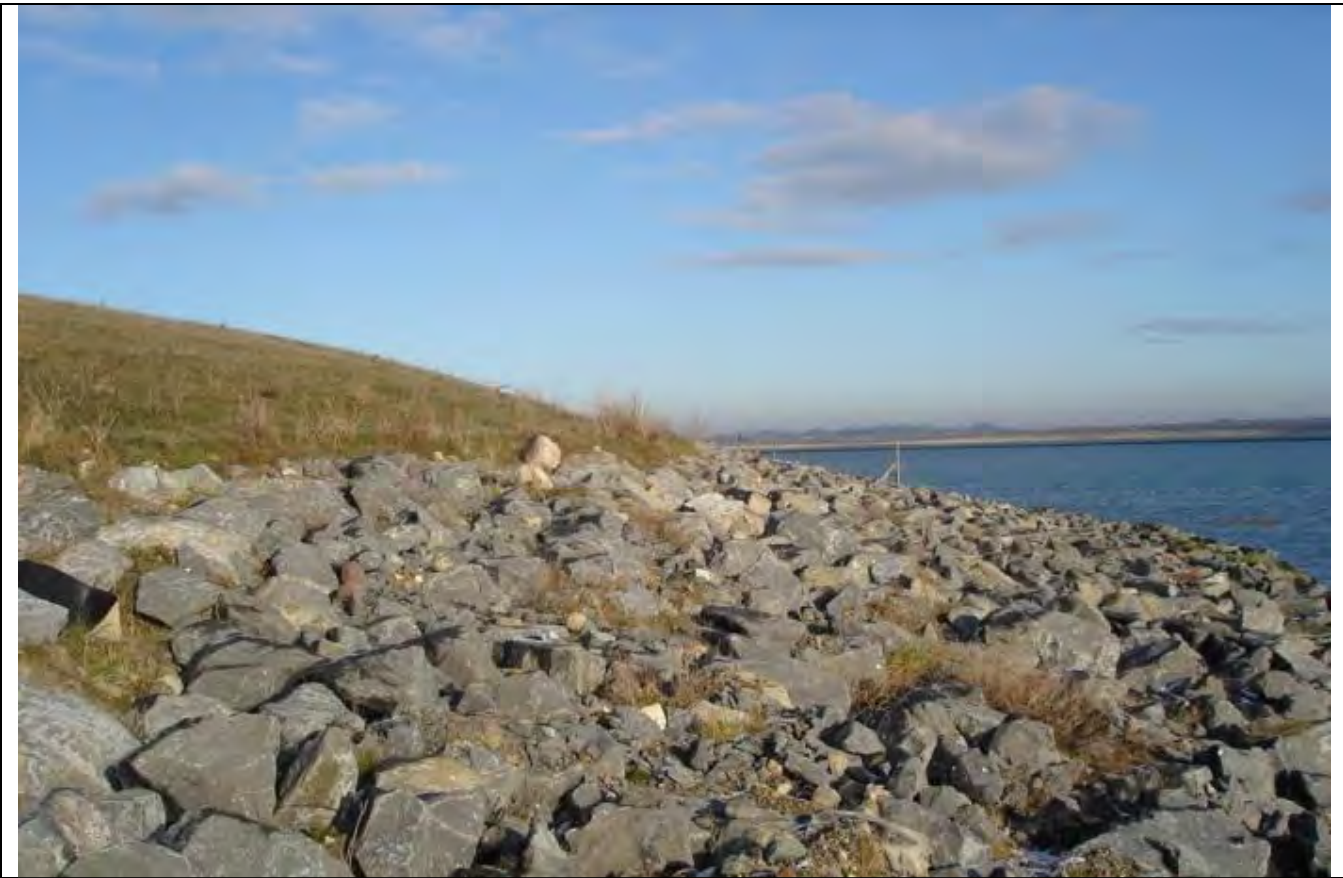
Vegetation is now thriving on this slope and the slope remains in a stable condition following the installation of rock armour to augment the protective grid that was installed during construction.

Slope Section 5 with Rock Armour.

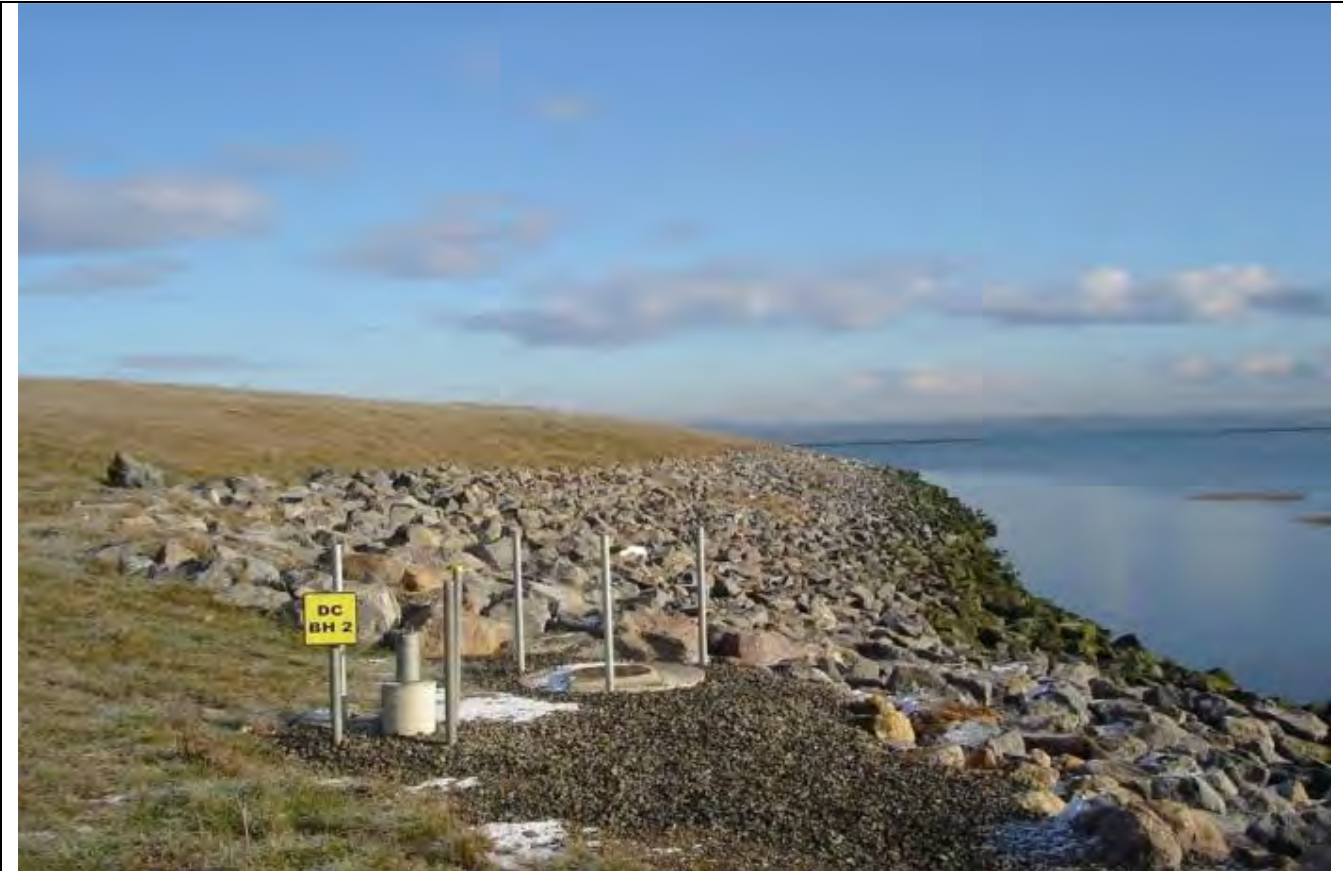
The rock armour that was installed on this slope has proved to be a success as there are no signs of movement or cracking thereon. Surface water drainage has been completed and a gravel pathway to the surface water outfall on the western end of this slope will be constructed over the rock armour. Vegetation in this area is also thriving.

Slope Section 6 showing Rock Armour

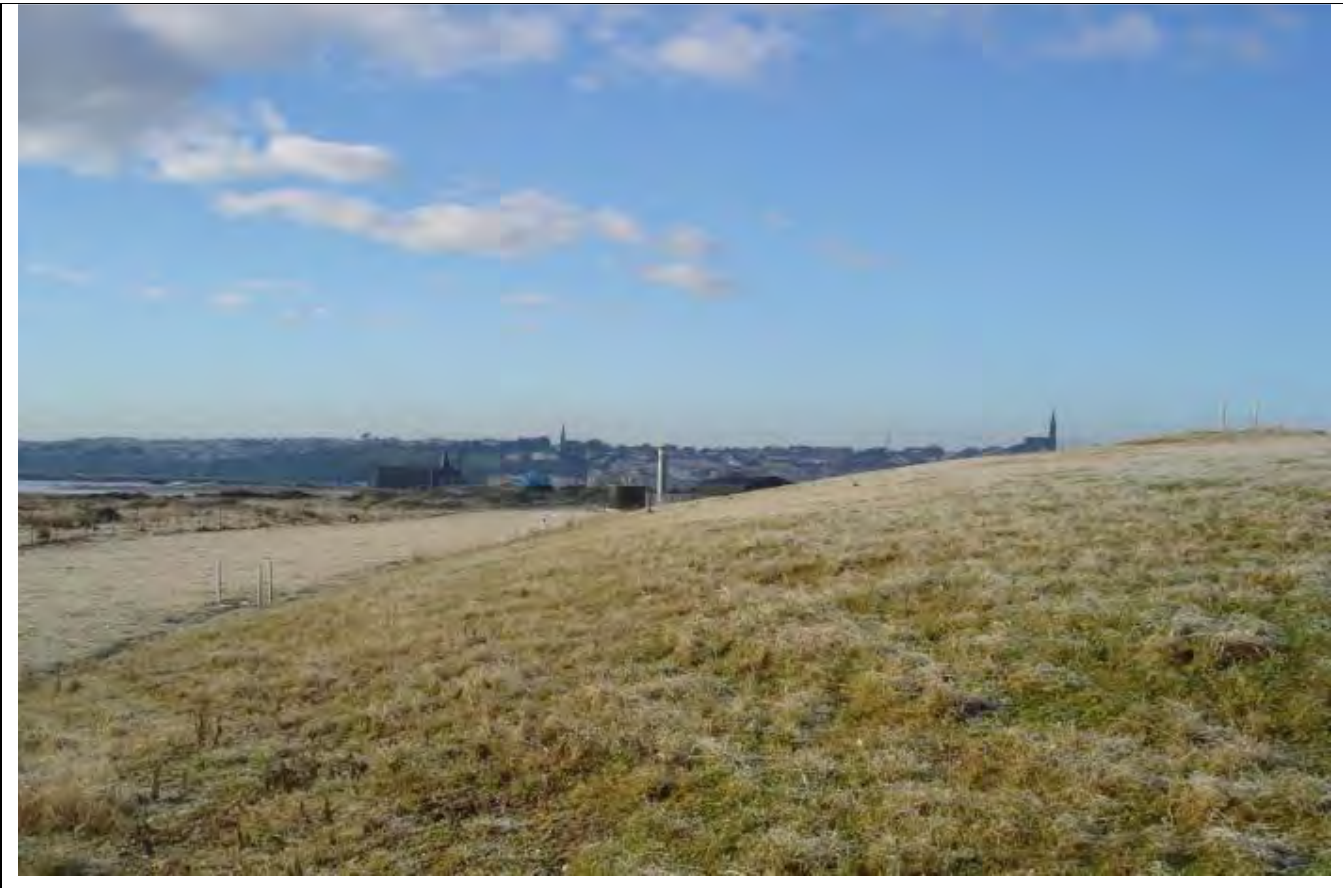
Slope Section 7

Vegetation on this slope is now thriving. Surface water drainage at the base of this slope has been completed. There are no signs of any movement or cracking. This slope is deemed to be in a stable condition.
