ANNUAL ENVIRONMENTAL REPORT 2012

For Kilbarry Landfill and Civic Amenity Site

**Compiled by : Facility Manager,
Vincent O'Shea.**
Date : May 2013

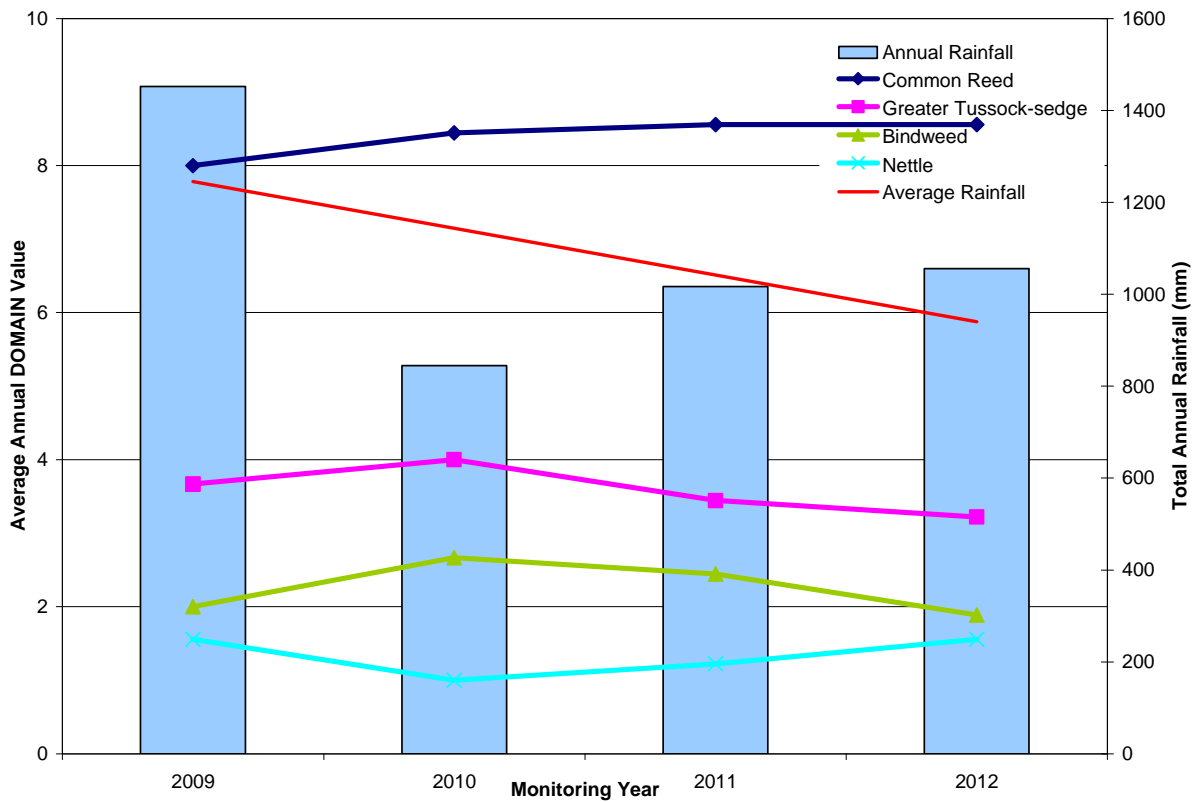
Graph 1: Changes in Vegetation Composition (Q1 – Q9) vs. Time.

A comparison of the annual average DOMIN values between four widespread species; common reed, greater tussock-sedge, bindweed and nettle are presented in Graph 1 (Q1 – Q9), 2 (Q1 – Q5) and 3 (Q6 – Q9) below. Annual rainfall for the monitoring period was obtained from Met Eireann (www.met.ie) for the nearest rainfall gauging station to the site at Johnstown Castle near Wexford (approximately 43 km east of Kilbarry Bog). It is to be noted that rainfall recorded at Johnstown Castle are only indicative of the hydrological changes occurring at the bog.

greater tussock-sedge in quadrats Q1 – Q5 (Graph 2) remain stable. This may suggest hydrological conditions have a greater impact the vegetative composition in the eastern part of the bog.

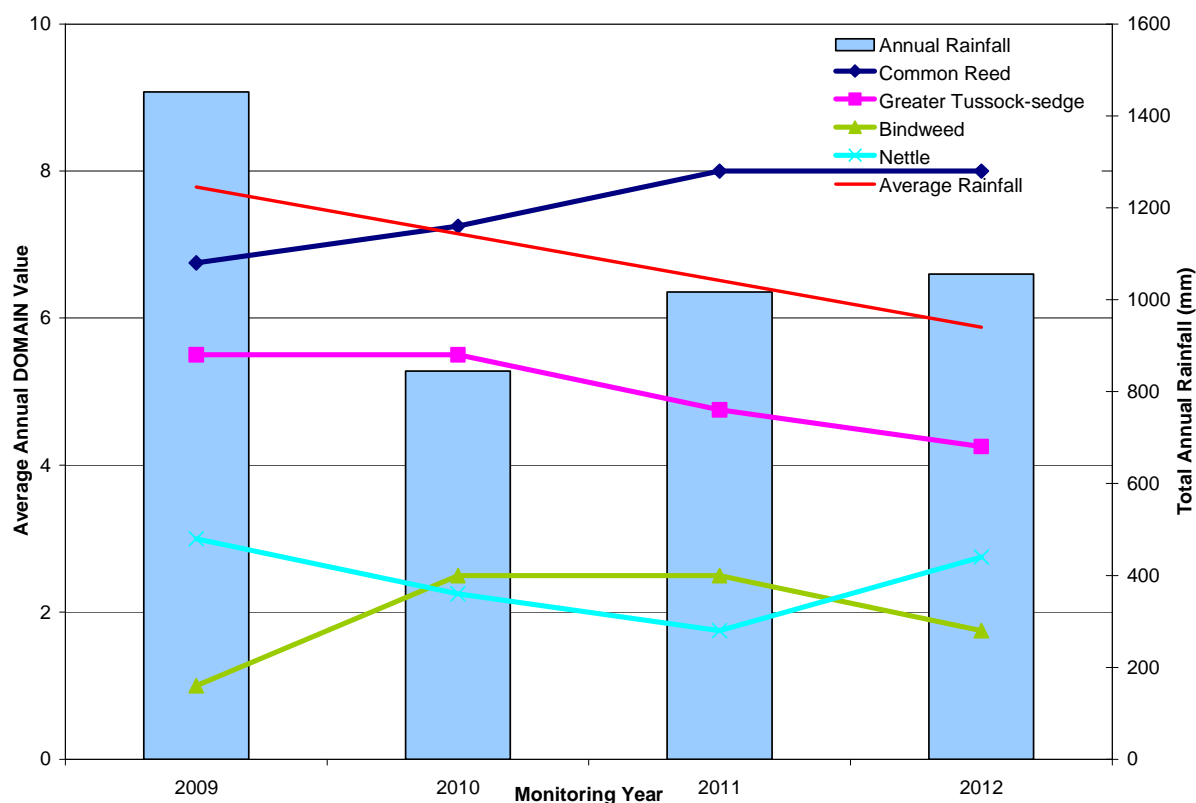
Graph 3: Changes in Vegetation Composition (Q6 – Q9) vs. Time.

There was an increase in the number of species in four (Q4, Q5, Q7-A, and Q9) of the quadrats and in one (Q6) quadrats, total species number decreased during 2012. There was no change in the number of plant species in the remaining three (Q1, Q2, Q3 and Q8) quadrats in 2012.

The plants which varied generally made up a small percentage of the quadrat (<5%). Overall there was no significant change in the general vegetation type or structure of any of the quadrats between 2009 and 2012.

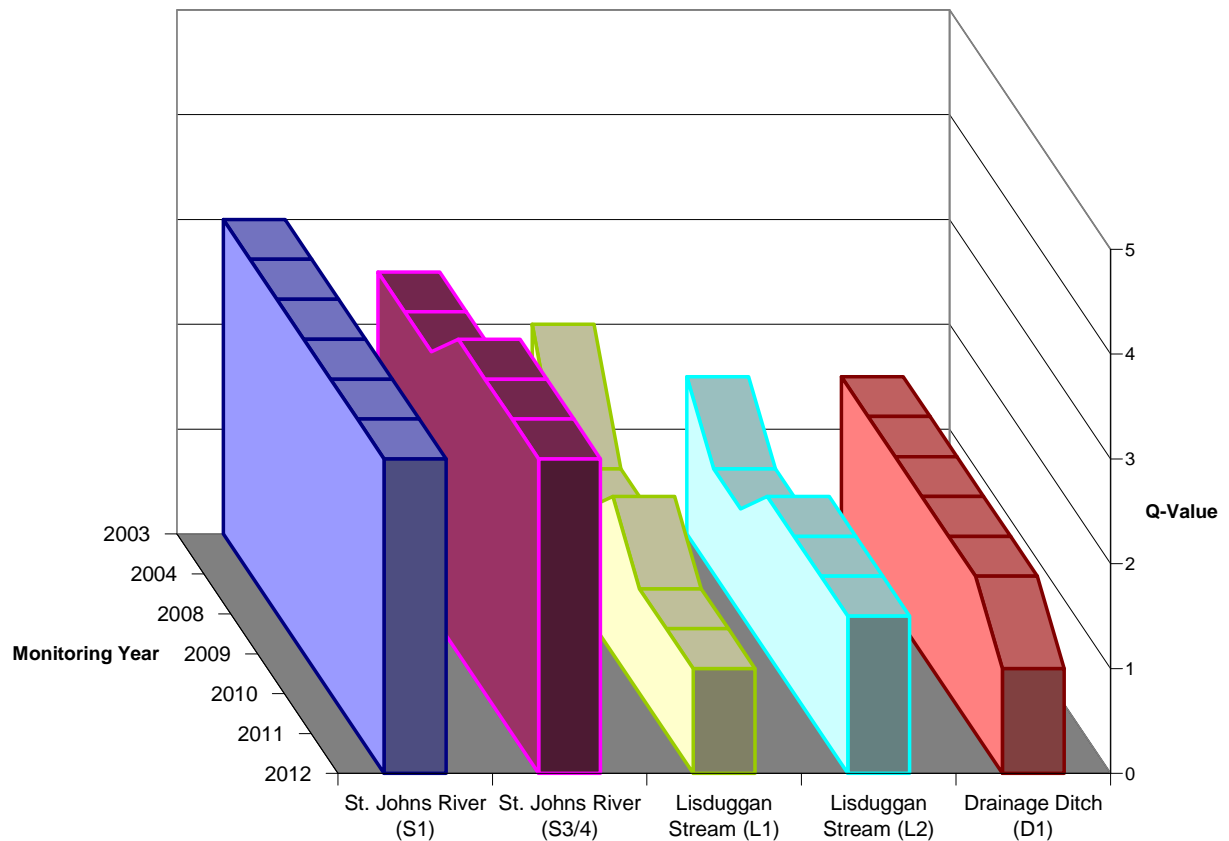
Graph 4: Temporal trend graph of Q-values recorded since 2003 (L6 not included).

The Lisduggan Stream remains seriously polluted with a score of Q1 recorded immediately upstream of the landfill (L1). Water quality at L1 continues to deteriorate since 2009 when a Q-value of Q1-2 was recorded. Along the landfill's northern boundary (L2) the Q-value is Q1-2 which is similar to previous years. The drainage ditch along the northwest boundary of the landfill is also seriously polluted and has deteriorated from Q1-2 in 2011 to Q1 in 2012. In 2012 a kick sample was obtained from a location on the Lisduggan Stream approximately 500m upstream of the landfill at the IDA Business Park (L6). A score of Q1-2 in 2012 has marked a modest improvement in water quality at this location from Q1 recorded in 2009.

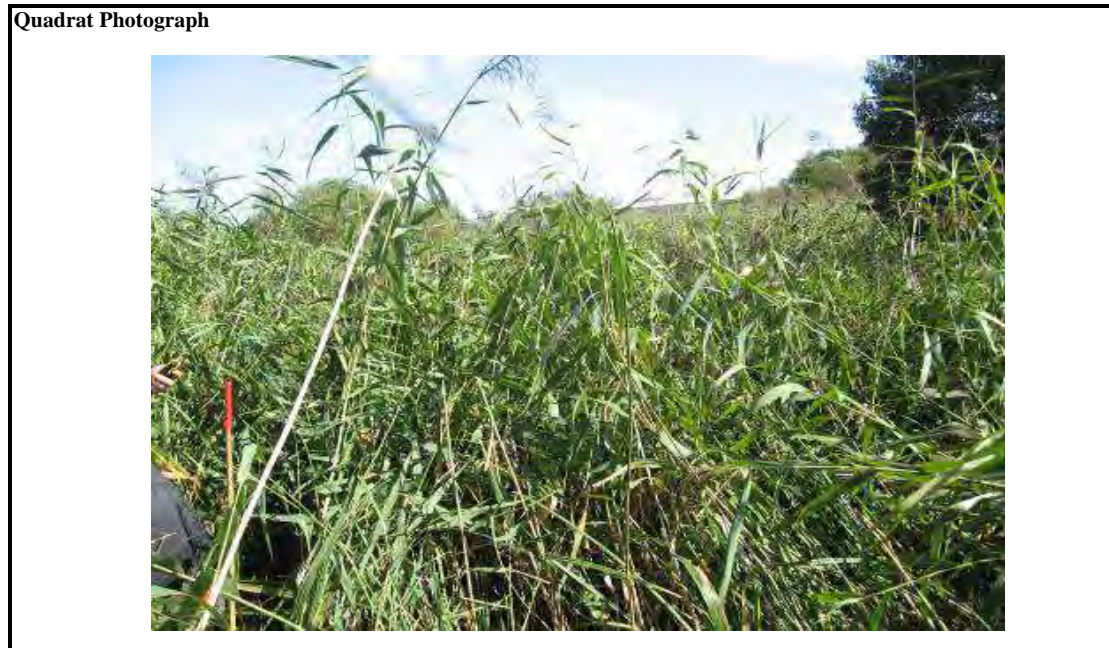
Quadrat Vegetation Composition	
Taxa	Domin value
Common Reed <i>Phragmites australis</i>	7
Greater Tussock-sedge <i>Carex paniculata</i>	6
Bindweed <i>Convolvulus arvensis</i>	4 (change from 6 in 2011)
Nettle <i>Urtica dioica</i>	2
Meadowsweet <i>Filipendula ulmaria</i>	1

Comments
Willow trees to south and east of quadrat

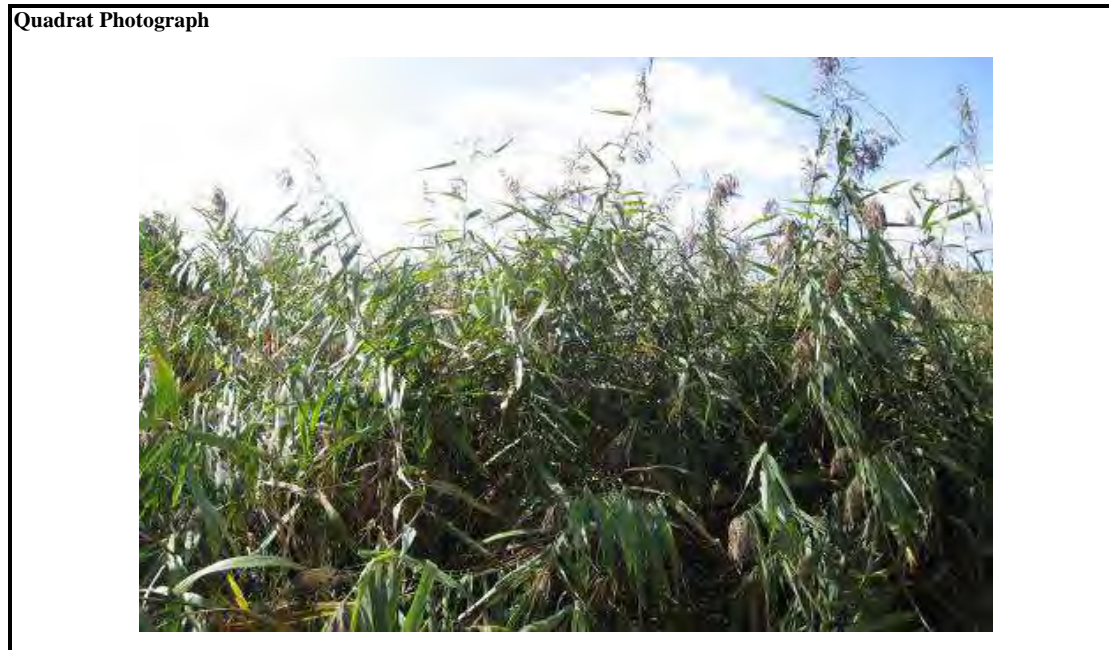
Quadrat Vegetation Composition	
Taxa	Domin value
Common Reed <i>Phragmites australis</i>	10
Bindweed <i>Convolvulus arvensis</i>	2

Comments
Willow trees within 10m of quadrat

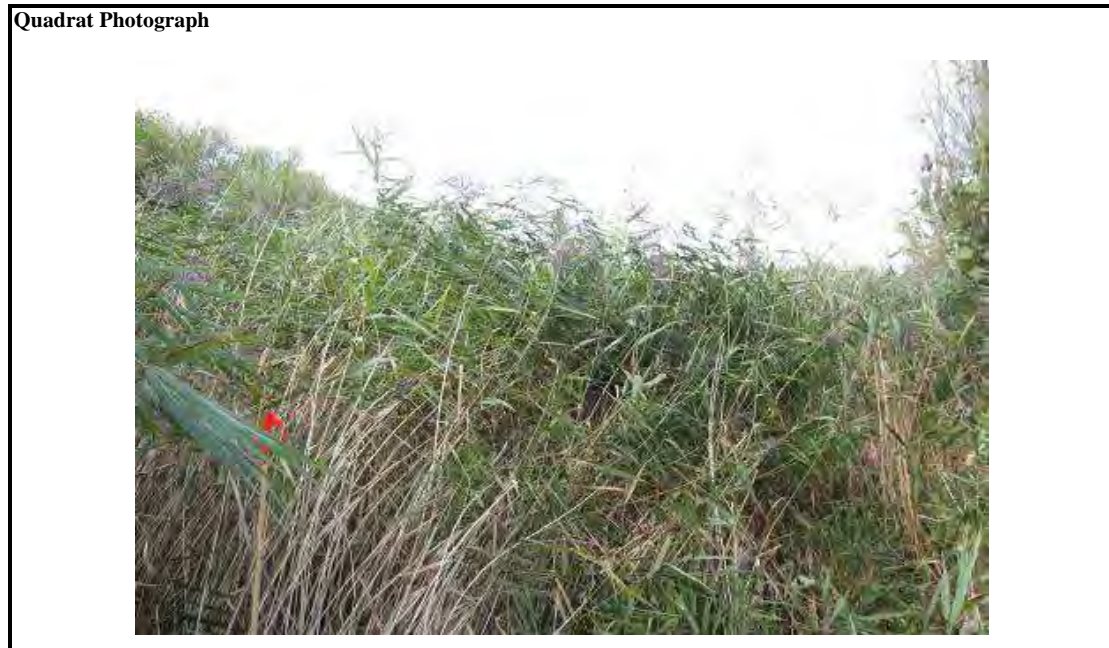
Quadrat Vegetation Composition	
Taxa	Domin value
Common Reed <i>Phragmites australis</i>	10
Bindweed <i>Convolvulus arvensis</i>	4
Meadowsweet <i>Filipendula ulmaria</i>	3 (change from 4 in 2011)
Nettle <i>Urtica dioica</i>	3
Marsh-bedstraw <i>Galium palustre</i>	1 (not recorded in 2011)

Comments
Willow and poplar trees located within 5m of quadrat

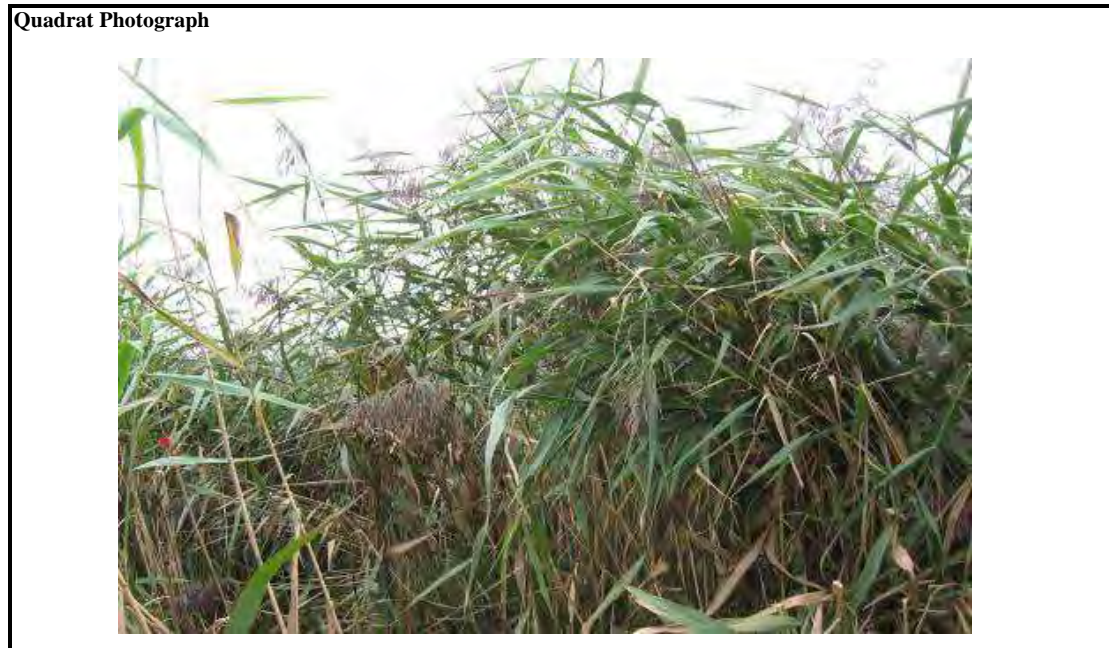
Quadrat Vegetation Composition	
Taxa	Domin value
Common Reed <i>Phragmites australis</i>	10
Water horsetail <i>Equisetum fluviatile</i>	4
Erect Bur-reed <i>Sparagnumium erectum</i>	3
Common Duckweed <i>Lemna spp.</i>	3
Fool's-water-cress <i>Apium nodiflorum</i>	1 (not recorded in 2011)
Gypsywort <i>Lycopus europaeus</i>	1 (not recorded in 2011)

Comments
Excavated pool located 5m east of quadrat

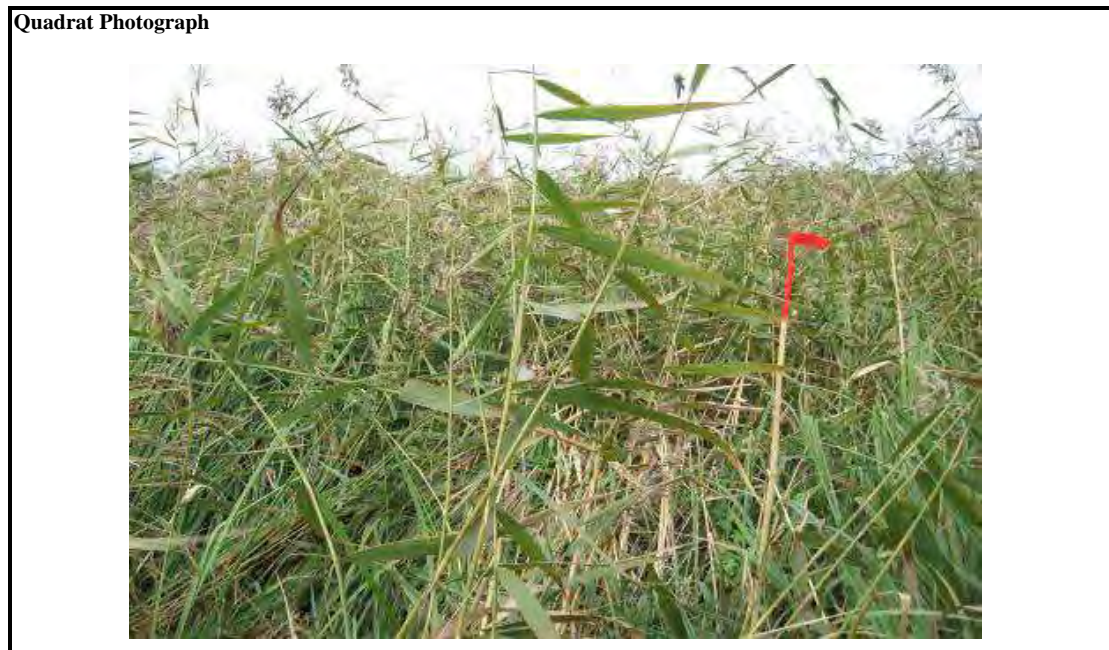
Quadrat Vegetation Composition	
Taxa	Domin value
Greater Tussock-sedge <i>Carex paniculata</i>	8
Common Reed <i>Phragmites australis</i>	7
Meadowsweet <i>Filipendula ulmaria</i>	3 (change from 2 in 2011)
Reed Canary-grass <i>Phalaris arundinacea</i>	1 (change from 3 in 2011)
Bindweed <i>Convolvulus arvensis</i>	0 (change from 3 in 2011)

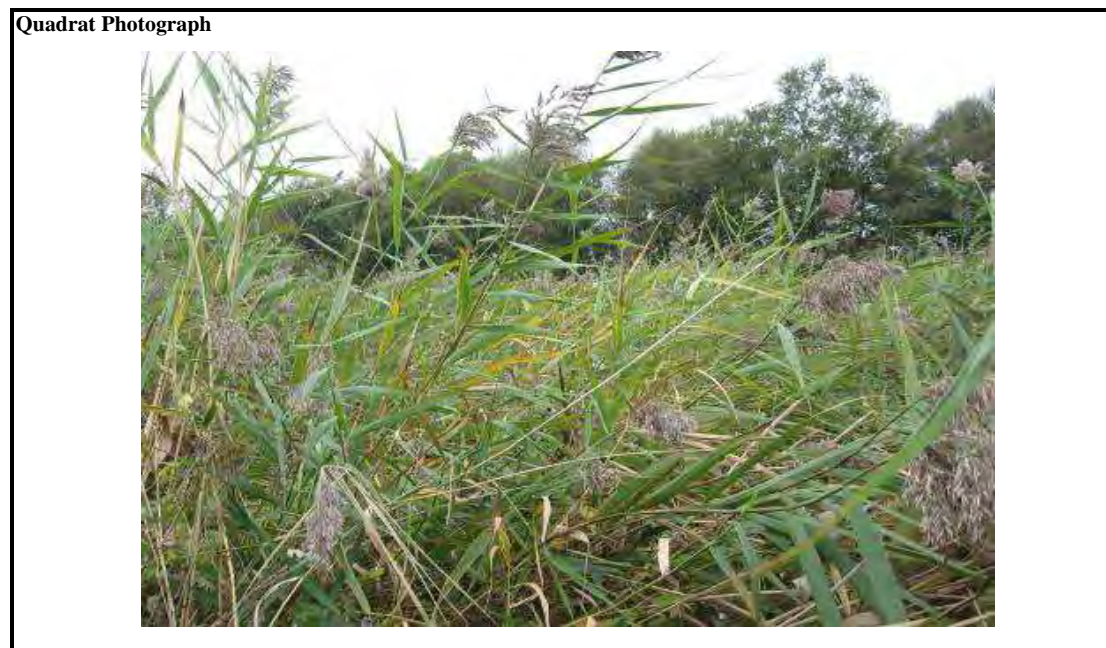
Quadrat Vegetation Composition	
Taxa	Domin value
Common Reed <i>Phragmites australis</i>	9
Meadowsweet <i>Filipendula ulmaria</i>	4 (change from 5 in 2011)
Bindweed <i>Convolvulus arvensis</i>	4
Willowherb <i>Epilobium</i> sp	4 (not recorded in 2011)
Common Valerian <i>Valeriana officinalis</i>	2
Nettle <i>Urtica dioica</i>	2 (not recorded in 2011)
Greater Tussock-sedge <i>Carex paniculata</i>	1 (change from 3 in 2011)
Water Mint <i>Mentha aquatica</i>	1 (not recorded in 2011)
Creeping bent <i>Agrostis stolonifera</i>	0 (change from 4 in 2011)
Angelica <i>Angelica sylvestris</i>	0 (change from 2 in 2011)

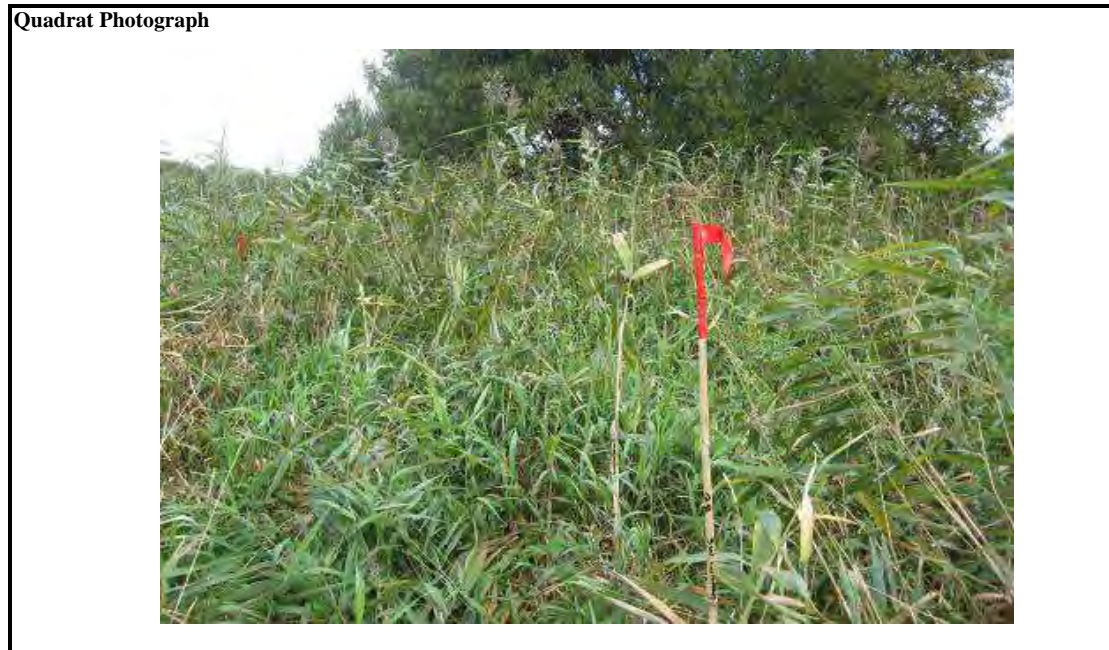
Quadrat Vegetation Composition	
Taxa	Domin value
Common Reed <i>Phragmites australis</i>	10
Nettle <i>Urtica dioica</i>	4 (changed from 2 in 2011)
Meadowsweet <i>Filipendula ulmaria</i>	2
Willowherb <i>Epilobium sp</i>	2

Comments
Willow located within 5 meters of quadrat

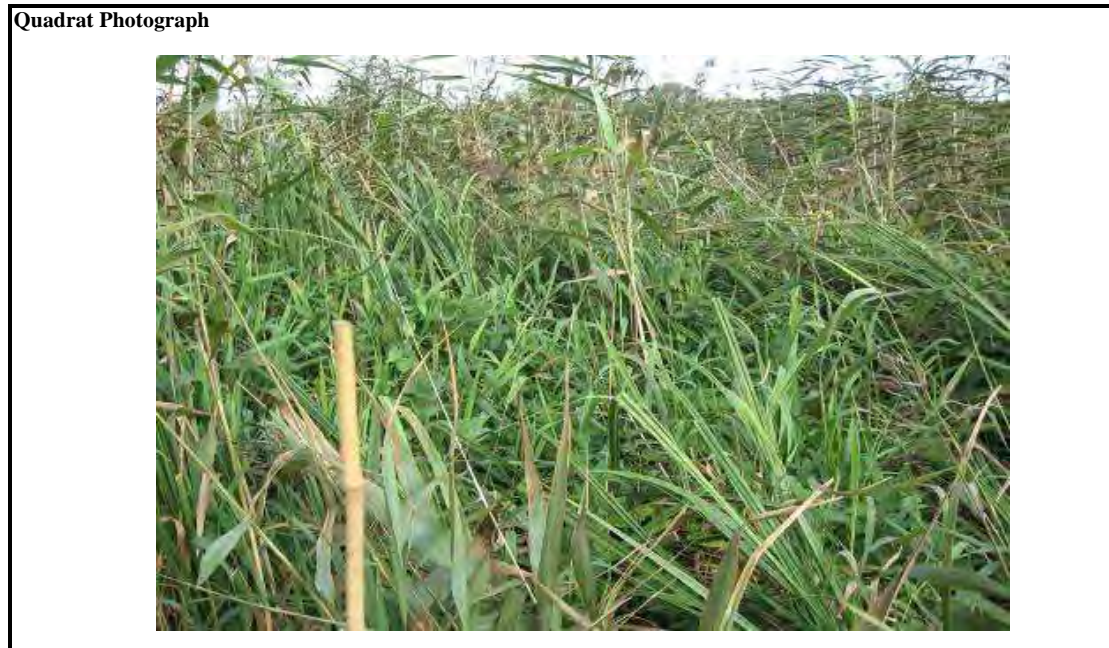
Quadrat Vegetation Composition	
Taxa	Domin value
Greater Tussock-sedge <i>Carex paniculata</i>	8
Common Reed <i>Phragmites australis</i>	6
Nettle <i>Urtica dioica</i>	5
Bindweed <i>Convolvulus arvensis</i>	3
Meadowsweet <i>Filipendula ulmaria</i>	3 (not recorded in 2011)
Common Valerian <i>Valeriana officinalis</i>	1

Comments
Willow located within 10 meters of quadrat

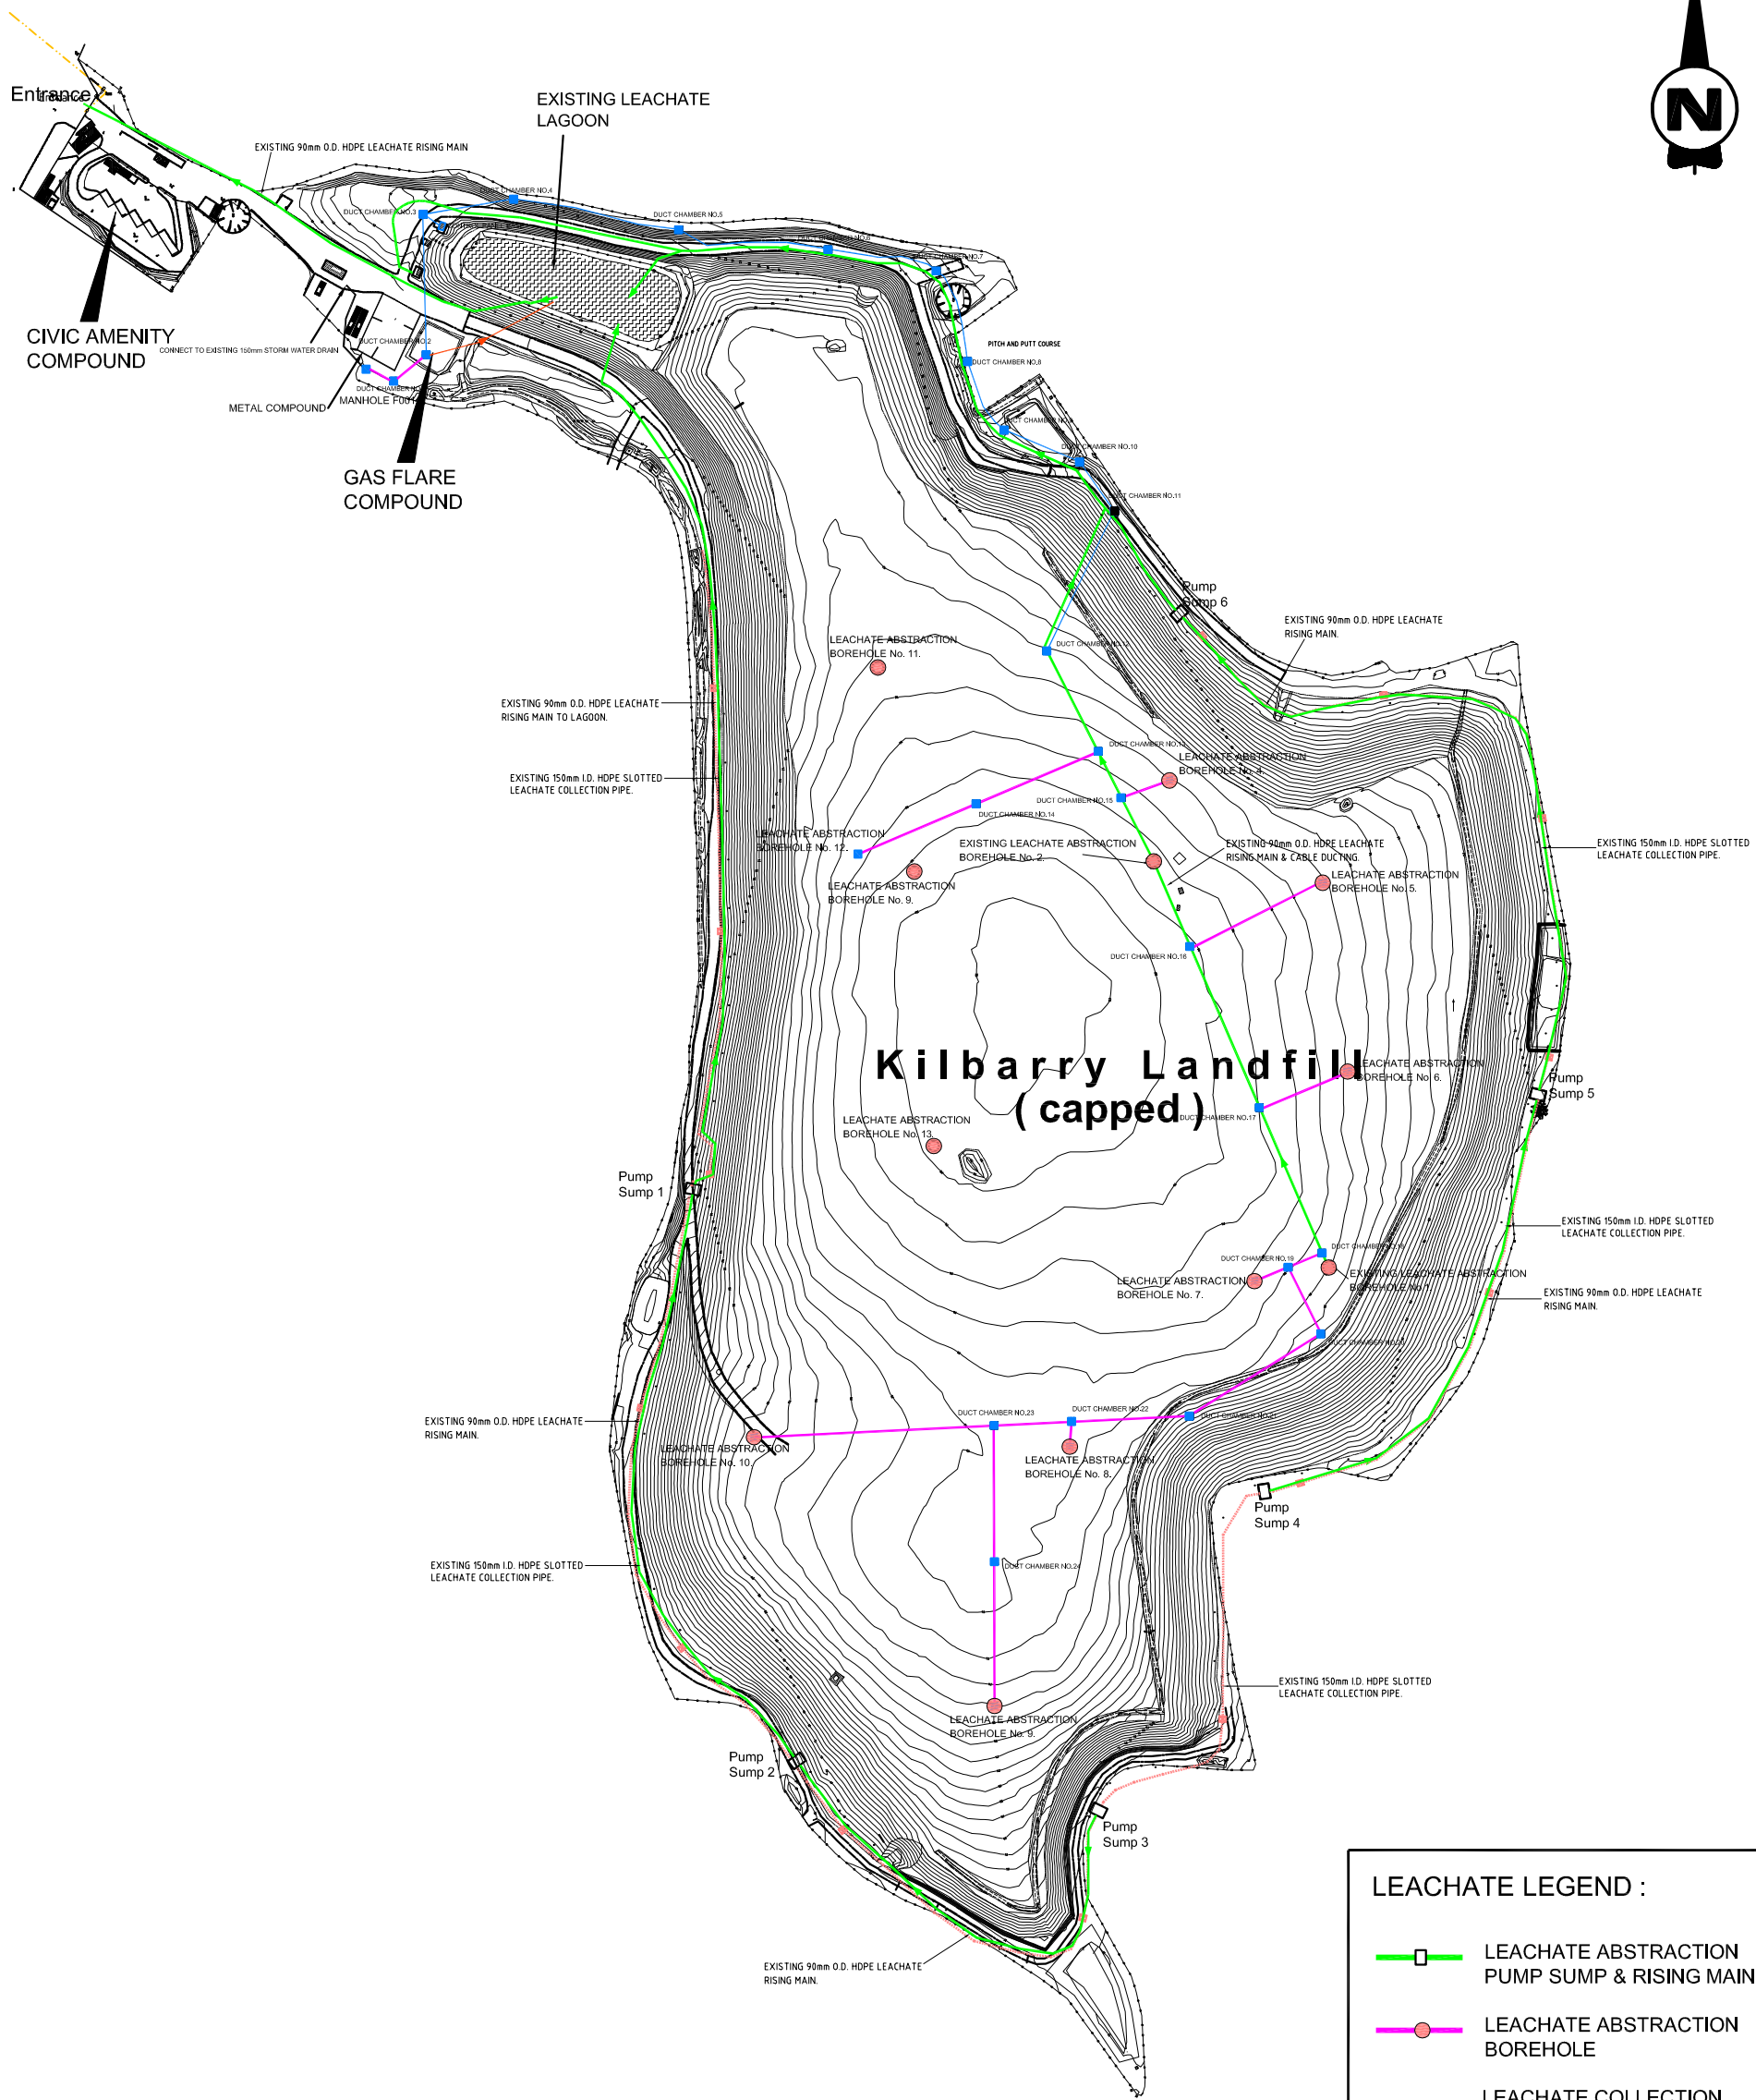
LEACHATE LEGEND :	
	LEACHATE ABSTRACTION PUMP SUMP & RISING MAIN
	LEACHATE ABSTRACTION BOREHOLE
	LEACHATE COLLECTION PIPEWORK.
