RAFFEEN CIVIC AMENITY & LANDFILL SITE CORK COUNTY COUNCIL, RAFFEEN, MONKSTOWN, CO. CORK

ANNUAL ENVIRONMENTAL REPORT 2012

WASTE LICENCE NO. W0023-1

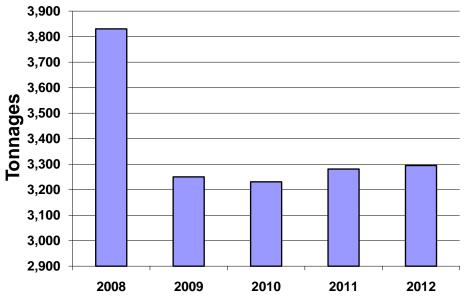
Figure 2.1: Tonnages of Recyclables Accepted at Raffeen CA Site

The quantity of materials (tonnes) collected for recycling during 2012 are outlined in Table 2.2. A total of 3294.92 tonnes of materials were collected for recycling during 2012. Figure 2.1 compares previous years.

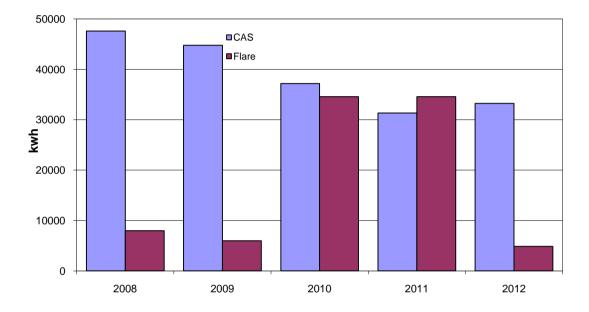
Figure 5.1: Energy Usage at Raffeen Landfill & Civic Amenity Site

The landfilling of waste has ceased at the site and therefore fuel is no longer used by site machinery. Records indicate that the ESB usage at the landfill site office during the year amounted to an estimated 38092kW hours in 2012. Usage trends are shown in Figure 5.1 below.

A permanent flare was also installed in 2008 and was commissioned at the end of June. The energy usage for this is accounted for on a separate connection. In total an estimated 4863 kW hrs were used to run this flare in 2012. The reduction in the energy usages can be attributive to running the flare at night on the night rate premium.
