Clare County Council

Waste Licence W0031-01

Annual Environmental Report for 2012

Location of facility: Doora Landfill, Bunnow, Ballaghboy,

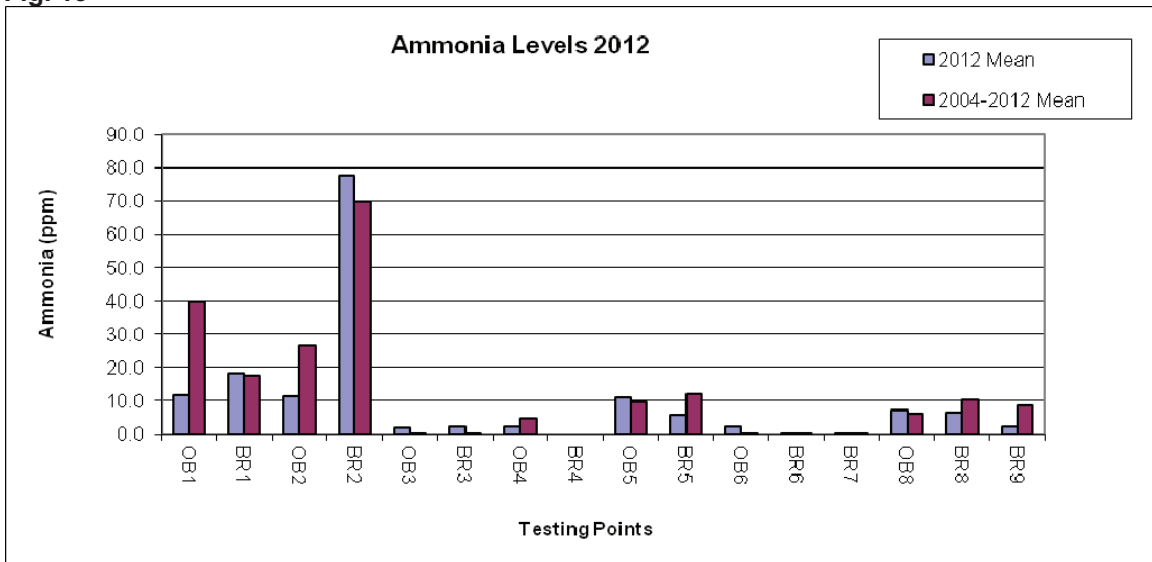
Groundwater ammonia levels for the nine-year period from January 2004 to December 2012 are graphed below in figures 4 to 12. Mean ammonia levels for the period are graphed in figure 13. Overall, values for 2012 are below that of historic trends for each well, with only BR2 (78ppm) showing a very slight increase, over the mean value of 70ppm for the previous 8 year period.

As can be seen from the graphs, groundwater ammonia results have been elevated for onsite monitoring wells (OB1/BR1 and OB2/BR2) since monitoring commenced at the site. Highest results for 2012 were obtained at these four wells, particularly at BR2, which is located close to the south-western boundary of the site. BR2 is down-gradient of zones 2 and 3 of the landfill.

Similarly results for BR10, remain elevated when compared to other wells within the site, but did remain generally on par with previous years, with results ranging between 600-750ppm throughout 2012.

As expected, lowest ammonia levels were found in up-gradient wells OB3, BR3 and BR7 and in the cross-gradient nested pair of wells OB6 and BR6.
