Roadstonewood Ltd
Fortunestown,
Tallaght,
Dublin 24,

Re: Annual Environmental Report 2012 for W0269-01, Fassaroe Waste Recovery Facility

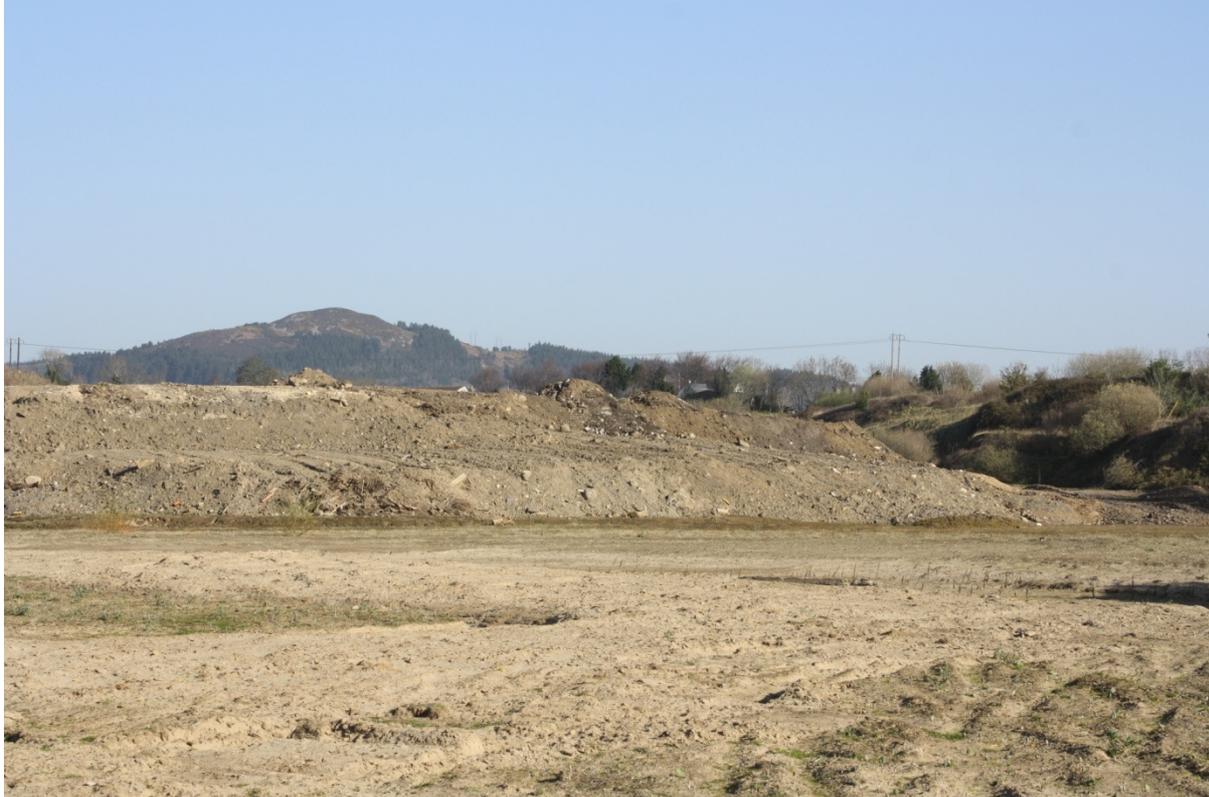
Plate 1 : Global View of Slope in Backfilled Material in NW Corner of Former Pit

In general, the temporary slopes developed in backfilled material around the north-western corner of the former pit, estimated to vary from approximately 12m to 16m high and approximately 20° to 30°, were observed to be marginally stable. Photographs of the existing slopes in backfilled material are presented in Plates 1 and 2. The slopes comprise variable imported natural soils excavated at construction and utilities works sites. The soils principally comprise clayey glacial till, granitic sand and/or weathered granite rock. There were occasional inclusions of construction and demolition type waste within the natural soils, principally lumps of ready mixed concrete and fragments of blocks, bricks and ceramics.

The marginal stability of the backfilled slopes is only to be expected, given that they comprise imported material which has been end-tipped from HGV lorries and had not been spread or compacted by bulldozers or other earthmoving plant. That said, there was no evidence at the time of the site inspection of any recent or imminent instability across the temporary backfilled slopes such as development of tension cracks behind the crest, toe bulging, near-vertical backscarps etc.

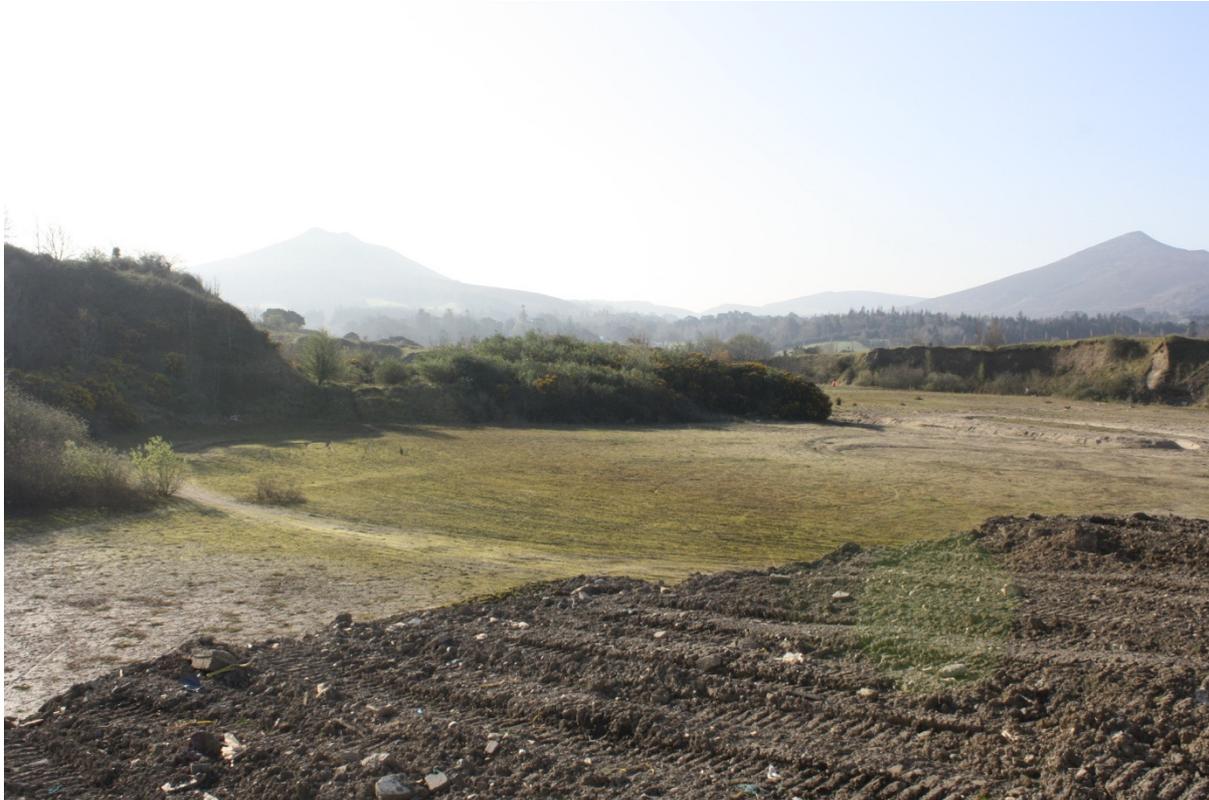
Plate 3 : View of Eastern and Southern Slopes of Former Pit from NW Corner

There does not appear to be any evidence of large scale (global) slope failure around the bare side slopes, rather it would appear that they are experiencing gradual regression, erosion and re-grading under both gravitational and climatic influences. No tension cracking or other sign of imminent instability was identified upslope or behind the crest of the steeper side slopes. The side slopes were generally dry, with no evidence of groundwater seepage, other than locally east of the descent ramp in the south-western corner of the former pit. It was also observed that

Taken together these observations indicate that the existing steep perimeter side slopes are relatively stable, albeit they are likely to be experiencing ongoing small scale spalling and erosion. This assessment concurs with experience and observations of Roadstone Wood's local site management.

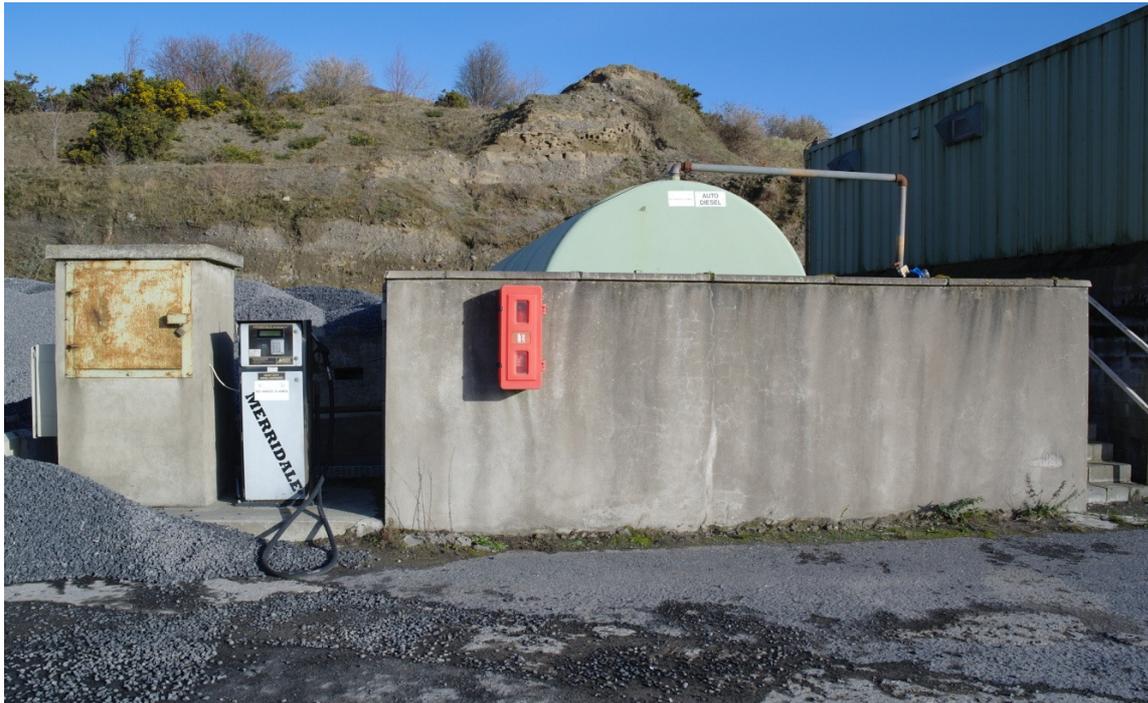
Species listed on Annex 1 Birds Directive

The site contains a 70,000 litre road diesel tank that is used to fuel company vehicles. The tank is protected against damage and leaks by a mass concrete bund, so the likely occurrence of a major rupture to the tank is considered low. However, without mitigation, there is a ‘medium’ risk of spillage of diesel during re-fuelling operations. The volume and location of such spillage may depend on mitigation measures employed at the site.

The severity of a 70,000 litre diesel spill to the gravel aquifer at the site is considered ‘very high’ as the clean-up costs could run to more than €100,000.

The 70,000 litre diesel tank is stored within a large concrete bund that is designed to contain more than the full volume of the tank. This provides mitigation against a major diesel spill at the site. An integrity test carried out in August 2011 showed that the bund is in very good condition and has capacity greater than 110% the capacity of the diesel tank.

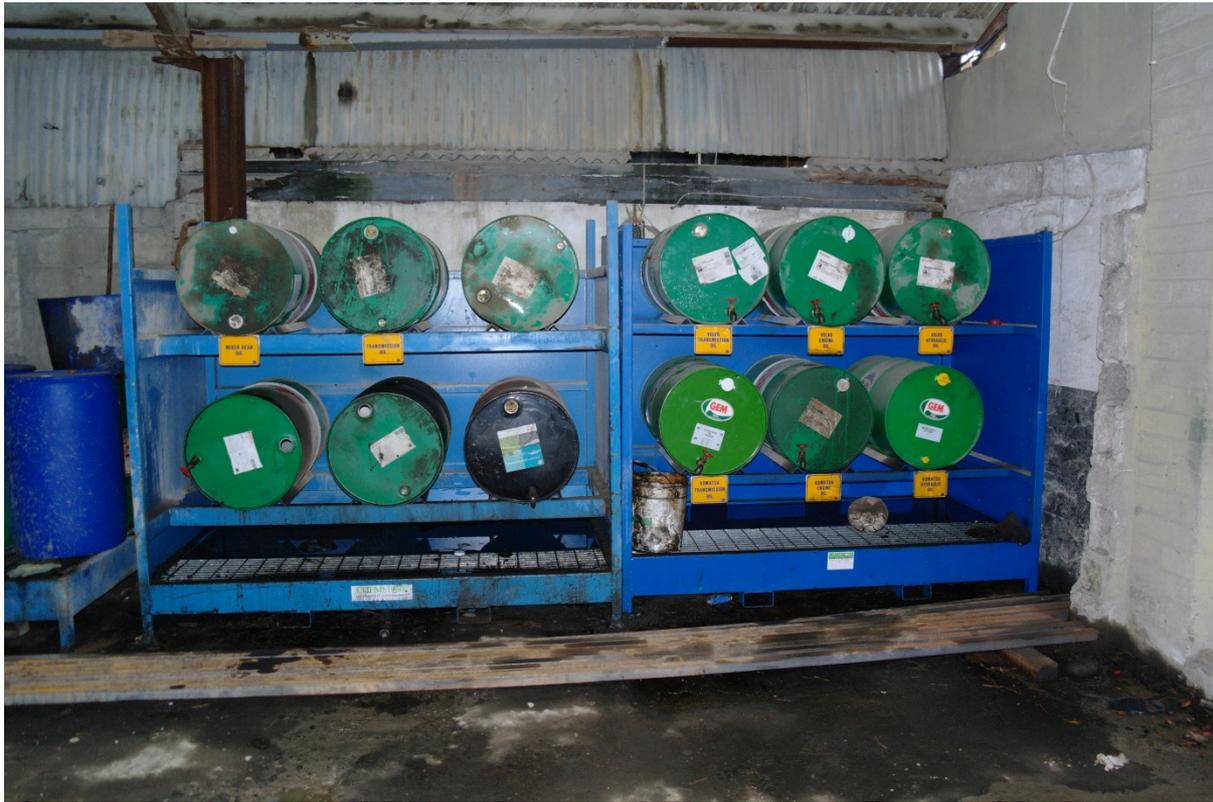
Coot

There are a number of substances used on site that have the potential to cause environmental pollution if spilled. These include a 2,500 litre double-skinned tank for gas-oil (machine diesel) for fuelling mobile plant, a smaller waste oil tank and 200 litre drums filled with hydraulic oils, engine oils and transmission oils. These are all stored in the Maintenance Shed close to the site offices and are protected against leaks by bunding.

The gas-oil, hydraulic oils, engine oils, transmission oils, waste oils, etc. are currently stored within bunded areas in the maintenance shed. The operator must maintain adequate capacity in these bunds for them to be effective.

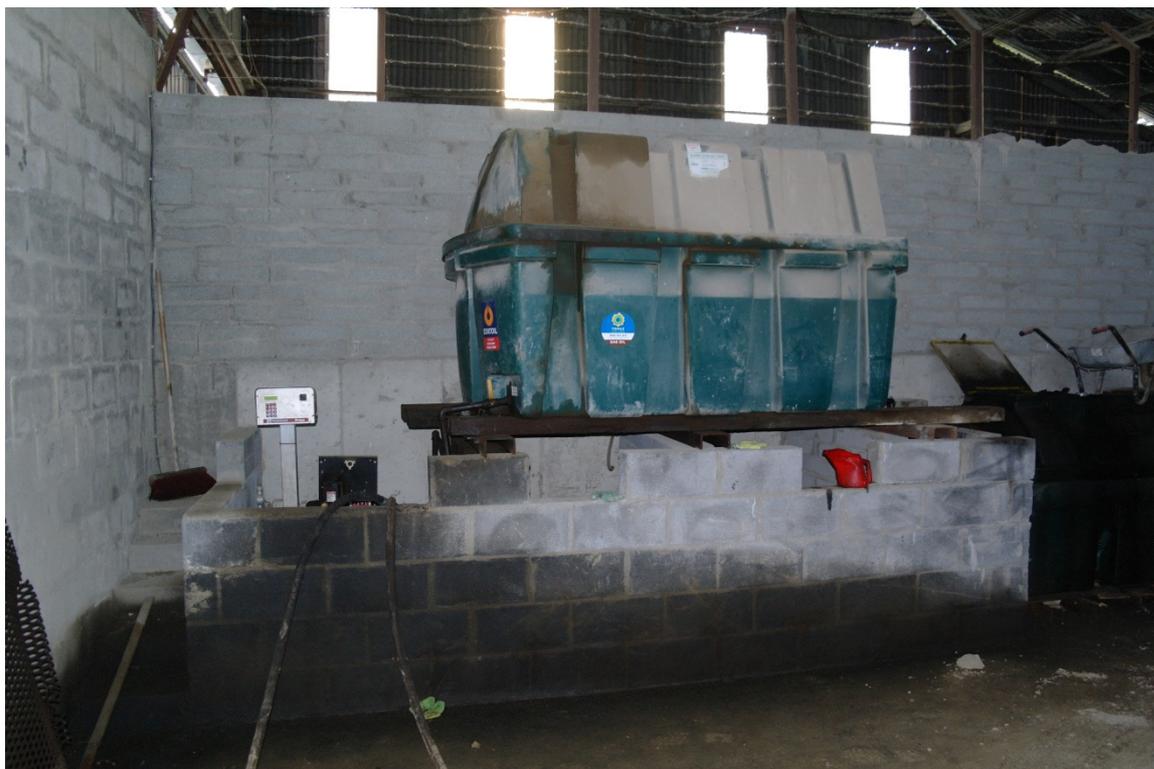
Photo 3 – Bunded Gas Oil (Diesel) Tank in Maintenance Shed

The 2,500 litre gas-oil tank consists of a self-bunded tank that is supported by the walls of a block-work bund (See Photo 3 below). There is a risk that a vehicle colliding with the bund wall would cause the tank to topple outside the bund and spill on the floor of the maintenance shed. The risk of such an occurrence is considered ‘high’.

A spill of up to 2,500 litres of gas oil (diesel) in the maintenance shed would be directed to the adjacent yard area. This is an unpaved yard, so we expect a spill of this size to percolate to ground rather than drain to the downgradient site pond, located approximately 200 metres away. The severity of such an event is considered ‘medium’ with clean-up costs between €10,000 and €50,000.

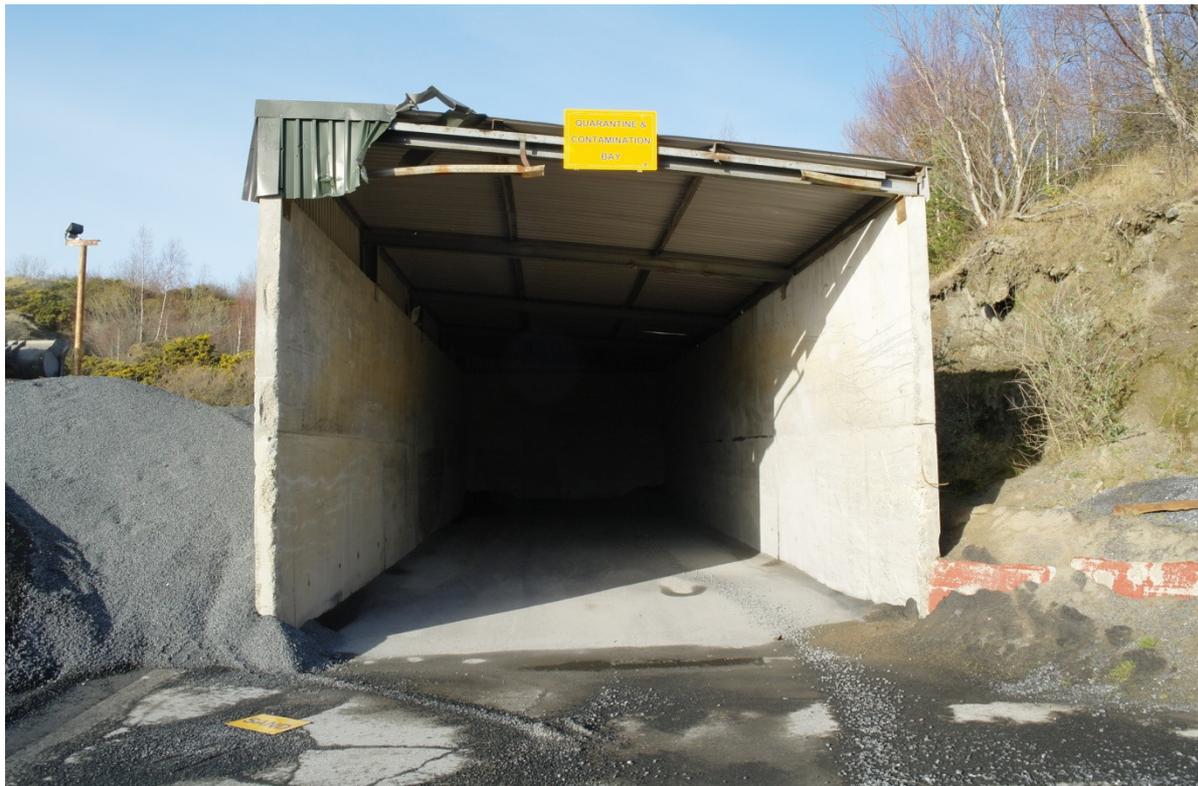
Photo 4 – Quarantine and Contamination Bay

These mitigation measures reduce the risk of occurrence of this event from ‘medium’ to ‘low’.

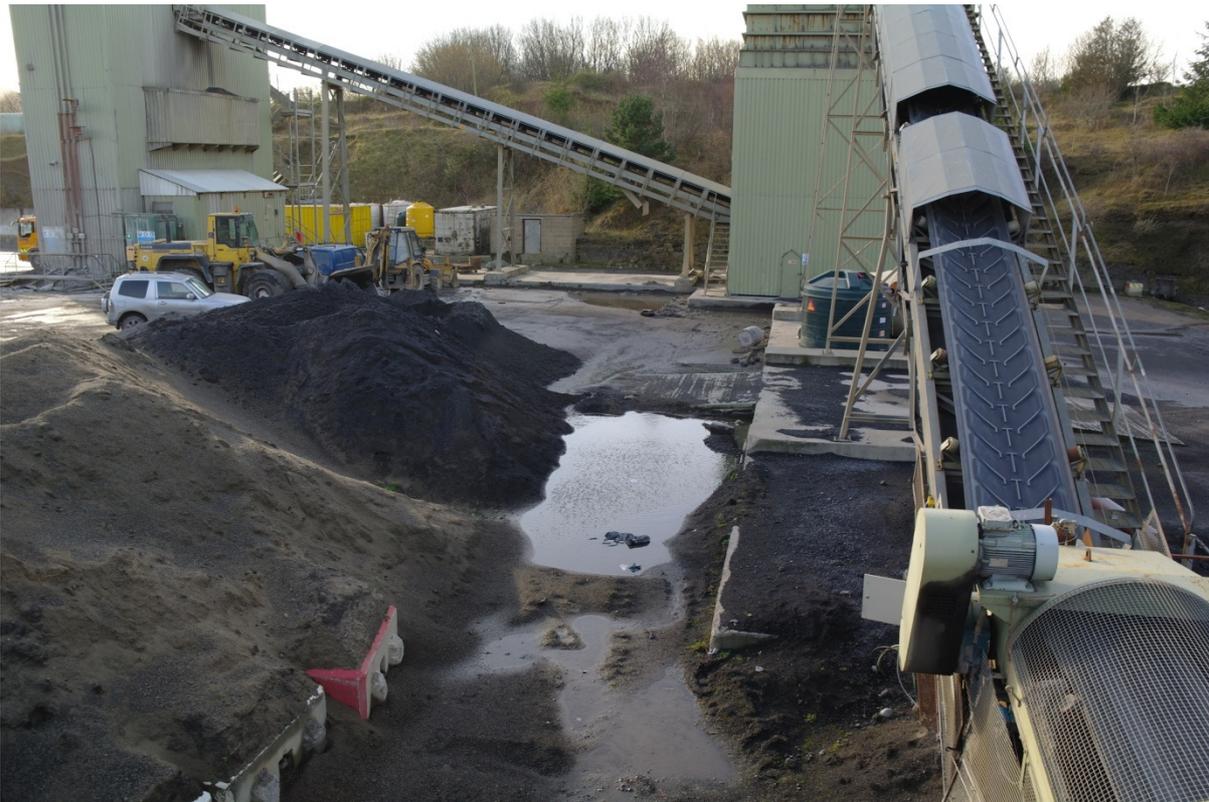
Photo 5 – Yard Drainage Impeded by Concrete Platform

These mitigation measures, when fully installed and properly maintained reduce the risk of occurrence of this event from 'Medium' to 'Low'.
