Article 14 Response

Waste Licence Application W0032-03

Application by Waterford County Council for Waste Licence Application W0032-03 for
Dungarvan Landfill, County Waterford

Dungarvan Landfill Waste Licence Application Article 14 Response

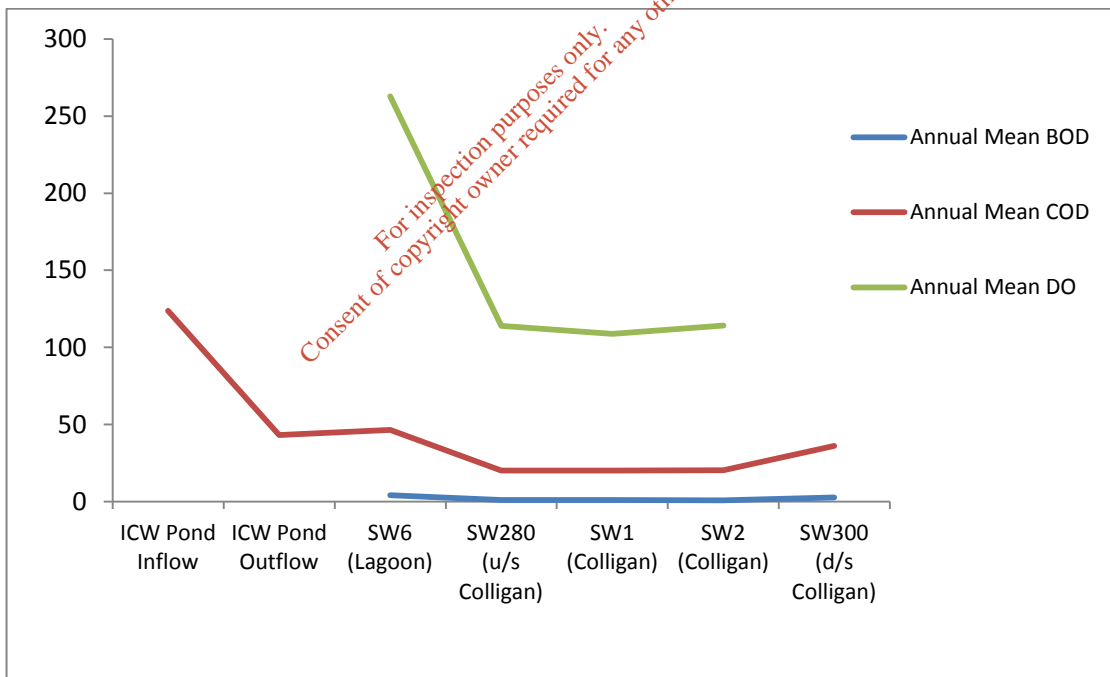
Text Figure 4.1 - Mean levels of selected pollutants recorded at Dungarvan Landfill 2011.

- 4.20 The results as presented in Text Figures 4.1 and 4.2; these illustrate a general reduction in the COD levels between the ICW system and the water quality in the River Colligan adjacent to the landfill. However, it was noted that a slight spike in COD was recorded during 2012 at sampling station SW2 in the River Colligan; this however is located upstream of the final discharge from of treated effluent. The cause of the spike in COD is unknown but was not observed during the previous year (i.e. 2011) when levels were consistently low across all riverine stations (between 20-36mg/l COD).

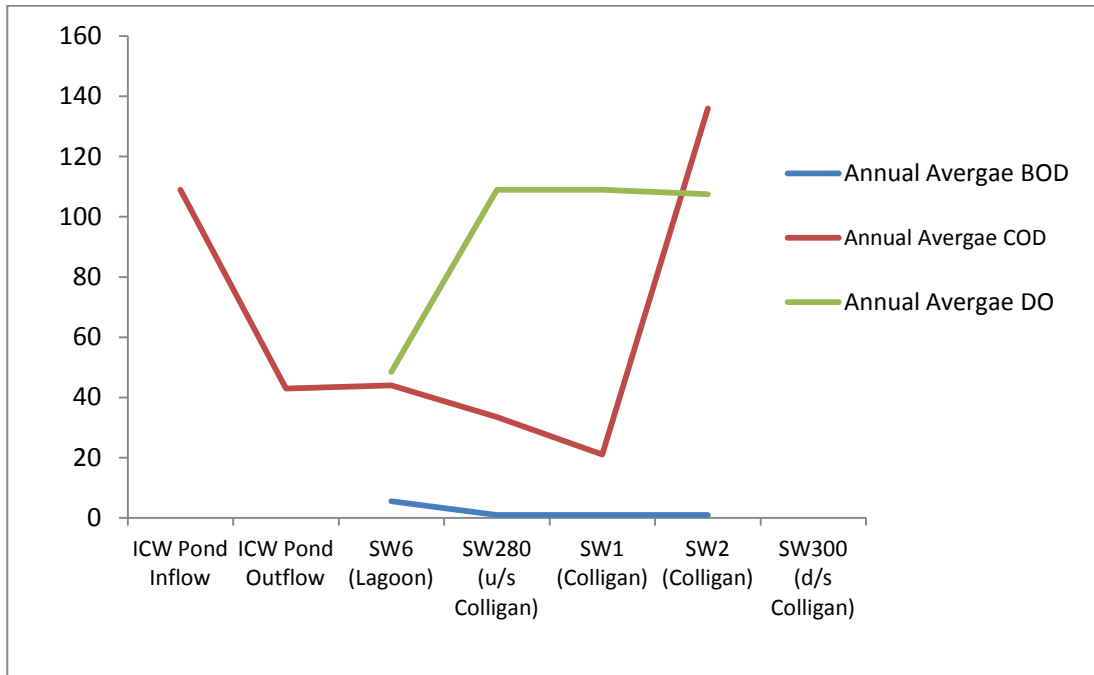
Text Figure 4.2 - Mean levels of selected pollutants recorded at Dungarvan Landfill 2012.

- 4.21 BOD levels were consistently low across all the riverine sampling stations (<2.7mg/l BOD) between 2011 and 2012, indicating no reduction in water quality as a result of the landfill operation. While slightly elevated levels were recorded in the lagoon during 2012 (max reading of 5.5mg/l BOD), these levels would not be considered of concern and are not causing any reduction in the BOD of levels in the River Colligan adjacent. The slightly elevated levels recorded in the lagoon would be still considered of good quality given that they result from the discharge of an ICW system treating landfill leachate (see Text Figures 4.2 & 4.3).

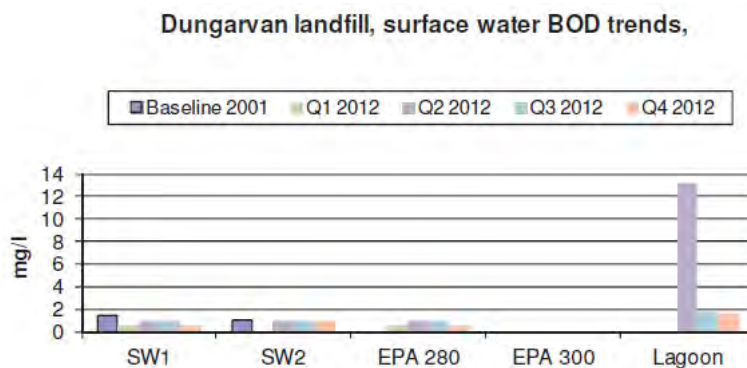
Text Figure 4.3 - illustrates BOD levels in 2012 against baseline levels in 2001

- 4.29 BOD levels were low at river sites and in the lagoon throughout the year. Other water quality tests were also satisfactory. Full water quality data is presented in Tables 5.1.1 – 5.1.4 of the 2012 AER (see above link).

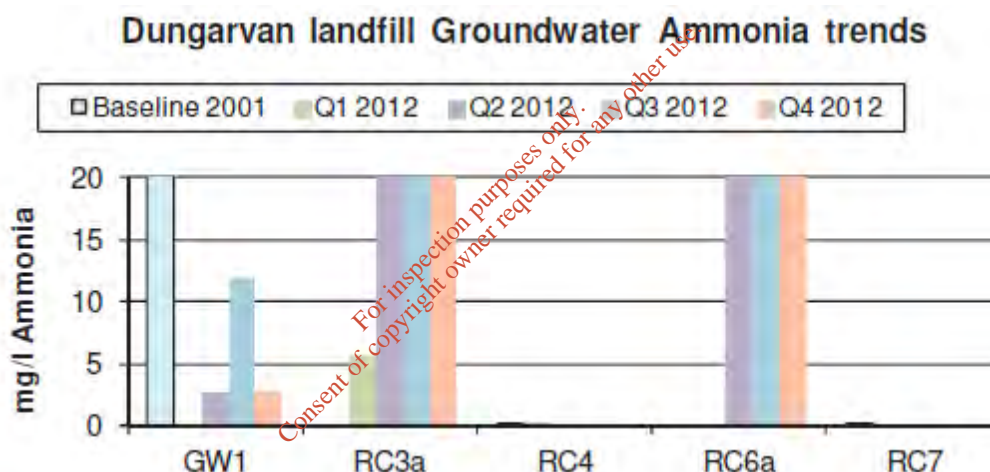
Text Figure 4.4 - illustrates Groundwater ammonia levels in 2012 against baseline levels in 2001

- 4.32 A key parameter being monitored in order to assess the performance of the leachate management system and the ICW's is Ammonia. Groundwater levels of ammonia are summarised in Text Figure 4.4.

- 4.33 Ammonia was elevated at sites GW1, RC3a and RC6a (both on the southern side of the landfill). RC4 and RC7, outside the landfill area, had relatively low ammonia. RC7 had a high ionic content at times, possibly indicating brackish water intrusion.
- 4.34 Heavy metals and organics were not detected or else were present in low concentrations. The results of groundwater monitoring are in line with results from previous rounds of testing. The sites within and closely adjacent to the working area appear to be impacted by landfill leachate in terms of ammonia and iron concentration. Site RC4 at the south-western boundary had relatively good water quality. Site RC7, 200 metres east of the facility, and outside the landfill area had generally satisfactory water quality though iron levels were elevated at times and saline intrusion was evident.

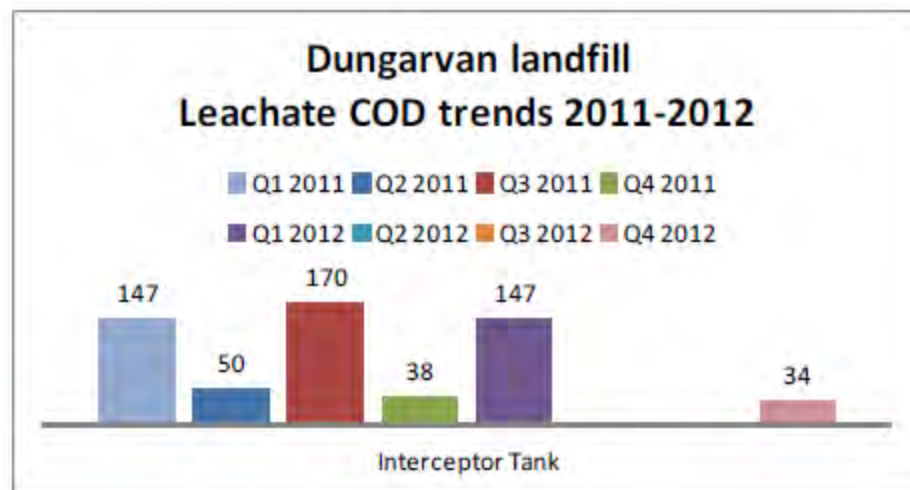
Text Figure 4.3 – COD trends 2011 – 2012.

- 4.38 Generally clean waters would have a COD of 10-20; the figures of ca. 150-200 shown in Text Figure 4.3 above for leachate would not be atypical for leachate (i.e. be equivalent to polluted waters).

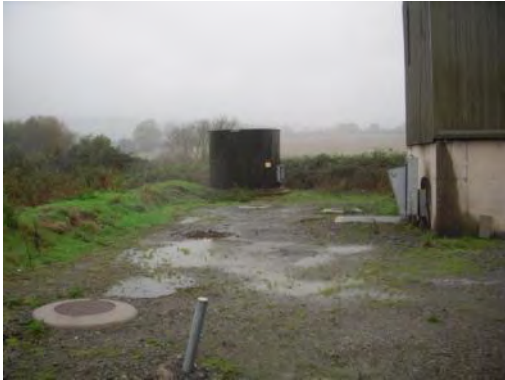
Plate 6: Leachate dilution tank to the north west (behind) the waste transfer station.

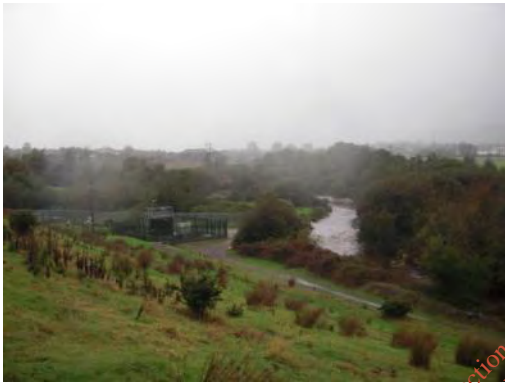
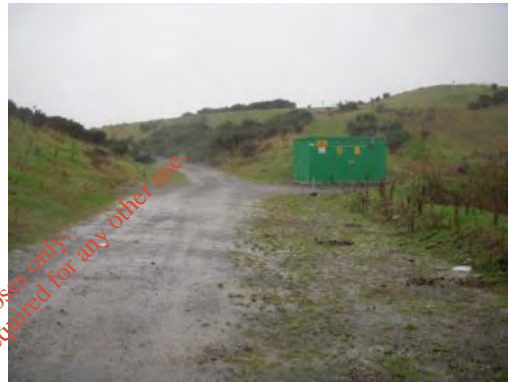
Plate 7: Left - Leachate monitoring and dilution tank at south western corner of site. Right – Main control hut.

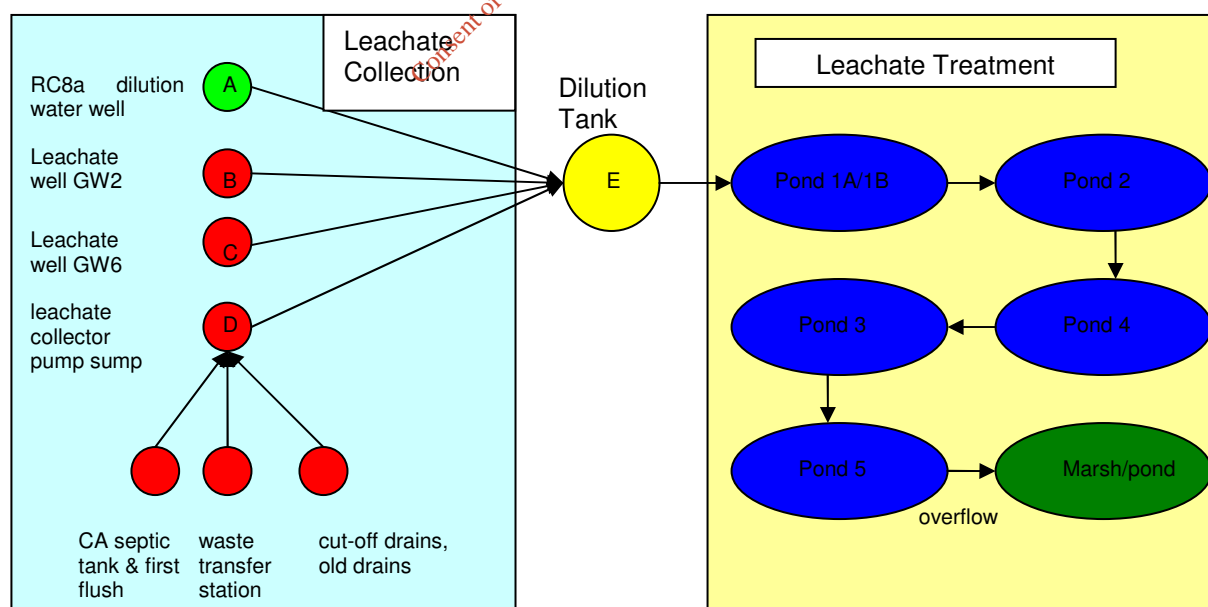
A process diagram below illustrates the leachate system operation. It is divided into three stages, leachate collection, leachate dilution and leachate treatment:

- Approximately 2 m³/day total (1 m³/day each), was extracted from leachate boreholes GW2 and GW6 and discharged to the Dilution Tank (timer based, consistent daily volume)
- the new leachate collector pump sump was float switch based, with variable daily volume
- Dilution water was extracted from groundwater borehole RC8a, intended to dilute water in the tank to less than 100 mg/l ammonium depending on concentration of leachate.

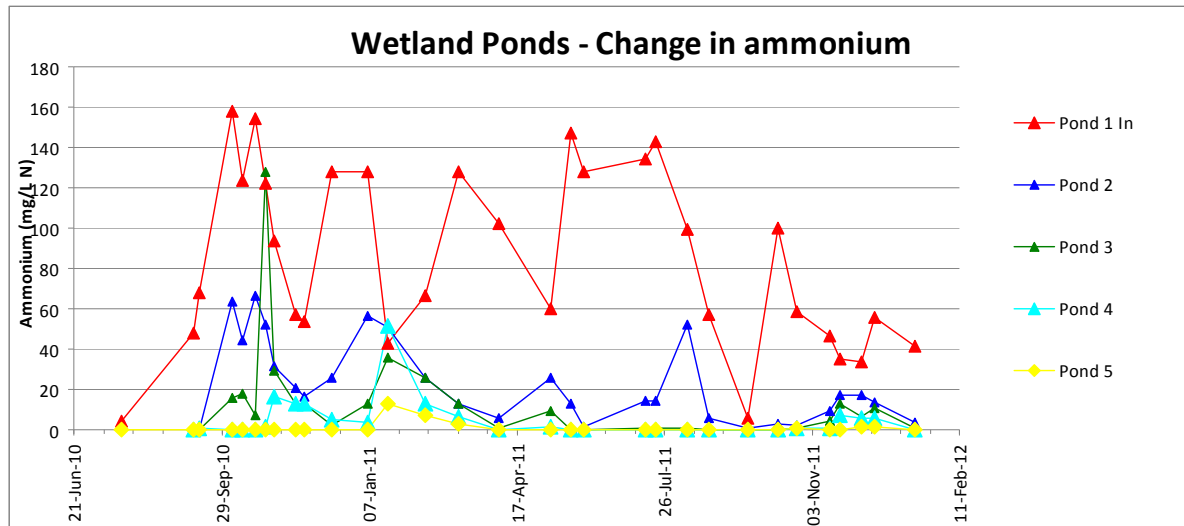
Figure 4.1: Ammonium Concentrations recorded from July 2010 to January 2012 at Ponds 1 -5

Figure 4.1 summarises the ammonium concentrations found at the outlet of each of the ponds in the ICW.

As discussed above, the dilution tank pumps diluted leachate into pond 1 at strength of approximately 100 - 200 mg/l. The effect on pond 1 can be seen from the graph above, with ammonium concentrations rising to over 150 mg/l during Sept-Oct 2010, but then falling back to below 100 mg/l as the pumping system flows settled post commissioning.

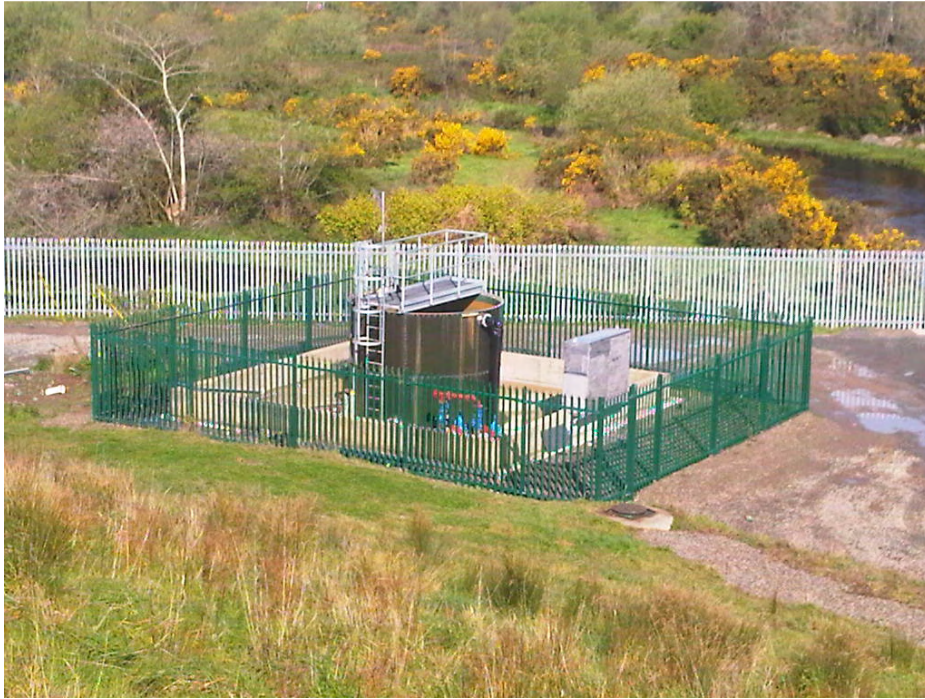
Dilution tank

The dilution tank receives all polluted arising from the landfill via leachate collector pipework connected to the tank. Dilution water is automatically pumped into the tank from either the recycle sump or dilution well to dilute the contents of the tank to the required value (operator variable, normally 100 mg/l). Once the required dilution has been achieved, the diluted leachate is pumped to Wetland cell 1A via a transfer pump.
