**VISUAL IMPACT ASSESSMENT of
BIOGAS PLANT on BARRYSHALL HOUSE
BARRYSHALL
TIMOLEAGUE
BANDON**

14th May 2013)

This report with its accompanying drawings photographs and photomontages assesses the visual impact of the proposed development on Barryshall House.

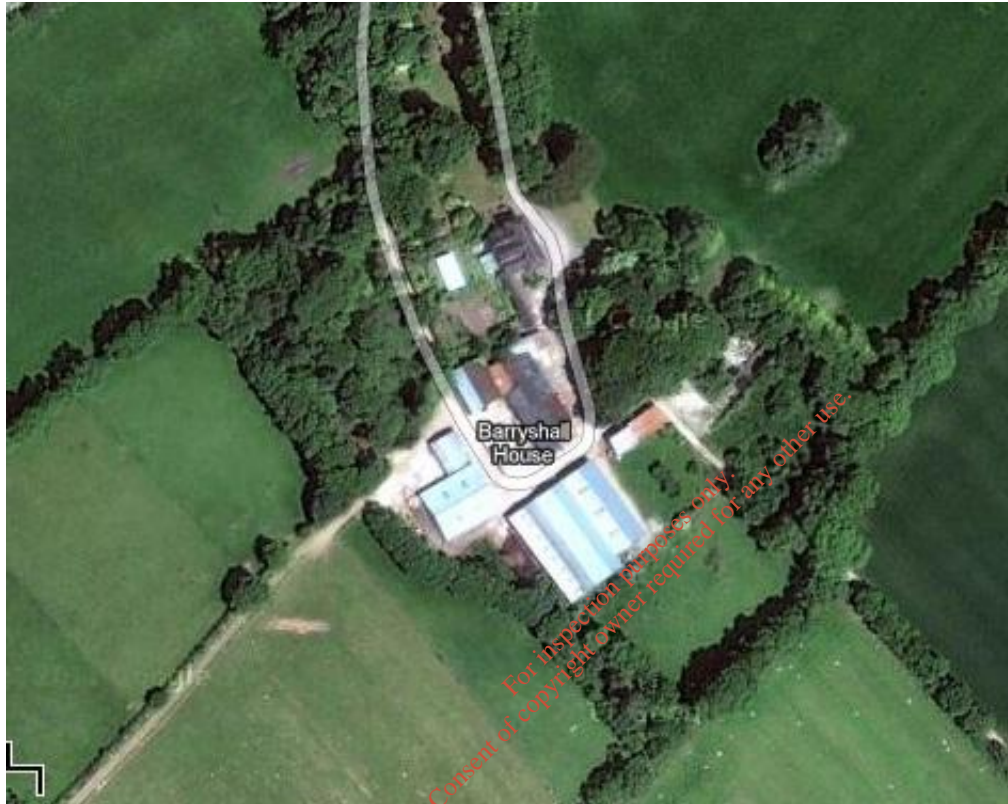
1.0 Satellite Image of Barryshall House and surrounding screening

We have not been able to find any vantage point on the public road network surrounding the facility where the House and the Biogas Plant site can both be seen together. The *Satellite Image* in **Appendix 1** demonstrated the extent of the screening between the House and the proposed development site.

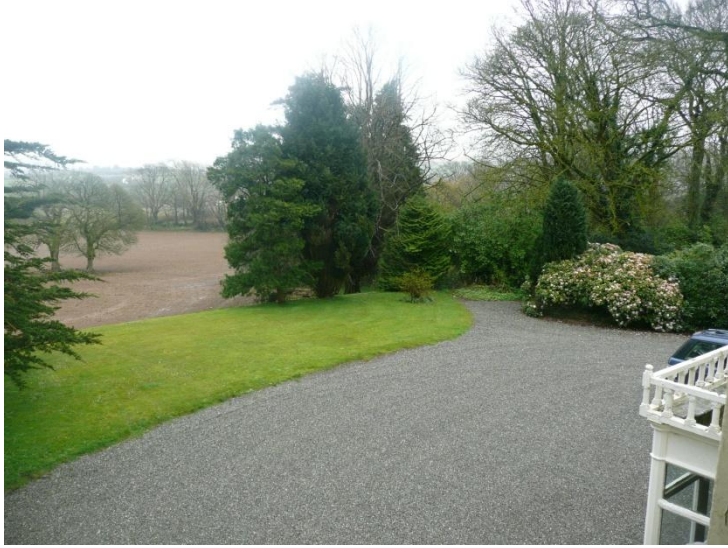
2. 0 Photo in the direction of the Biogas Plant Site from the first floor Window at the Northern End of the dwelling.

The extent of the screening obscures the proposed Biogas Plant from the dwelling. Photographs attached both from the first floor and the front of the House demonstrates the extent of the screening between the Biogas Plant and Barryshall House. A wide angle collage has been made from photographs taken at the Northeast corner and the North West Corner of the house which confirms the extent of the screening. (*Photograph 4 and 5 Appendix 1*)

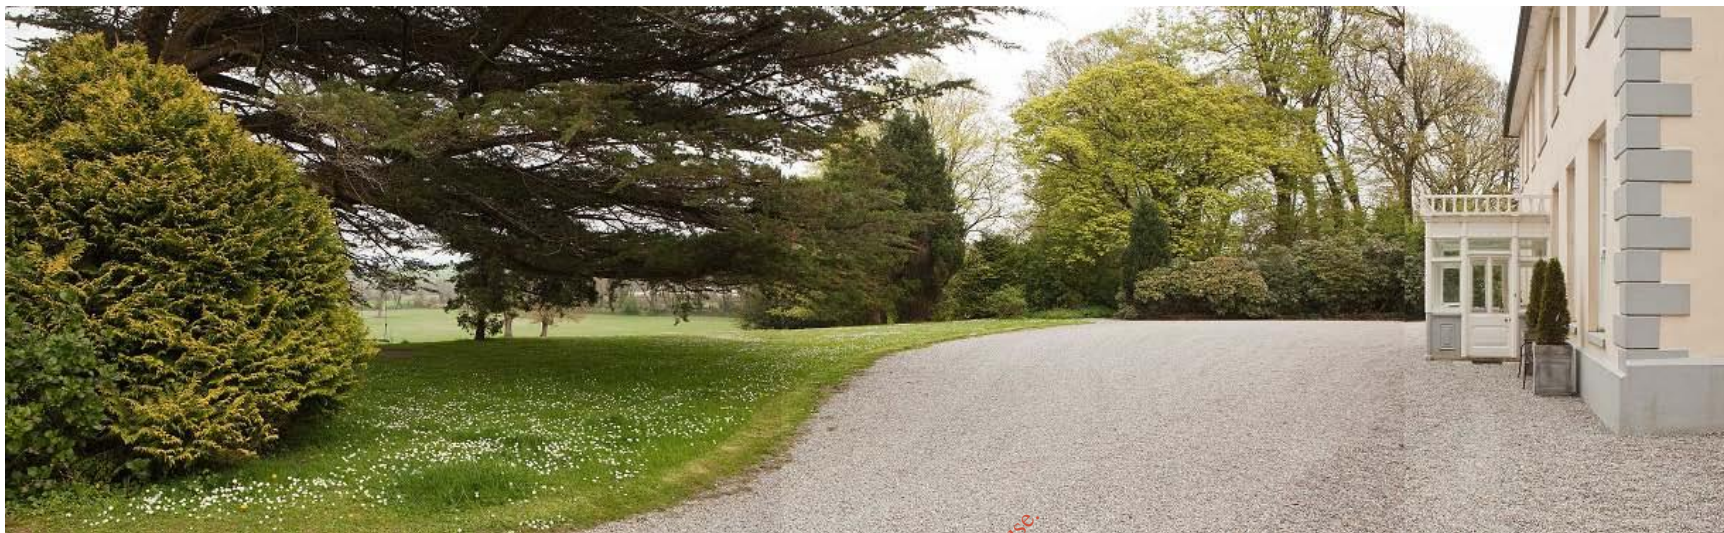
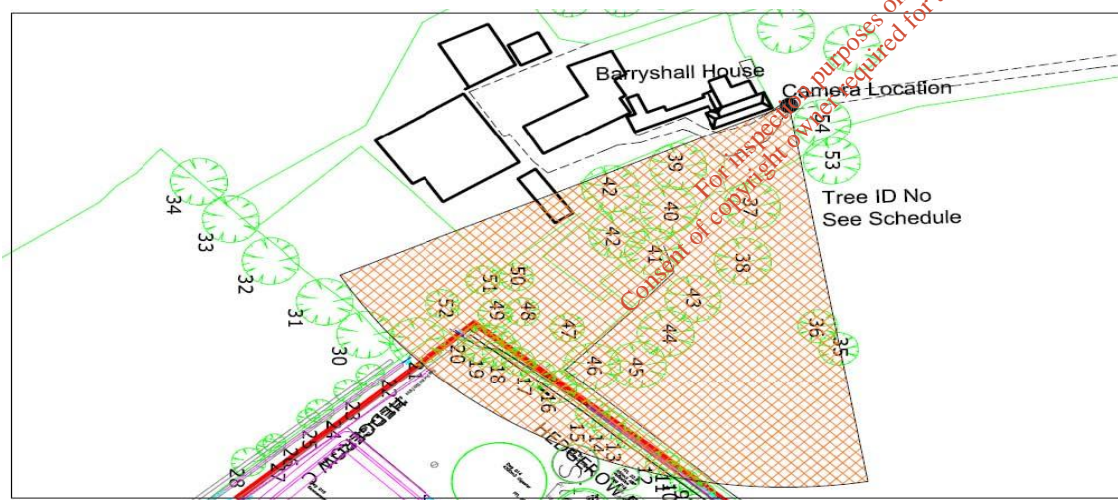
4.0 Panoramic view of the proposed Biogas Plant site from the Northeast corner of Barryshall House.

Map Showing Extent of Panoramic View 4.0

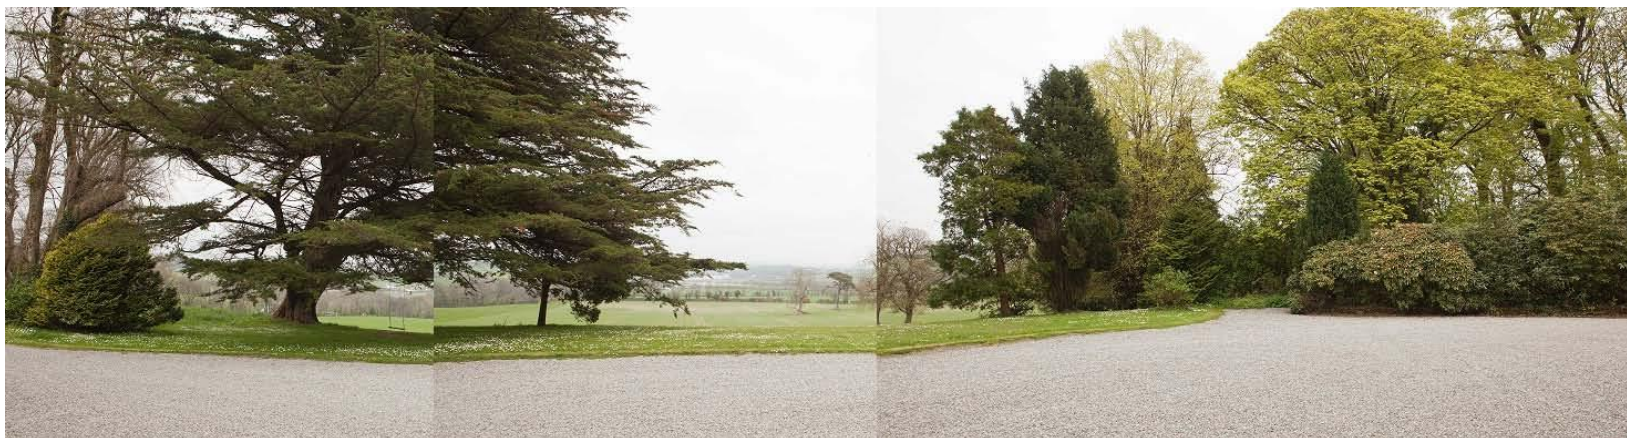
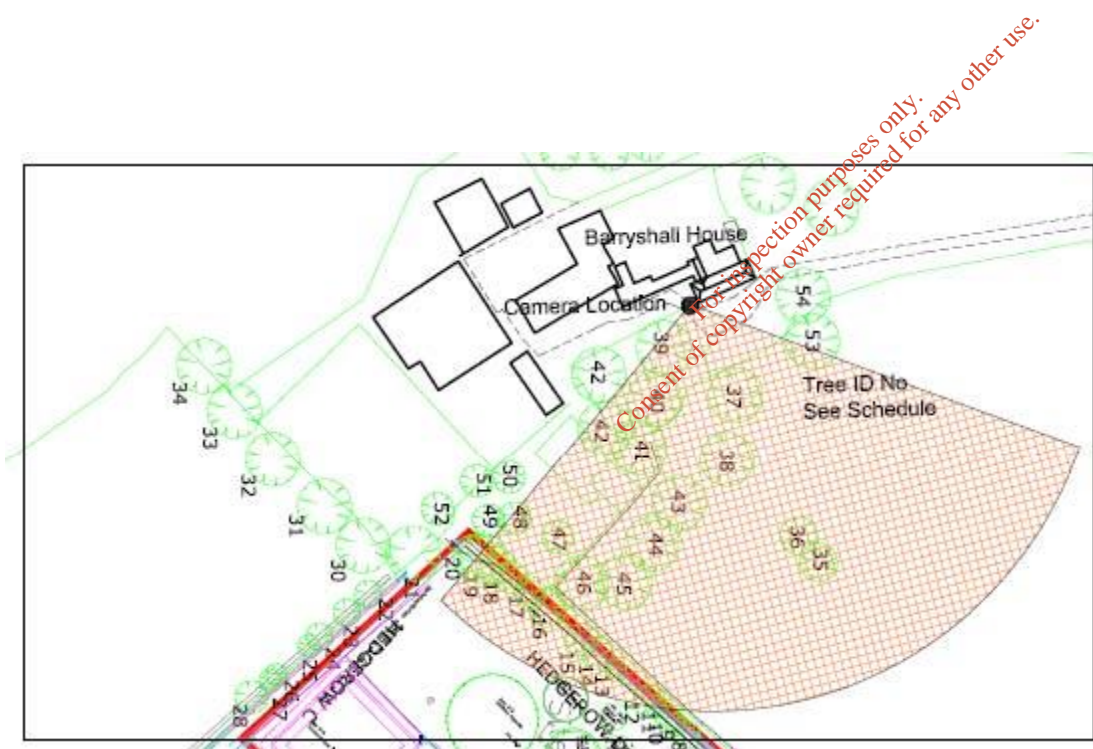
5.0 Panoramic view of the Proposed Plant Site from the Northwest corner of Barryshall House

Map Showing Extent of Panoramic View 5.0

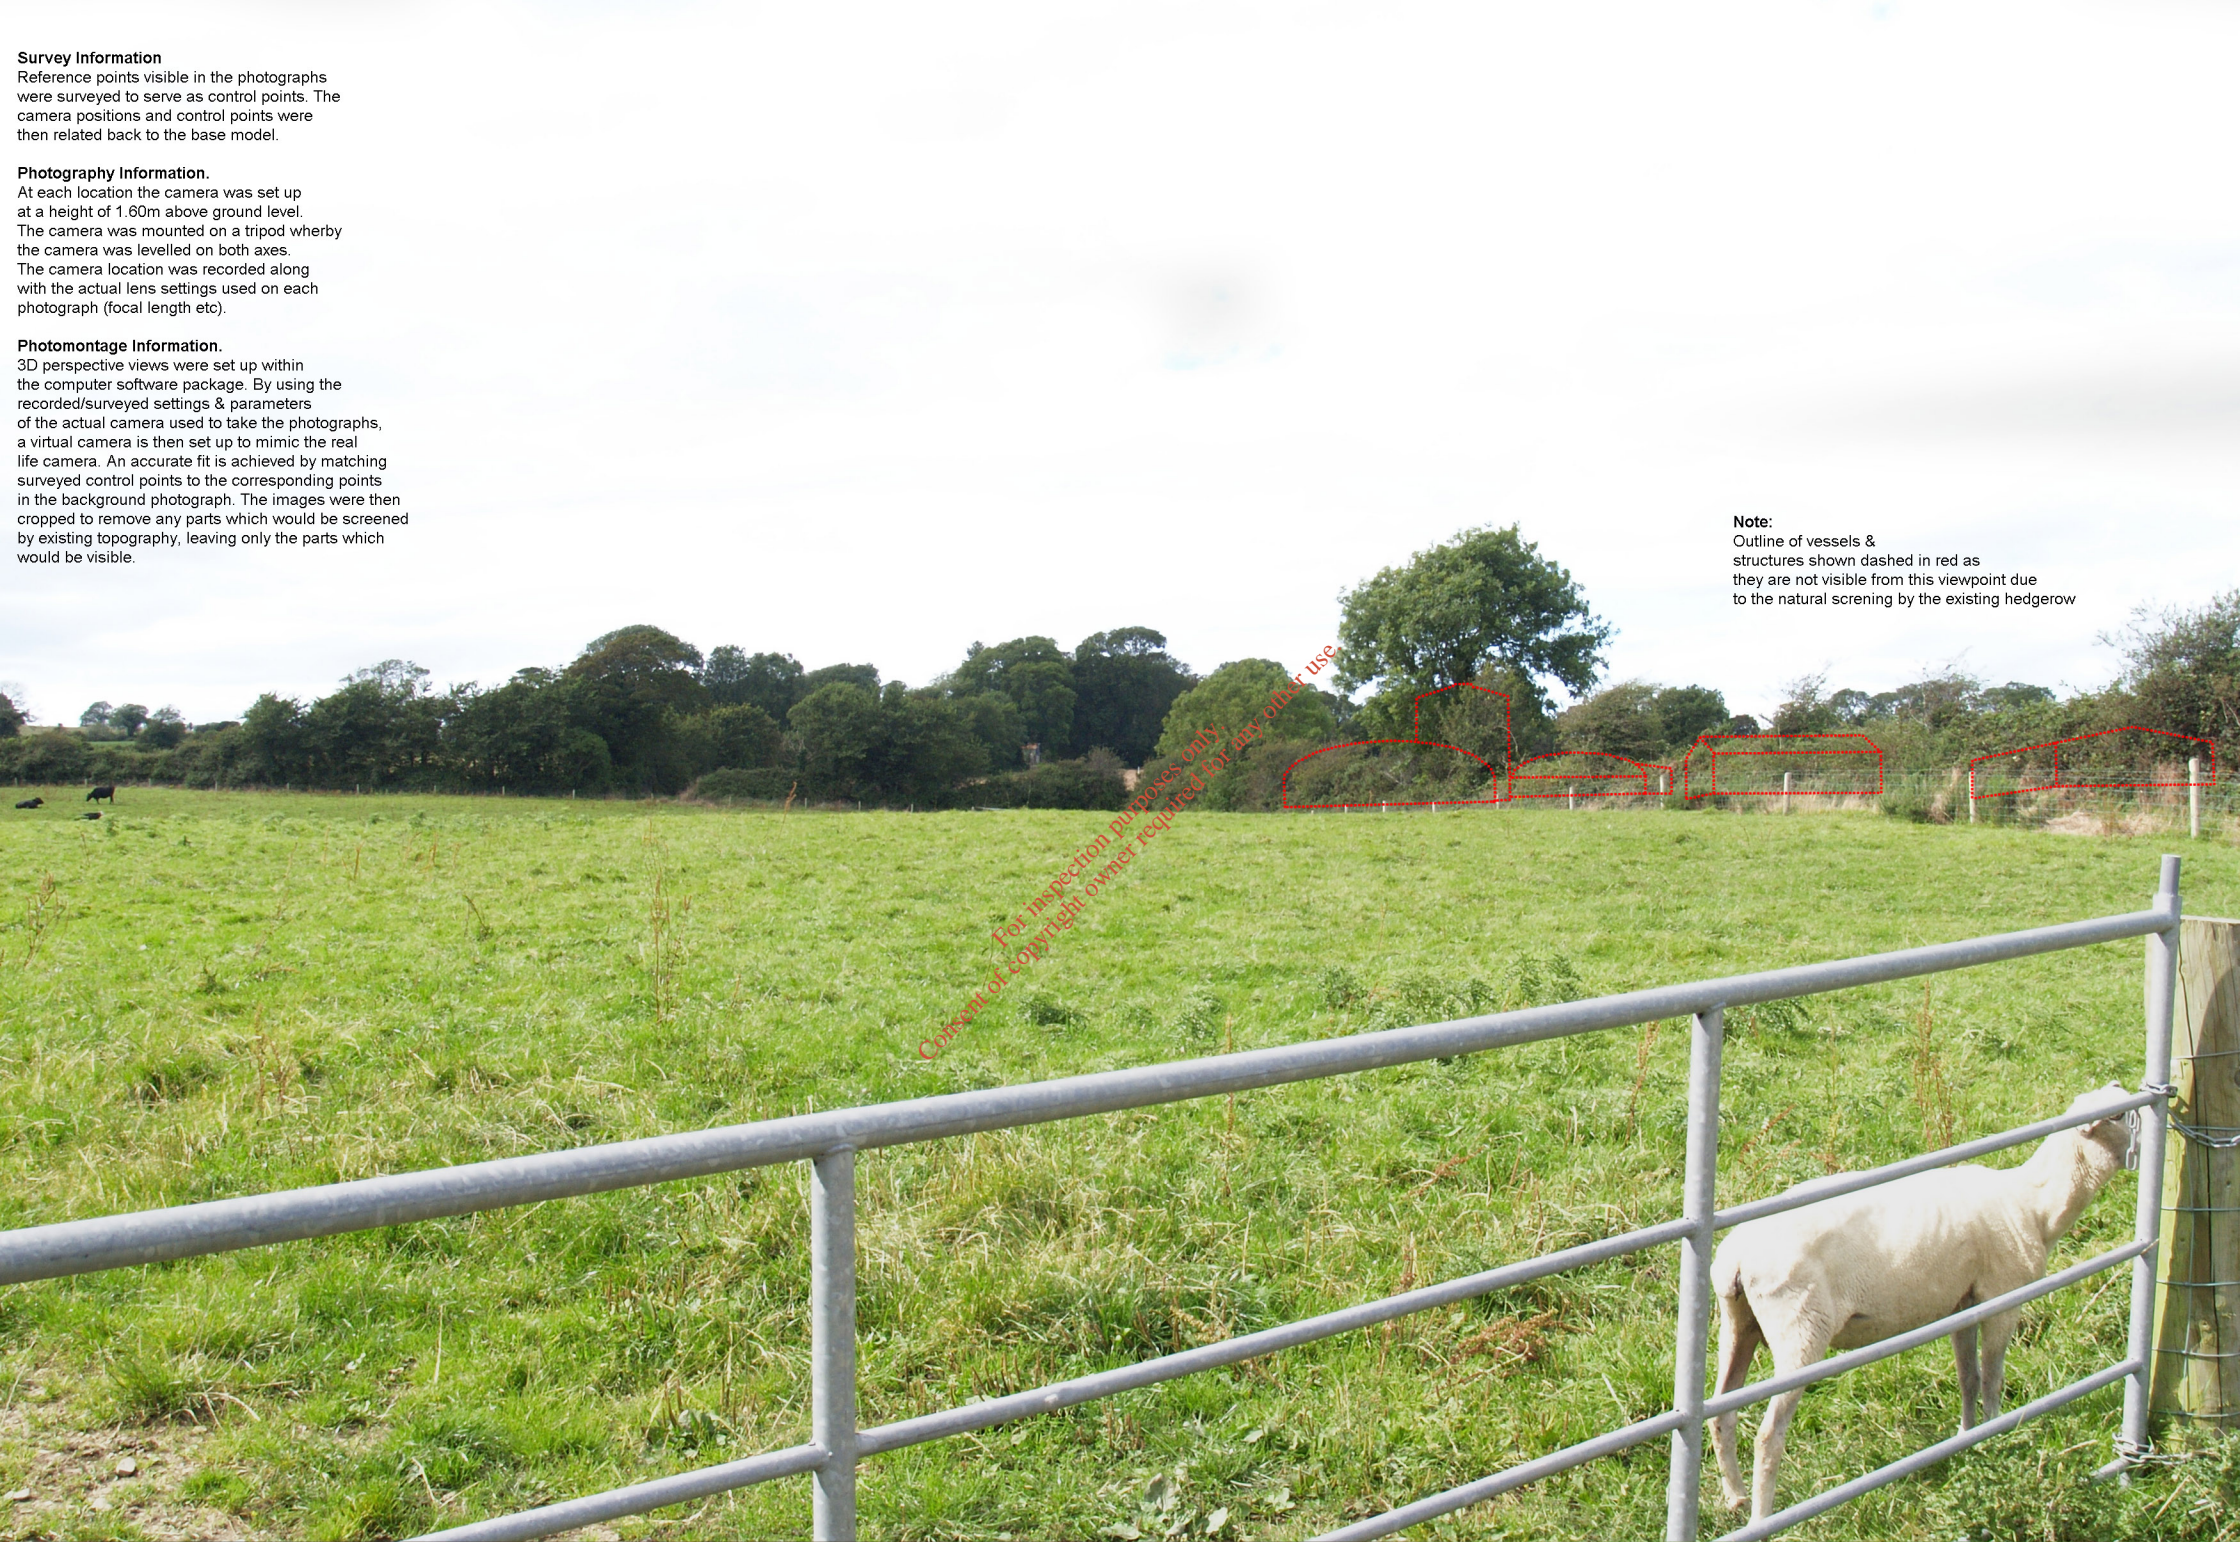
Survey Information
Reference points visible in the photographs were surveyed to serve as control points. The camera positions and control points were then related back to the base model.

Photography Information.
At each location the camera was set up at a height of 1.60m above ground level. The camera was mounted on a tripod whereby the camera was levelled on both axes. The camera location was recorded along with the actual lens settings used on each photograph (focal length etc).

Photomontage Information.
3D perspective views were set up within the computer software package. By using the recorded/surveyed settings & parameters of the actual camera used to take the photographs, a virtual camera is then set up to mimic the real life camera. An accurate fit is achieved by matching surveyed control points to the corresponding points in the background photograph. The images were then cropped to remove any parts which would be screened by existing topography, leaving only the parts which would be visible.

Note:
Outline of vessels & structures shown dashed in red as they are not visible from this viewpoint due to the natural screening by the existing hedgerow

Photomontages No 1 – 3 illustrate the extent of the existing screening in place and to be maintained with the proposed development. We have also attached *Photomontages 1.2 and 3.2* highlights the extent of the screened area of the proposed structures by the existing planting without taking into account the proposed augmented landscaping plan. These also have the location of Barryshall House relative to the location of the image.

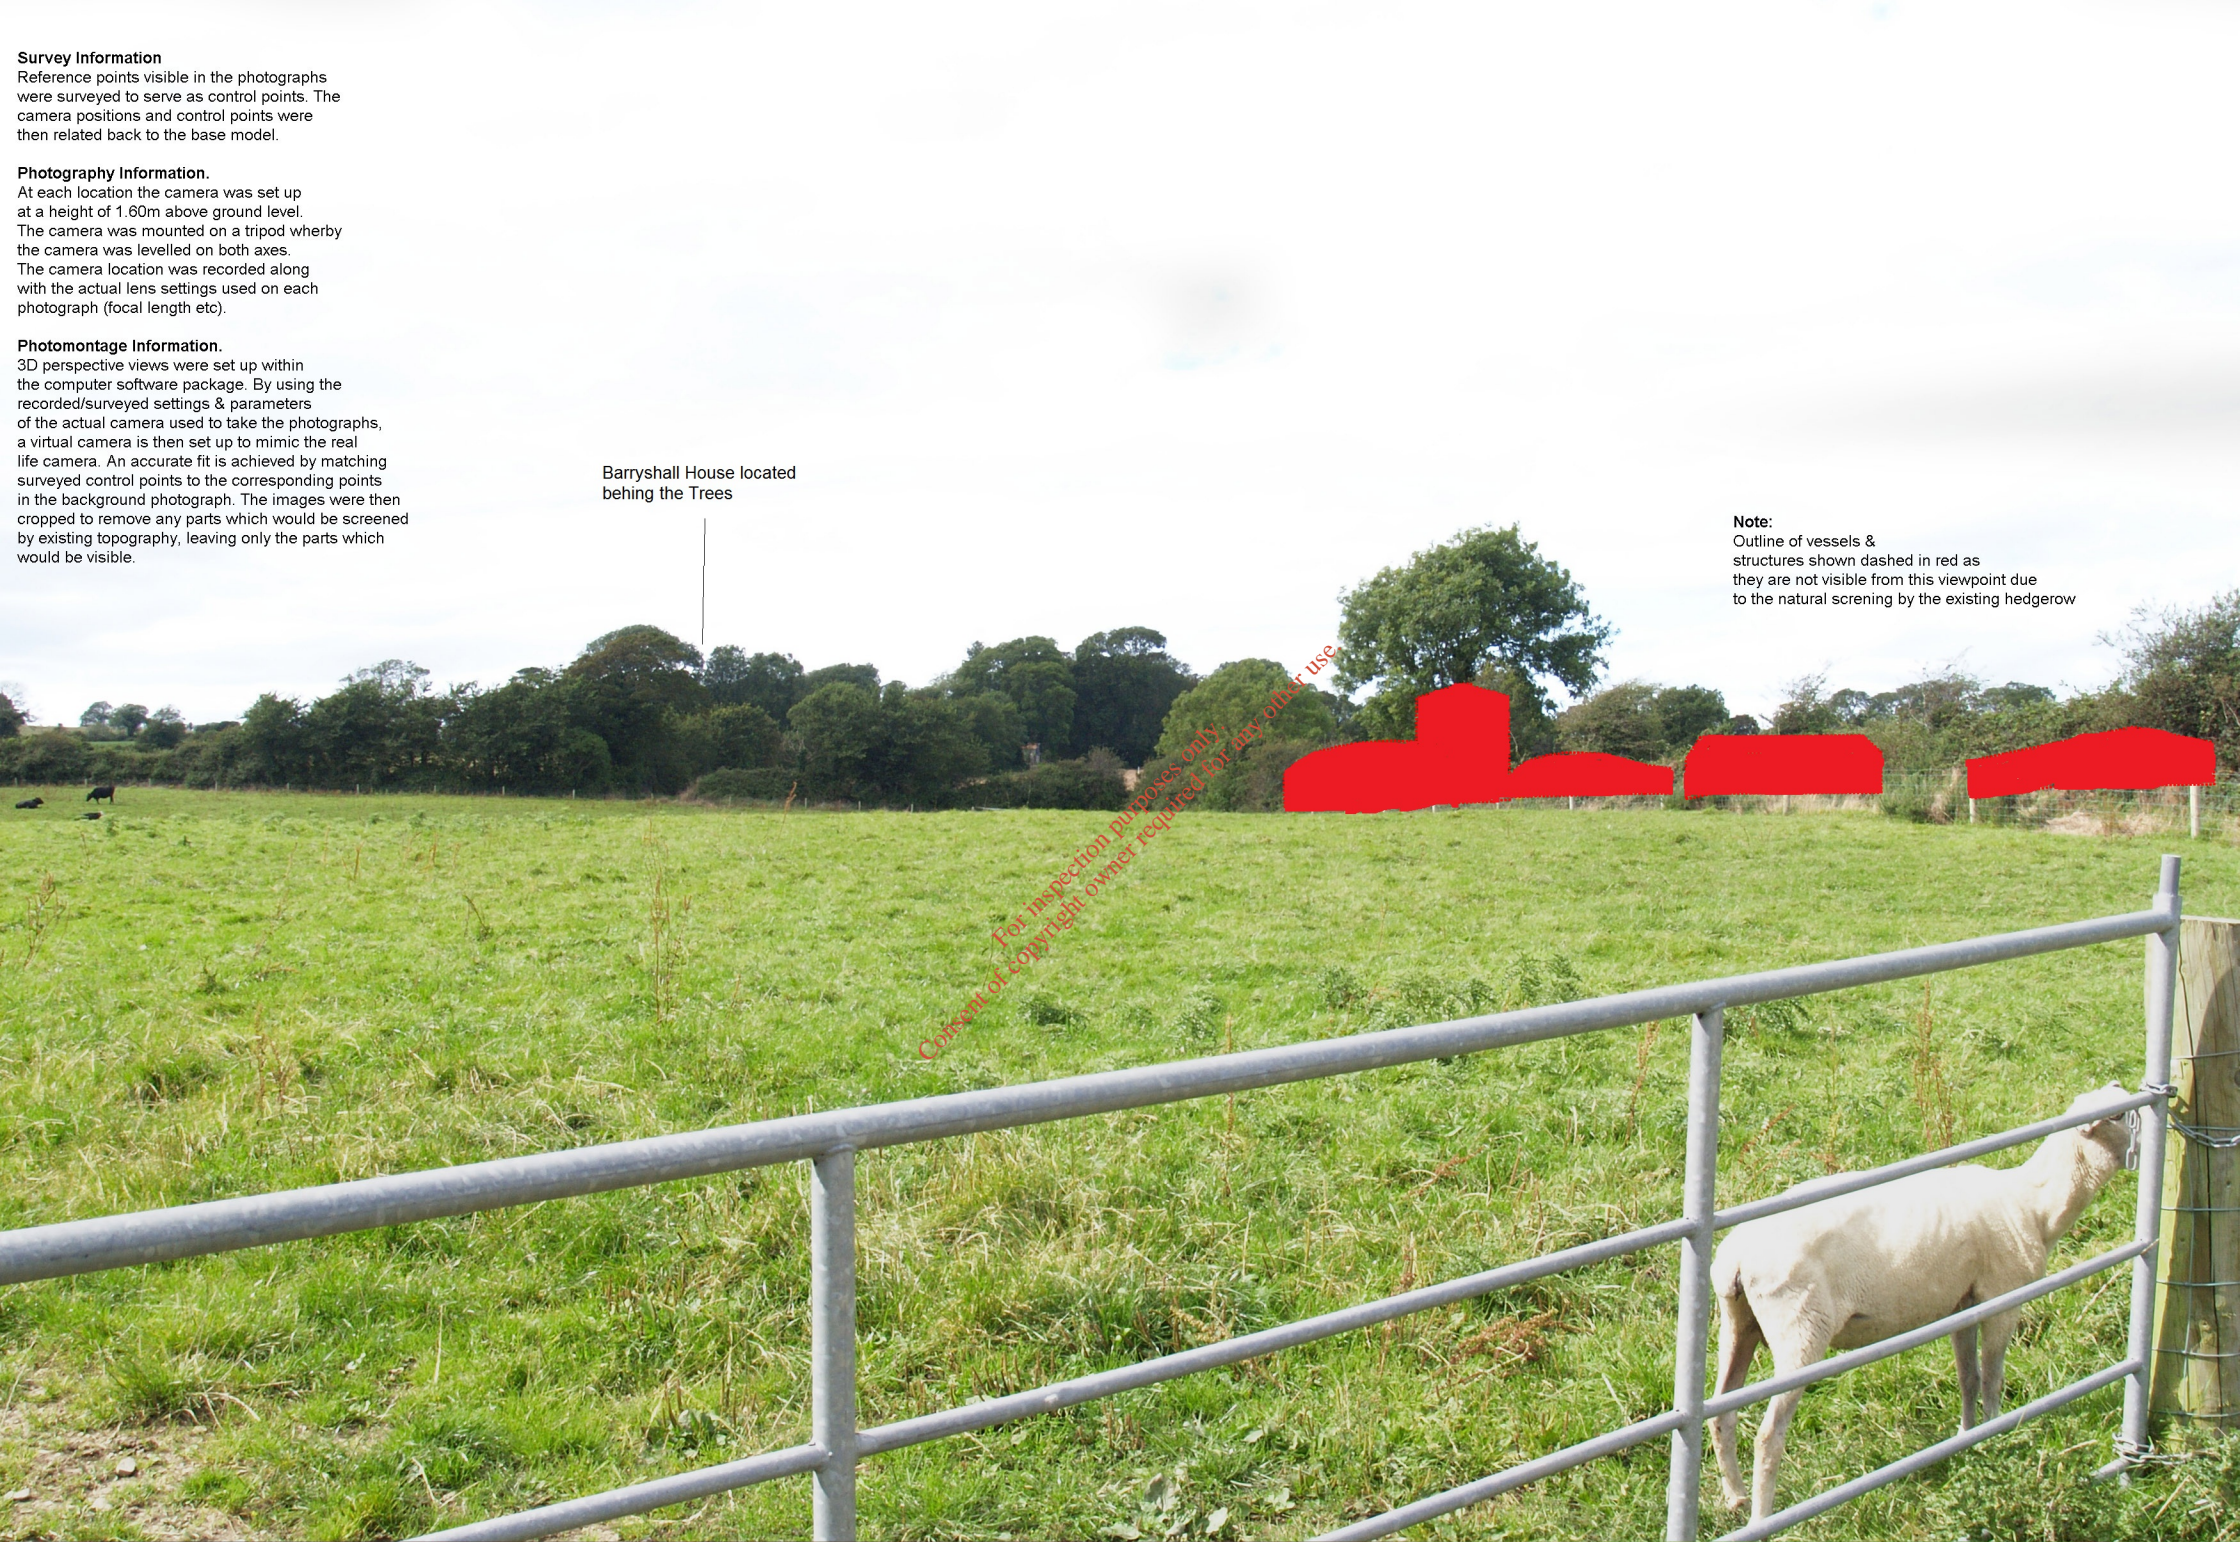
Barryshall House located behind the Trees

Note:
Outline of vessels & structures shown dashed in red as they are not visible from this viewpoint due to the natural screening by the existing hedgerow

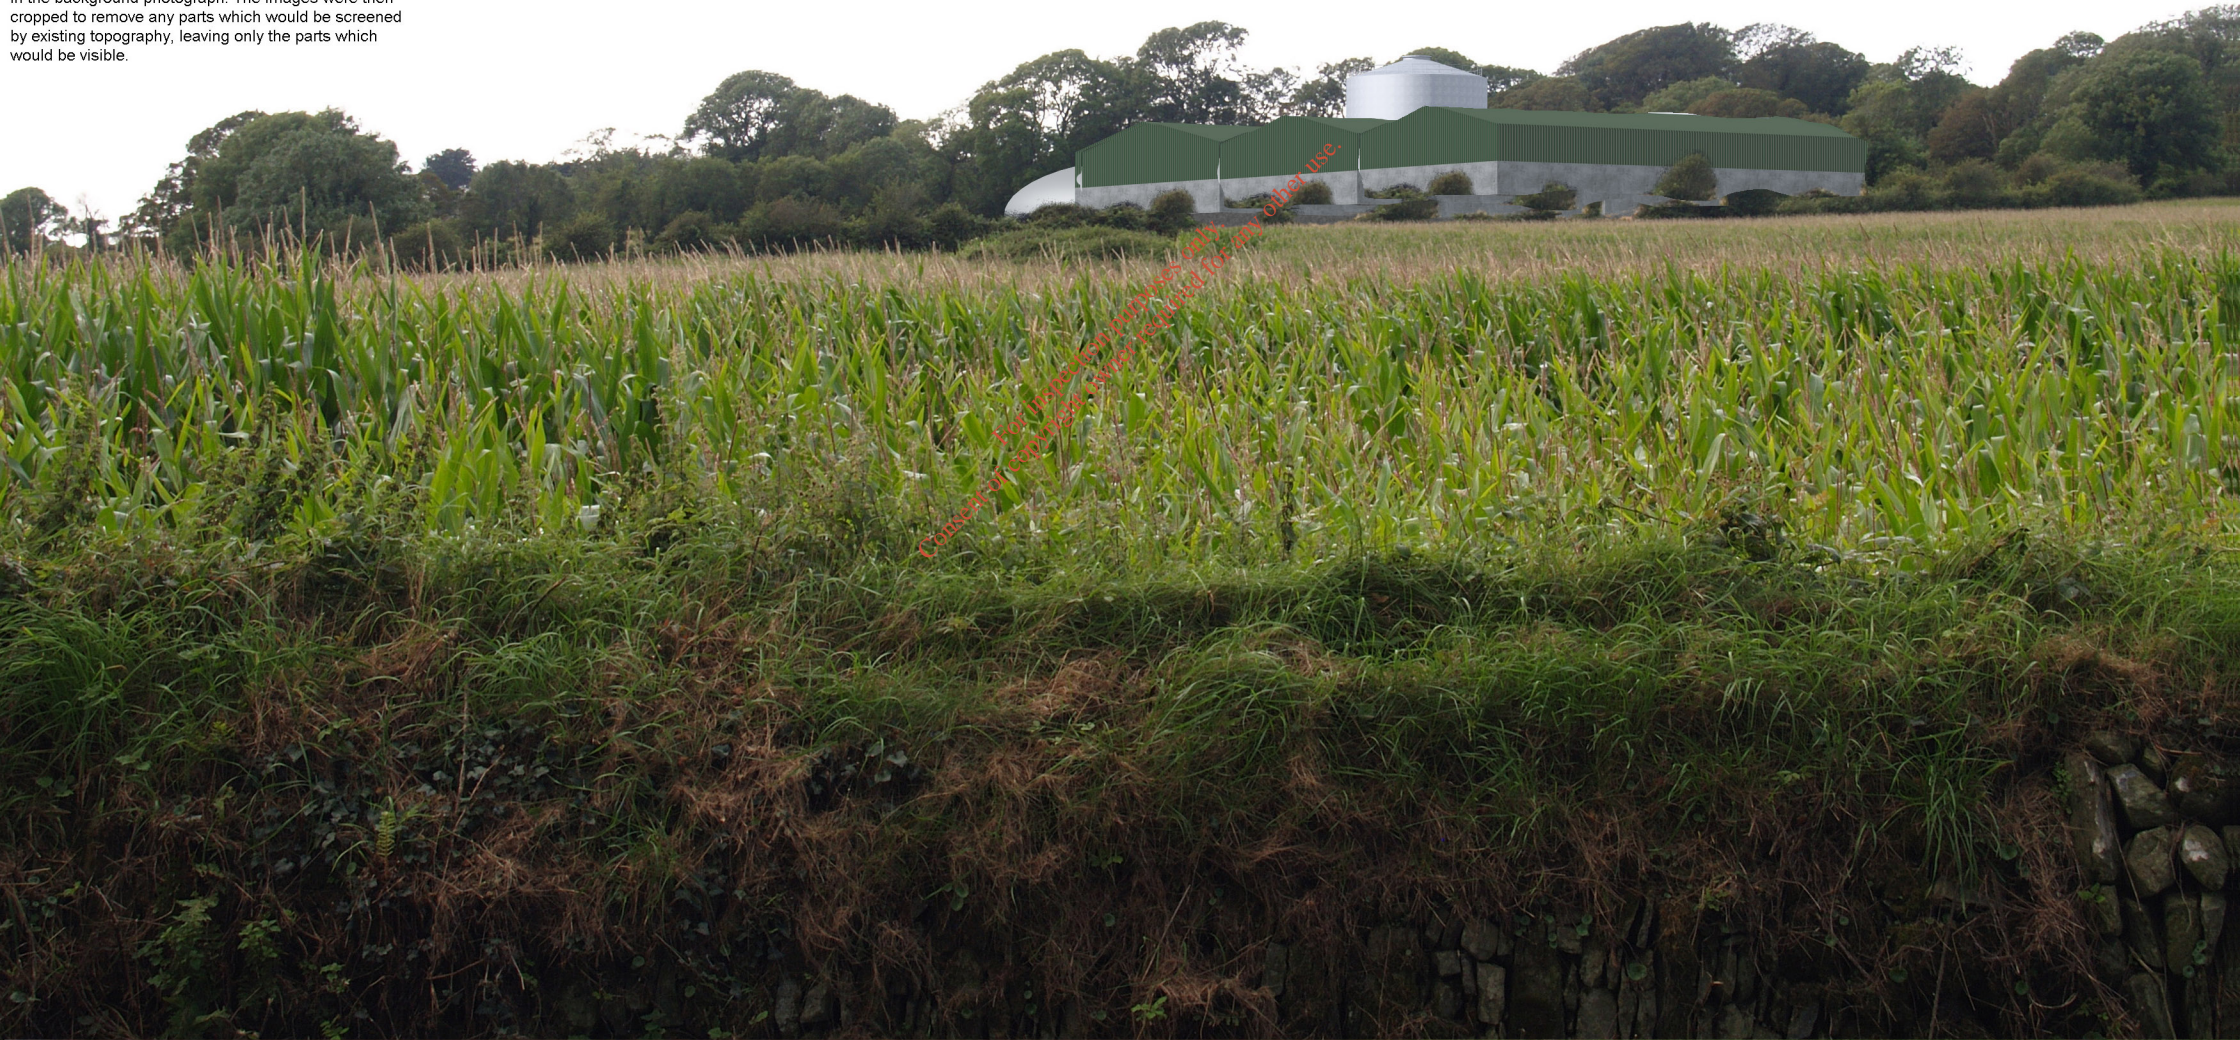
Important Note:
This photomontage was created based on a photograph taken at an eye level of 2.2m above the public road level, ie from a viewpoint when standing on the 600mm high wall at the eastern side of the public road at Stauntons factory.

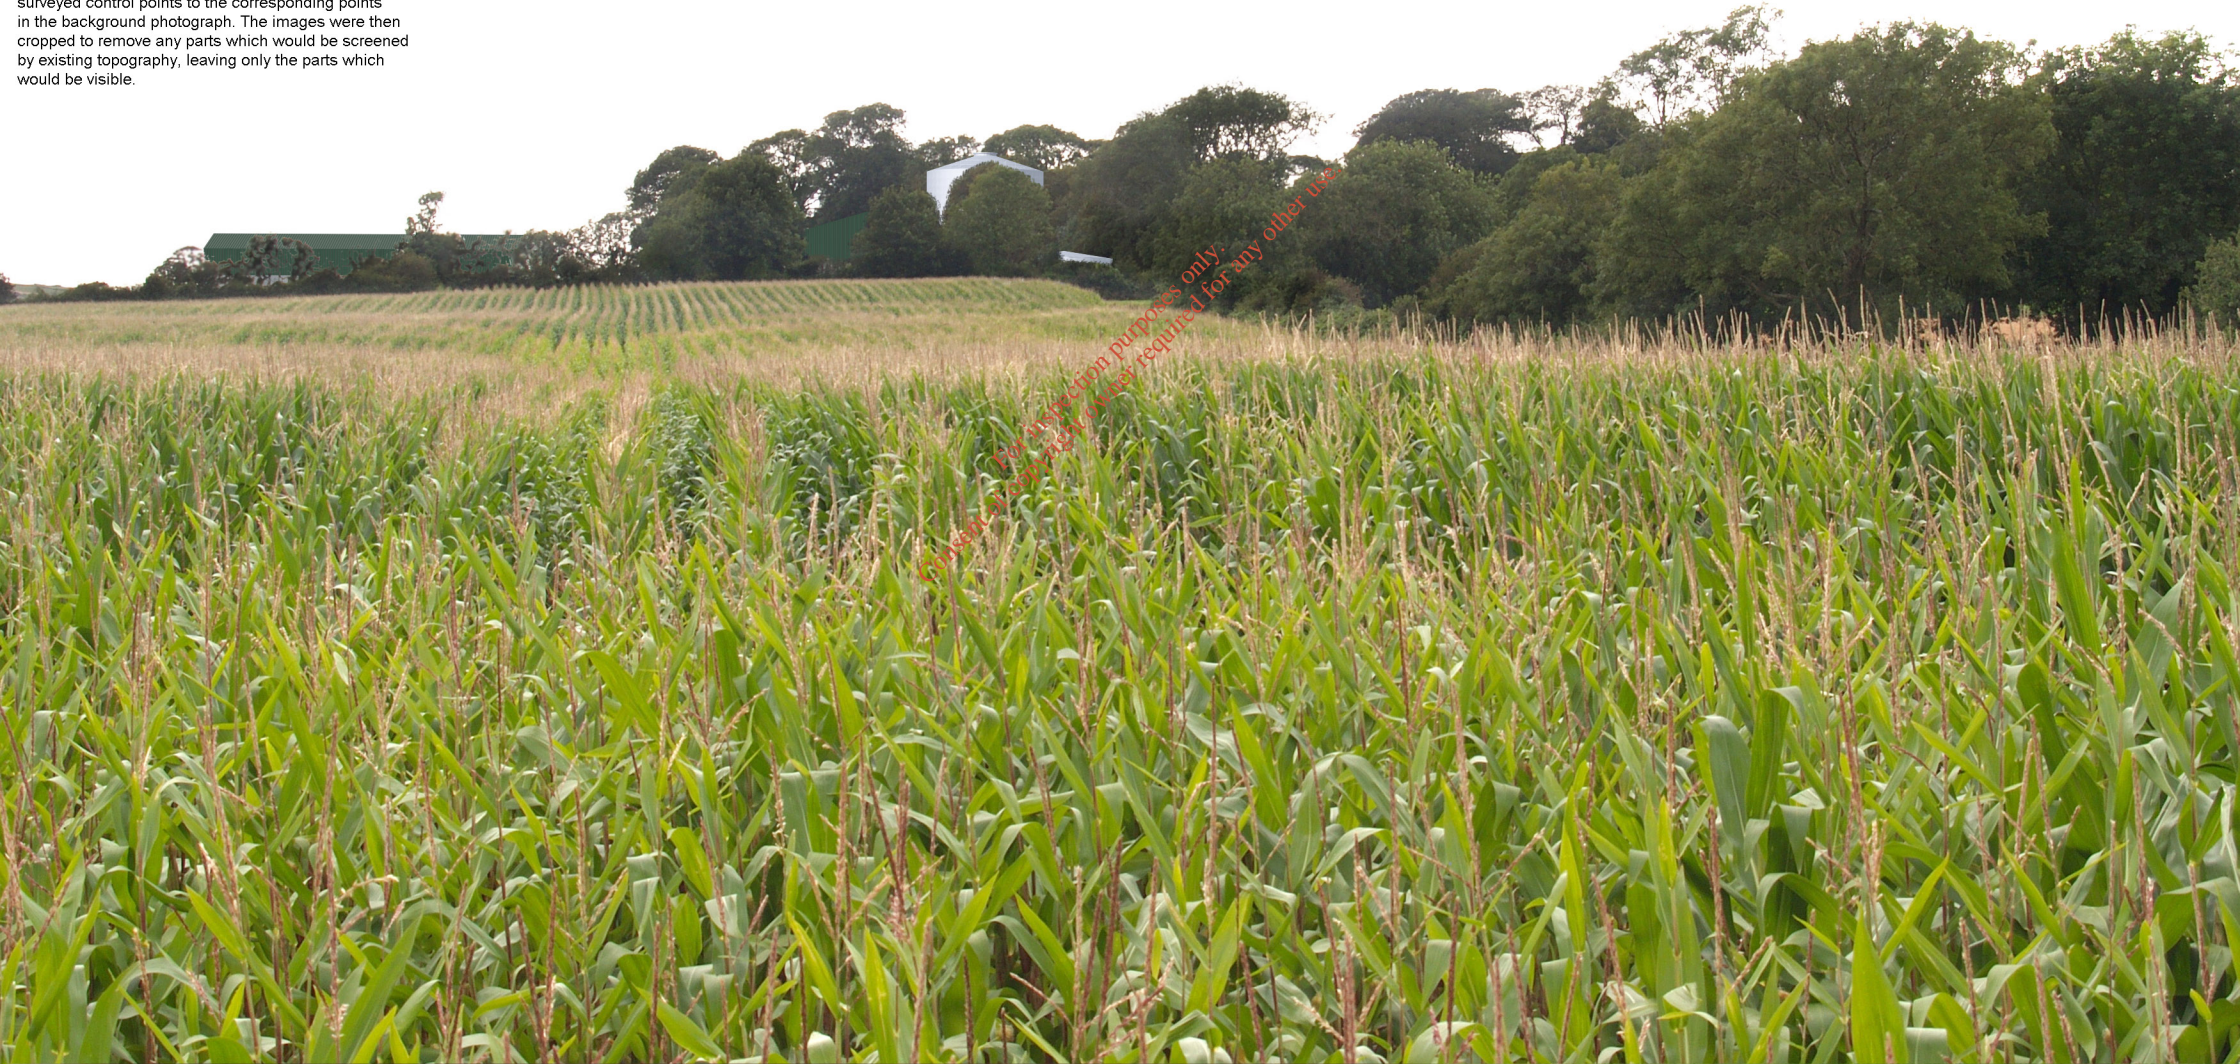
This photomontage was created based on a photograph taken at an eye level of 3.0m above the public road level, ie from a viewpoint when standing on the 1400mm high ditch at the north-eastern point of adjacent field to the site.

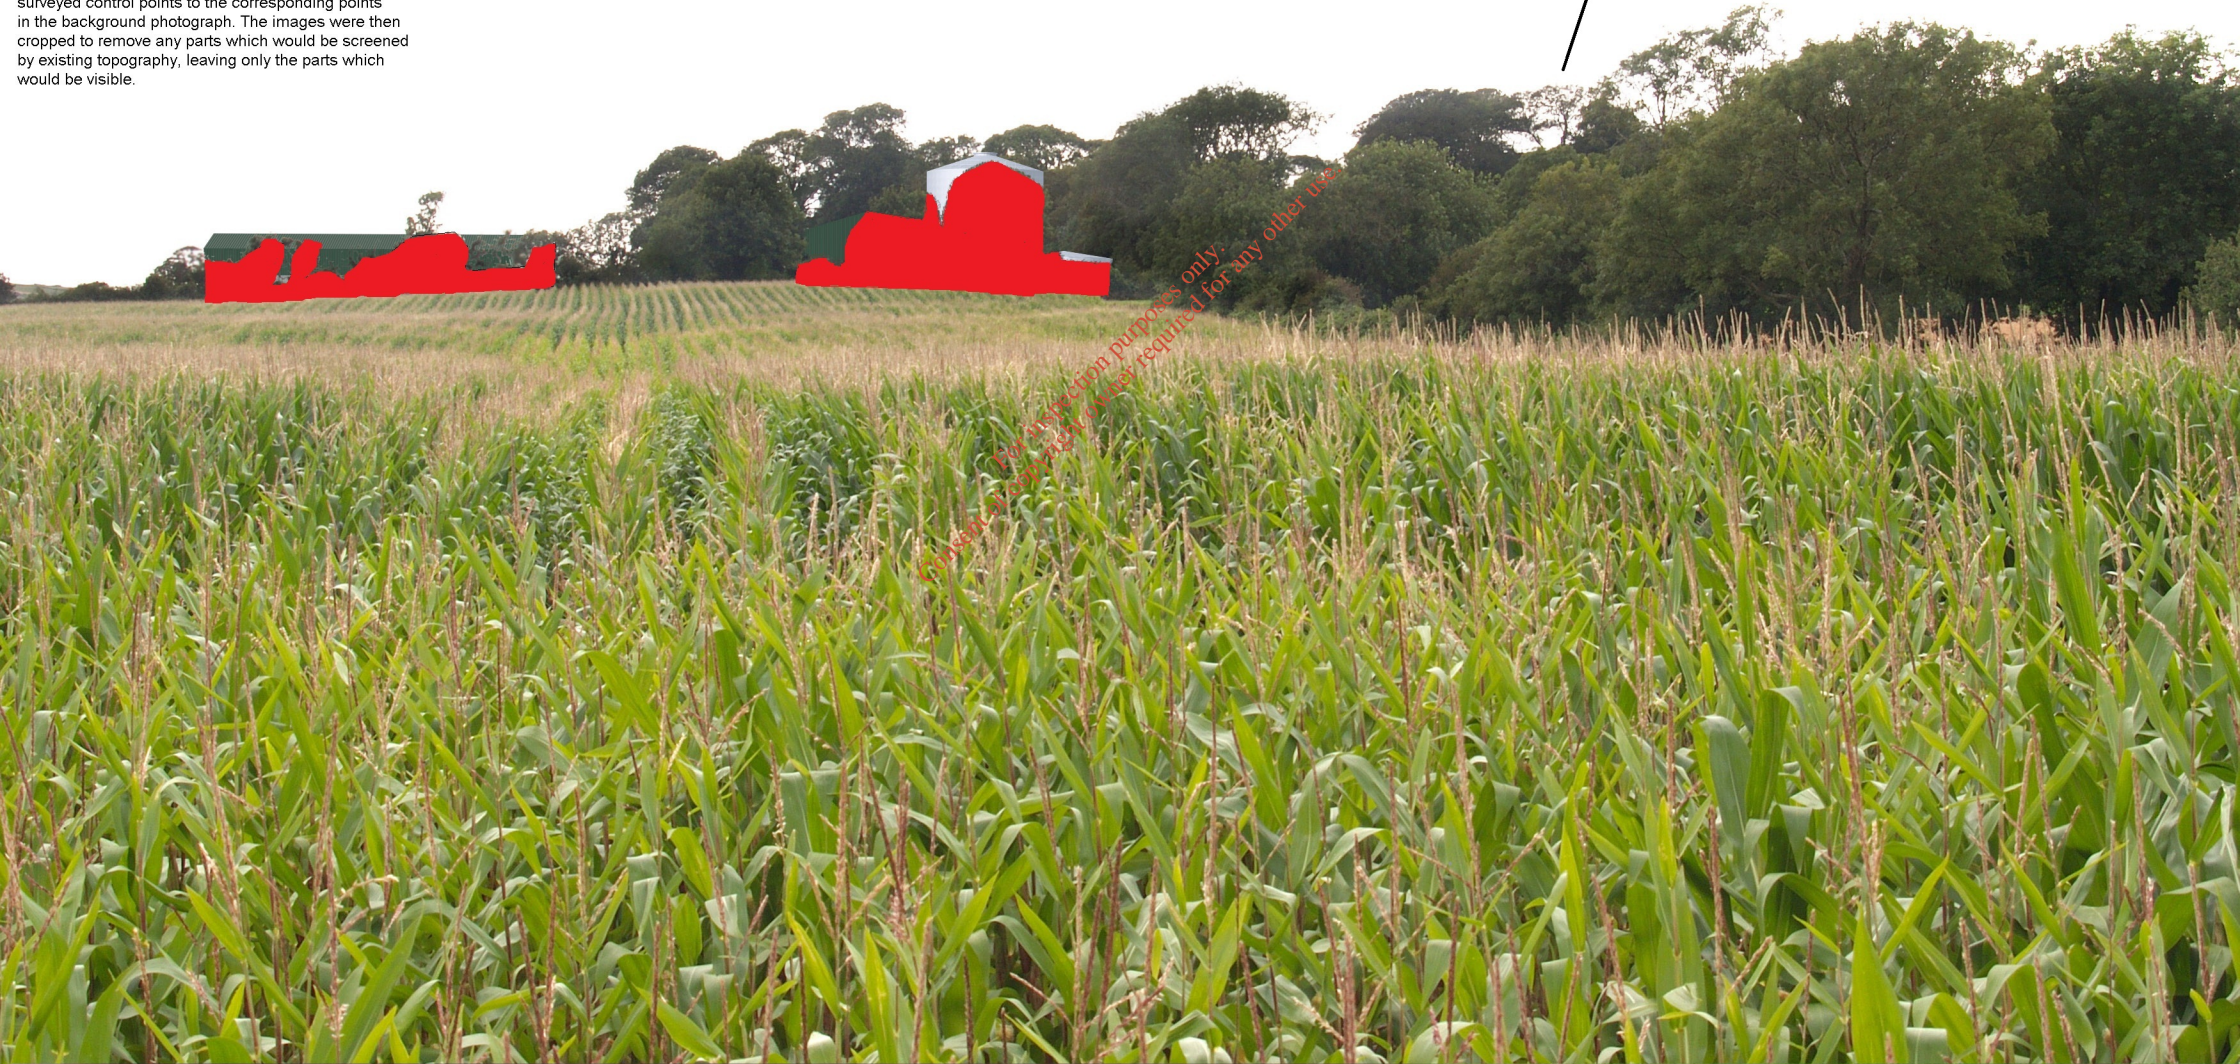
Important Note:
This photomontage was created based on a photograph taken at an eye level of 3.0m above the public road level, ie from a viewpoint when standing on the 1400mm high ditch at the north-eastern point of adjacent field to the site.

**Barryshall House
Located behind
the Trees**

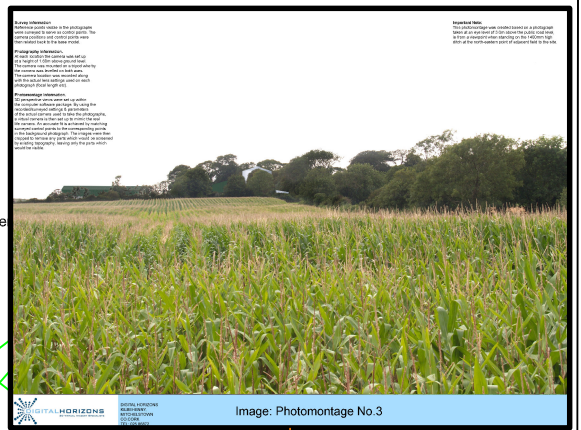
Image: Photomontage No.3

Visual Impact - Photomontage No3

Partial and glimpsed views of the main built structure are possible in winter months from the Public Road. The visual impact is of a low magnitude. Note : Camera Elevation raised for unobstructed view of facility location over the maize crop

Biogas Plant to be located behind Mature Screening. Barry's Hall House
