# East Tip, Haulbowline Island, Cork

## **Foreshore Waste Assessment Addendum to Detailed Quantitative Risk Assessment**

Document: Foreshore Waste Assessment

Project: Haulbowline East Tip Site Investigation & DQRA

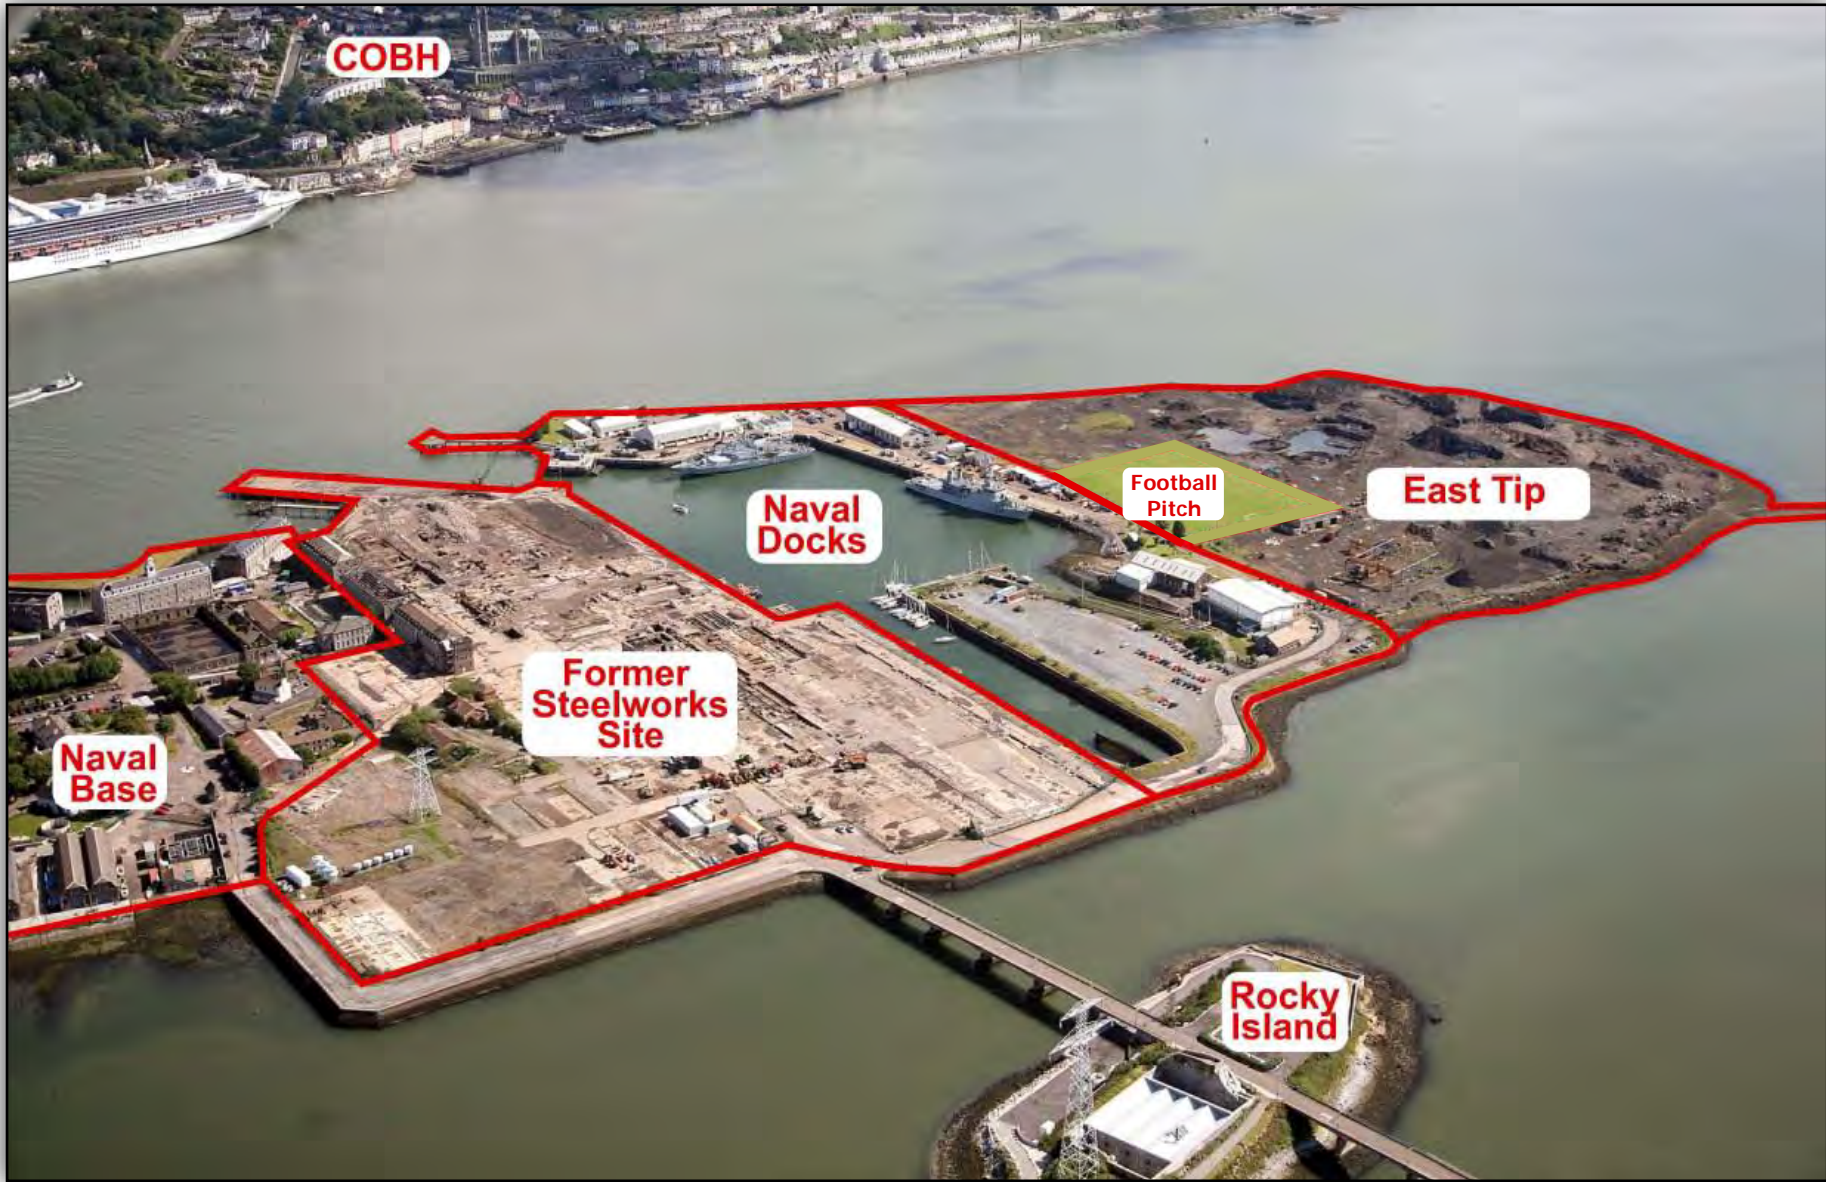
**Figure No. 2.**

**Cork County Council - Haulbowline**  
Aerial Photograph

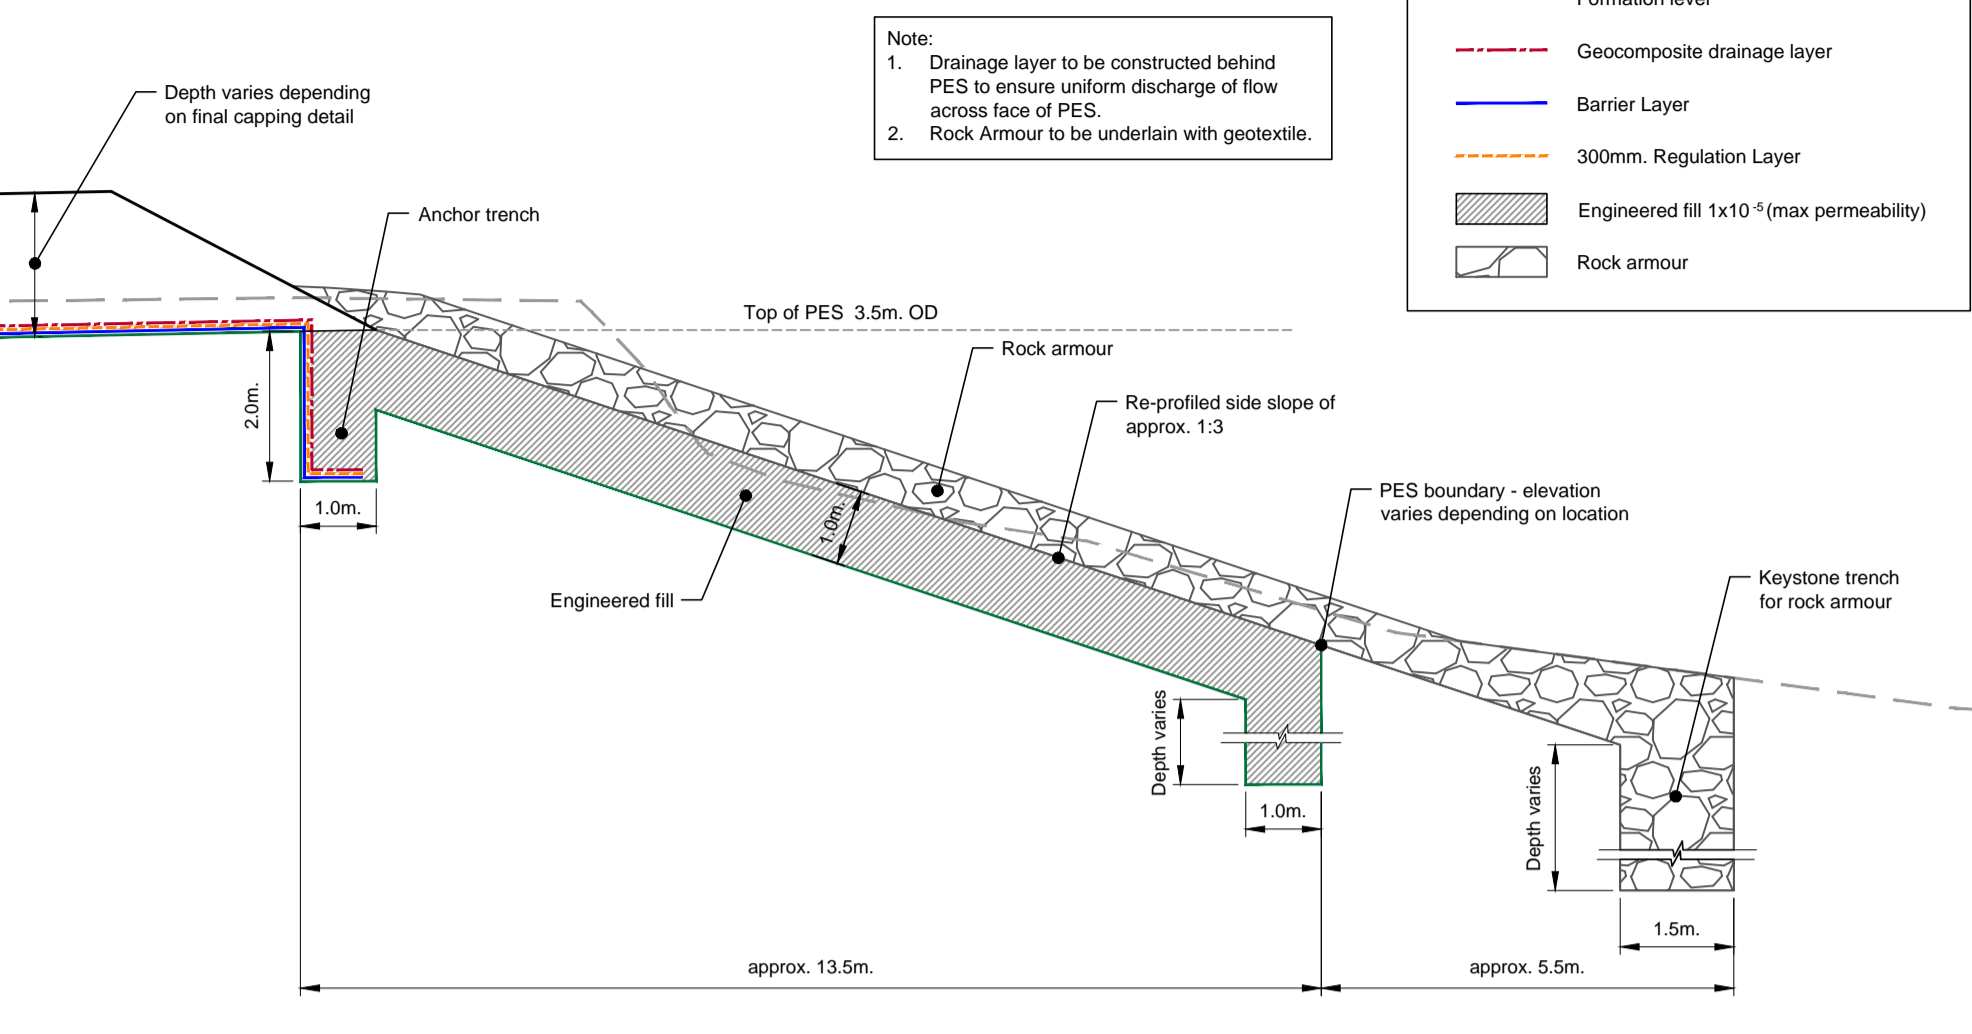
**PES - Typical Sectional Detail 1:  
Trench and Wedge Option**

In considering the above it should also be noted that post remediation, the foreshore area will be almost entirely covered by the proposed perimeter engineered structure which effectively will remove any direct contact human health exposure pathways. Exposure through dust generation pathways will also be highly unlikely due to the damp nature of the waste material which is in the tidal zone, is constantly wet and is mostly submerged by seawater. Access to the foreshore will also not be provided post remediation and will be limited by the proposed perimeter engineered structure and rock armour.

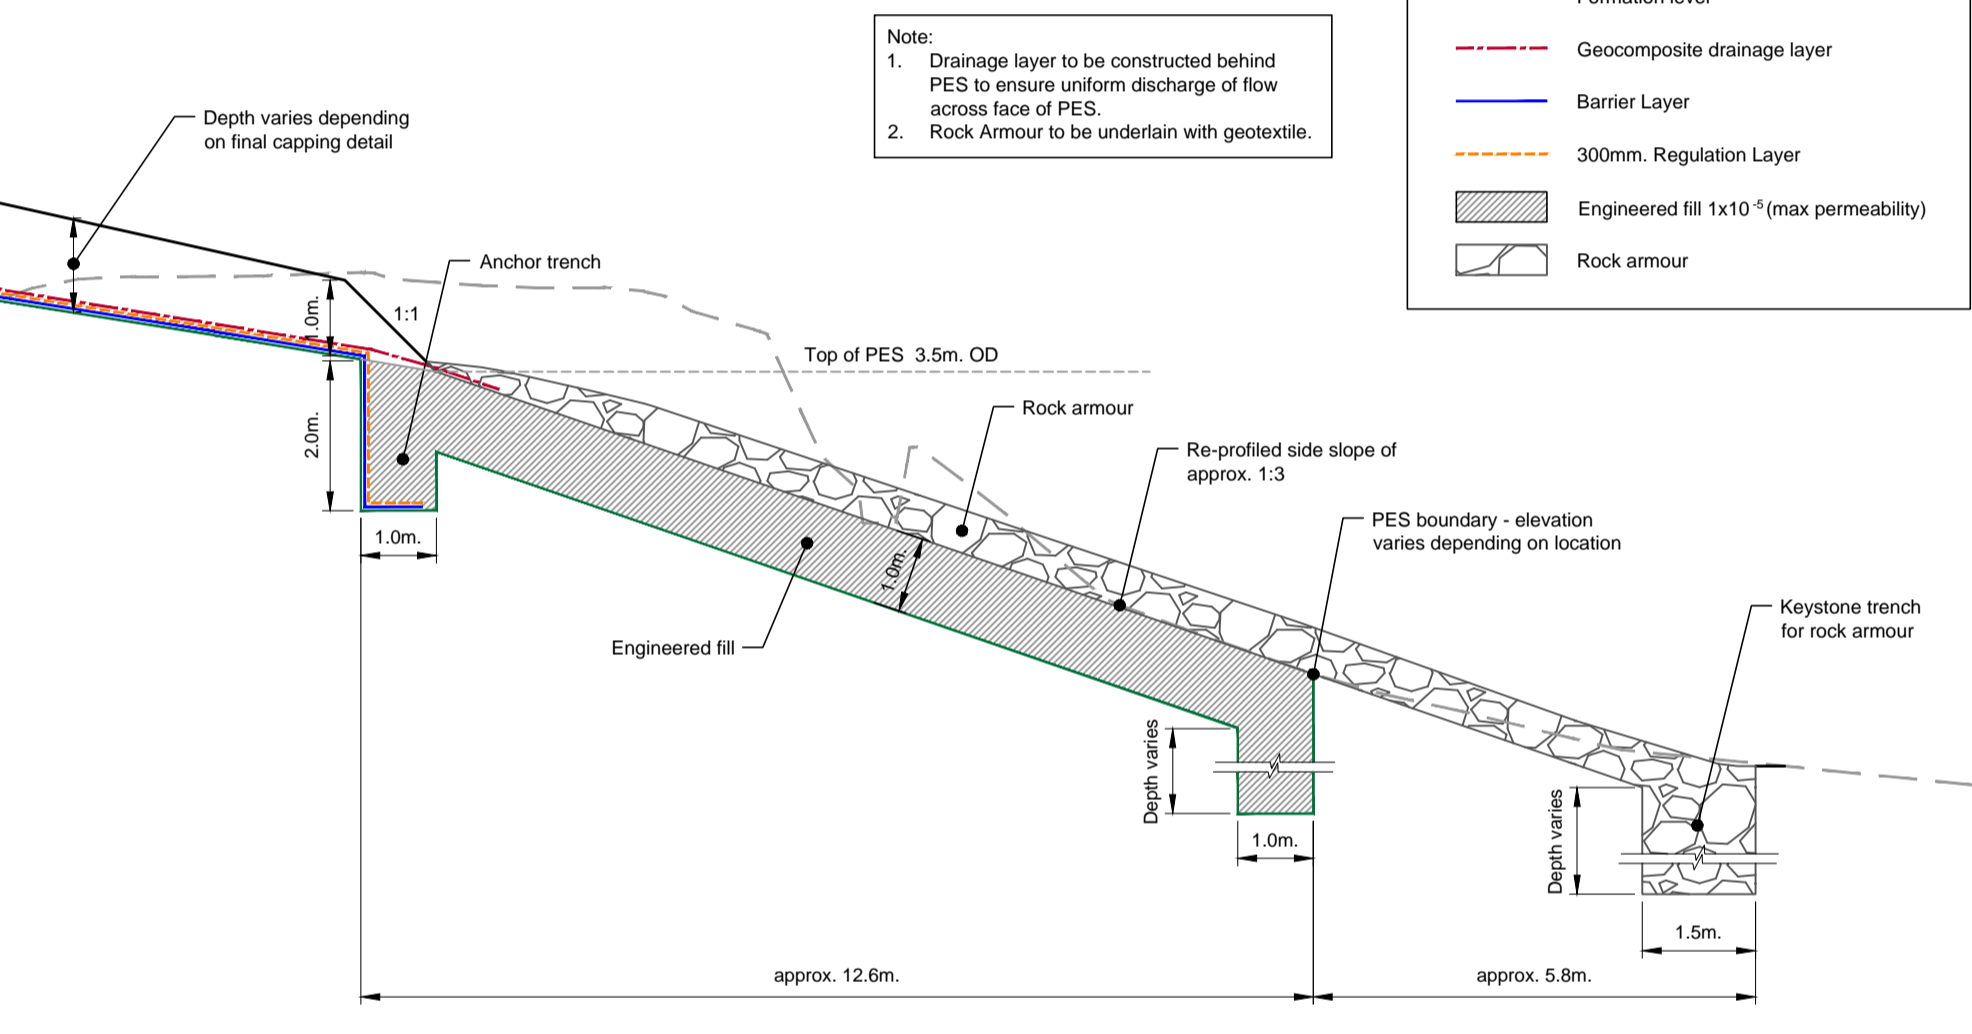
**PES - Typical Sectional Detail 2:  
Trench and Wedge Option**

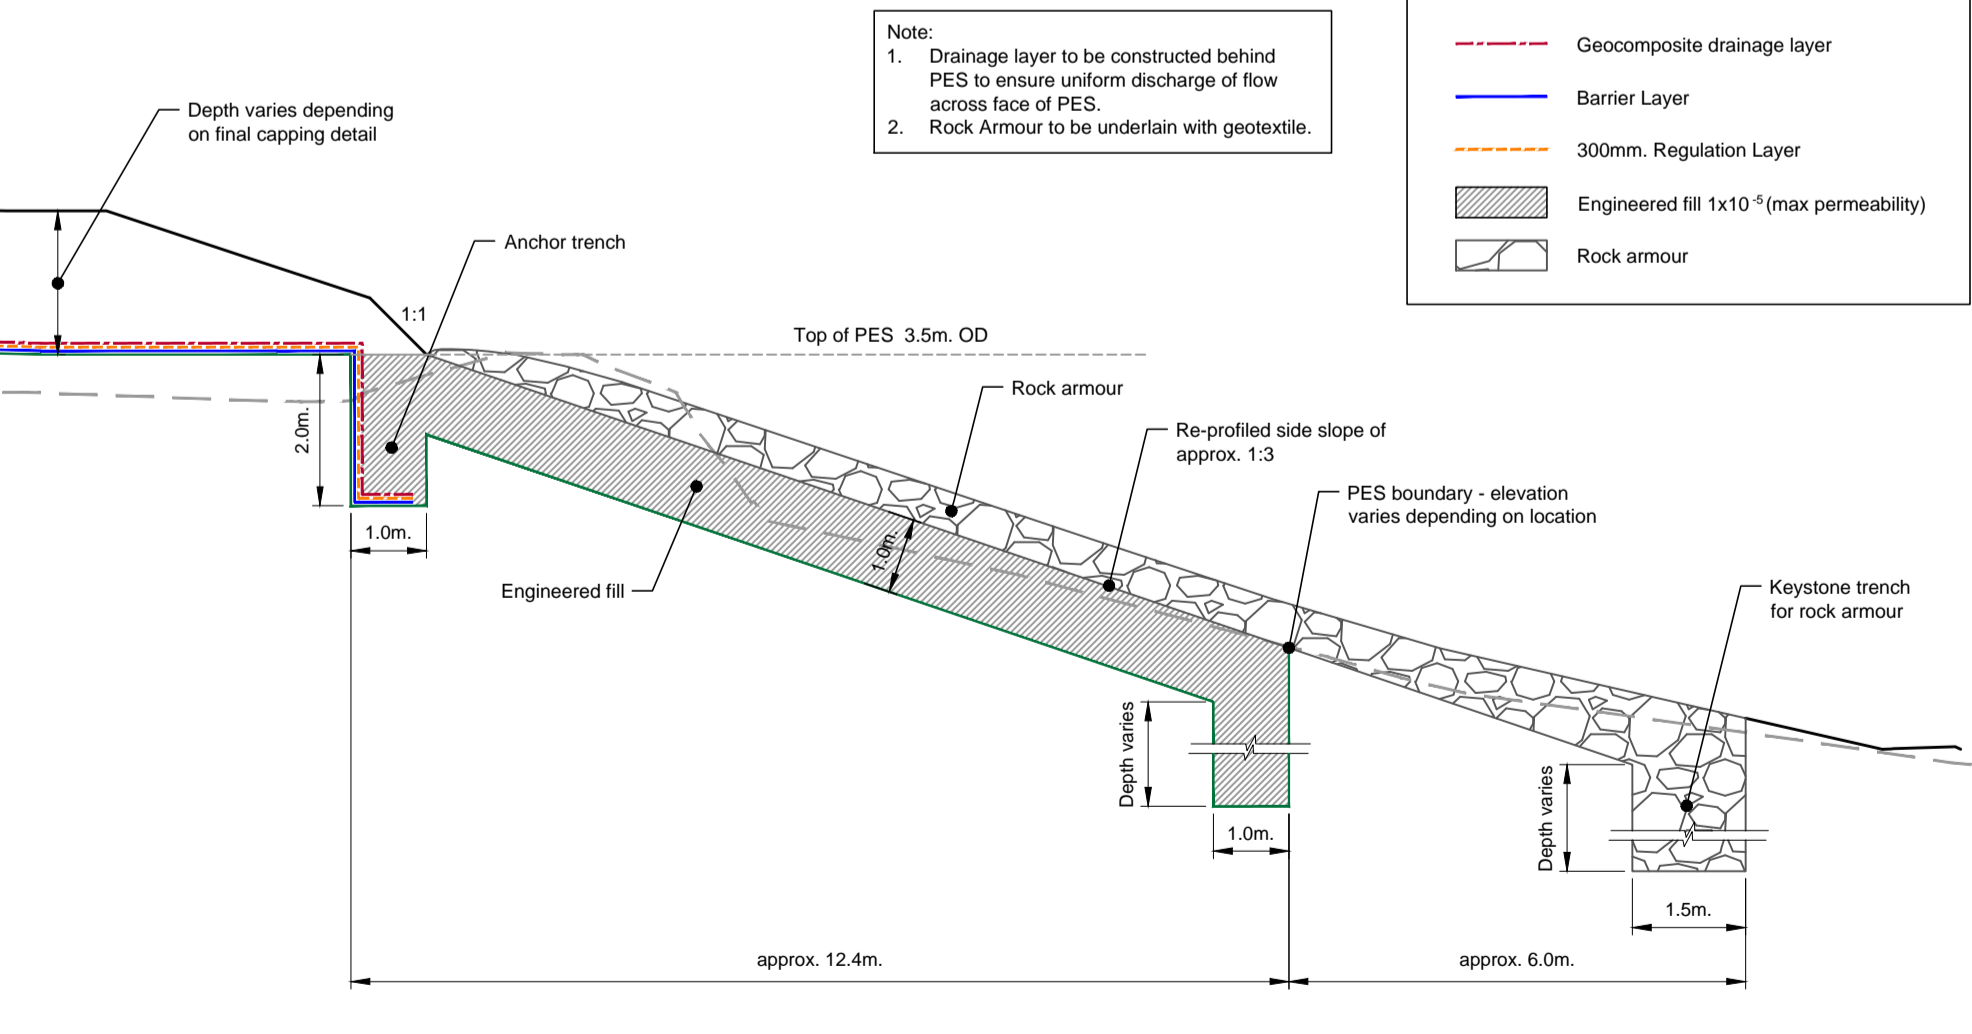
**PES - Typical Sectional Detail 3:  
Trench and Wedge Option**

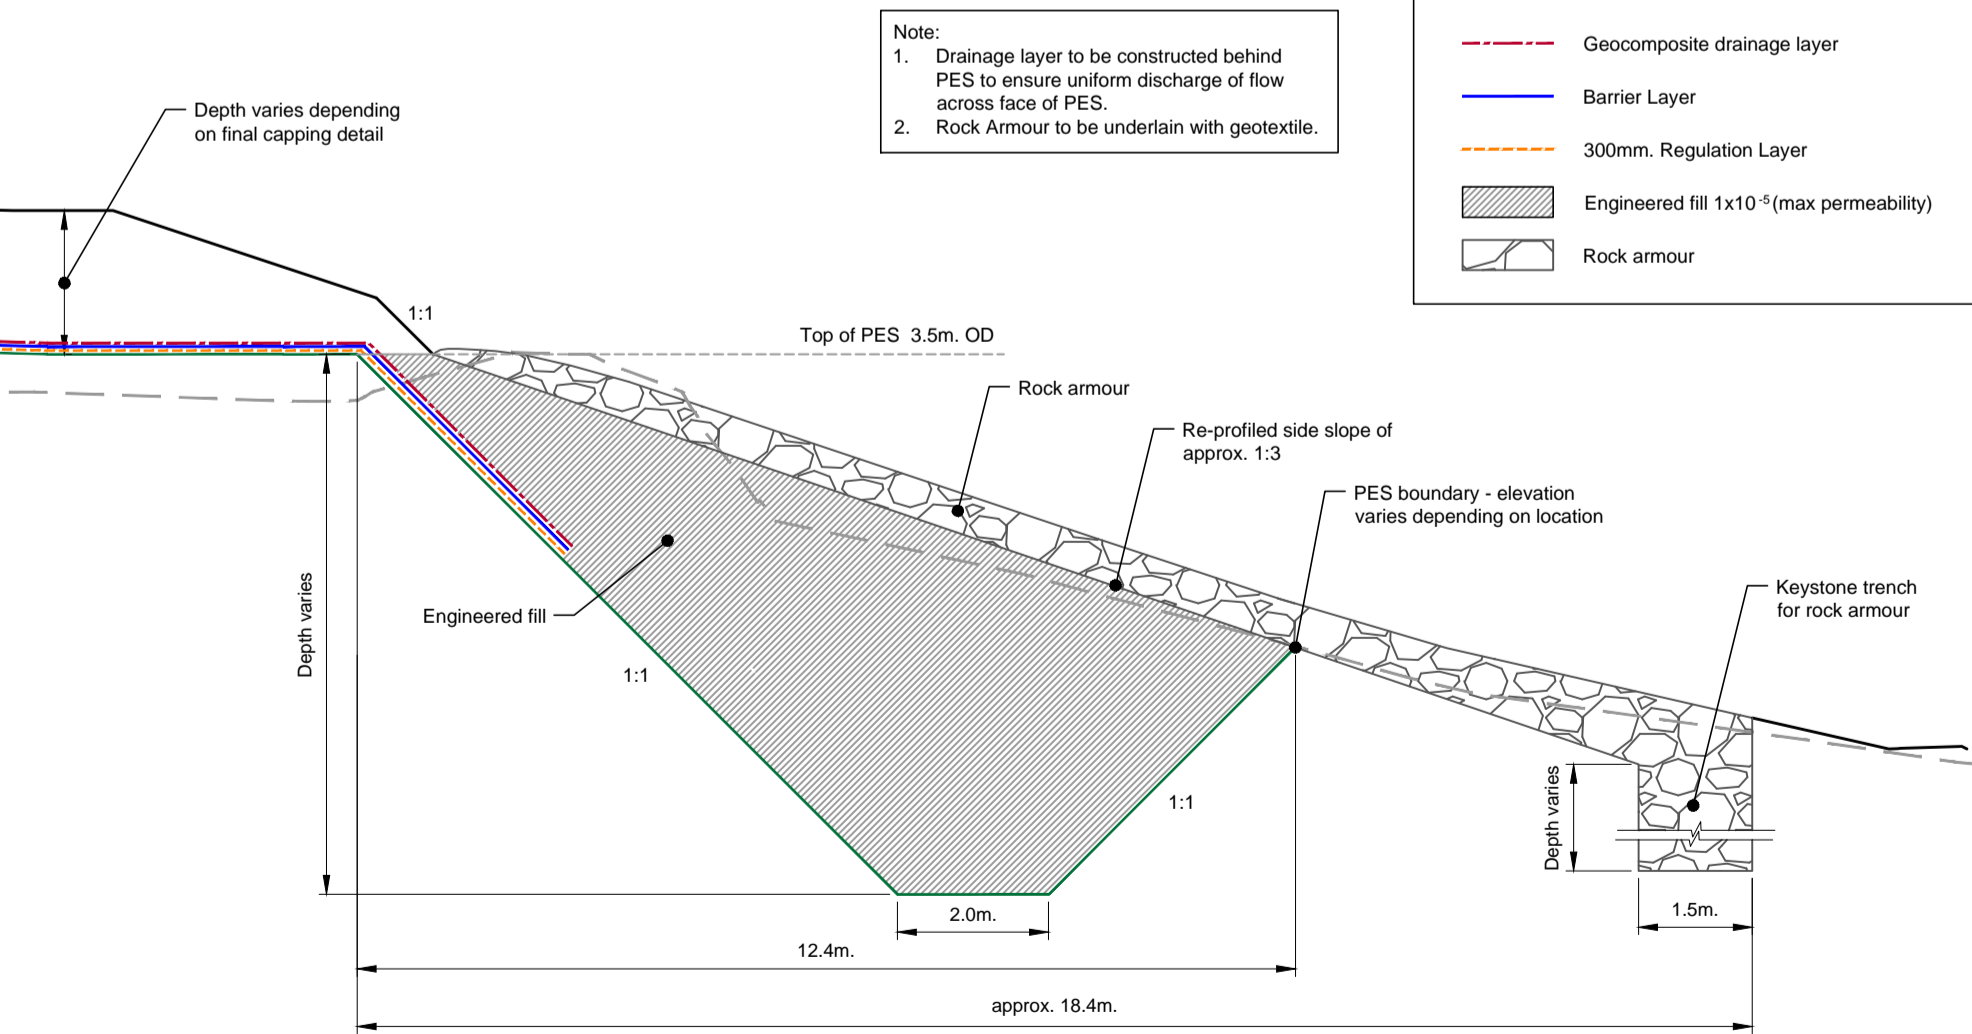
**PES - Typical Sectional Detail 3:  
Wedge Option**

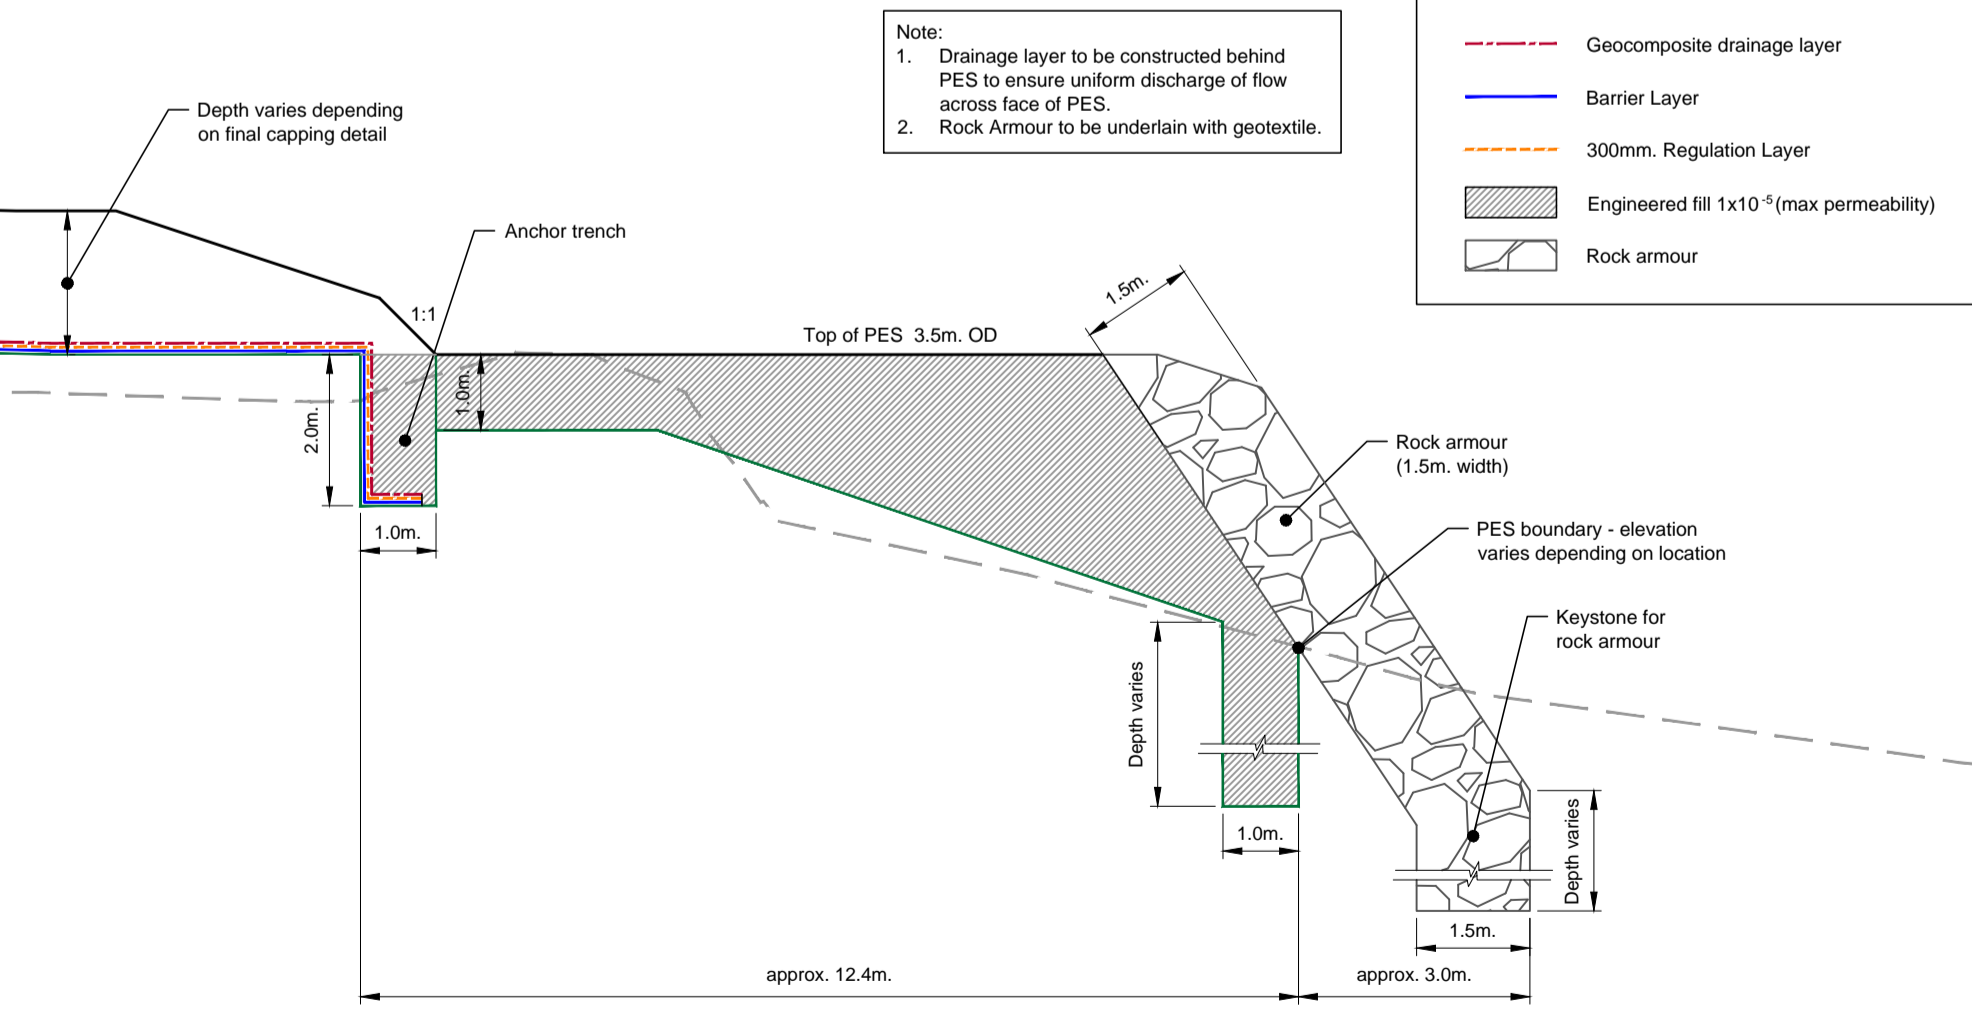
**PES - Typical Sectional Detail 3:  
Berm and 1 to 1:5 Side Slope Option**
