**COASTAL PROCESSES STUDY**

# Haulbowline Island Remediation Project

## Coastal Processes Study

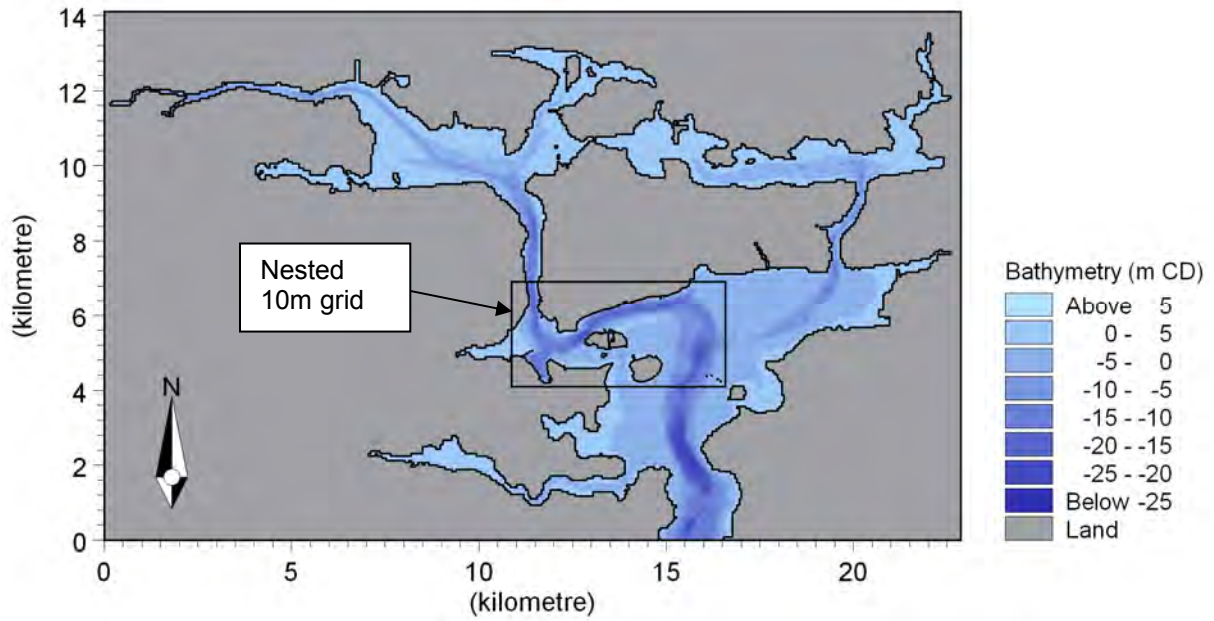
The tidal regime in Cork Harbour was simulated using the 2D depth averaged tidal flow model MIKE21 HD (hydrodynamic module). Bathymetric data for this model was taken from a number of hydrographic surveys including those relating to recent maintenance dredging completed by the Port of Cork within Cork Harbour. These surveys were supplemented with Admiralty Chart Data (as digitally supplied by C.Map of Norway). The base hydrodynamic flow model used in the study was a 2D MIKE21 nested HD flow model consisting of an outer model with a 30m grid resolution and a finer inner model at 10m resolution. Figure 1.1 shows the extent of the tidal models.

**Figure 1.1: Tidal model domain 30m grid with nested 10m section**

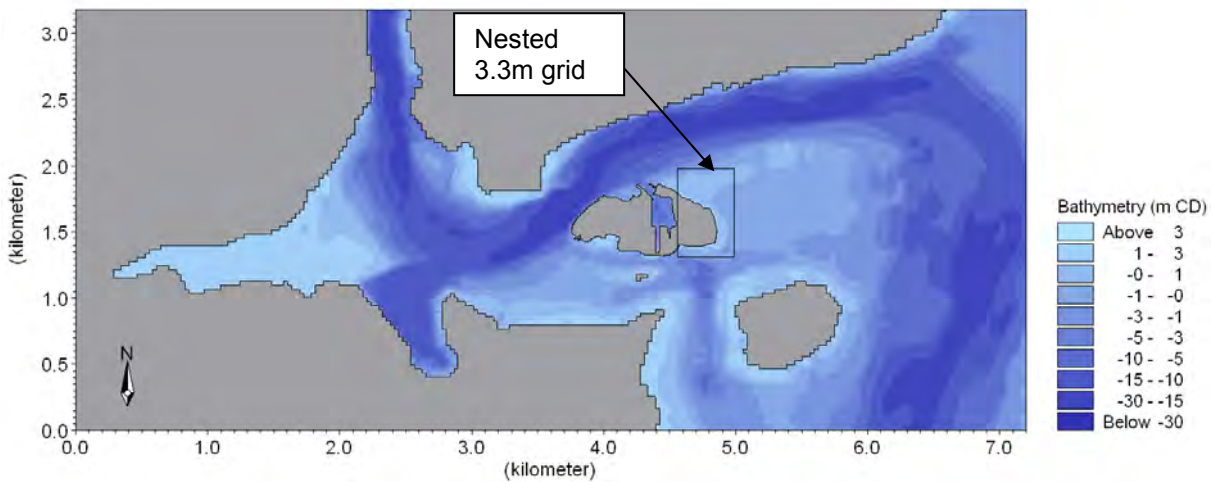
For the purposes of sediment plume modelling further refinement of the model resolution, to 3.3x3.3m grid, was required in the immediate area of Haulbowline Island. The extent of the 10m grid and inner 3.3m nested model is shown in Figure 1.2 below.

**Figure 1.2: Bathymetry and the extent of the 10m nested model with detailed 3.33m area**

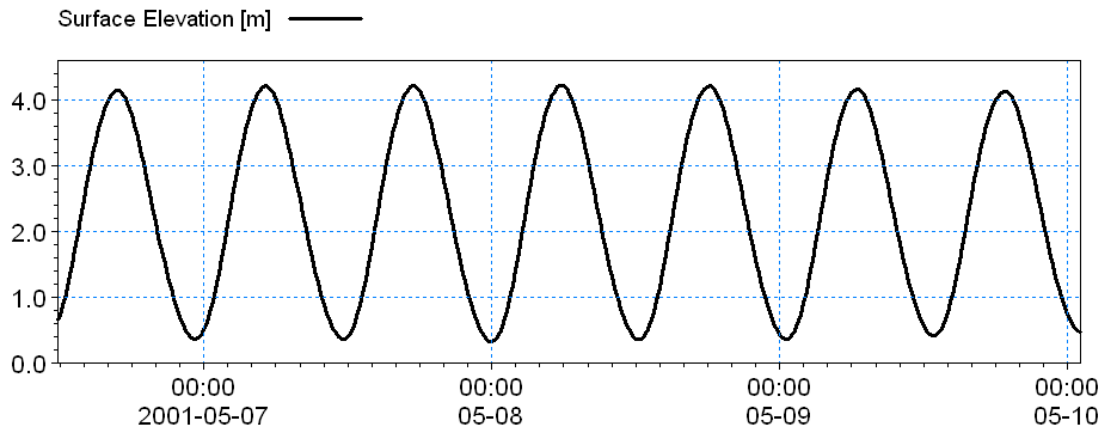
of the Port of Cork. For illustration purposes Figure 1.3 shows the model generated water surface elevation (tidal curve) at Haulbowline during a typical spring tide. Similarly, Figure 1.4 shows the water surface elevation for a typical neap tide.

**Figure 1.3: Simulated tidal elevations (m) for spring tide at Haulbowline**

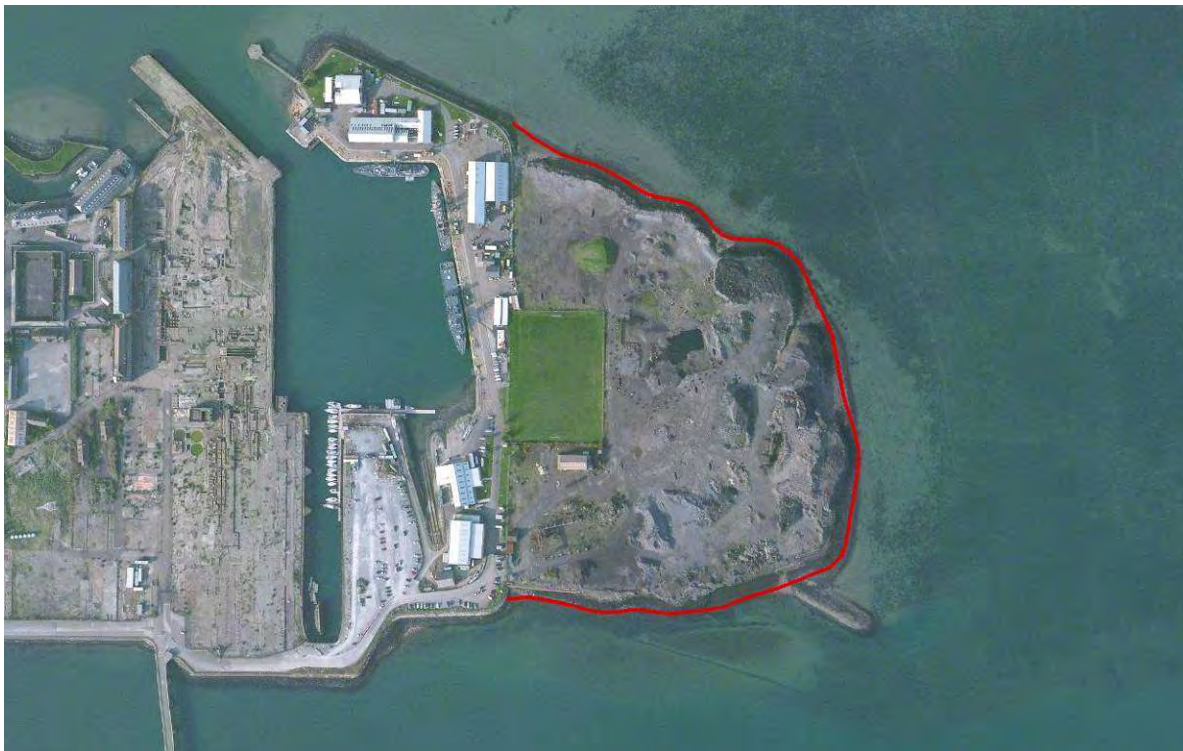
- 1) **Scenario A:** One month of hydrodynamic model data (assumed construction period) was generated based on the existing bathymetry with a bund located on the landward side of the keystone trench. A 1.5m wide x 2m deep x 900m long excavation around the island was assumed giving 2700m<sup>3</sup> excavated material. The location of the trench is shown on Figure 2.1

**Figure 2.1: Location of the keystone trench from Scenario A**

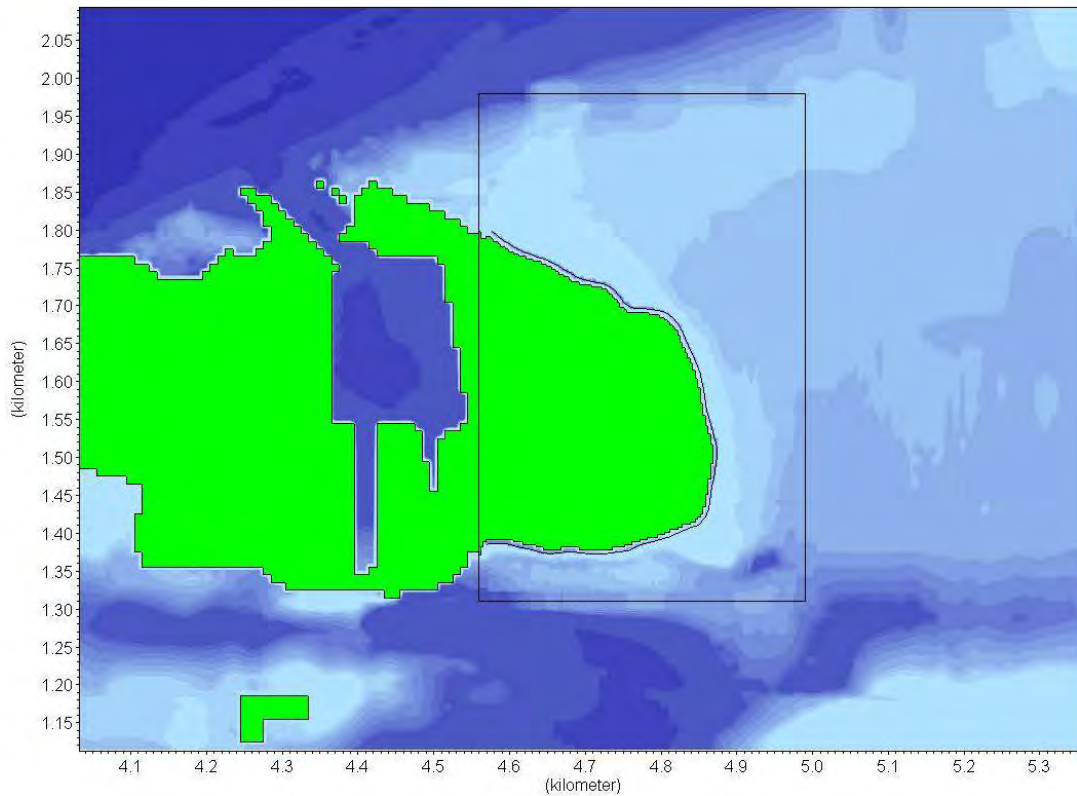
Figure 2.2 illustrates the location of the trench a simulated in the nested 3.33m model with the updated bathymetry.

**Figure 2.2: Updated bathymetry for the Scenario A with marked trench in 3.33m nested model**

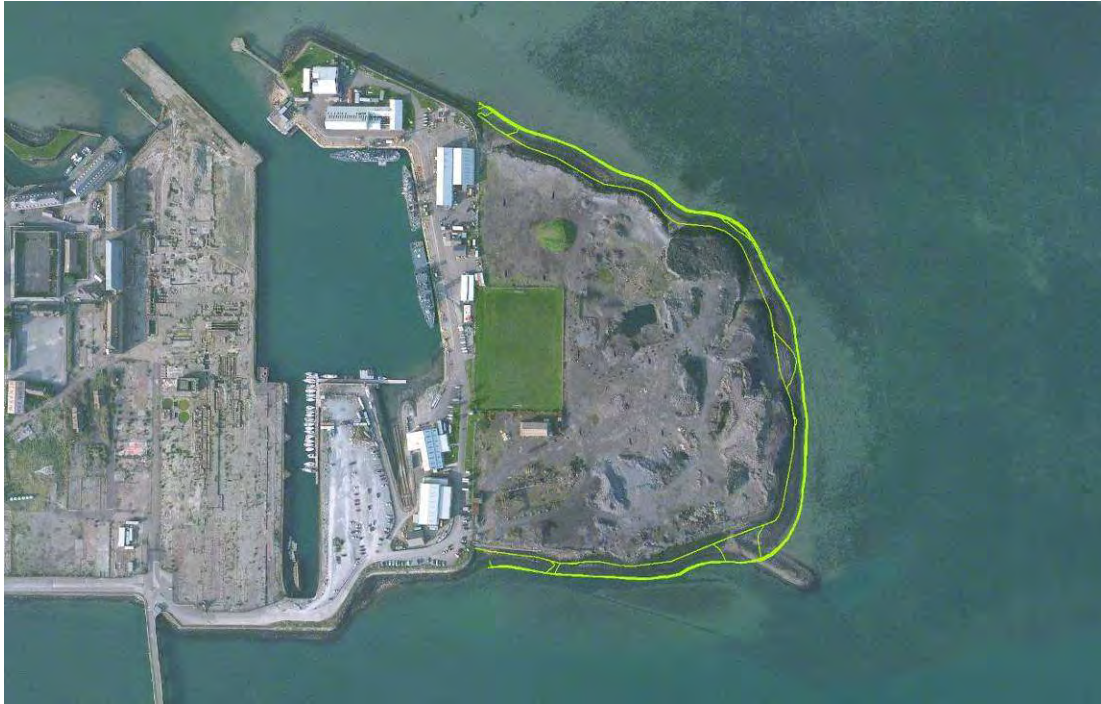
- 2) **Scenario B:** One month of hydrodynamic model data based on the existing bathymetry and incorporating an assumed bulk excavation from the foreshore area around the perimeter of the island. This excavation is assumed to have a maximum depth of 3m with an approximate trench width of 20m. Figure 2.3 below shows the extent of the bulk waste excavation and Figure 2.4 illustrates the updated bathymetry for this scenario within the 3.3m nested model extent.

**Figure 2.3: Extent of the bulk excavation of waste from Scenario B**

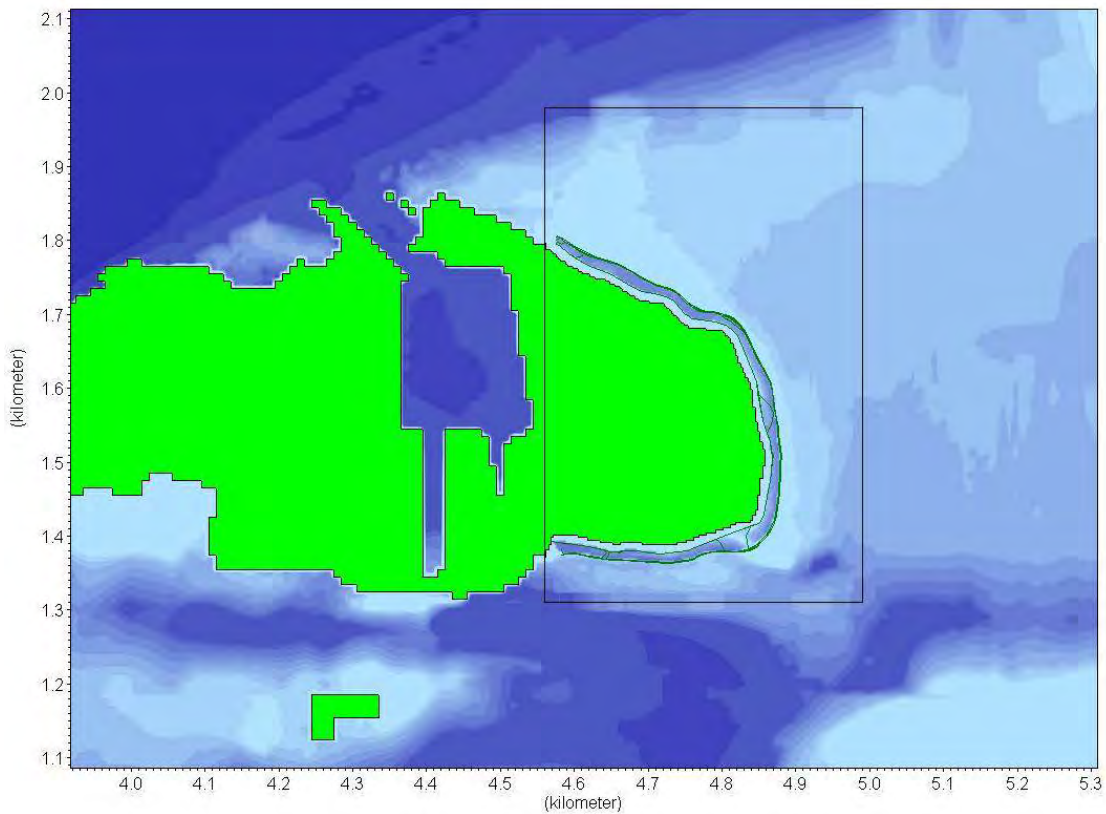
**Figure 2.4: Updated bathymetry for the Scenario B with bulk excavation in 3.33m nested model**

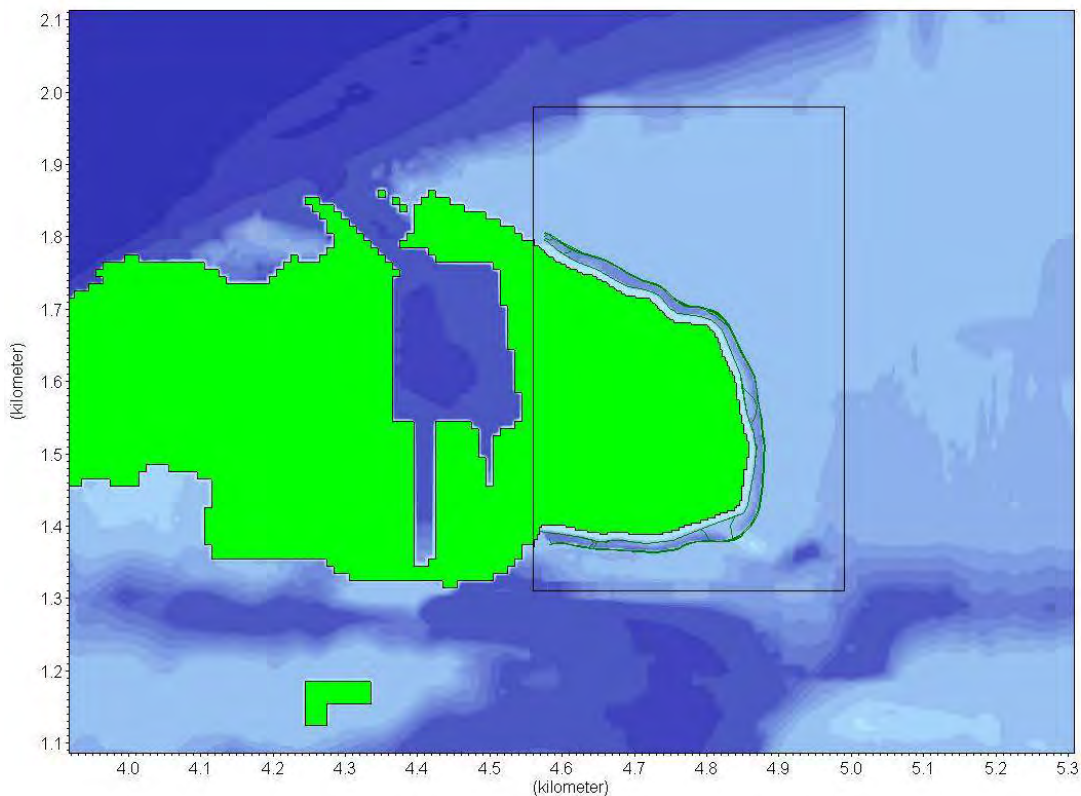
Figure 2.5 below illustrates altered bathymetry in the nested 3.33m model and contours of the excavation for Scenario C.

**Figure 2.5: Updated bathymetry for the Scenario C with bulk excavation in 3.33m nested model**

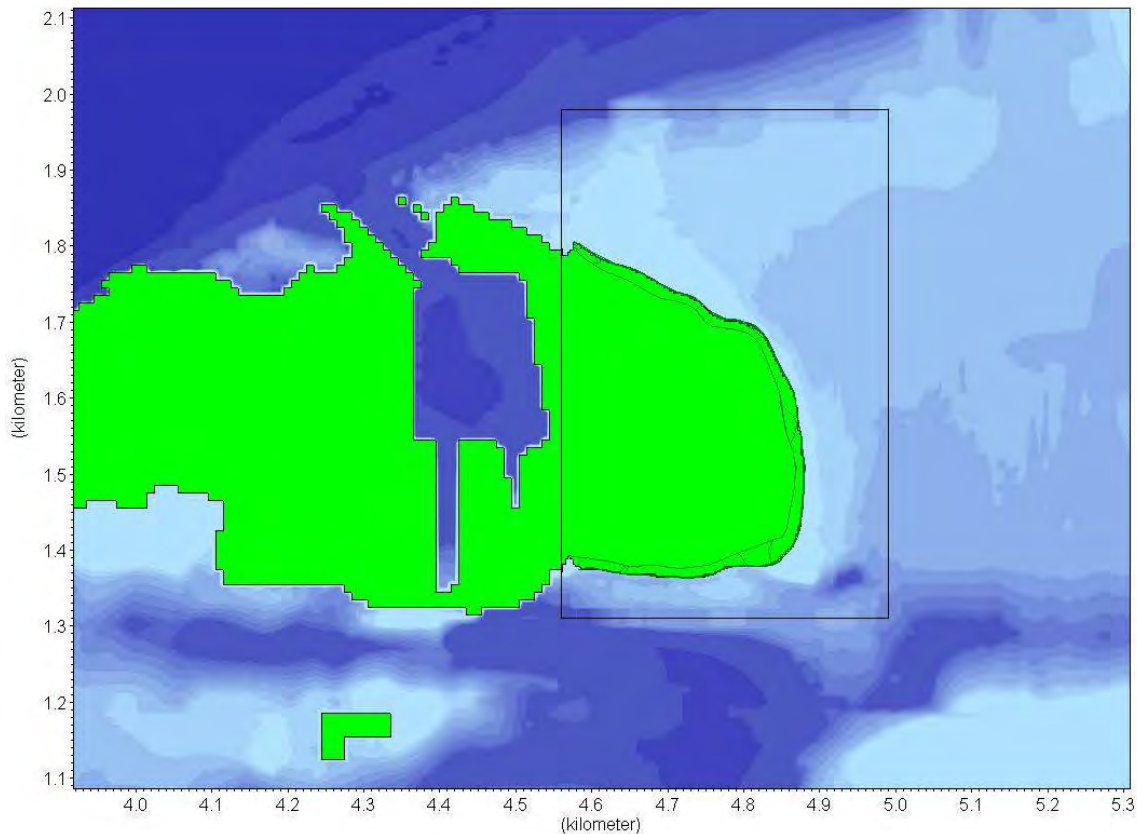
Figure 2.6 below show extent of the bund which is the extent of the excavation.

**Figure 2.6: Updated bathymetry for the Scenario D with bulk excavation in 3.33m nested model**

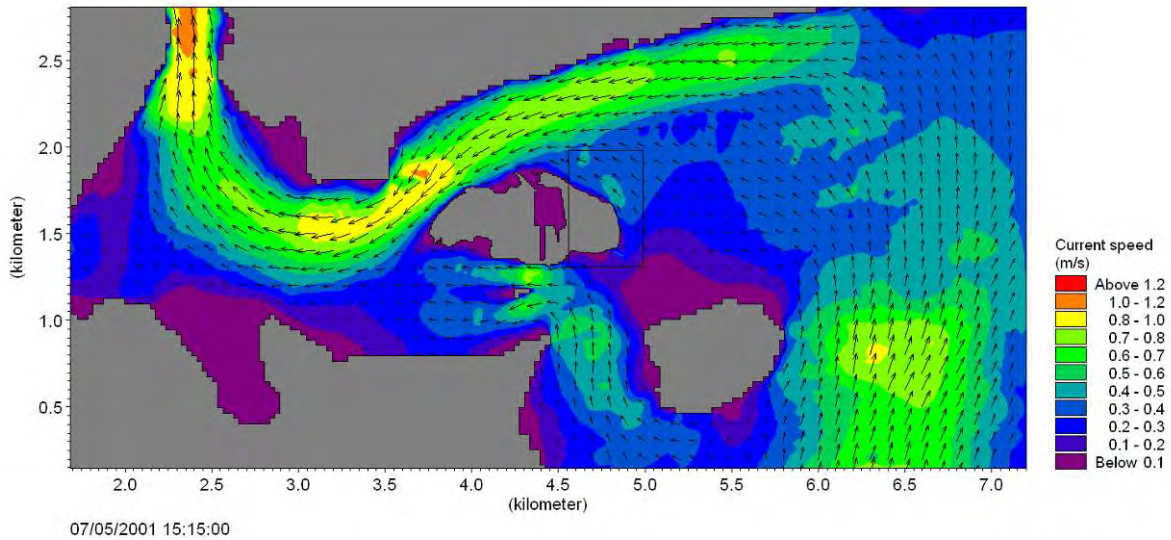
The Spring to Neap Tidal cycle was simulated based on tidal data for May 2001. This month was selected for modelling purposes as it represented a period of average tidal conditions and would therefore be representative of the general range of tidal conditions. Typical tidal patterns are presented in Figure 2.7 and Figure 2.8 for mid-ebb and mid-flood respectively, both during spring tide conditions.

**Figure 2.7: Existing Typical Spring Current Speed on Flood**

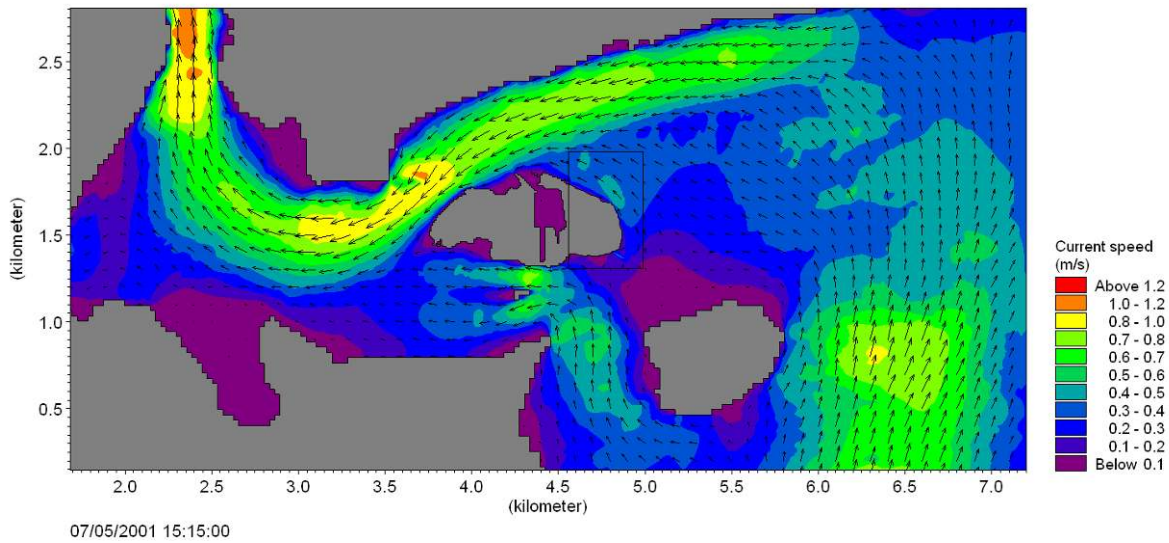
**Figure 2.9: Scenario A: Spring Current Speed on Flood tide**

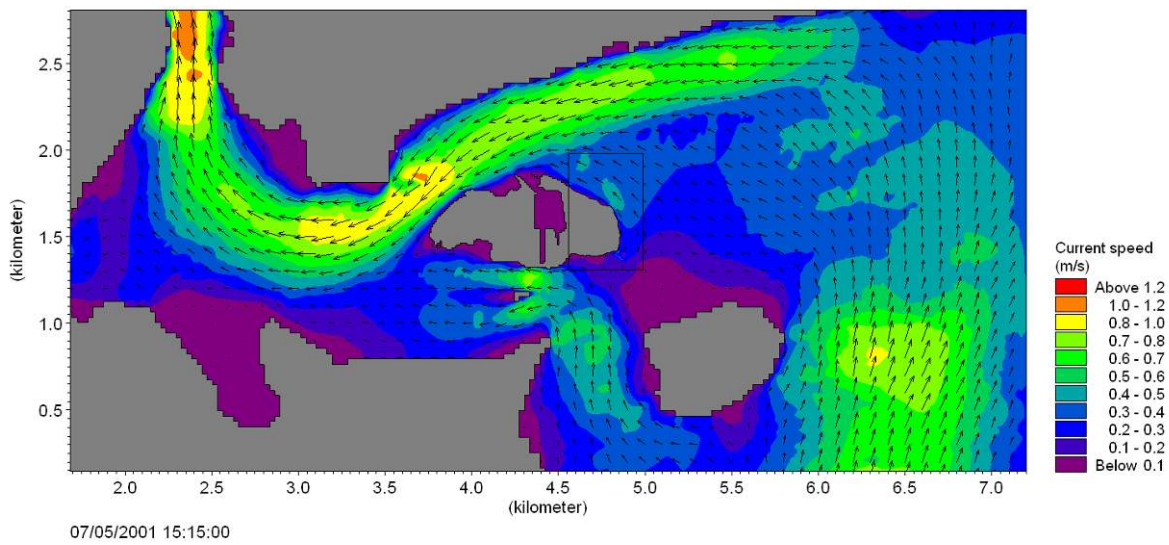
**Figure 2.13: Scenario B: Spring Current Speed on Flood tide**

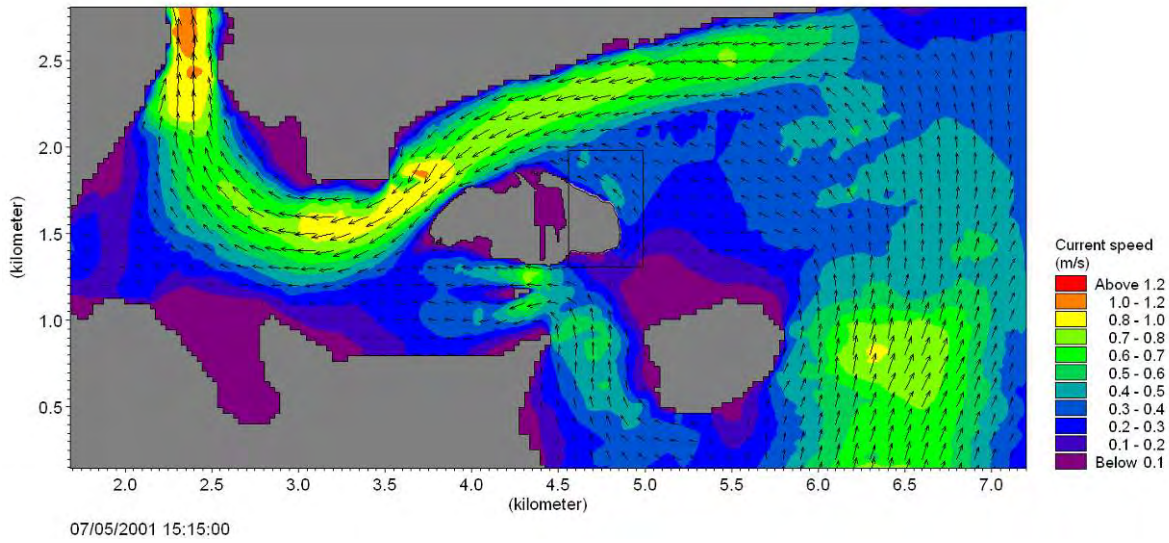
Peak flood and ebb current speed plots (Figure 2.17 & Figure 2.19) and difference plots (Figure 2.18 & Figure 2.20) are presented for Scenario C. It can be seen that the difference in current speed both on flood and ebb for this scenario, as in two previous scenarios, is very localised and changes in velocity variations, range -0.04 to +0.08 m/s, are not considered to be significant and can only be discerned on the flood tide.

**Figure 2.17: Scenario C: Spring Current Speed on Flood**

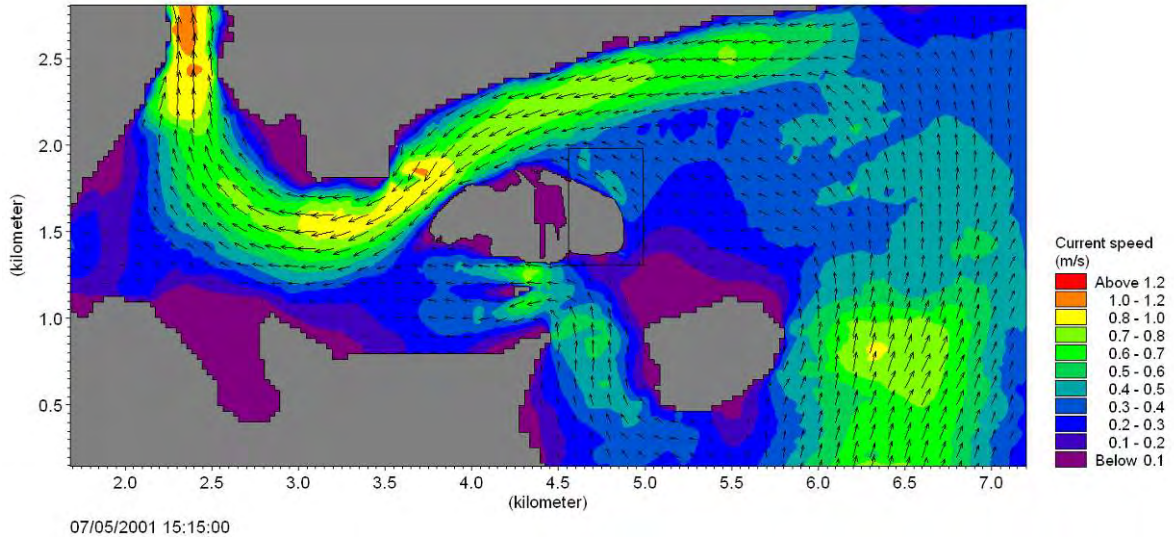
Figures 2.21 and 2.23 present peak velocities for flood and ebb tides for Scenario D. Pre and post works differences are limited to a small area with the change in peak current speed as illustrated in Figure 2.22 and Figure 2.24 for flood and ebb respectively.

Figure 2.21: Scenario D: Spring Current Speed on Flood tide

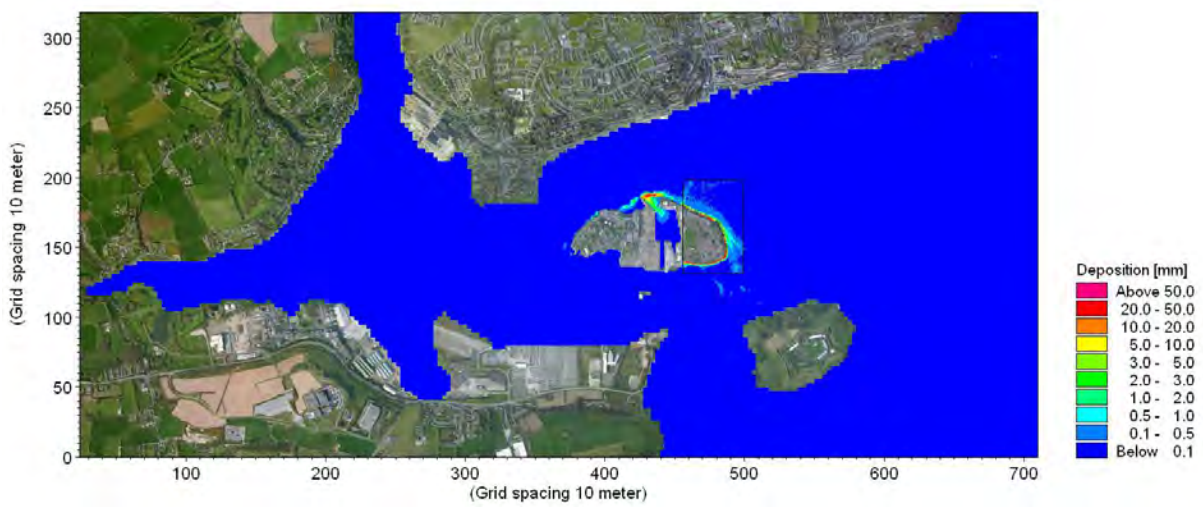
**Figure 3.1: Scenario A: Maximum sediment deposition**

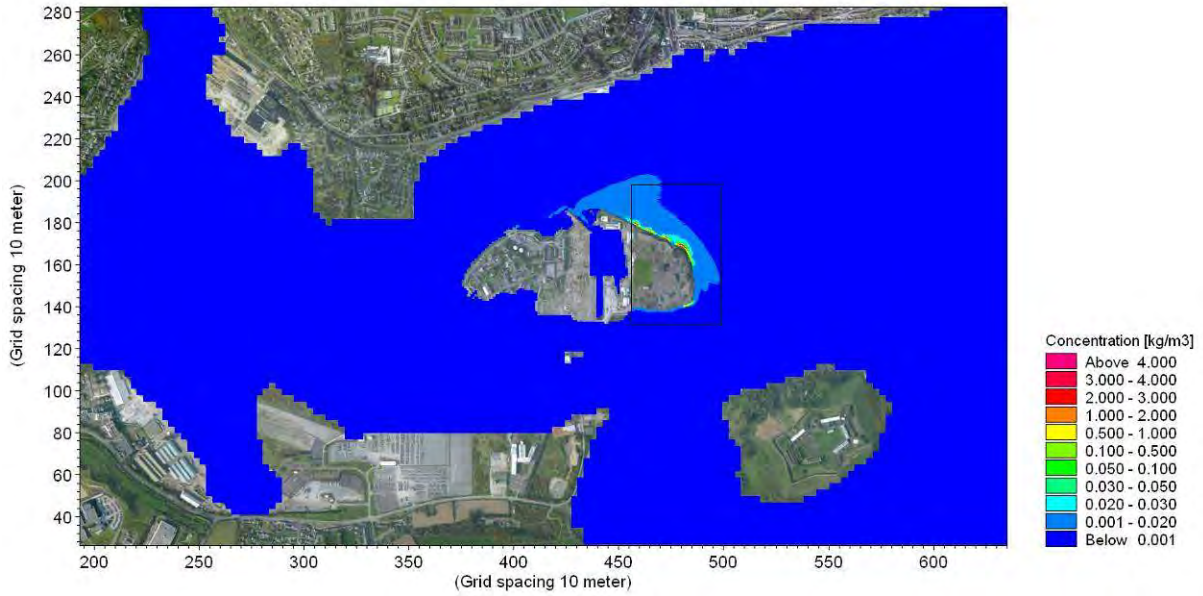
Figure 3.9 and Figure 3.10 illustrate average plume concentration in the water column respectively for Scenarios A and B. Average suspended solids concentrations for Scenario A remain less than  $0.02 \text{ kg/m}^3$  ( $20\text{mg/l}$ ) and less than  $0.1 \text{ kg/m}^3$  ( $100\text{mg/l}$ ) for Scenario B. In some isolated inter-tidal regions this level is increased due to re-suspension of deposited material, however as discussed earlier, this sedimentation is likely to be over-predicted due to the wave induced dispersion which would occur in these regions but is not included within the model.

**Figure 3.9: Scenario A: Average suspended solids concentration – water column**

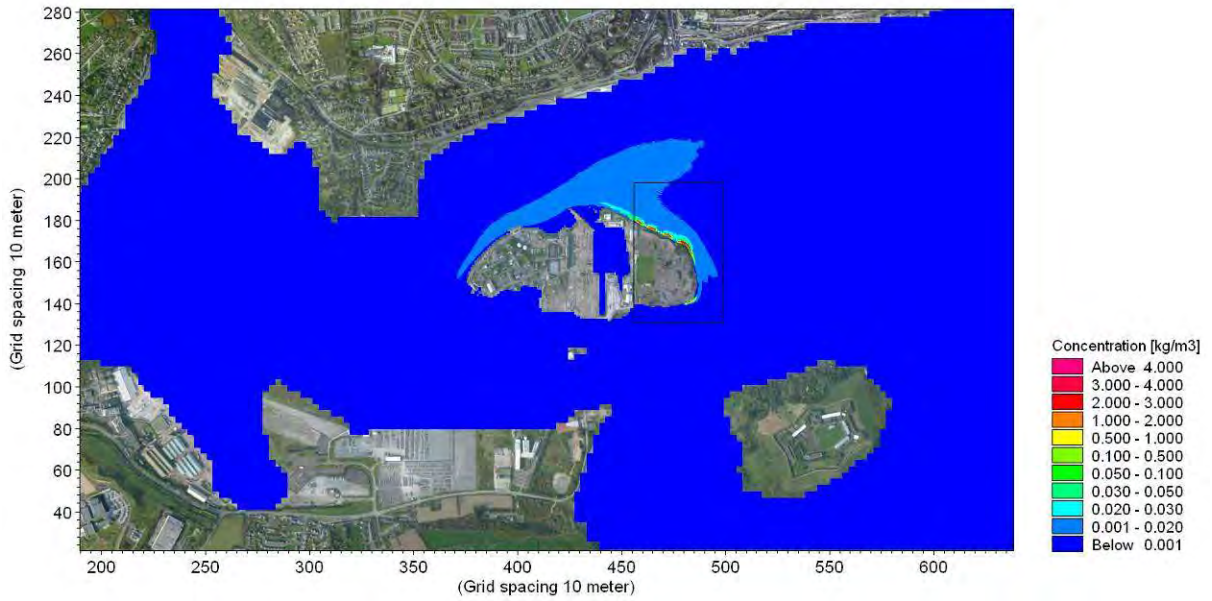
Average suspended solids concentration in the bottom 0.5m is presented in Figure 3.11 for the keystone trench scenario and in Figure 3.12 for the bulk excavation scenario. Values in close vicinity of the construction in both cases are similar to those reported in the water column but the plume envelope has greater extent. Although the extent of the plume in Scenario B seems to be more widespread the values far from the site do not exceed  $0.03\text{kg/m}^3$  (30mg/l).

**Figure 3.11: Scenario A: Average suspended solids concentration – bottom 0.5m**

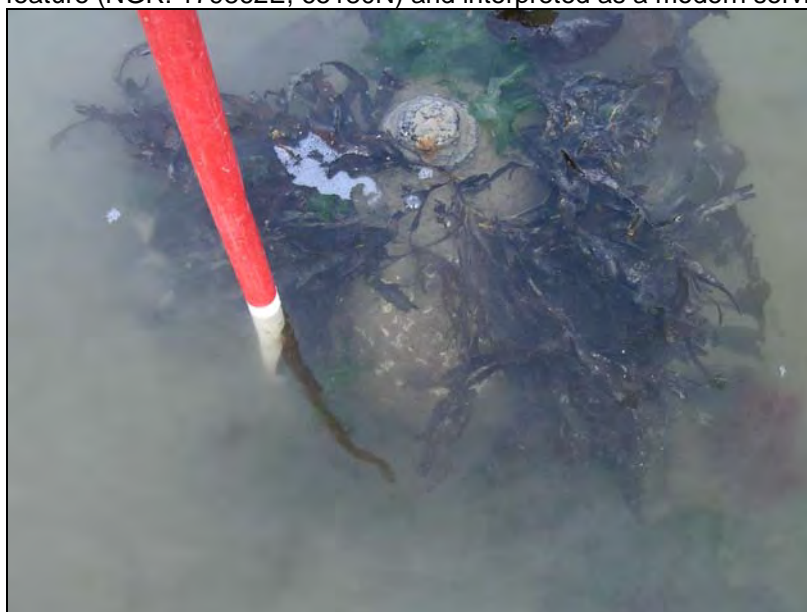
**Plate 26:** North-facing view of steel-pipe arrangement inserted at the toe of causeway feature (NGR: 179862E, 65180N) and interpreted as a modern service pipe (1m scale).

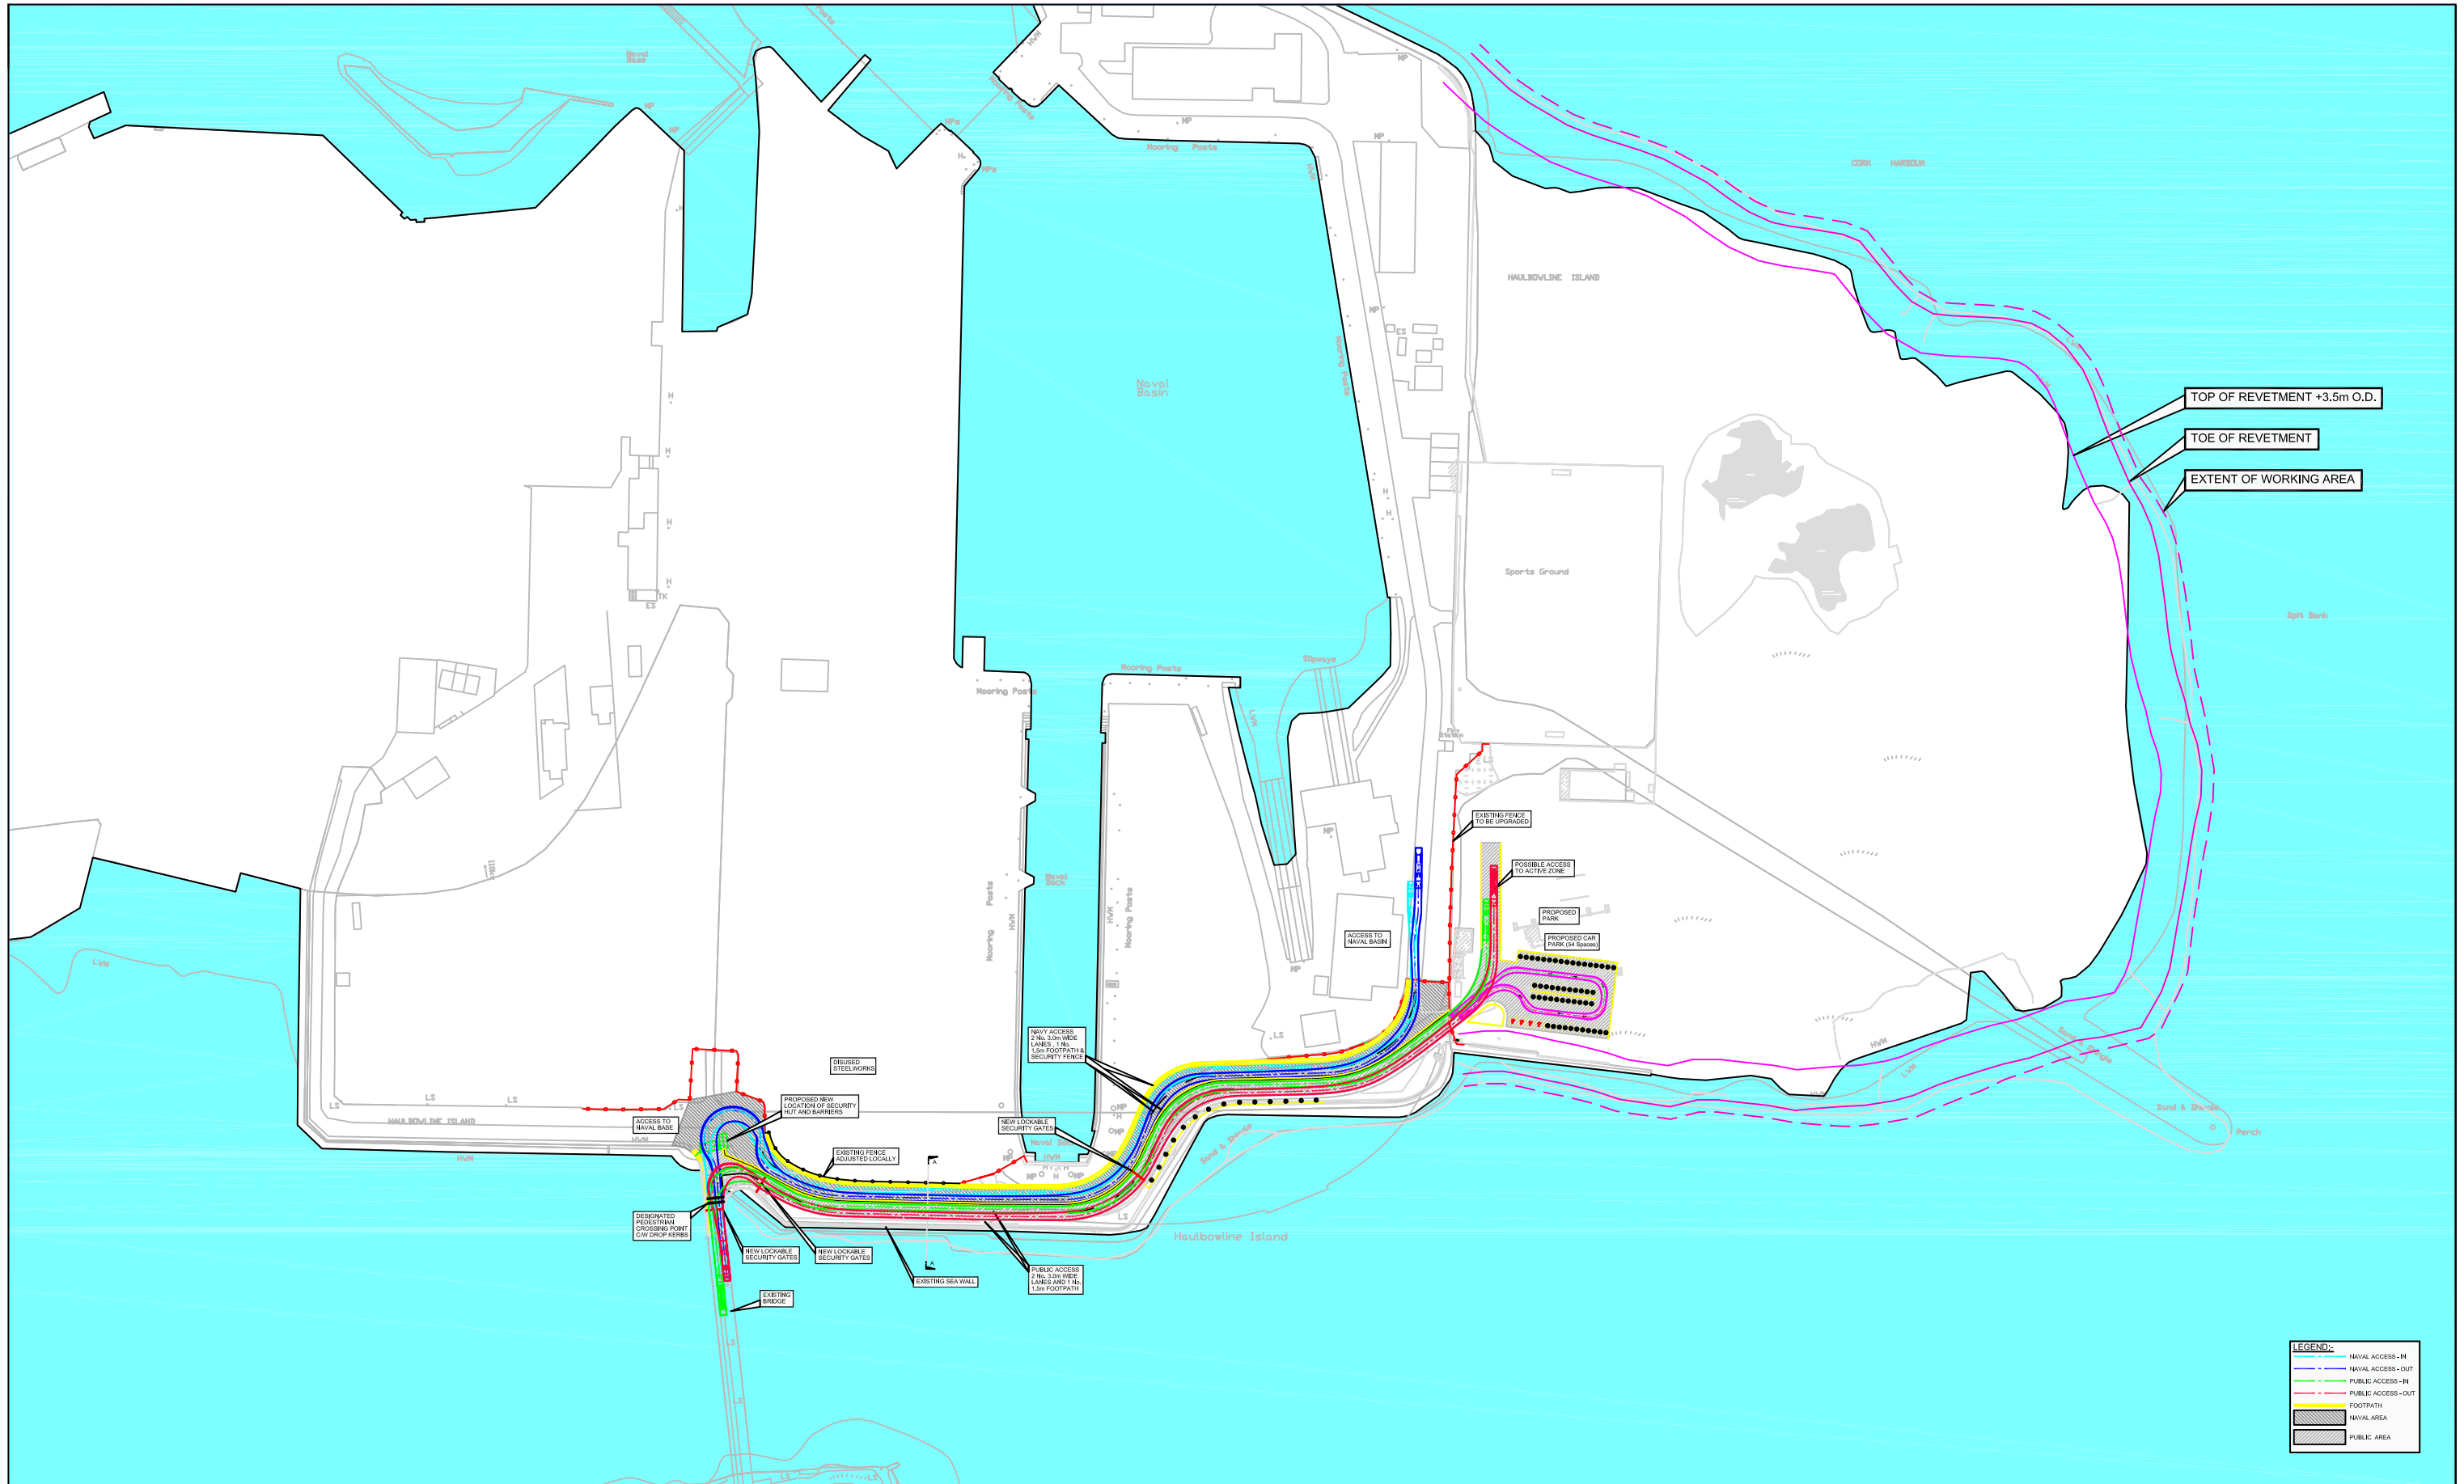
**Notes**  
 Figure Adapted from Project Drawing MCE0736DG001 and Overlay Working Area Lines 101212.dwg provided by RPS Ltd.

**Title**  
 Figure 2- OS Background mapping of Haulbowline Island, Cork Harbour, with proposed development works superimposed.
