# HAULBOWLINE EAST TIP – EXPLORATORY GROUND INVESTIGATION FACTUAL REPORT

NO. P12030

Cork County Council

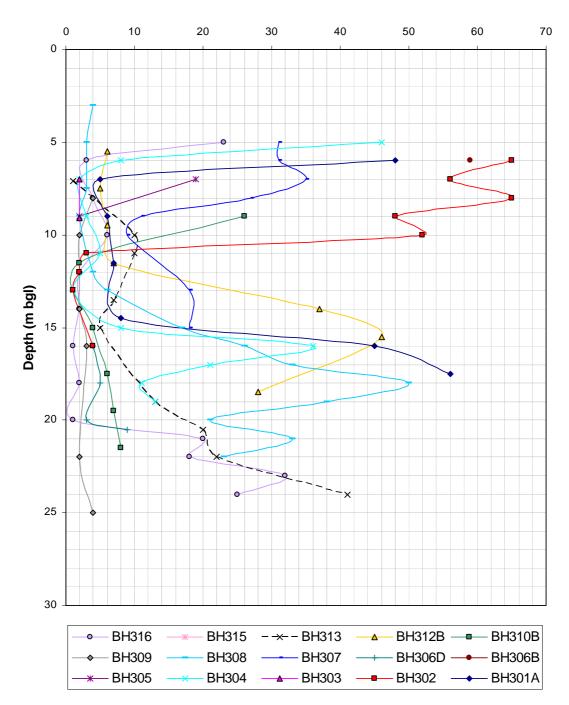
#### Uncorrected Nspt value

The distribution of uncorrected Standard Penetration Test, Nspt values with depth, m below existing ground level (bgl) is presented below for cable percussion boreholes. Refusals, Nspt>50 where the complete set of 4 number 75mm increments were not achieved are not plotted.

Standard penetration test,  $N_{SPT}$  values ( $N_{SPT}$  35 to 65) indicated dense to very dense Slag. The  $N_{SPT}$  values indicated very soft to firm SILT and CLAY deposits ( $N_{SPT}$  0 to 9). The  $N_{SPT}$  values indicated firm to stiff CLAY underlaying the SILT ( $N_{SPT}$  11 to 56) at BH301A and BH304. The GRAVEL is described as medium dense to dense ( $N_{SPT}$  21 to 46).

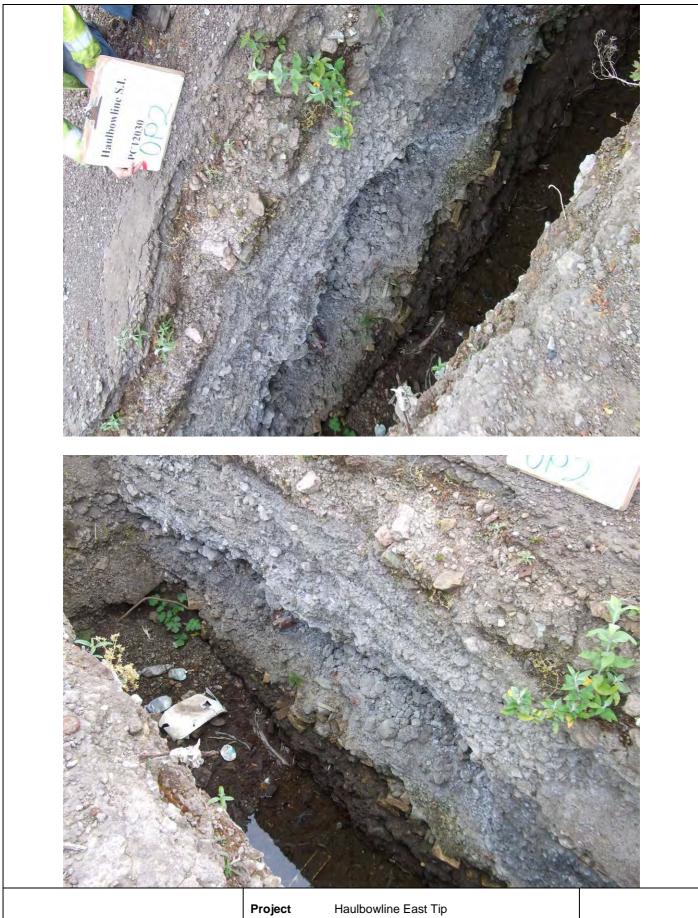
OP02

3.06	0.10	Light grey, unpro		-	
				2.76	0.40	This motellin la			
				2.72	0.44	Thin, metallic la	yer. ocessed SLAG in gravel	and cobble form.	
				1.16	2.00	Refractory bricks	s (approx. 70%).		
$\overline{}$				0.86	2.30	Dark grey, unpro	ocessed SLAG with meta	al (approx <1%).

0.46	2.70		Slit Trench Com	plete at 2.70 m	
1									
/ater D	Depth	Туре	Results	Level	Depth
