**HAULBOWLINE EAST TIP –  
EXPLORATORY GROUND INVESTIGATION  
FACTUAL REPORT  
NO. P12030**

Cork County Council

WYG EPT Ltd.

**HAULBOWLINE EAST TIP –  
EXPLORATORY GROUND INVESTIGATION  
FACTUAL REPORT  
NO. P12030  
VOL. 1**

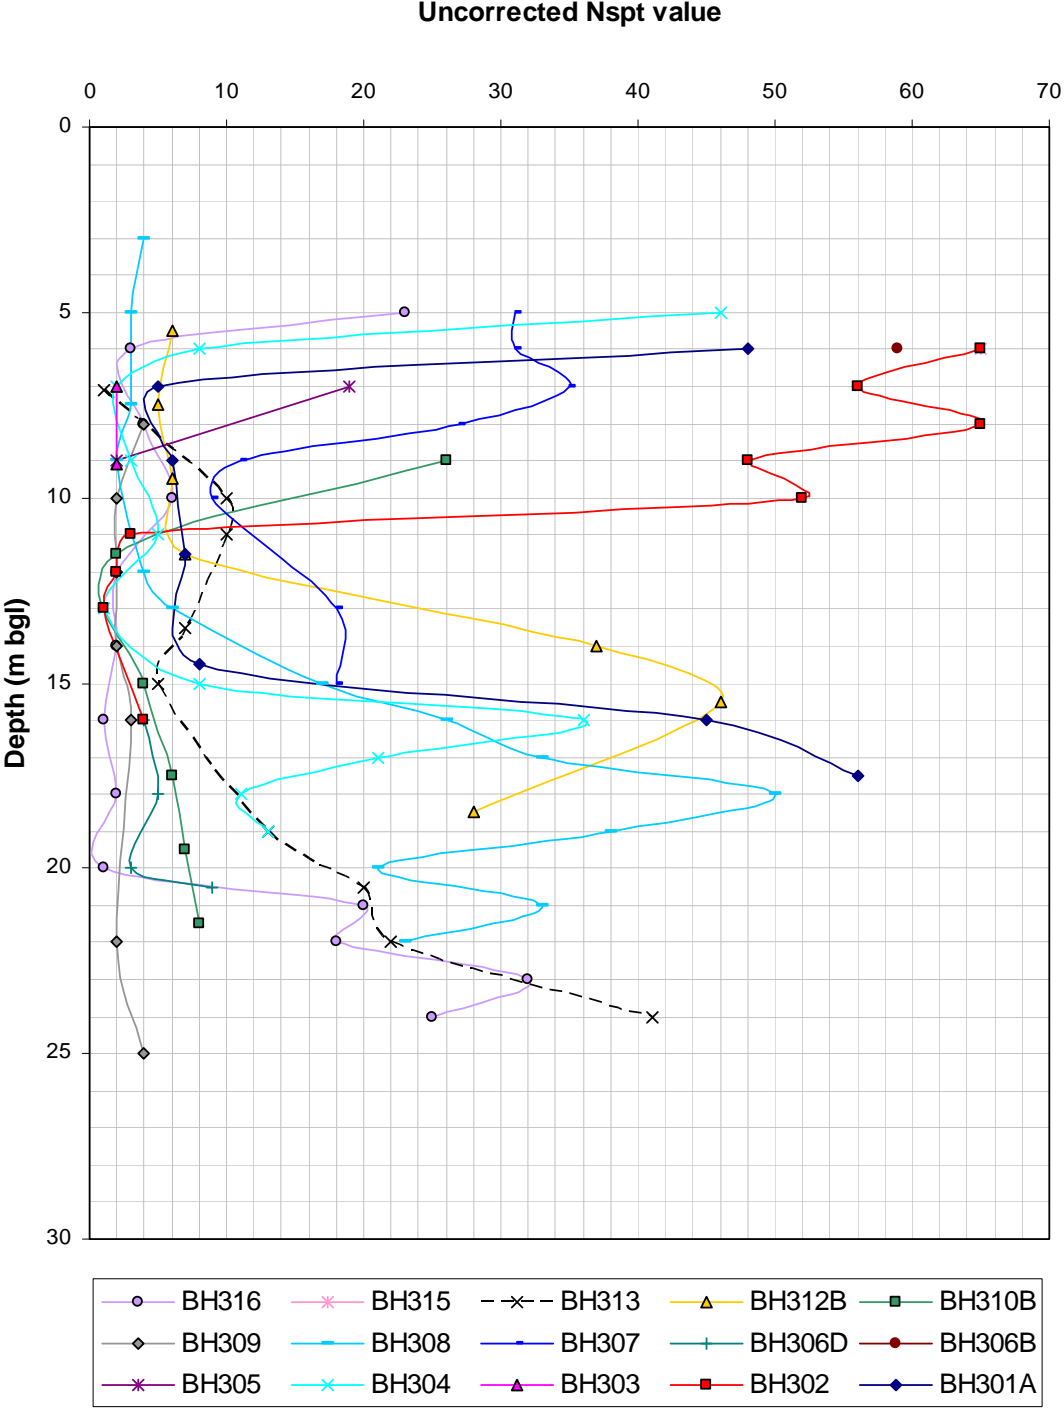
The distribution of uncorrected Standard Penetration Test, N<sub>spt</sub> values with depth, m below existing ground level (bgl) is presented below for cable percussion boreholes. Refusals, N<sub>spt</sub>>50 where the complete set of 4 number 75mm increments were not achieved are not plotted.

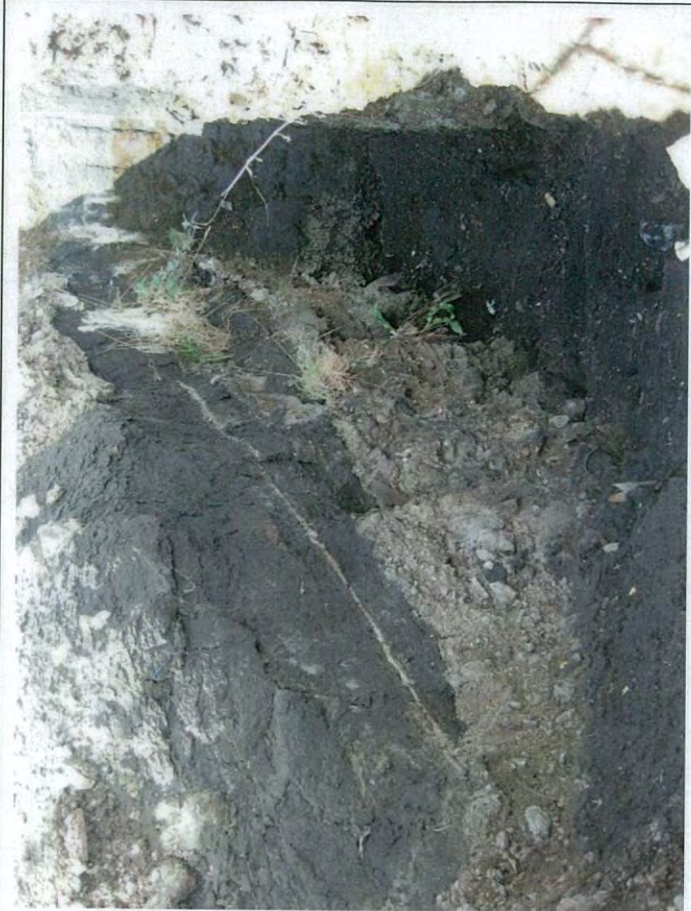
<b>Source</b>	Scale water (rolling mill and caster scale pits) clarifier system	
<b>Waste Type</b>	<b>Flue Dust:</b>	
<b>Waste Code</b>	10.09.09* / 10.09.10	
<b>Waste Description</b>	<b>Colour</b>	Black – dark grey
	<b>Forms</b>	Very fine powder, can also be found in pelletised form, and can be found as cake or sludge dependant on moisture
	<b>Texture</b>	Very loose
	<b>General</b>	Dense, heavy
	<b>Source</b>	Temporarily stockpiled in bags from bag filter houses and later pelletised forms. Main constituents iron and carbon

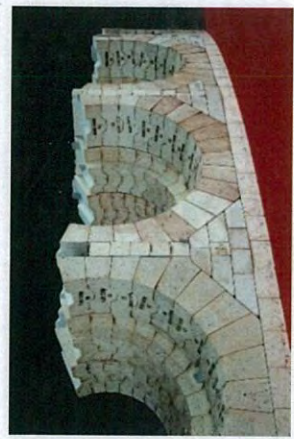
<b>Waste Type</b>	<b>Refractories</b>	
<b>Waste Code</b>	16.11.03* / 16.11.04	
<b>Waste Description</b>	<b>Colour</b>	Lighter browns and greys
	<b>Forms</b>	Powdery, fragmented brickwork
	<b>Texture</b>	Rubble
	<b>General</b>	Light coloured whole crushed and fragmented brickwork
	<b>Source</b>	Refractories are from the linings of the furnaces (usually as bricks) and mainly contain magnesium chloride

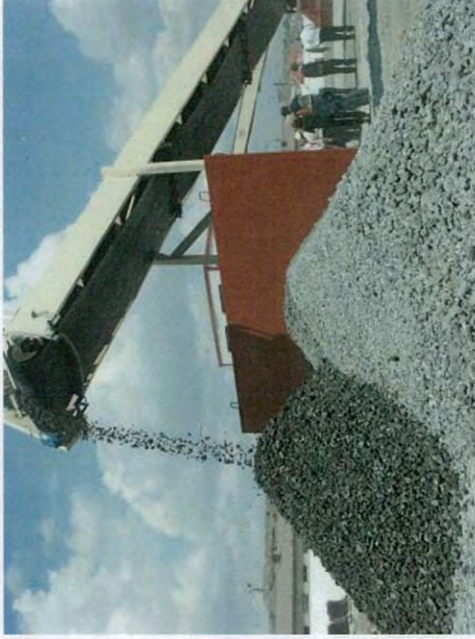
<b>Waste Type</b>	<b>Slag: wastes from the processing of slag</b>	
<b>Waste Code</b>	10.02.01	
<b>Waste Description</b>	<b>Colour</b>	Grey and mottled rusty brown
	<b>Forms</b>	Crushed – granular form
	<b>Texture</b>	Pockmarked
	<b>General</b>	Dense, heavy, conglomerated
	<b>Source</b>	Failed ladles, 'sculls', skimmed wastes from molten metal then crushed and graded for re-use

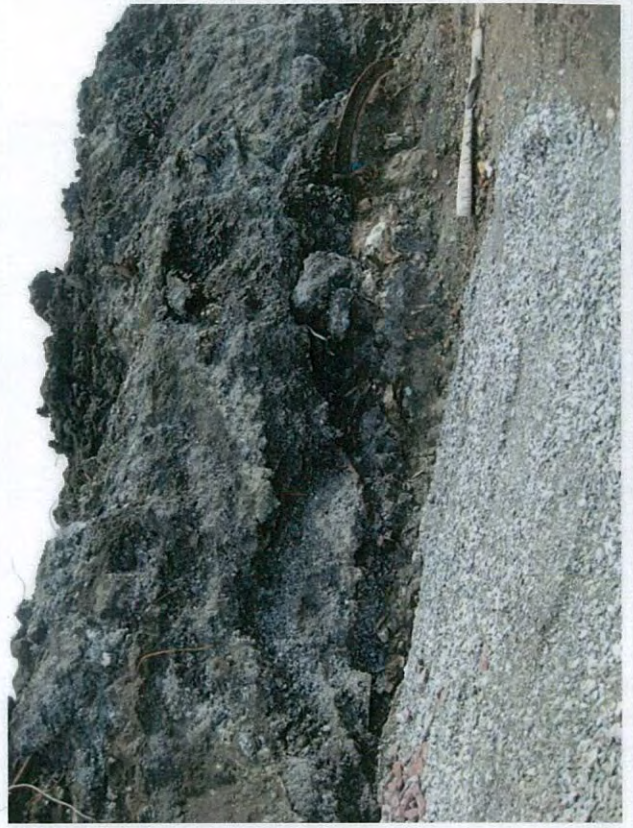
<b>Waste Type</b>	<b>Slag: unprocessed slag, furnace slag</b>	
<b>Waste Code</b>	10.02.02 & 10.09.03	
<b>Waste Description</b>	<b>Colour</b>	Grey and mottled rusty brown
	<b>Forms</b>	Unprocessed – fused, molten, angular, metallic
	<b>Texture</b>	Pockmarked
	<b>General</b>	Dense, heavy, conglomerated, difficult to drill and excavate through
	<b>Source</b>	Failed ladles, 'sculls', skimmed wastes from molten metal

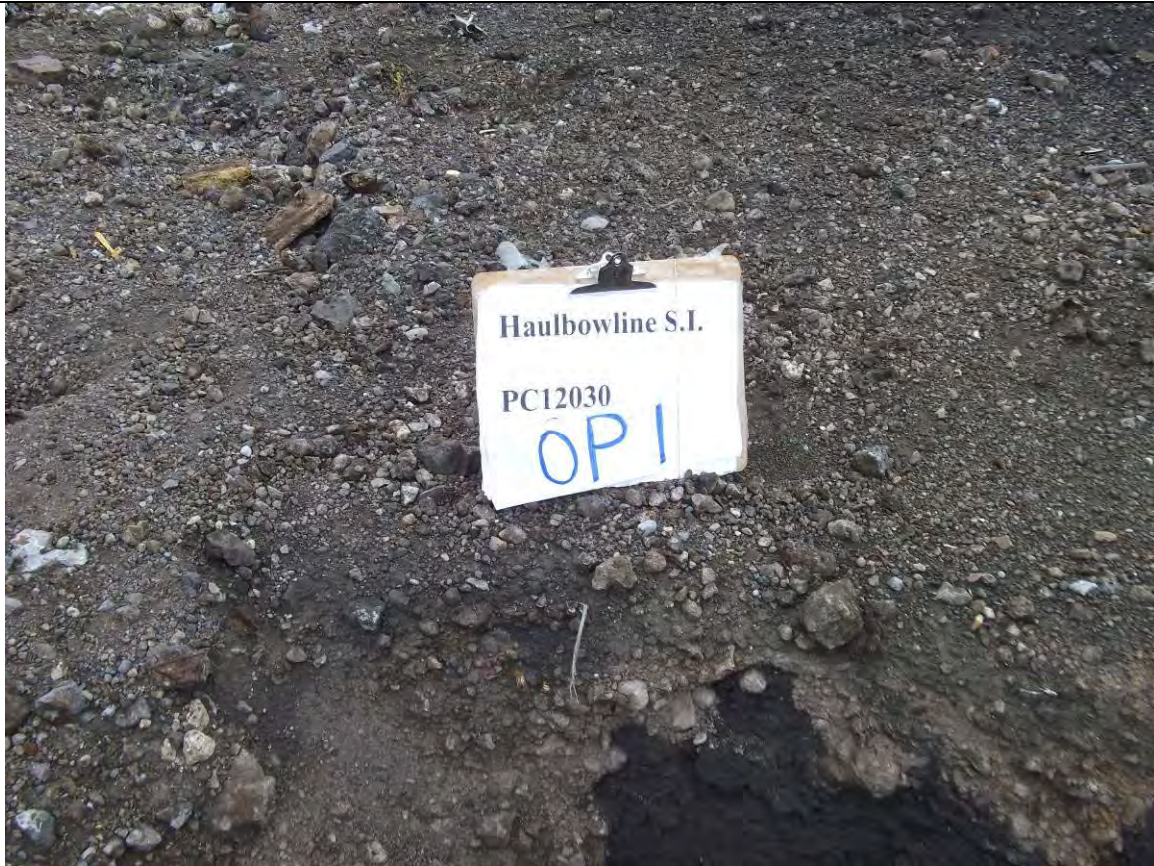
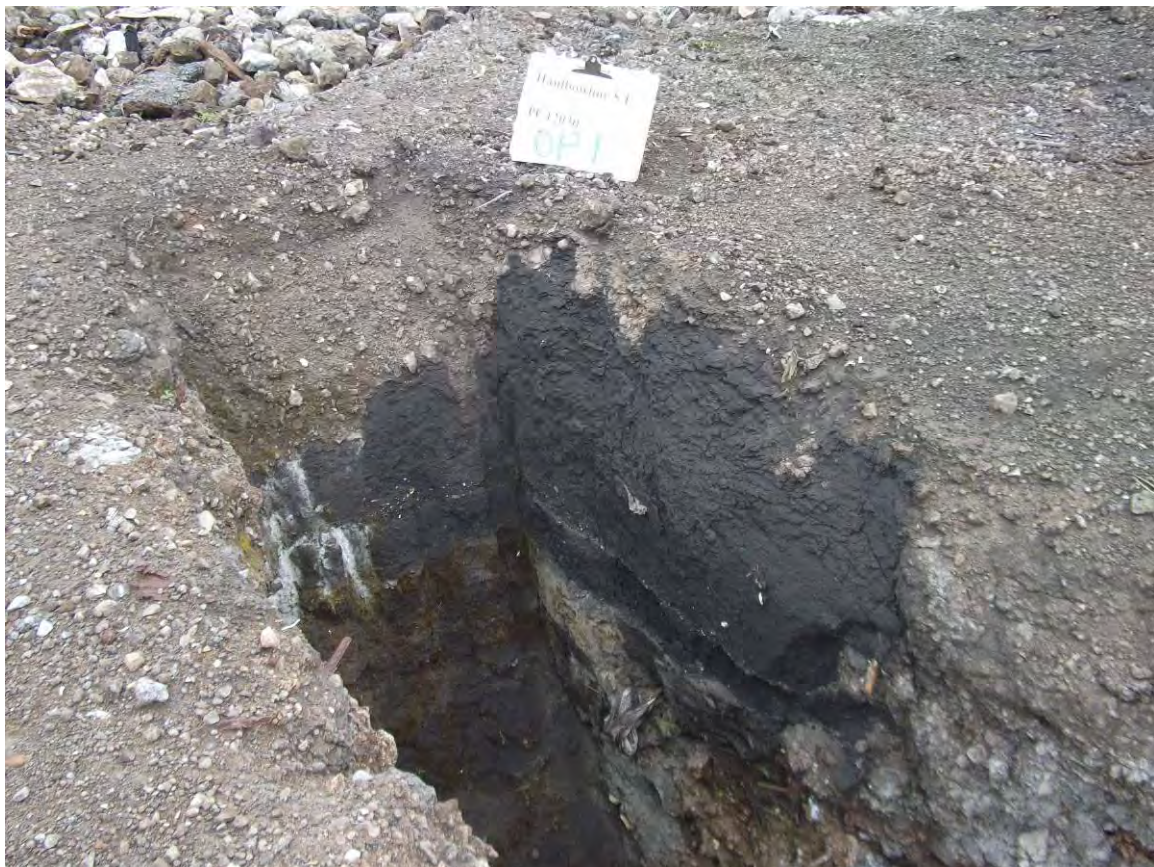
OP01

Water Strikes	Samples & In Situ Testing			Level (m AOD)	Depth (m)	Stratum Description	Legend
	Depth (m)	Type	Results				
				2.19	1.00	Very dark grey Sludge/ Filtercake.	
				1.49	1.70	Light grey, unprocessed SLAG with occasional plastics, metal (<1%) and small refractory bricks (<1%).	
				0.39	2.80	Unprocessed SLAG with occasional plastic, oily cloth and vegetation.	
						Slit Trench Complete at 2.80 m	3
Water	Depth	Type	Results	Level	Depth

**Remarks:** Existing pit.

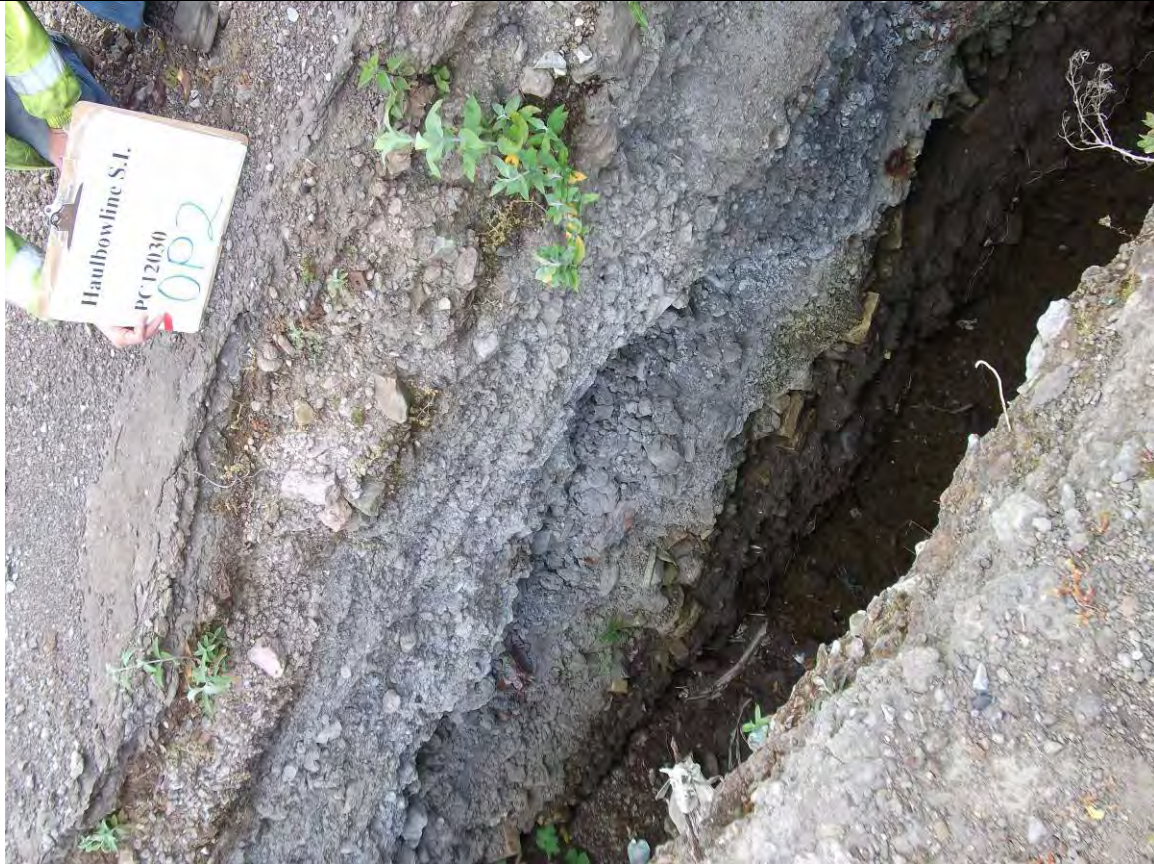
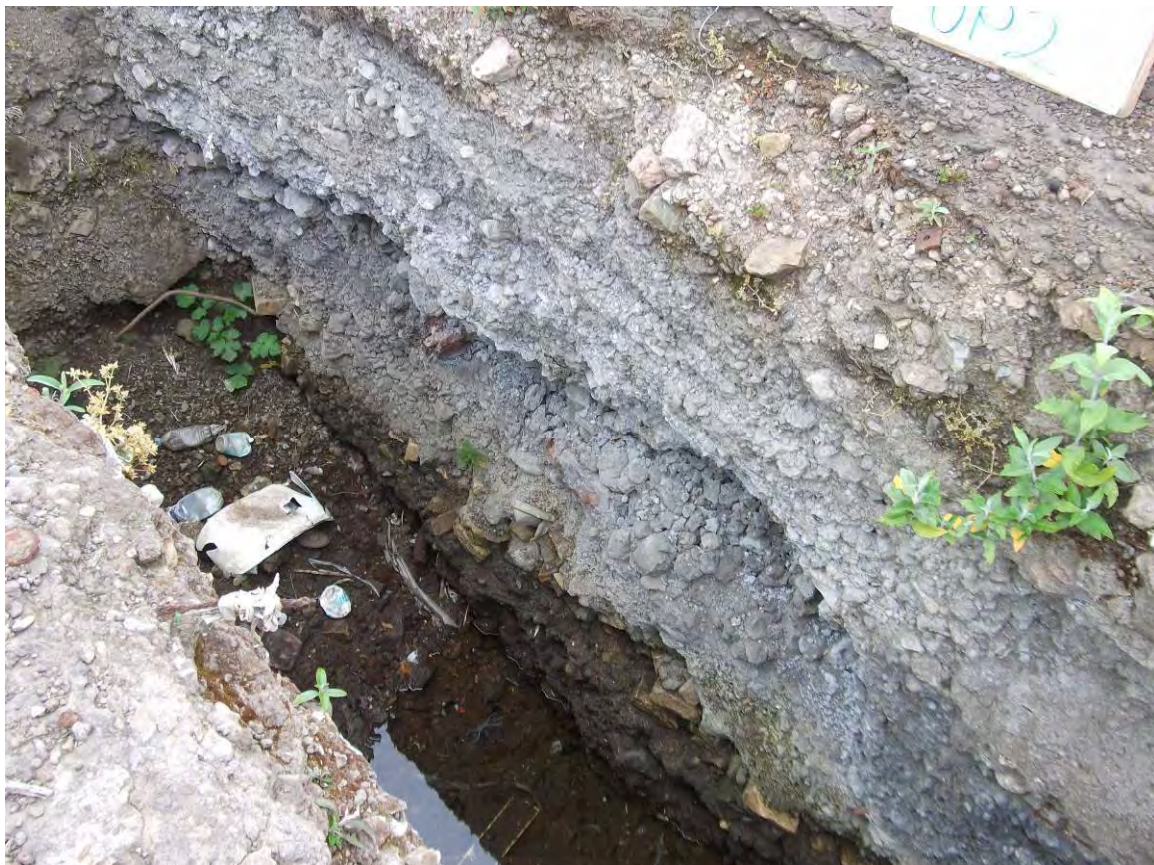
**OP02**

Water Strikes	Samples & In Situ Testing			Level (m AOD)	Depth (m)	Stratum Description	Legend
	Depth (m)	Type	Results				
				3.06	0.10	Compacted, unprocessed SLAG with in gravel and cobble form.	[Cross-hatched pattern]
						Light grey, unprocessed SLAG.	
				2.76 2.72	0.40 0.44	Thin, metallic layer.	[Cross-hatched pattern]
						Light grey, unprocessed SLAG in gravel and cobble form.	
				1.16	2.00	Refractory bricks (approx. 70%).	[Cross-hatched pattern]
				0.86	2.30	Dark grey, unprocessed SLAG with metal (approx <1%).	[Cross-hatched pattern]
				0.46	2.70	Slit Trench Complete at 2.70 m

**Remarks:** Existing pit.

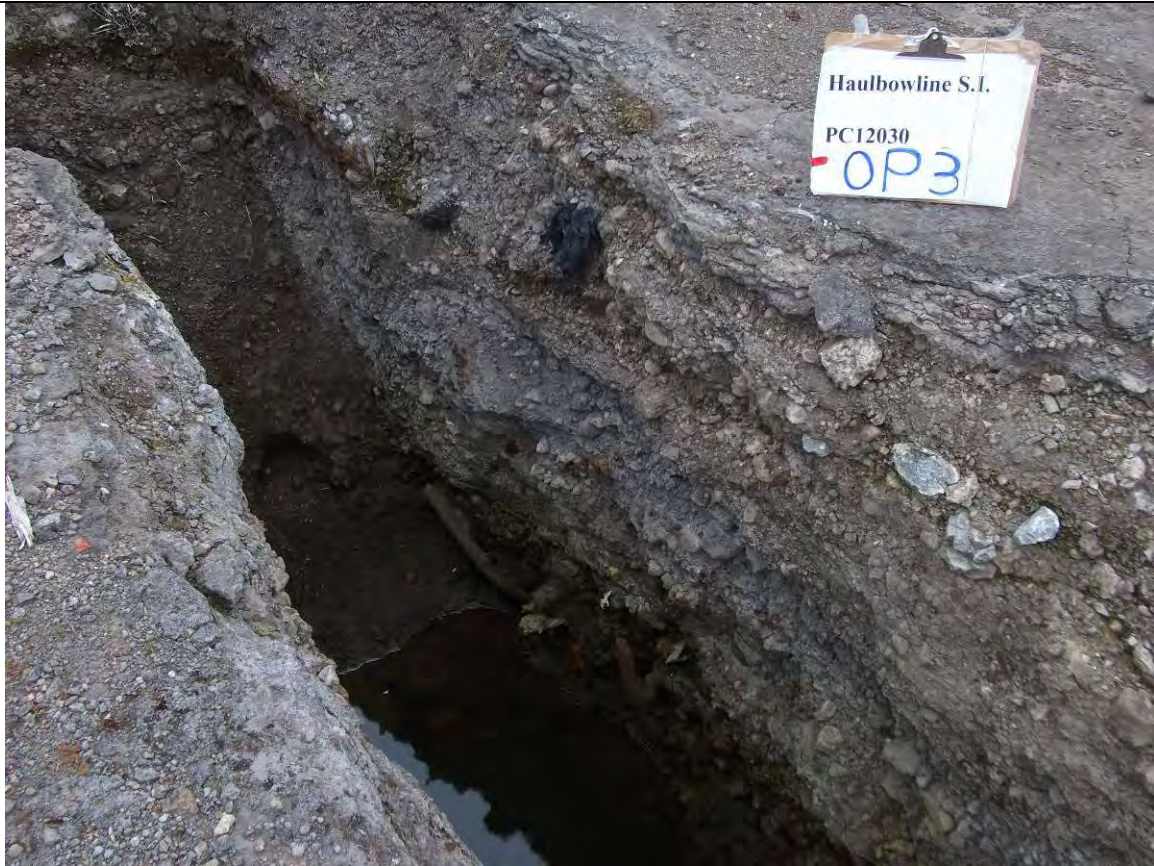
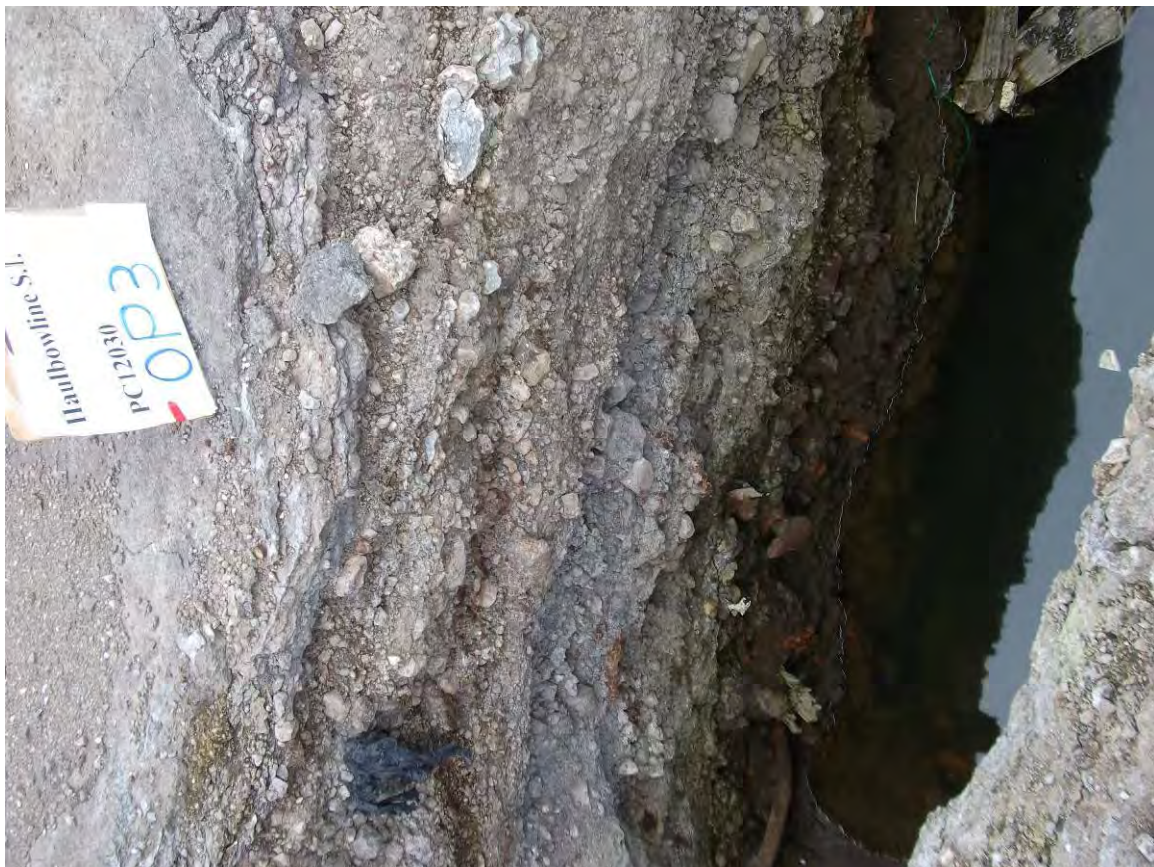
OP03

Water Strikes	Samples & In Situ Testing			Level (m AOD)	Depth (m)	Stratum Description	Legend
	Depth (m)	Type	Results				
▽				2.89	0.10	Compacted, unprocessed SLAG.	1
						Grey, unprocessed SLAG with molten/ angular pieces.	
				2.19	0.80	Light grey, unprocessed SLAG.	2
				1.29	1.70	Dark, oxidised brown, unprocessed SLAG with metal waste (<1%).	
			-0.22	3.20	Slit Trench Complete at 3.20 m		3
Water	Depth	Type	Results	Level	Depth

**Remarks:** Existing pit.

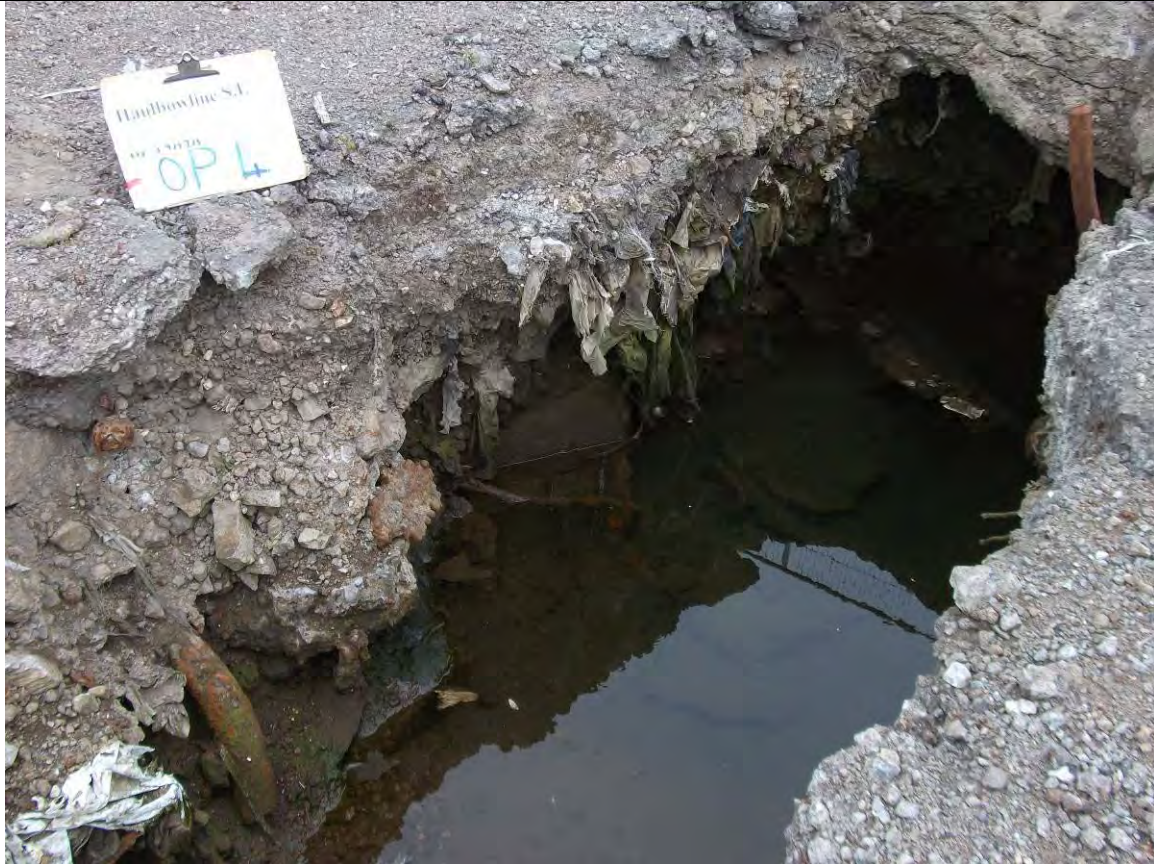
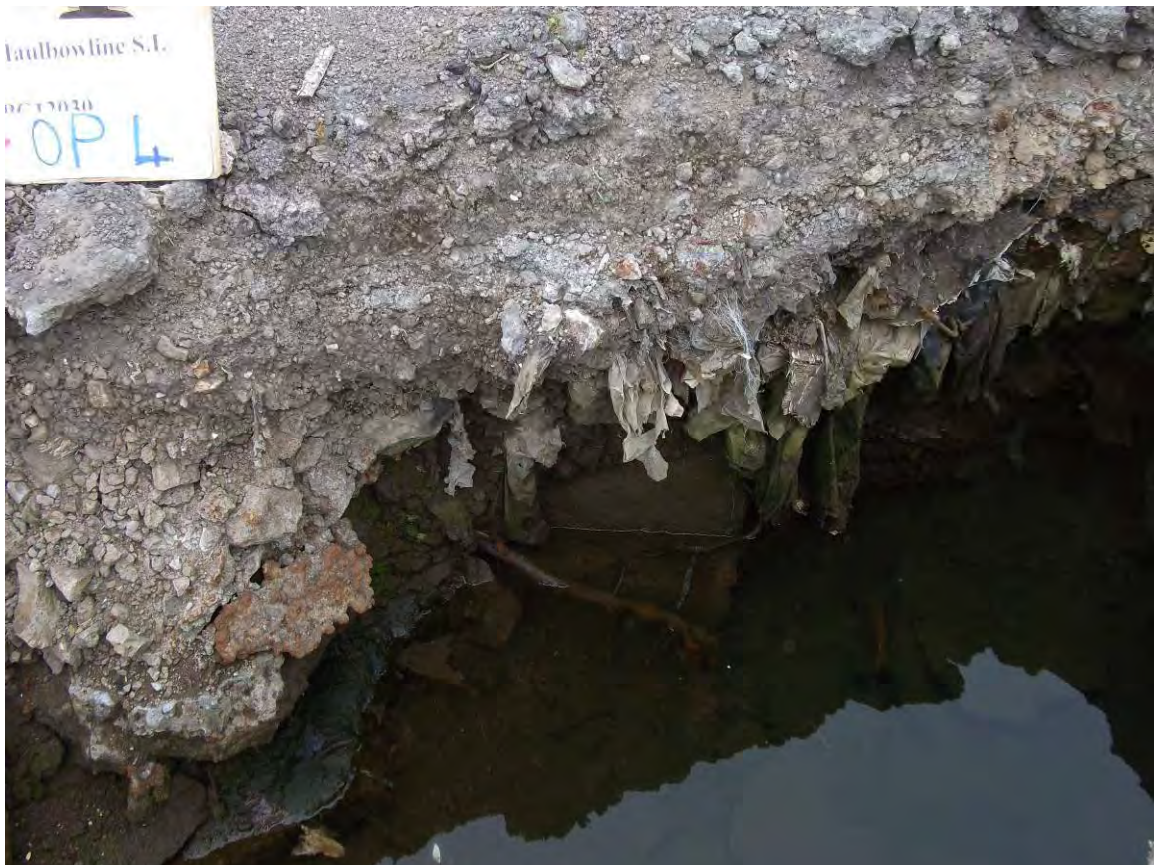
**OP04**

Water Strikes	Samples & In Situ Testing			Level (m AOD)	Depth (m)	Stratum Description	Legend
	Depth (m)	Type	Results				
▽				2.30	0.30	Compact, molten, unprocessed SLAG.	
						Grey, unprocessed SLAG in gravel and cobble form.	
				1.80	0.80	Red/ brown, unprocessed SLAG with 600mm dia metal pieces and plastic.	
				0.30	2.30	Slit Trench Complete at 2.30 m

**Remarks:** Existing pit.

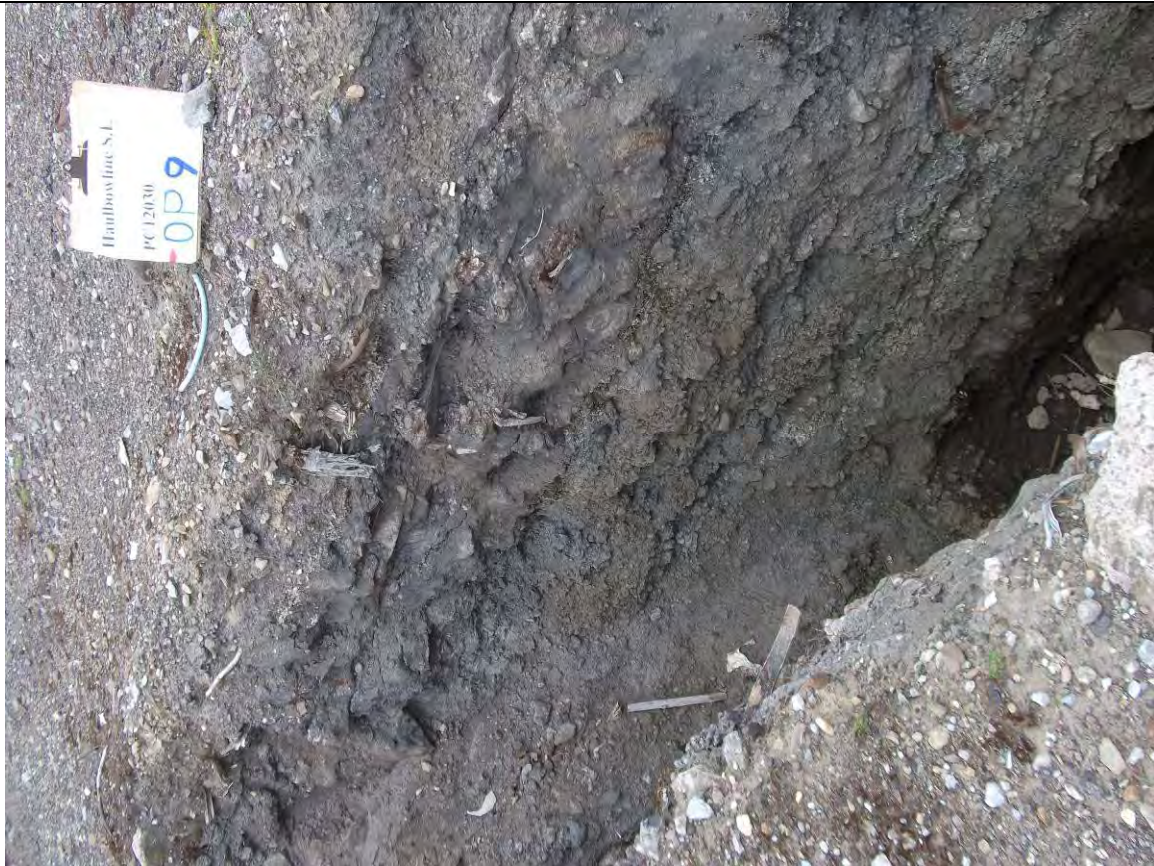
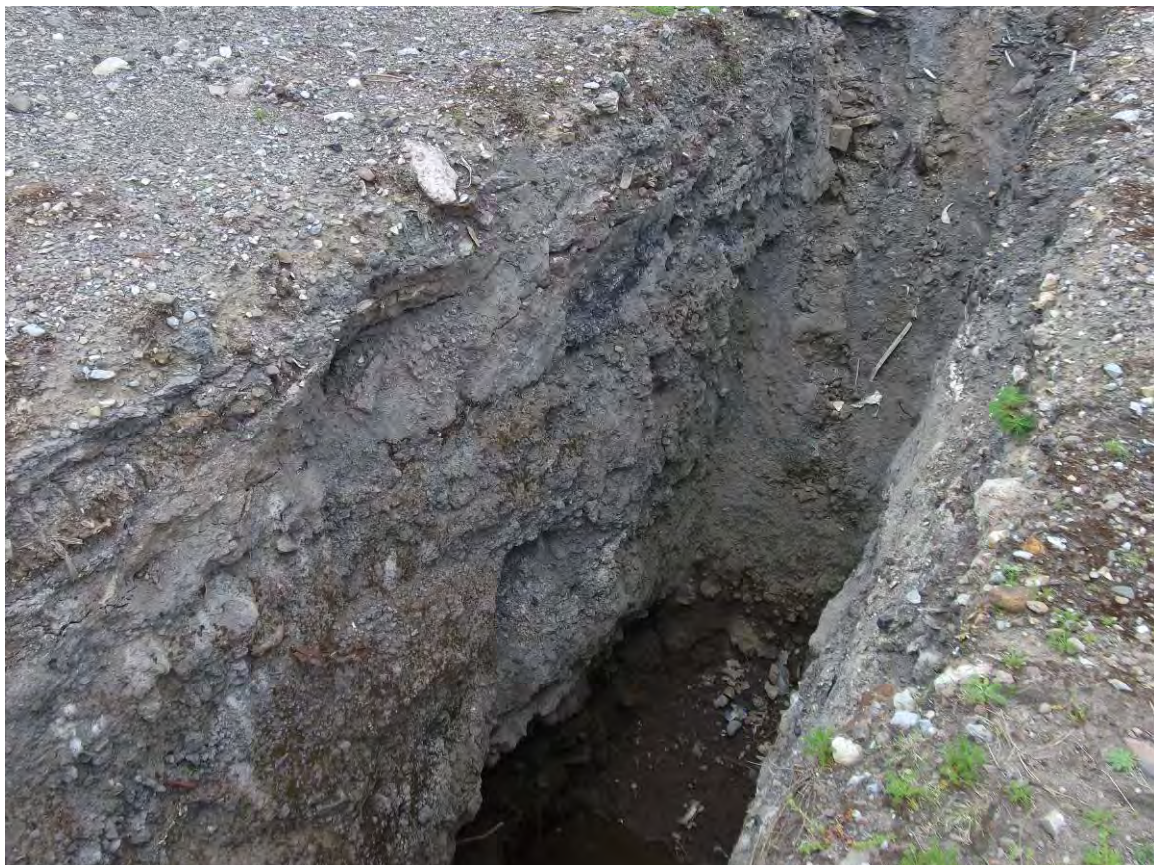
**OP09**

Water Strikes	Samples & In Situ Testing			Level (m AOD)	Depth (m)	Stratum Description	Legend
	Depth (m)	Type	Results				
				2.61	0.60	Grey, unprocessed, molten SLAG.	 1 2 3
				0.91	2.30	Light grey, granular, unprocessed SLAG.	
				-0.39	3.60	Brown, unprocessed SLAG.	
						Slit Trench Complete at 3.60 m	
Water	Depth	Type	Results	Level	Depth

**Remarks:** Existing pit.
