**Connaught Regional Residual Landfill
EPA Waste Licence W0178-02**

Annual Environmental Report

January 2013 - December 2013

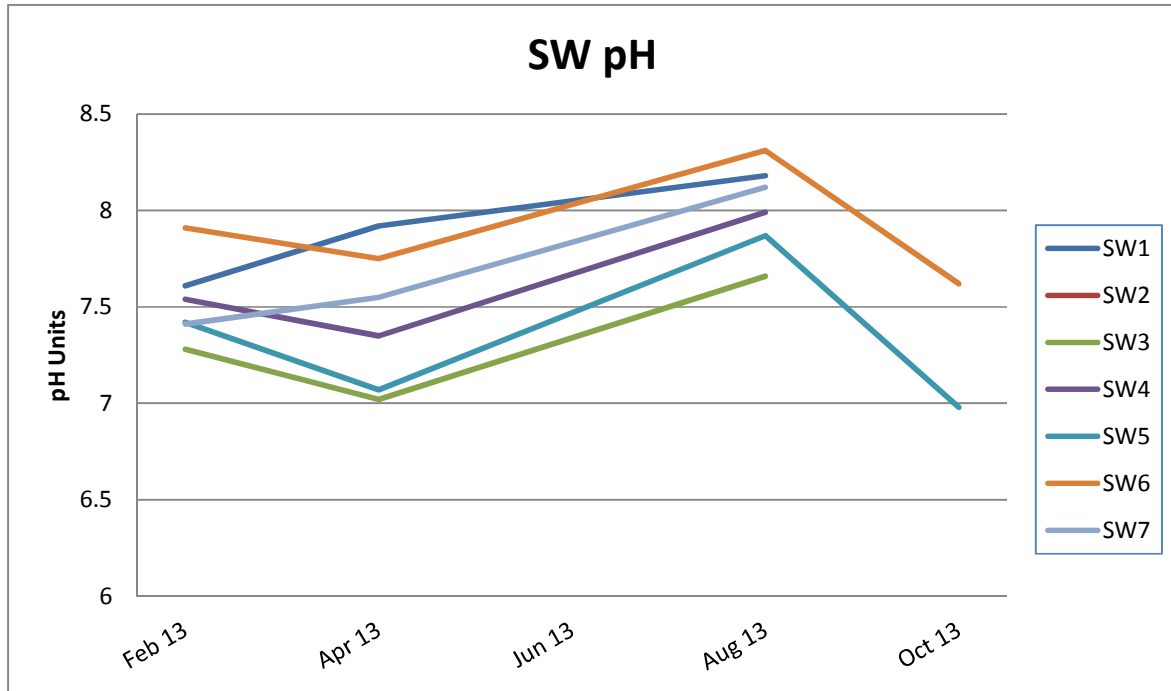
Figure 4.1 SW pH Results at CRRL 2013

PH and conductivity results were found to be within normal ranges for natural uncontaminated surface waters. Chloride concentrations ranged from 10.53 mg/l (SW7 in Q3) to 24.02 mg/l (SW3 in Q1) during 2013. These results are within the normal range for uncontaminated freshwater (15-35mg/l, EPA). Ammoniacal nitrogen (total ammonium plus total ammonia) ranged between <0.01mg/l (SW7 in Q1) to 0.37mg/l (SW3 in Q3). Ammonia is generally present in natural waters, usually at very low concentrations. Concentrations of Ammoniacal nitrogen far in exceedance of 0.1 mg/l can be an

indication of contamination by sewage¹ however it can also be a result of mineralization of organic matter following the lowering of the water table in areas of peat².

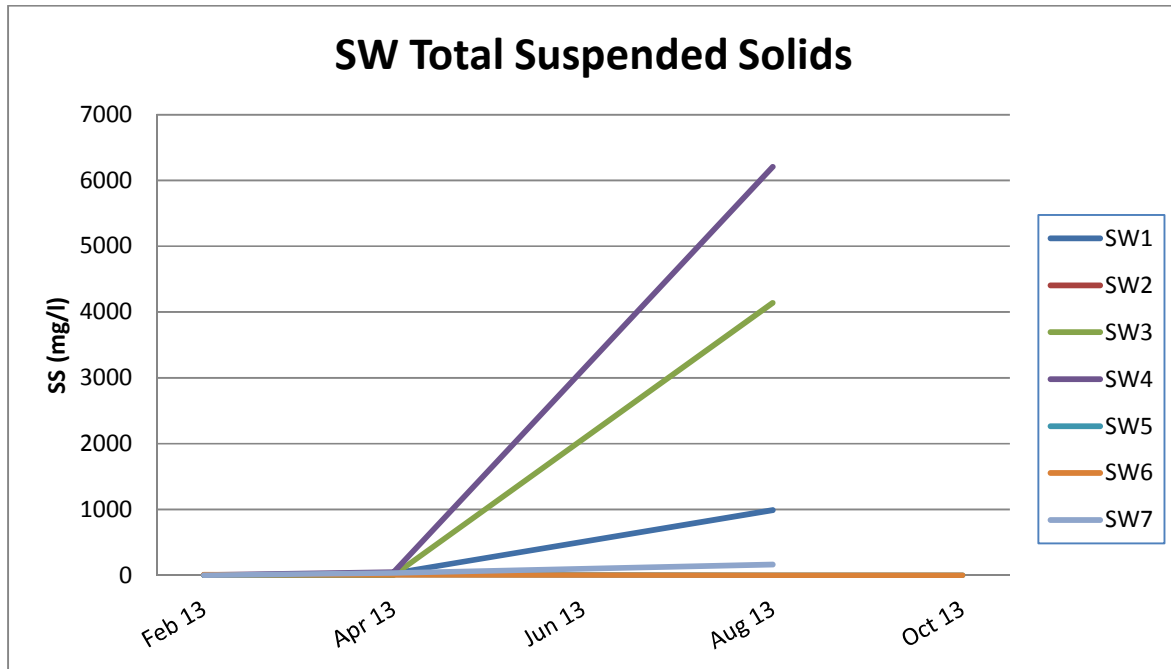
Figure 4.5 SW Total Suspended Solids Results at CRRL 2013

Suspended solids concentrations at SW6, SW7 complied with the 35mg/L ELVs during all monitoring events throughout 2013 with the exception of SW7, which was elevated in Q3 (163mg/l). On the day of sampling, the water level observed at locations SW1, SW3, SW4 and SW7 was extremely low. The elevated concentrations of Suspended solids were therefore attributed to disturbance of sediments while sampling in extremely low water levels. In Q4 2013, the water level was again extremely low at SW7 and no sample could be obtained. All exceedance and instances where sampling was not possible were reported to the EPA prior to the end of the relevant quarter.

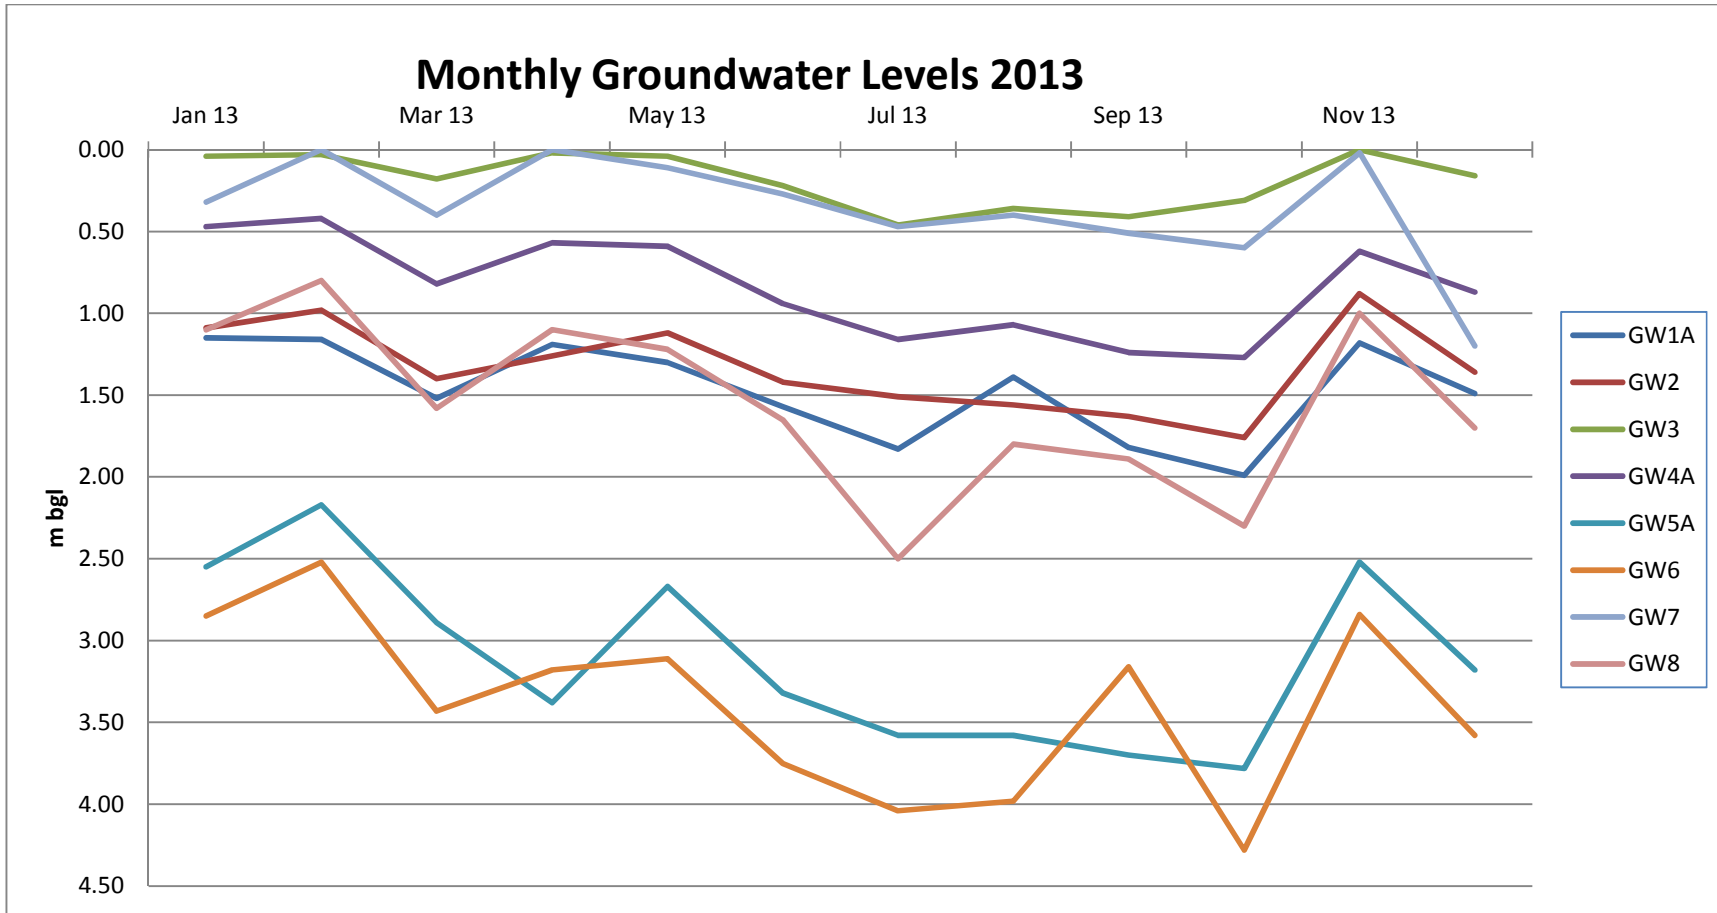
Figure 4.6 Monthly Groundwater Levels at CRRL – 2013

Groundwater levels were recorded on a monthly basis during 2013 and the results are presented in Figure 4.6 below. The recorded water levels remained relatively constant while allowing for seasonal variation during 2013.

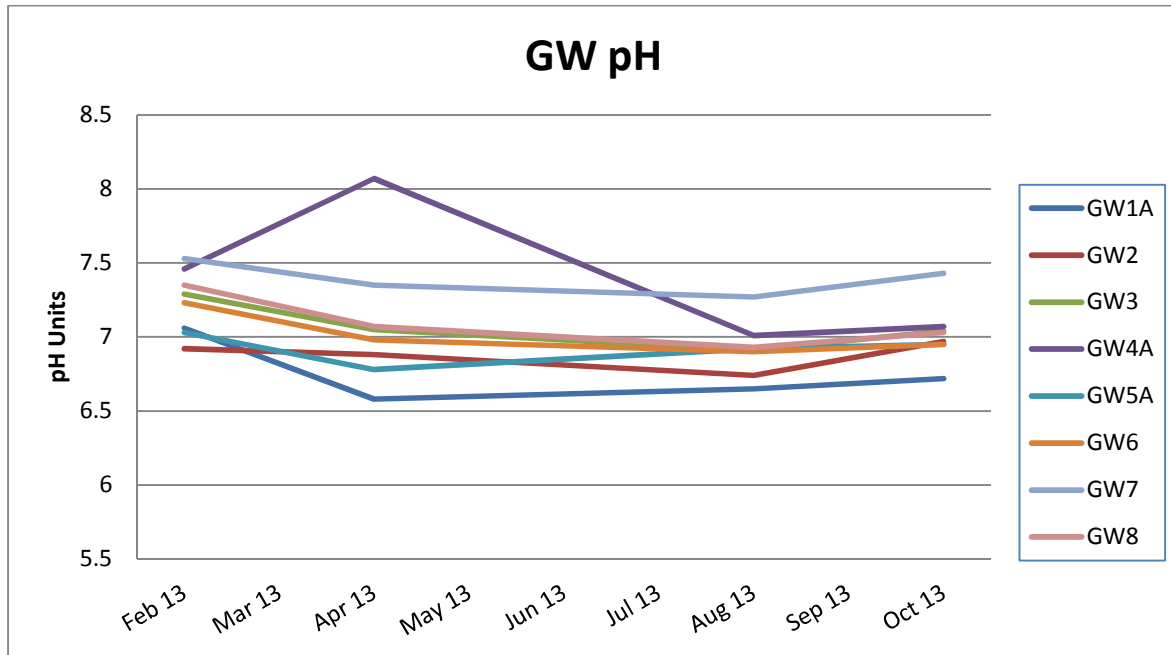
Figure 4.7 Groundwater pH Laboratory Results at CRRL – 2013

The results of routine licence compliance groundwater monitoring are all under the trigger values as revised and submitted in the 2008-2012 AERs. This AER report employs the aforementioned trigger levels for the parameters listed in Condition 6.4.3 of the Waste Licence for wells GW1-A, GW2, GW3, GW4-A, GW5-A, GW6, GW7 and GW8.

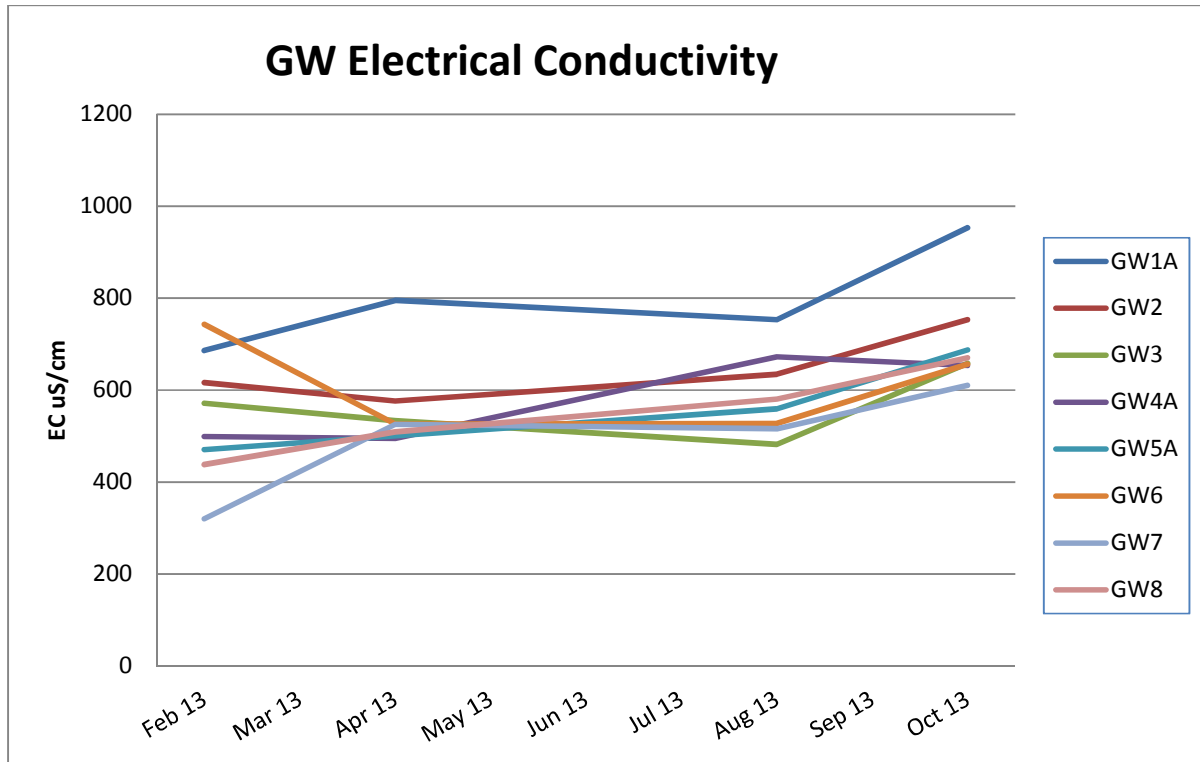
Figure 4.8 Groundwater Electrical Conductivity Results at CRRL – 2013

Note 1: No Set limit for electrical conductivity in groundwater trigger values.

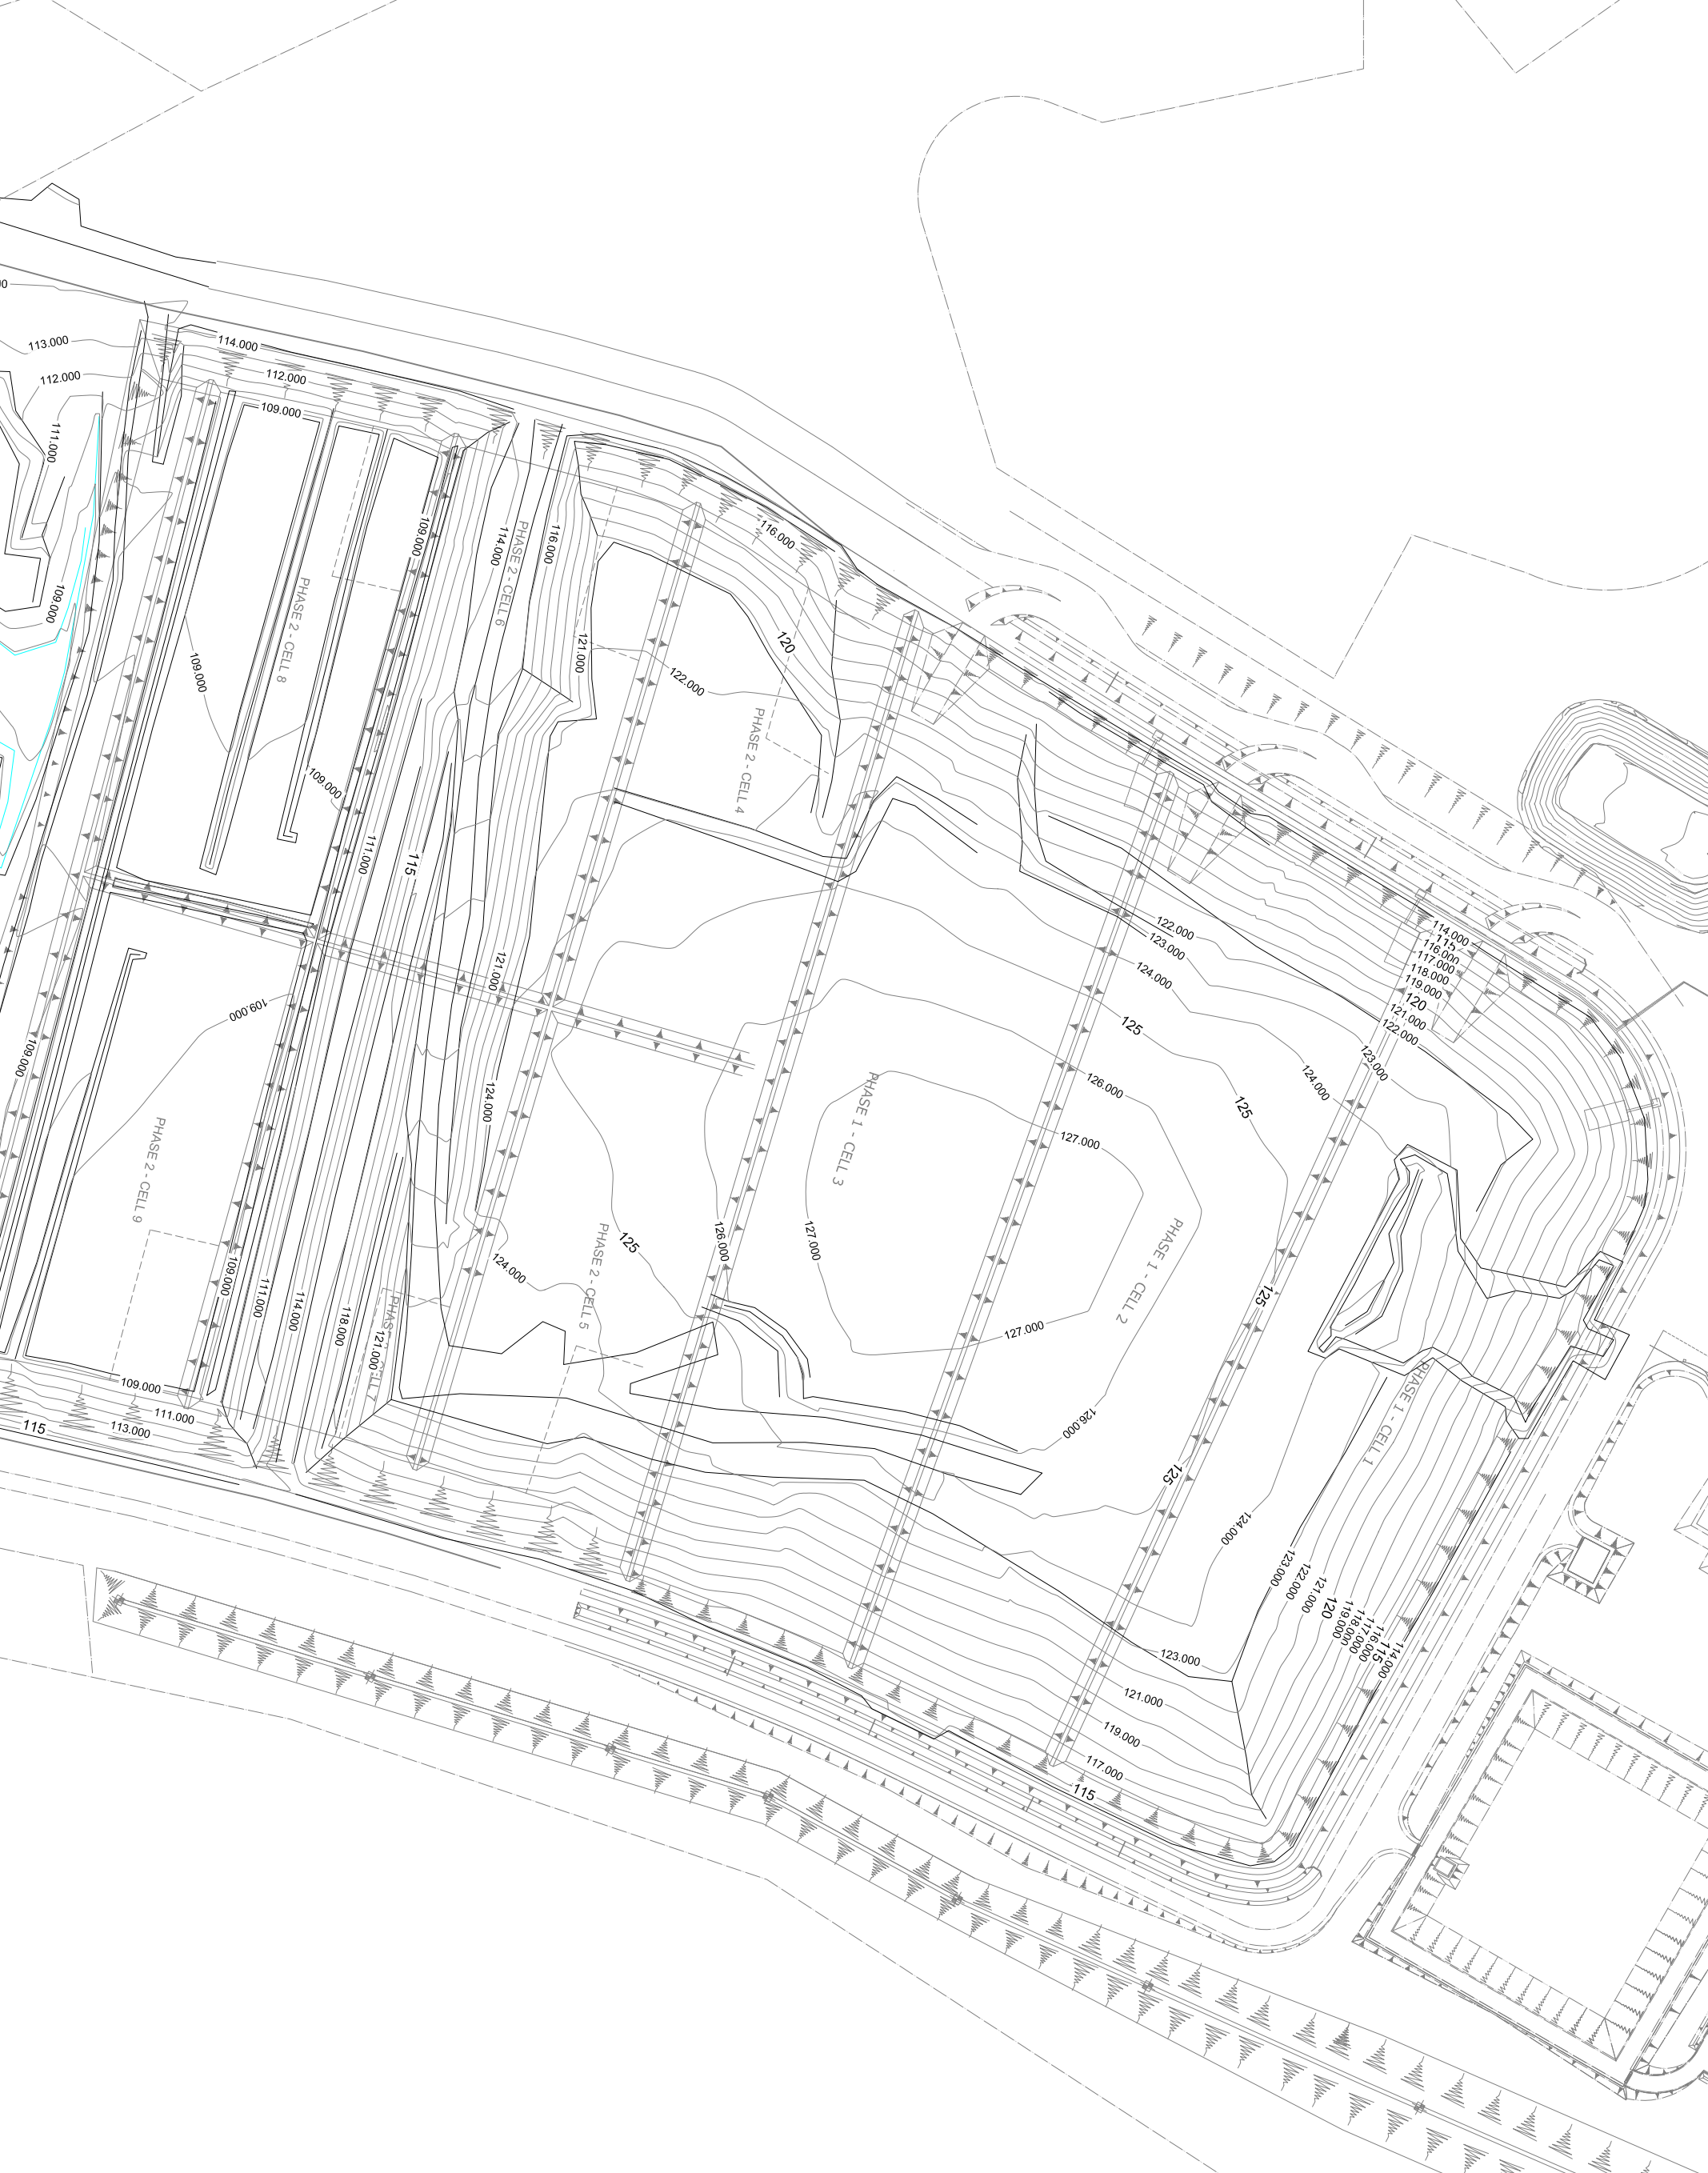
Topographical Site Survey – August 2013

As per condition 8.7 of the waste licence, a survey showing the topography of the facility at the end of the reporting period is included in Appendix B.
