**GREENSTAR LTD. - KNOCKHARLEY LANDFILL,
CO. MEATH**

ANNUAL ENVIRONMENTAL REPORT:

Report Period: January 2013 – December 2013

WASTE LICENCE REF. NO. W0146-02

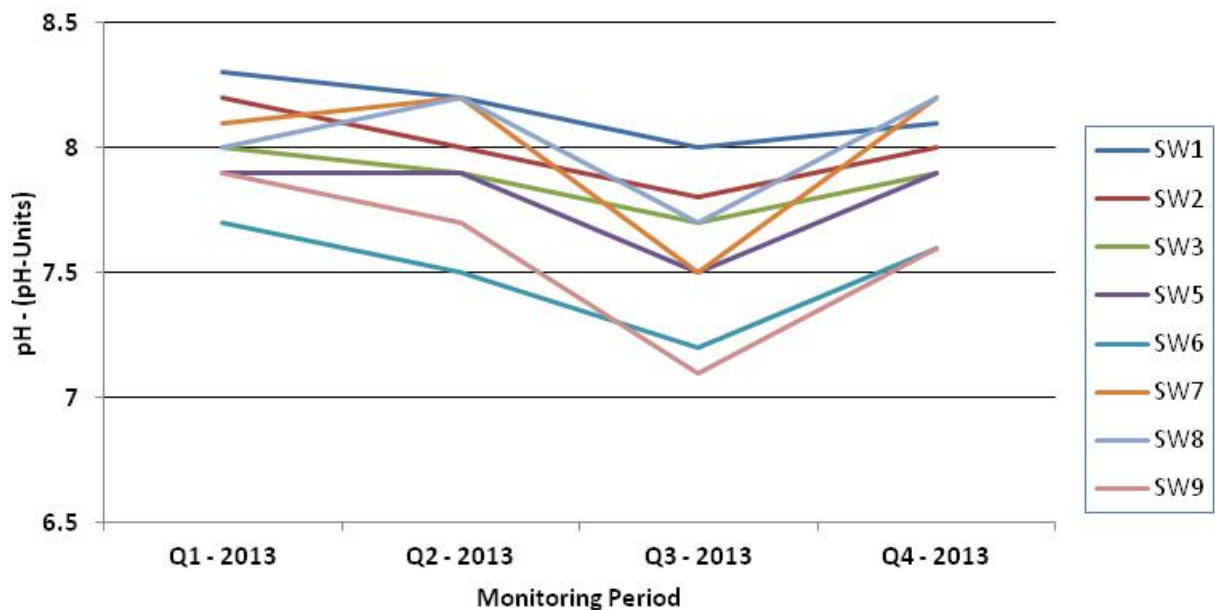
Figure 4.6: pH Results for Surface Water

The pH results, presented in Figure 4.6, are relatively consistent throughout the reporting period. The results are consistent across all monitoring locations.

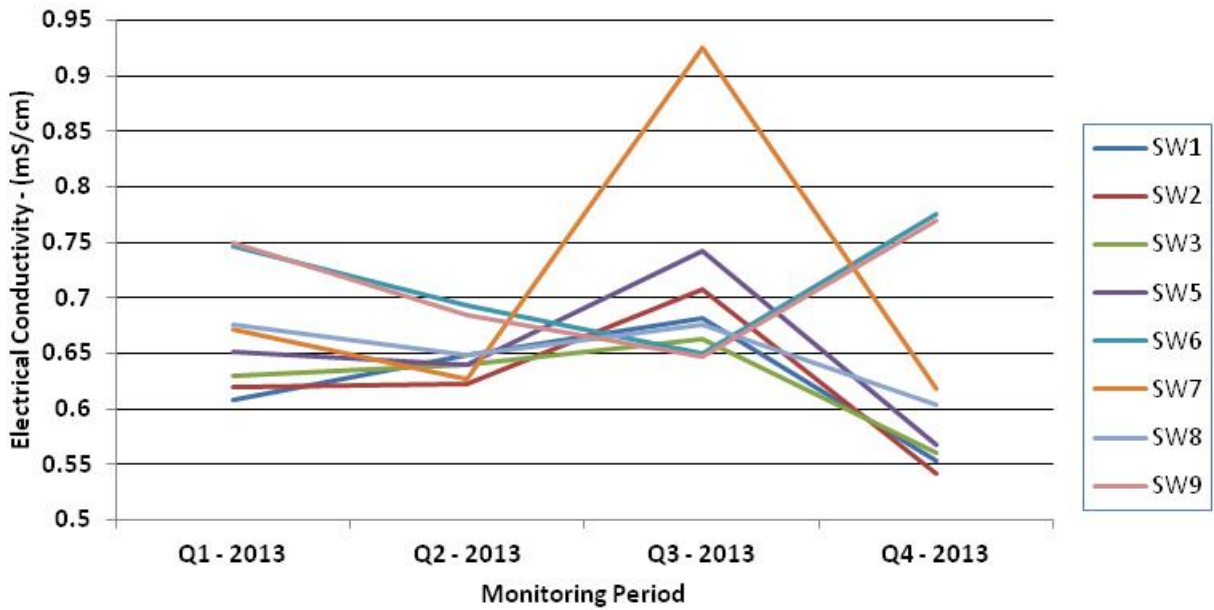
Figure 4.7: Electrical Conductivity Results for Surface Water

The electrical conductivity (EC) results, presented in Figure 4.7, were also relatively consistent throughout the reporting period. All pH and EC readings were within normal ranges for surface water except for elevated EC readings at SW7 during quarter 3. Greenstar staff has suggested the elevated reading may be from agricultural influences including land spreading in adjoining fields to this location.

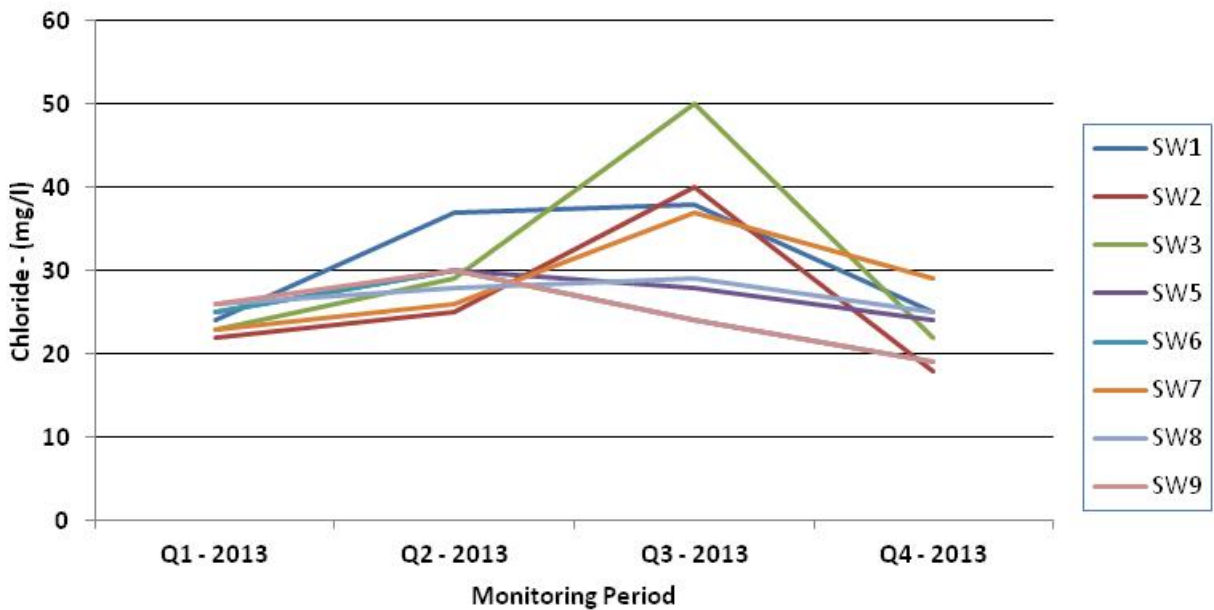
Figure 4.8: Chloride Results for Surface Water

The results for chloride (Cl) at surface water locations as presented in Figure 4.8, are consistent across all locations showing a similar trend during the reporting period.

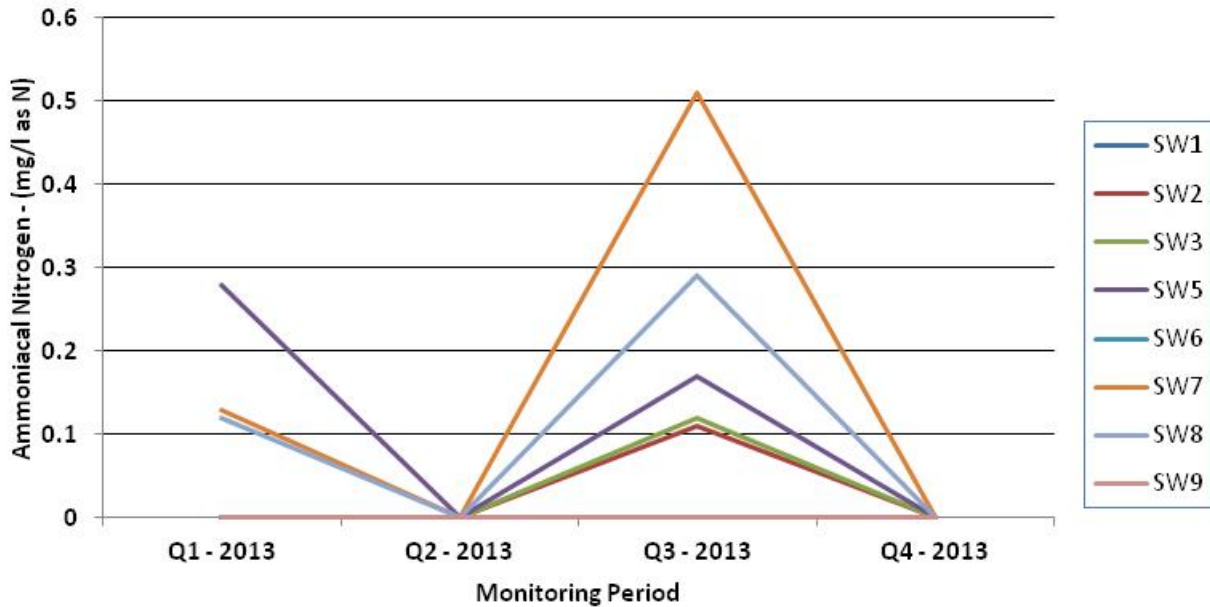
Figure 4.9: Ammoniacal Nitrogen Results for Surface Water

There is some variation in the ammoniacal nitrogen results (as shown in Figure 4.9) during the reporting period. Elevated results were recorded at all locations during Quarter 3 but not exceeding baseline levels. All results from Quarter 4 were below 0.3 mg/l as N. Results at all monitoring locations were so low during all quarters at SW9 that they were under the laboratory limit of detection.

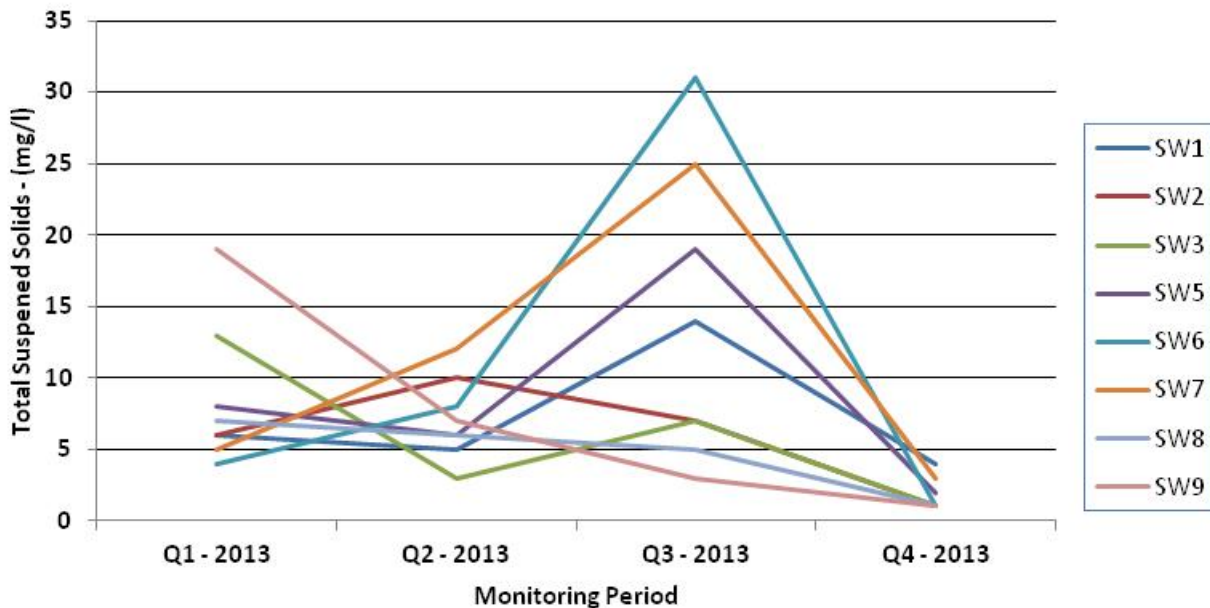
Figure 4.10: Total Suspended Solids Results for Surface Water

Levels of total suspended solids (TSS), Figure 4.10, were all within the normal range for surface waters with the exception of the results for SW7 during quarter 2 and SW5, SW6 and SW7 during quarter 3, which were recorded marginally above the baseline range.

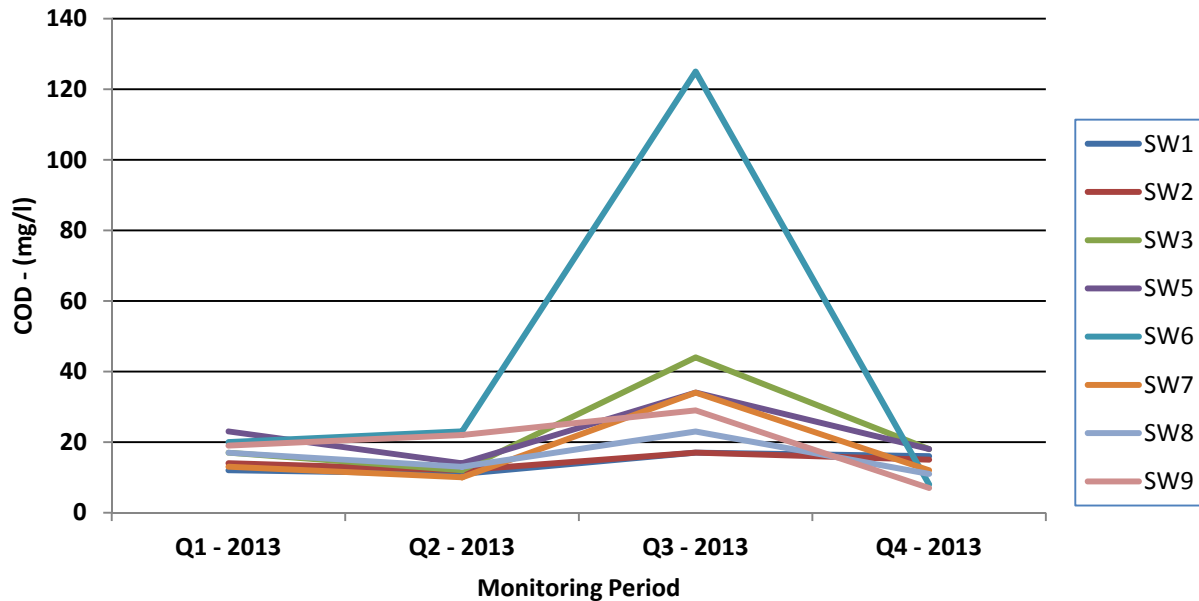
Figure 4.11: Chemical Oxygen Demand Results for Surface Water

COD levels, Figure 4.11, in general are consistent through Quarters 1 to 4 at all monitoring locations. There was a slight increase in levels at all locations during Quarter 3, with results for SW6 and SW7 both above the baseline range.

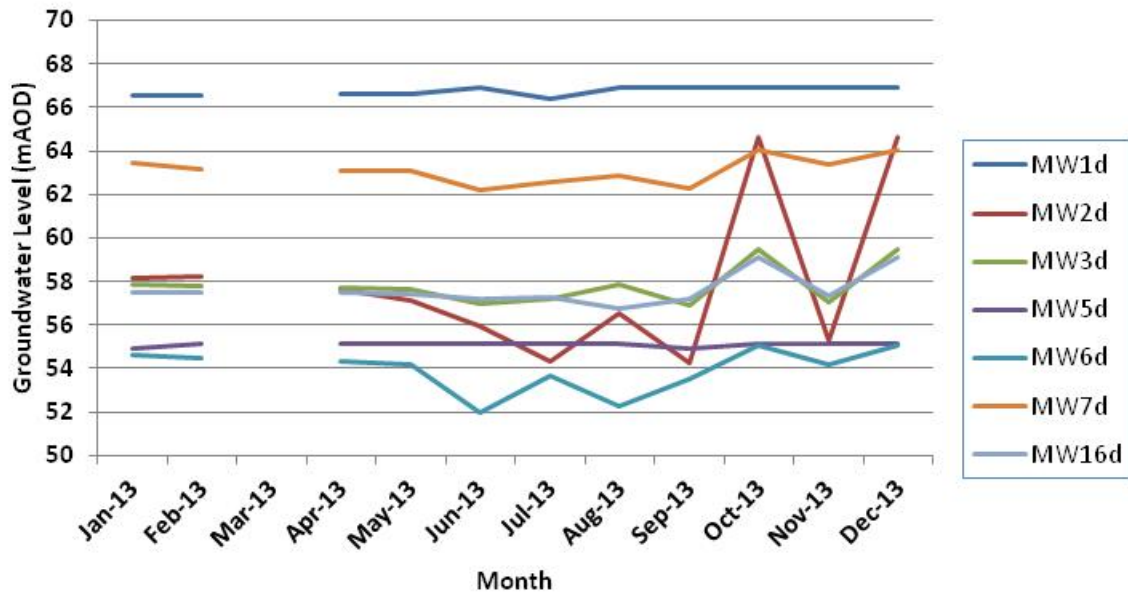
Figure 4.12: Groundwater Levels

The groundwater levels were recorded on a monthly basis and the results are presented in Figure 4.12. The levels remained relatively stable throughout the reporting period. During October and December 2013 there was a sharp increase in groundwater levels at MW2d. Levels in these wells have since recovered and are being monitored closely.

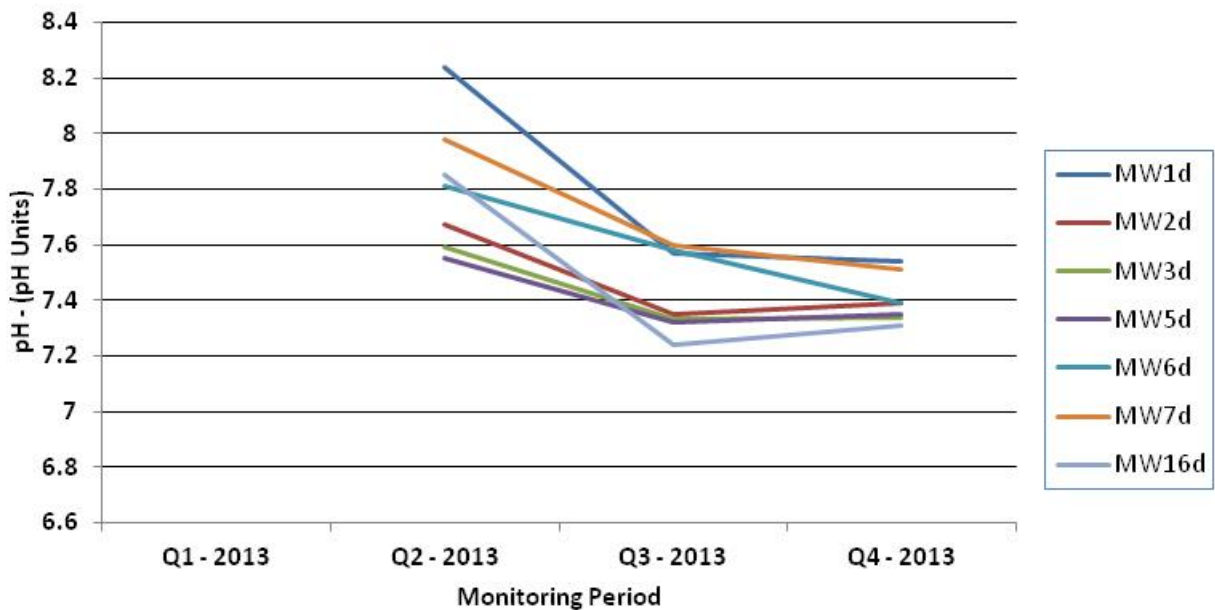
Figure 4.13: pH Results for Groundwater

The pH levels recorded in the groundwater were under the GWTL for all samples. The pH levels, presented in Figure 4.13, in general fell from quarter 2 through to quarter 4. The pH results range from 7.24 to 8.24 pH units. pH for quarter 1 was not available due to faults with the monitoring equipment during sampling.

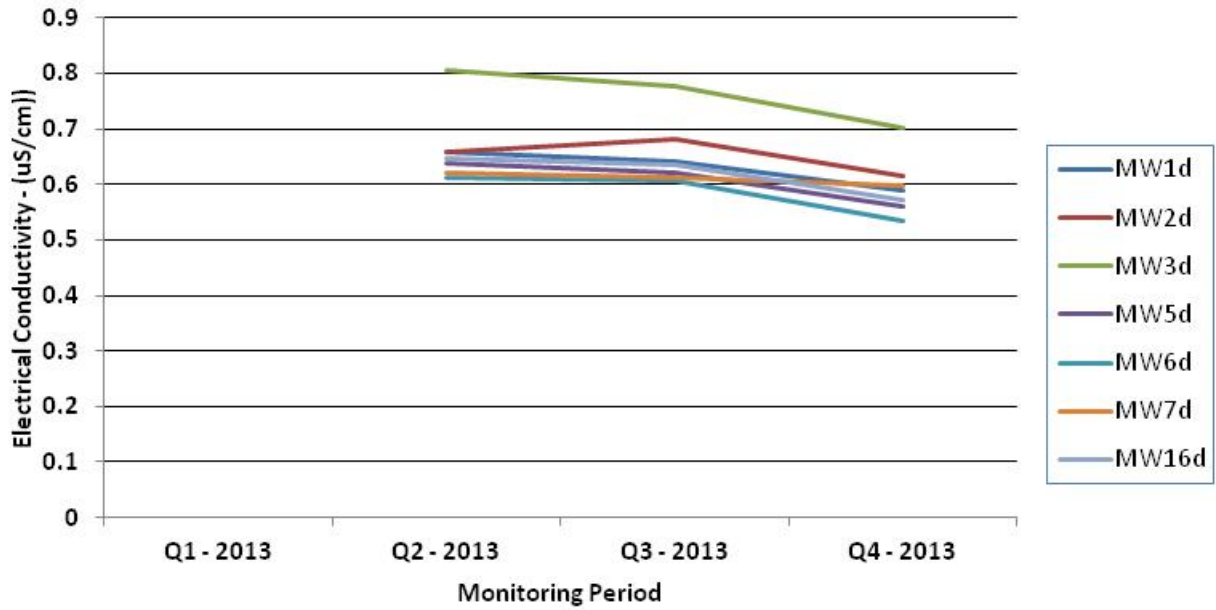
Figure 4.14: Electrical Conductivity Results for Groundwater

Electrical conductivity levels, presented in Figure 4.14, show that all readings remain consistent through quarters 2 to 4, ranging from 0.534 to 0.776 mS/cm, and are below the GWTL for all samples. The electrical conductivity levels are all consistent with unpolluted groundwater. Electrical conductivity for quarter 1 was not available due to faults with the monitoring equipment during sampling.

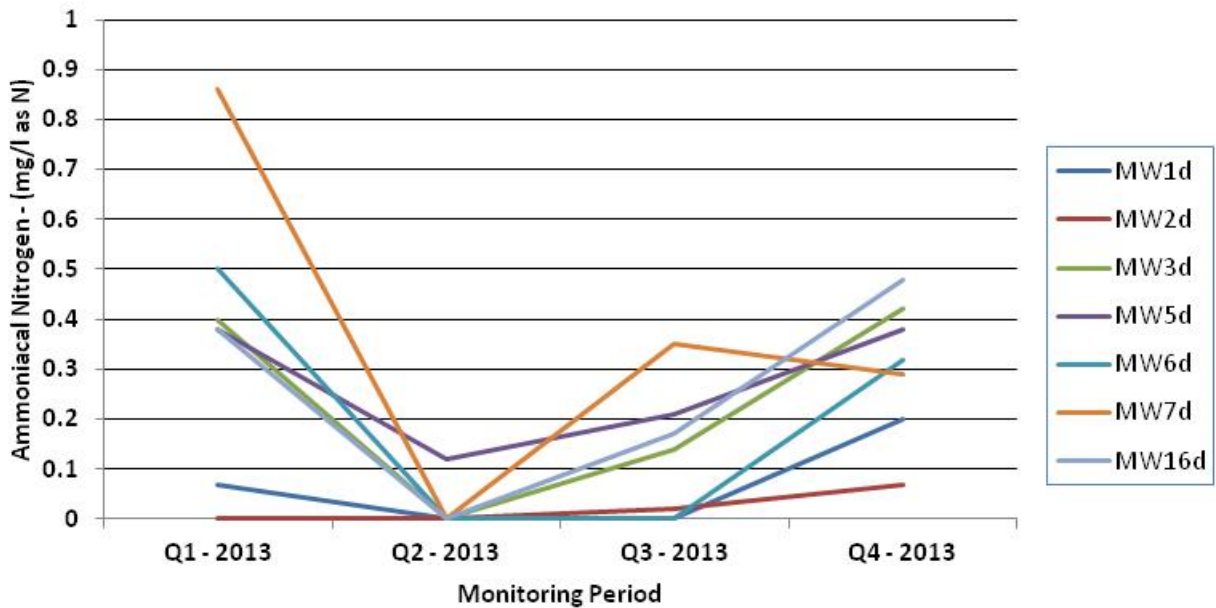
Figure 4.15: Ammoniacal Nitrogen Results for Groundwater

The levels of ammoniacal nitrogen are presented below in Figure 4.15. The ammoniacal nitrogen results are relatively consistent over the reporting period and are all below the GWTL, ranging from <0.2 to 0.544 mg/l as N. The most significant difference in results was recorded in MW7d in quarter 1 where the ammoniacal N levels was 0.86 mg/l. Although below the GWTL, it is more elevated than the levels over the past 2 years. MW7D is up-gradient of the landfill and so the levels of ammoniacal N are likely to be from agricultural practices.

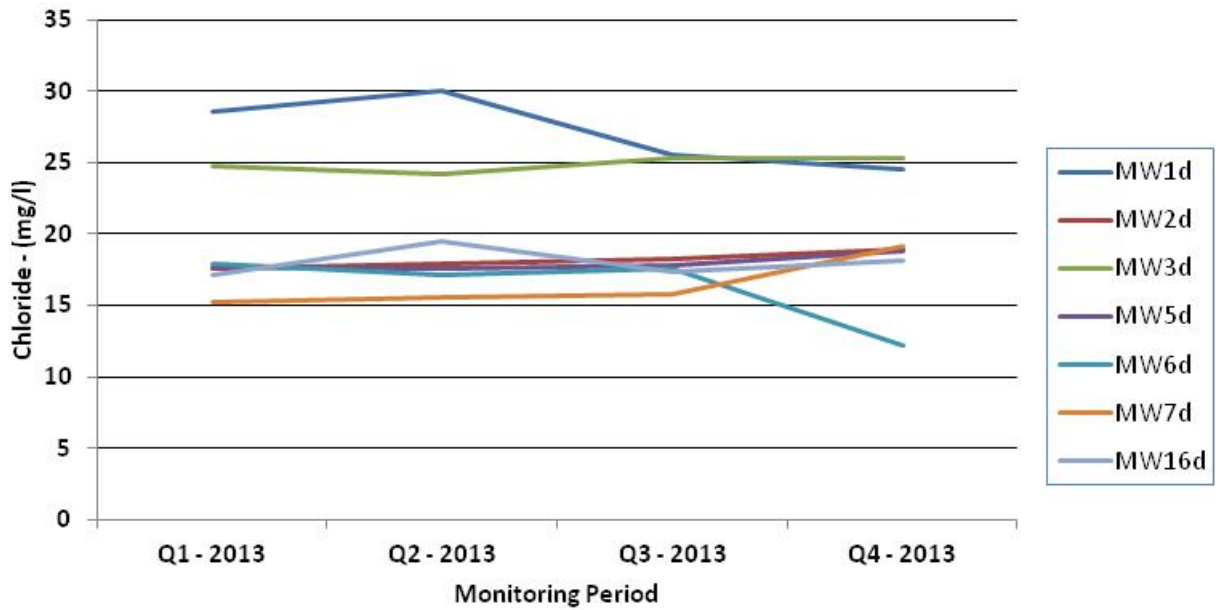
Figure 4.16: Chloride Results for Groundwater

Chloride (Cl) levels, presented in Figure 4.16, show that levels are consistent during the reporting period and all samples fell below the GWTL. The results range from 15.2 to 30.01 mg/l. All CL levels recorded during the reporting period are also within the Interim Guideline Values, (IGV) set out in the Environmental Protection Agency, (EPA) Groundwater *"Towards Setting the Guideline Values for the Protection of Groundwater in Ireland"* apart from MW1d during quarter 2 2013. The level is 0.01 mg/l above the IGV of 30 mg/l. MW1D is up-gradient of the landfill and so the levels of chloride N are unlikely to be from landfilling practices.

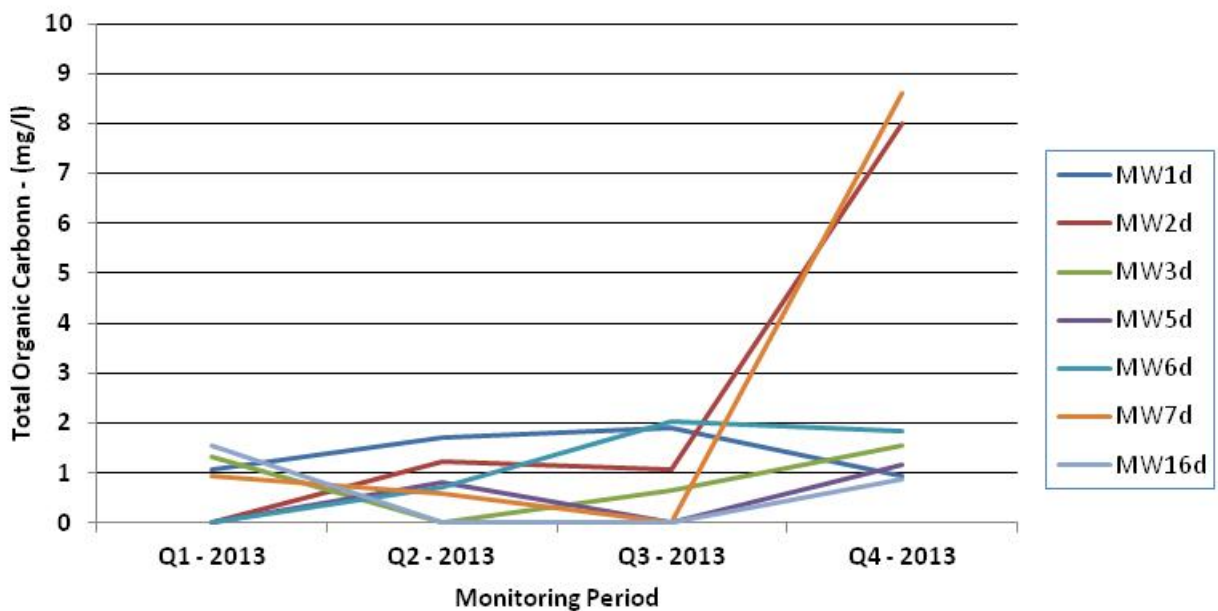
Figure 4.17: TOC Results for Groundwater

The total organic carbon (TOC), presented in Figure 4.12, levels during all quarters were all below the GWTL and ranged from <0.5 to 8.62 mg/l.

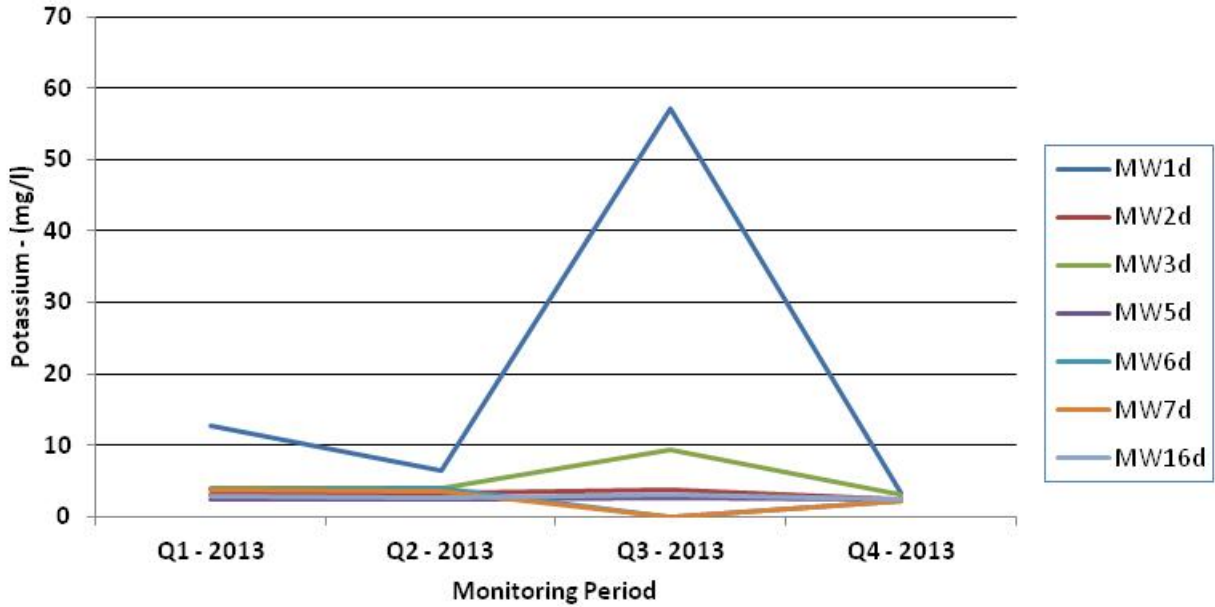
Figure 4.18 Potassium Results for Groundwater

Potassium level spikes above the GWTL was observed in quarters 1, 2 and 3 at MW1d and during quarter 3 at MW3d, presented in Figure 4.18. The potassium levels at MW1d peaked at 57.2 mg/l during quarter 3. All other potassium results during quarters 1 to 4 were below the GWTL, ranging from <0.4 to 6.5 mg/l. As both MW1d and MW3d are up-gradient of the landfill, the elevated levels are unlikely to be as a result of landfill activities.

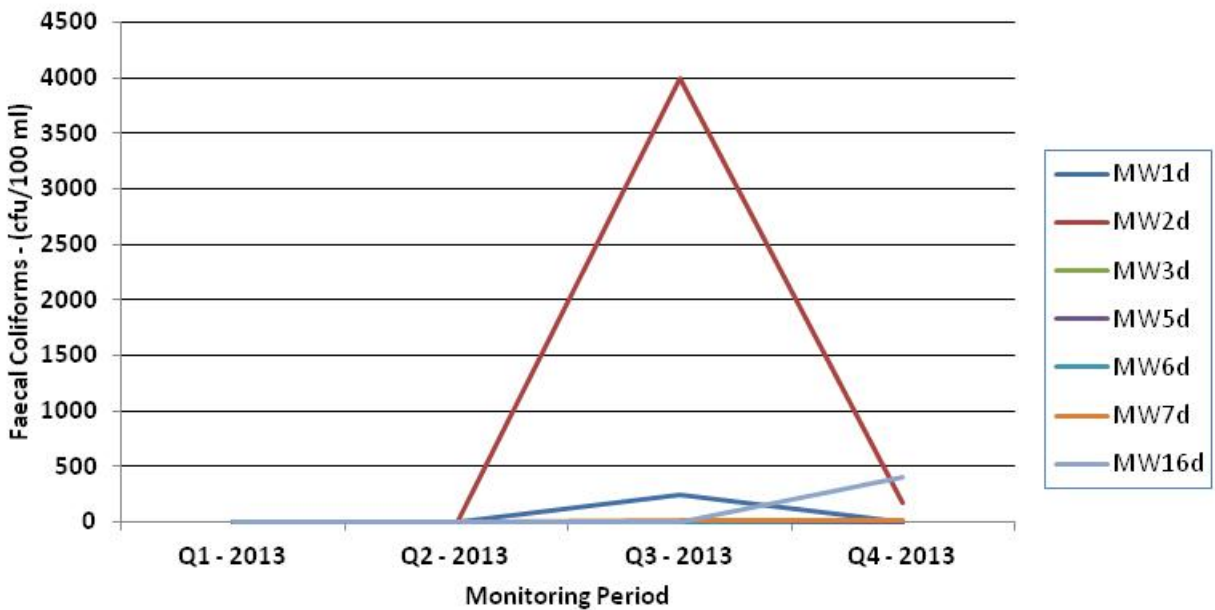
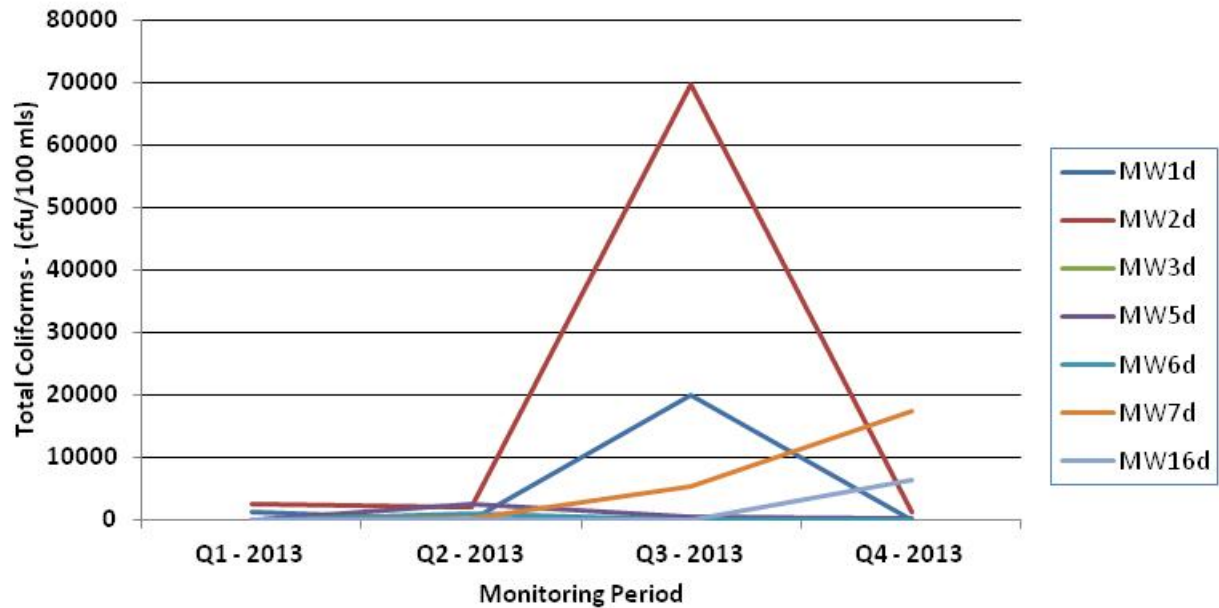
Figure 4.19: Faecal Coliforms Results for Groundwater

Figure 4.20: Total Coliforms Results for Groundwater

Variable levels of faecal and total coliforms, presented in Figure 4.19 and Figure 4.20 respectively, were recorded in a number of wells during the reporting period. Historically total and faecal coliforms have been detected in all groundwater monitoring boreholes around the site. All the monitored groundwater boreholes are dedicated monitoring wells and not used for any other purpose than groundwater monitoring.

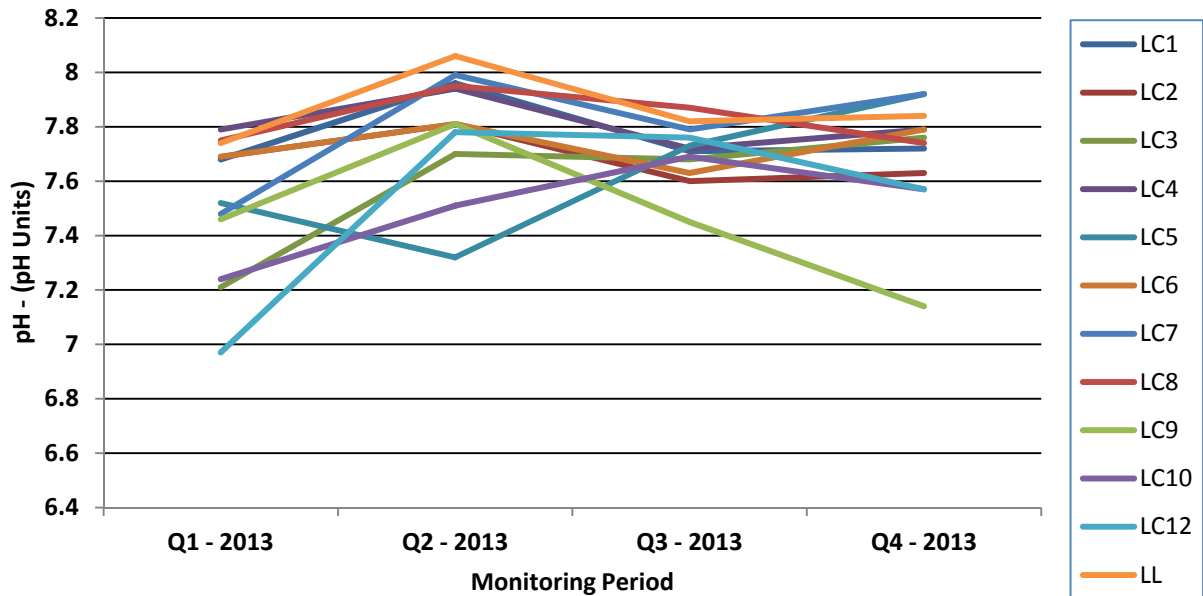
Figure 4.21: pH Results for Leachate

The pH level, presented in Figure 4.21, for leachate samples, though showing variation between quarters, follows a similar trend for all sample locations. The pH level trend indicates that the leachate is generally becoming more acidic from quarter 1 through to quarter 4.

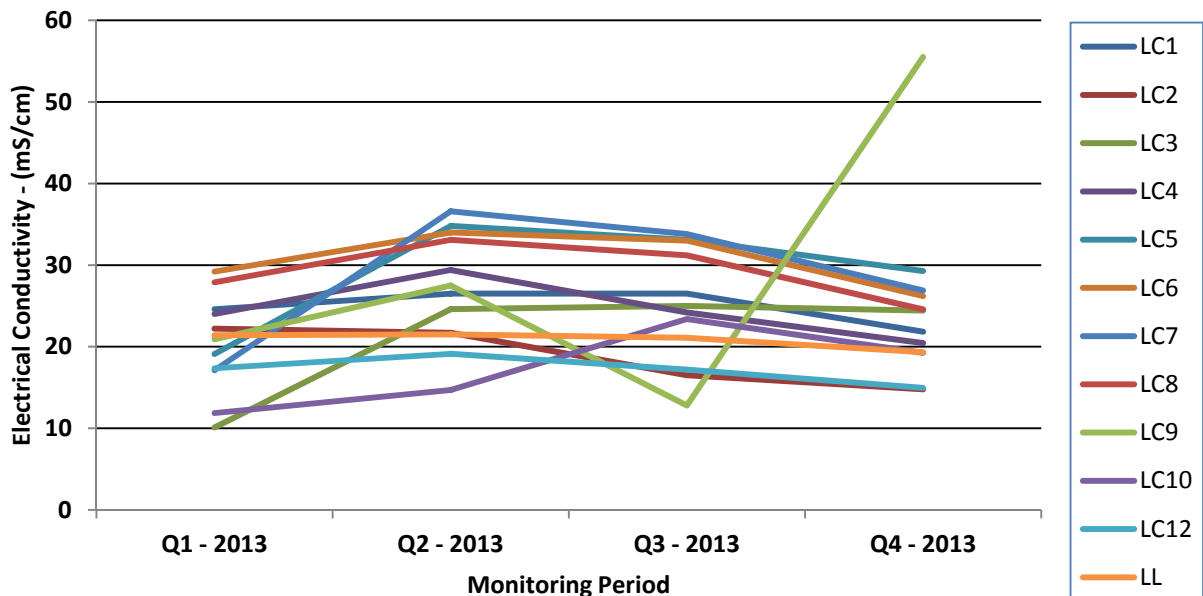
Figure 4.22: Electrical Conductivity Results for Leachate

The electrical conductivity (EC), readings presented in Figure 4.22, show greater variation in results between individual cells and between quarters. High EC levels are observed in all cells with a large elevation in cell 9 during quarter 4 2013.

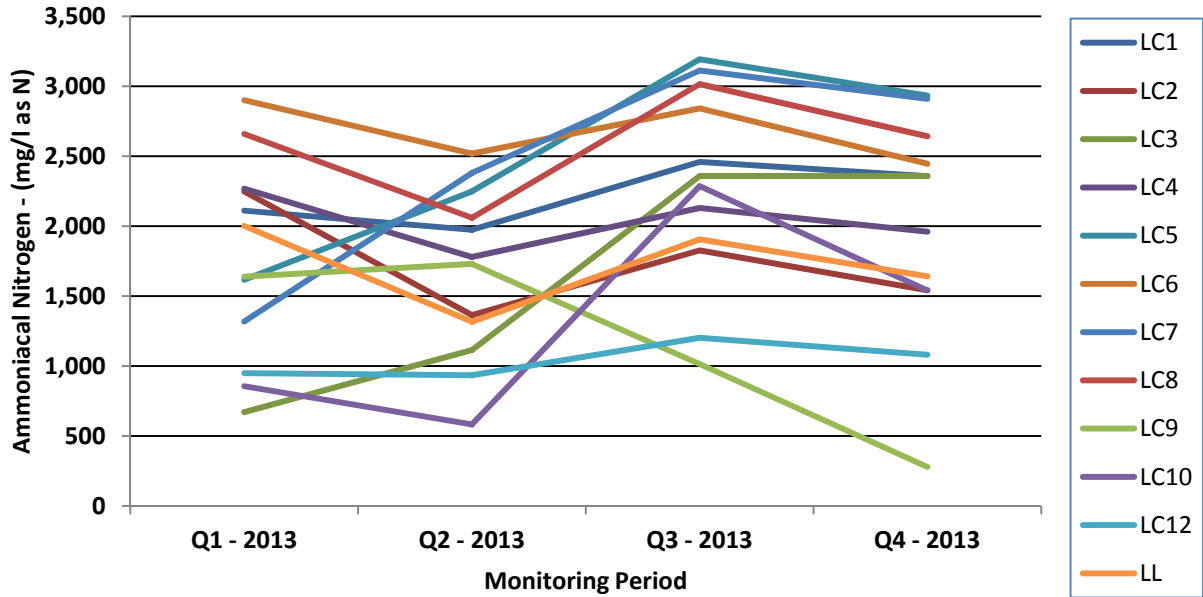
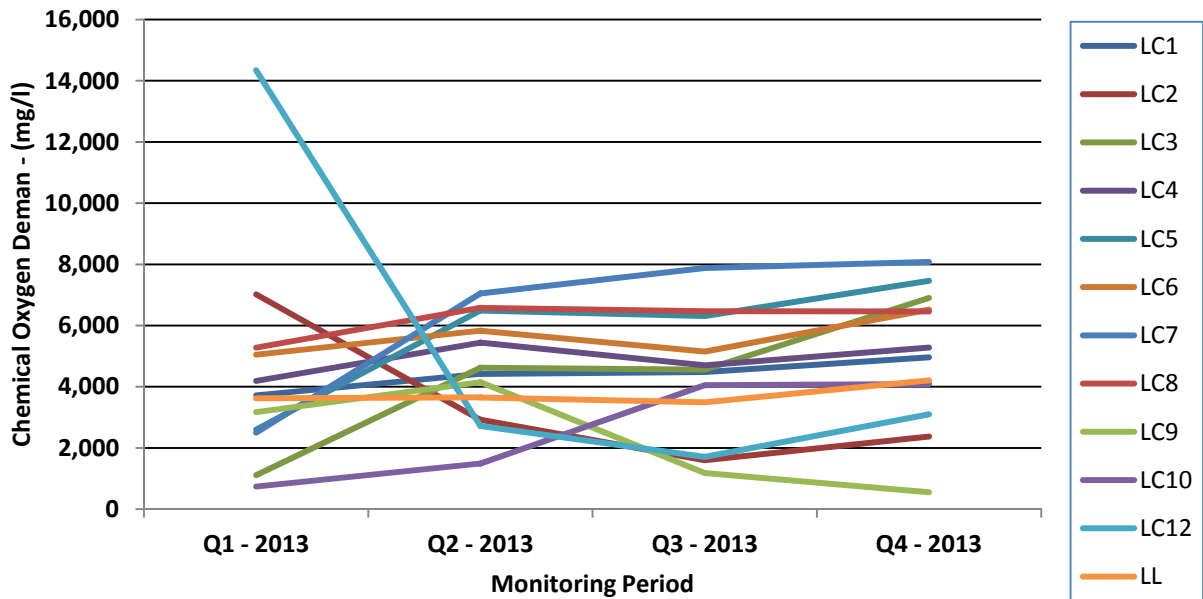
Figure 4.23: Ammoniacal Nitrogen Results for Leachate

Figure 4.24: Chemical Oxygen Demand Results for Leachate

There are no trends associated with ammoniacal nitrogen, presented in Figure 4.23, and chemical oxygen demand, presented in Figure 4.24 in leachate sampled through the reporting period apart from elevated COD levels at LC12 during quarter 1.

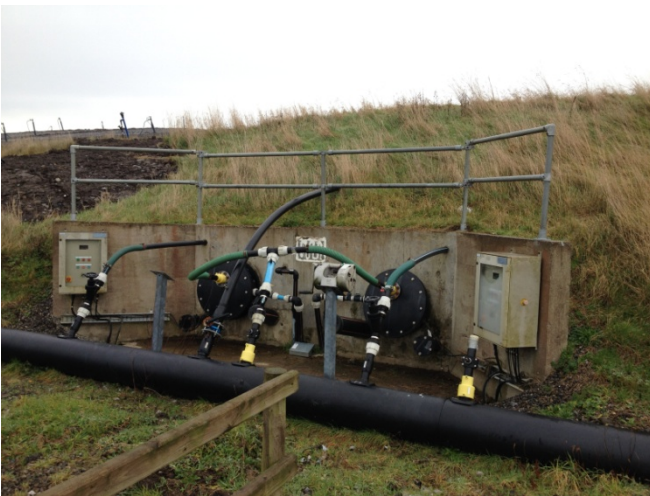
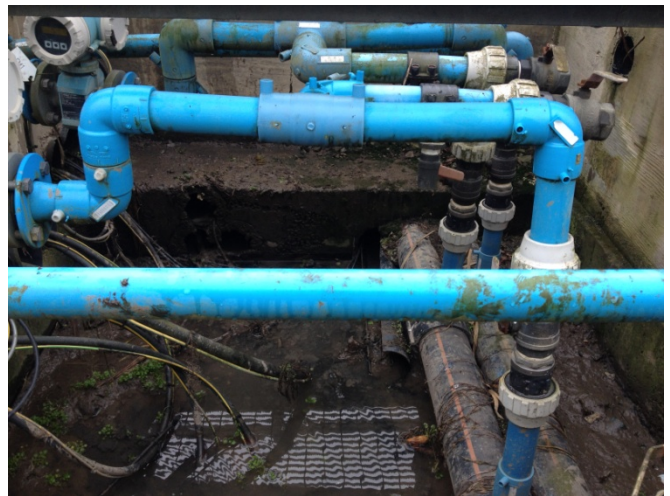
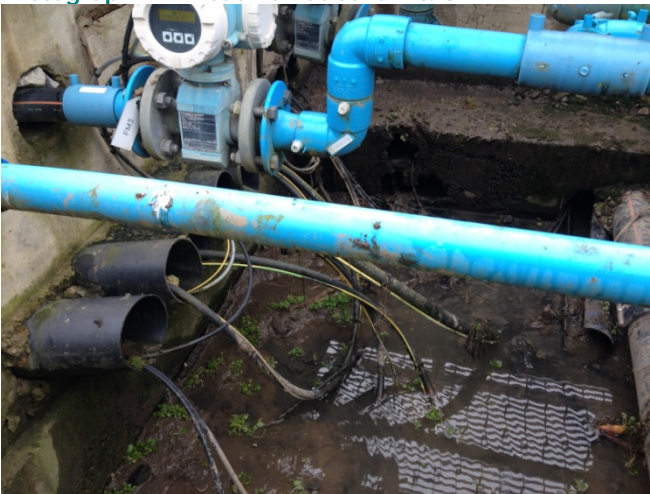
No damage or concrete deterioration was observed at the chamber at Cells 1 and 3. Vegetation growth is evident but does not compromise integrity. Regular removal is recommended.

Photograph 1: Headwall at cells 1 & 3

Photograph 2: Pipework in Chamber 1 & 3

Photograph 3: Pipework in Chamber 1 & 3

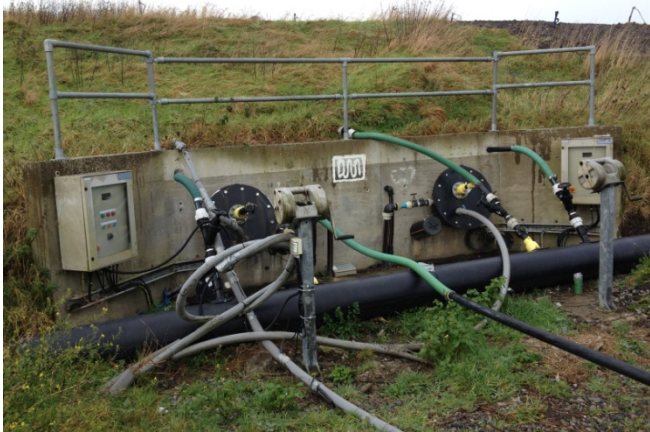
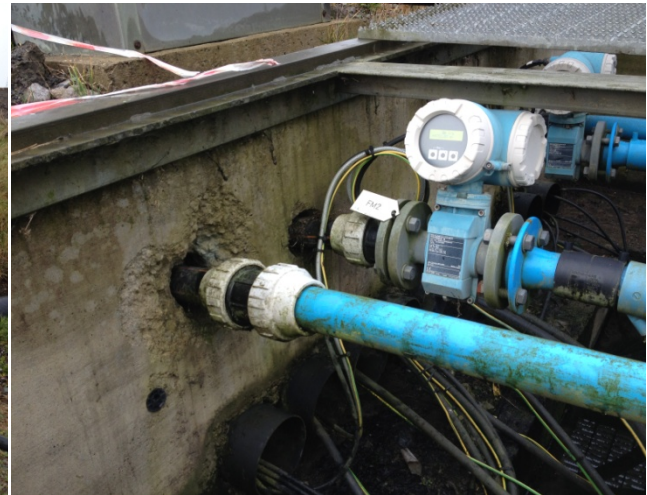
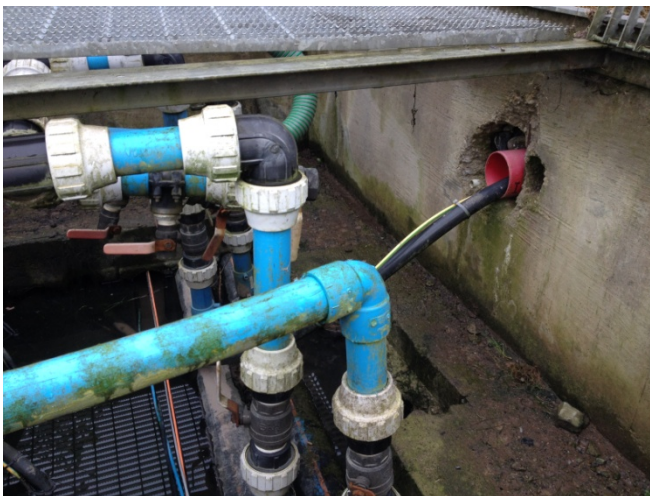
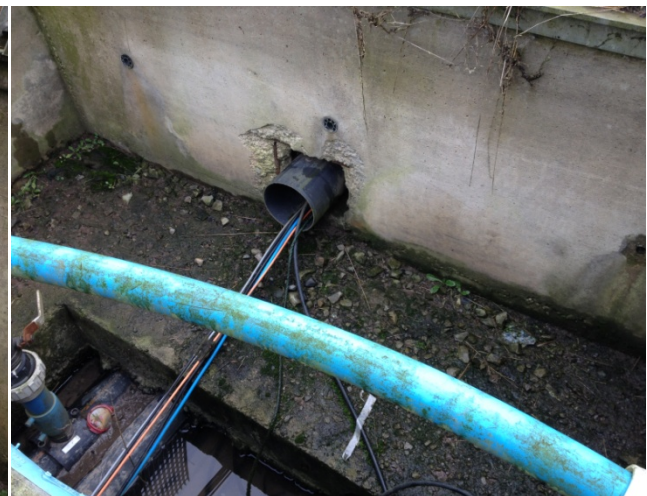
Some concrete damage (at construction stage) was observed around the duct pipes at the chamber at Cells 2 and 4. This does not compromise the integrity of the leachate system. A monthly photographic record of the concrete damage was taken in 2011, which indicated that no deterioration occurred during the period. Vegetation Growth in the vicinity of the headwall does not compromise the integrity of the leachate containment system but its removal is recommended. There are no visible leaks from any of the pipework.

Photograph 4: Headwall at cells 2 & 4

Photograph 5: Concrete damage (construction stage finish)

Photograph 6: Concrete damage (construction stage finish)

Photograph 7: Pipework for Cells 2 & 4

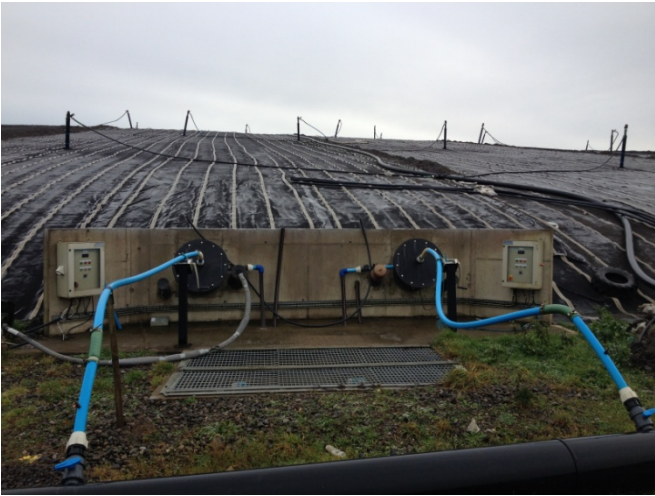
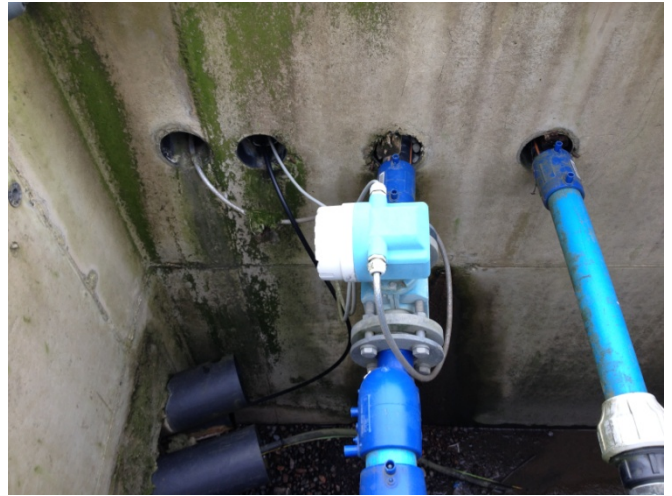
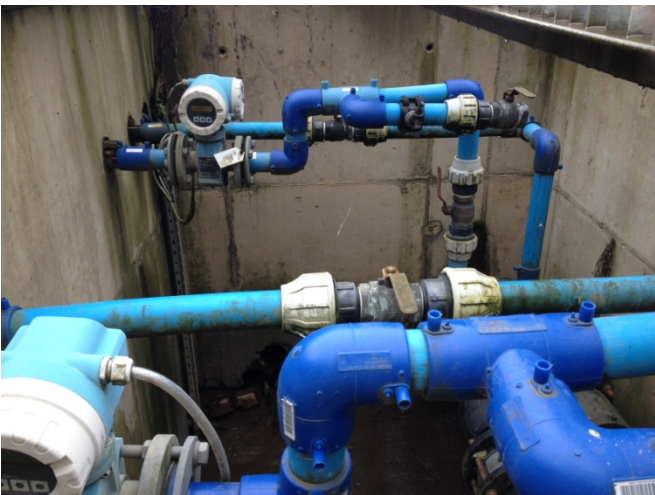
No damage or concrete deterioration was observed at the chamber at Cells 5 and 7. There are no visible leaks from any of the pipework.

Photograph 8: Headwall at Cells 5 & 7

Photograph 9: Pipework at Cells 5 & 7

Photograph 10: Pipework at Cells 5 & 7

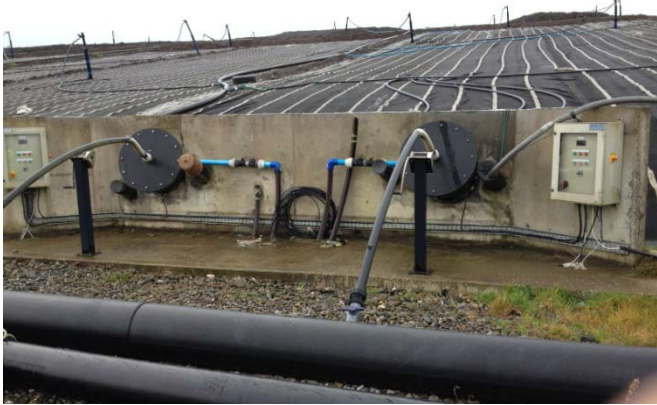
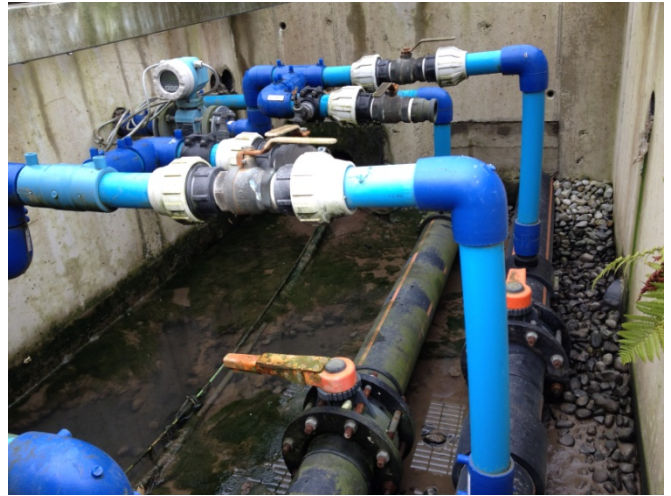
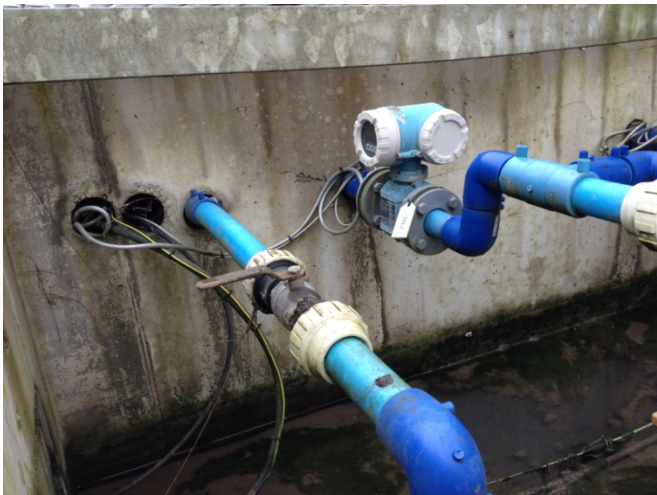
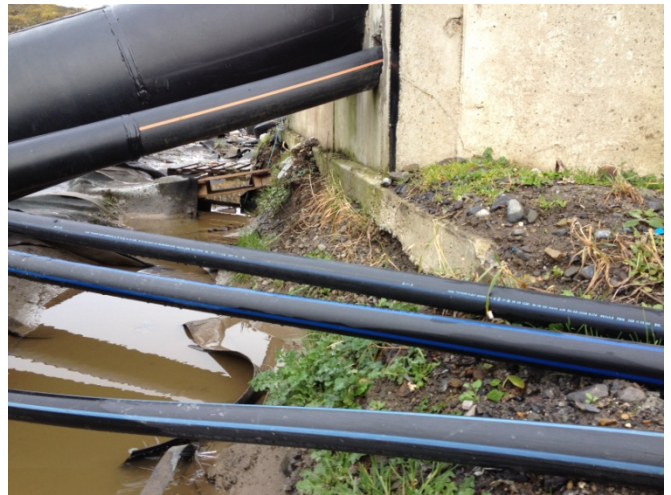
No concrete deterioration was observed at the chamber at Cells 6 and 8. There are no visible leaks from any of the pipework. Undermining of the headwall foundations to the rear is evident. This is as a result of capping works and will be rectified with the placement of cover soil on top of the bare liner during Spring 2014.

Photograph 11: Headwall at Cells 6 & 8

Photograph 12: Pipework for Cells 6 & 8

Photograph 13: Pipework for Cell 8

Photograph 14: Undermining to rear of headwall

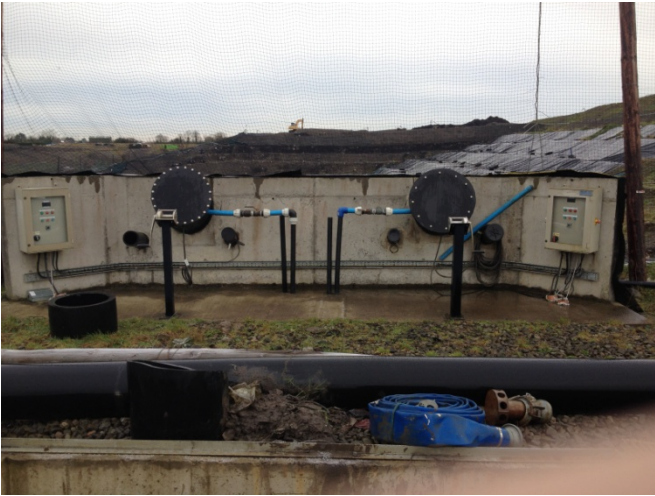
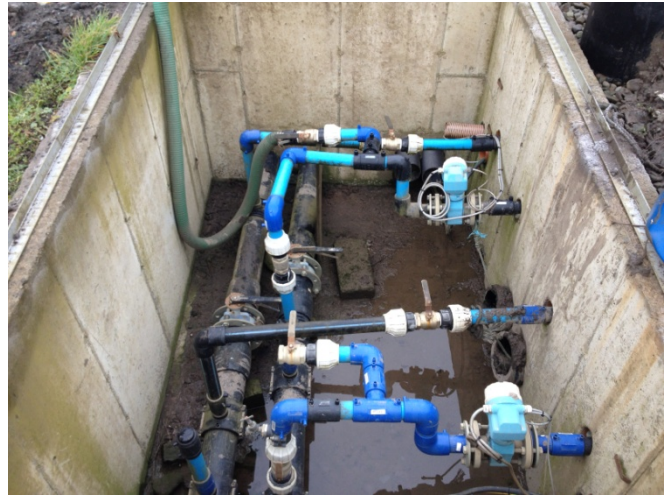
No damage or concrete deterioration was observed at the chamber at Cells 9 and 11. There are no visible leaks from any of the pipework. It is noted that as cells 11 and 12 contain no waste, discharge from the pump in Cell 11 is directed to the swale (discharge pipe is green in colour in the photograph).

Photograph 15: Headwall at Cells 9 & 11

Photograph 16: Pipework at Cell 9 & 11

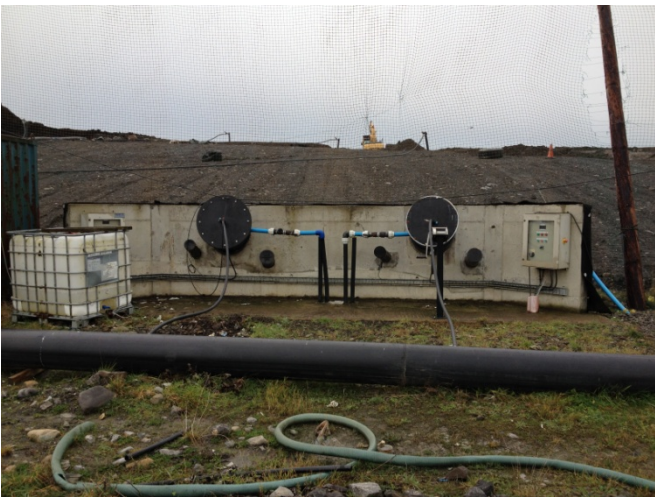
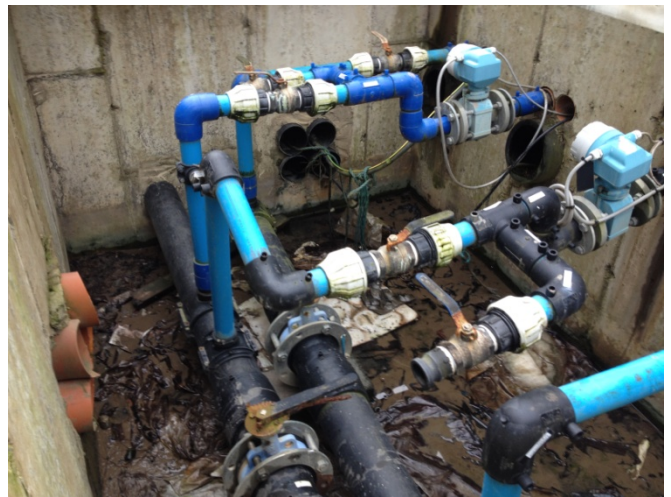
No concrete deterioration was observed at the chamber at Cells 10 and 12. It is noted that as cells 11 and 12 contain no waste, discharge from the pump in Cell 12 is directed to the swale.

Photograph 17: Headwall at 10 & 12

Photograph 18: Pipework at Cell 10

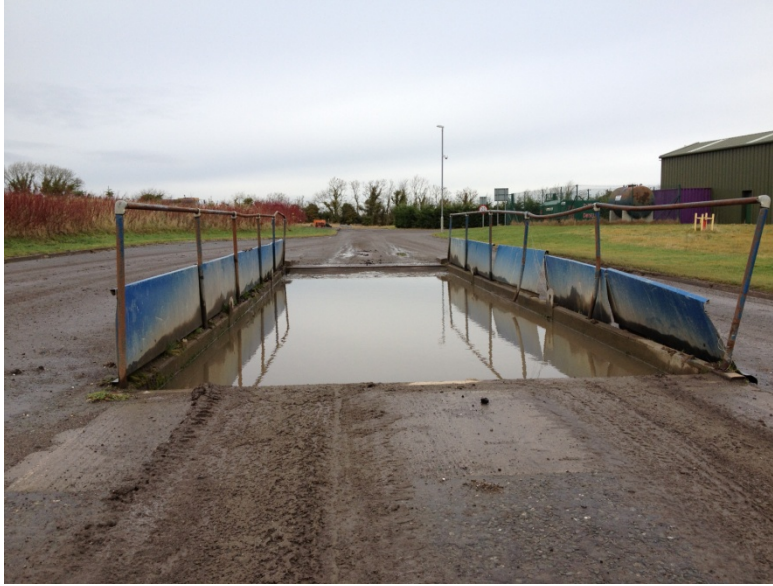
The contents of the wheel wash are managed as leachate. Trucks drive through a water bath before exiting the site. There was no evidence of cracking or other deterioration of the concrete that would give rise to concerns regarding containment of the wheel wash water.

Photograph 19: View of wheelwash, looking North
